Rockingham BF 0125-1(48)
Regional Concerns Meeting
VT Route 103– Bridge #3 over Unnamed Brook

October 6, 2021

Rockingham NH CULV(66)
Regional Concerns Meeting
VT Route 103– Bridge #6 over Unnamed Brook

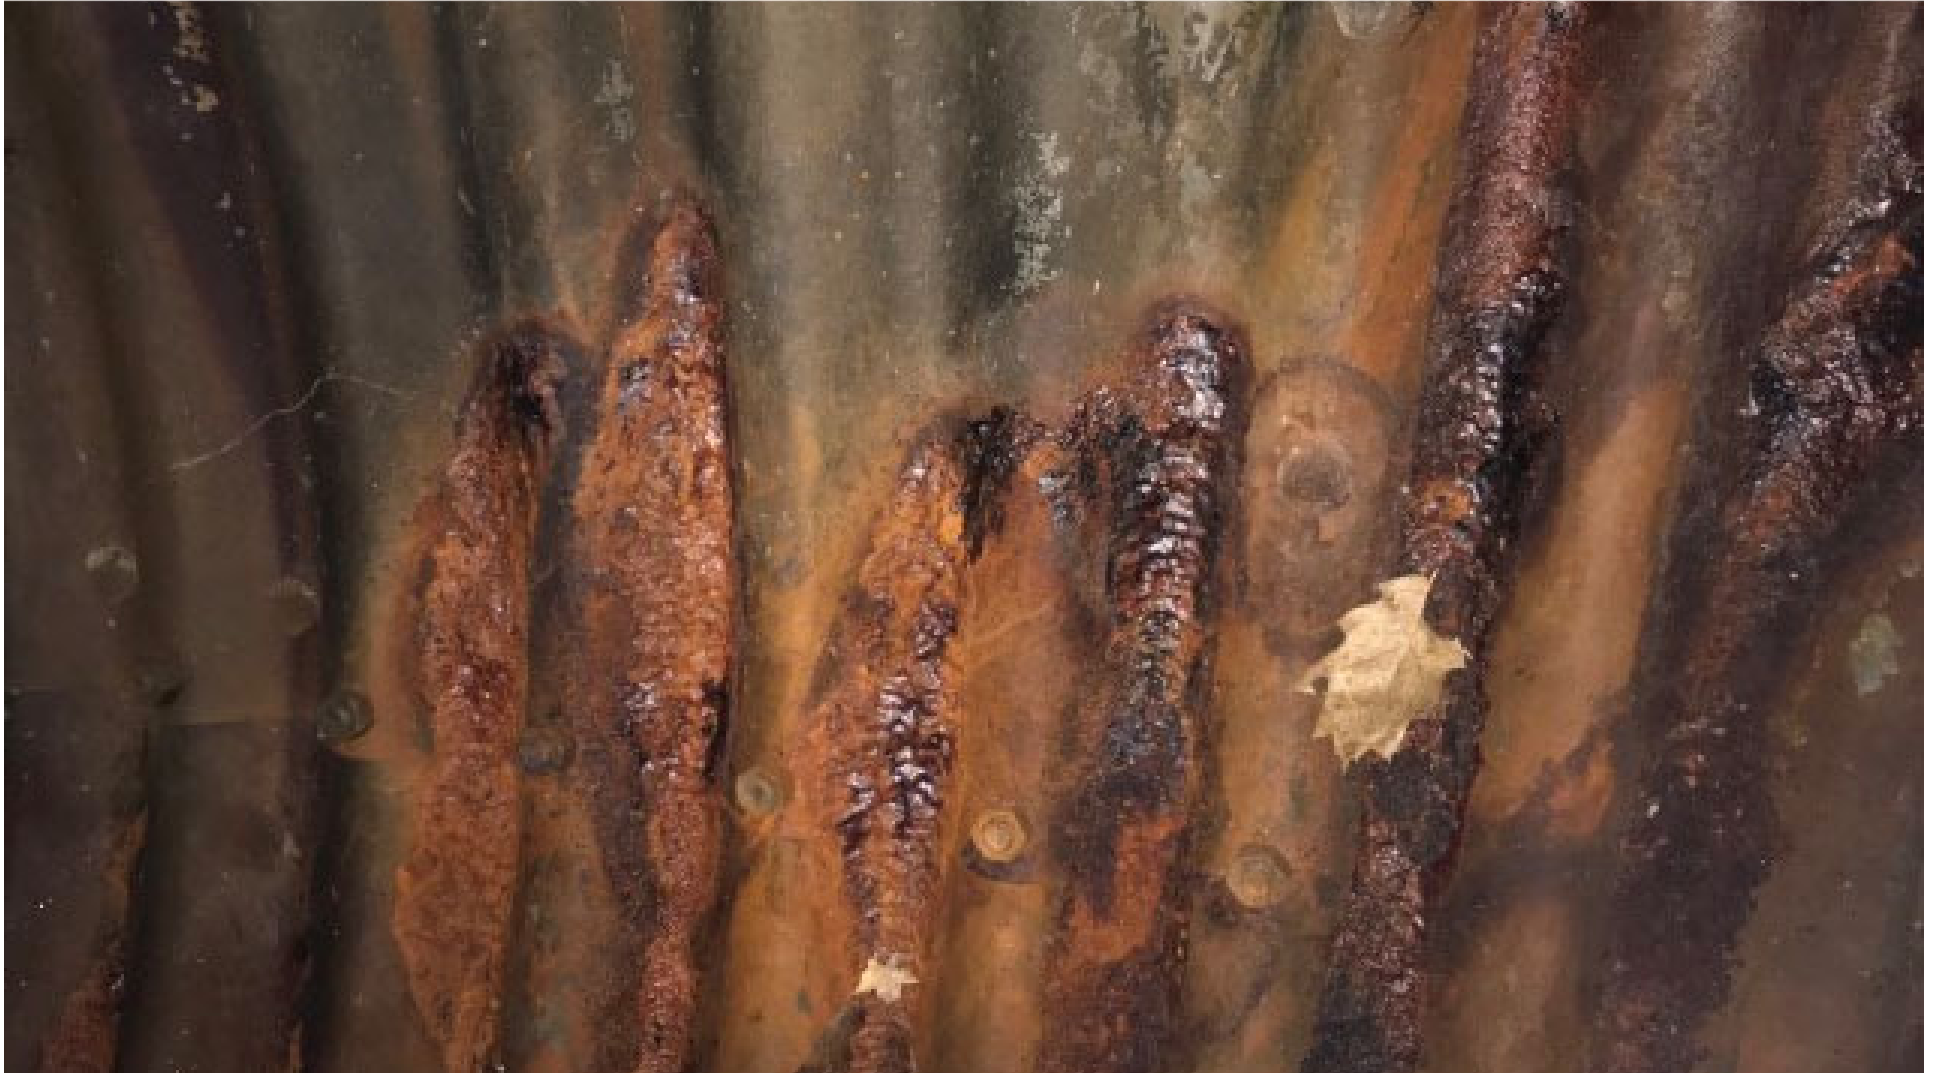
Condition Ratings

- The existing culvert is rated as poor with a heavily rotted and rusted out invert.
- The culvert does not provide aquatic organism passage.
- The culvert does not meet the minimum bank full width.
- The shoulder on the northbound side of VT Route 103 is substandard by 1 foot.

Existing Conditions - Bridge #6

■ Culvert Rating 4 (Poor)

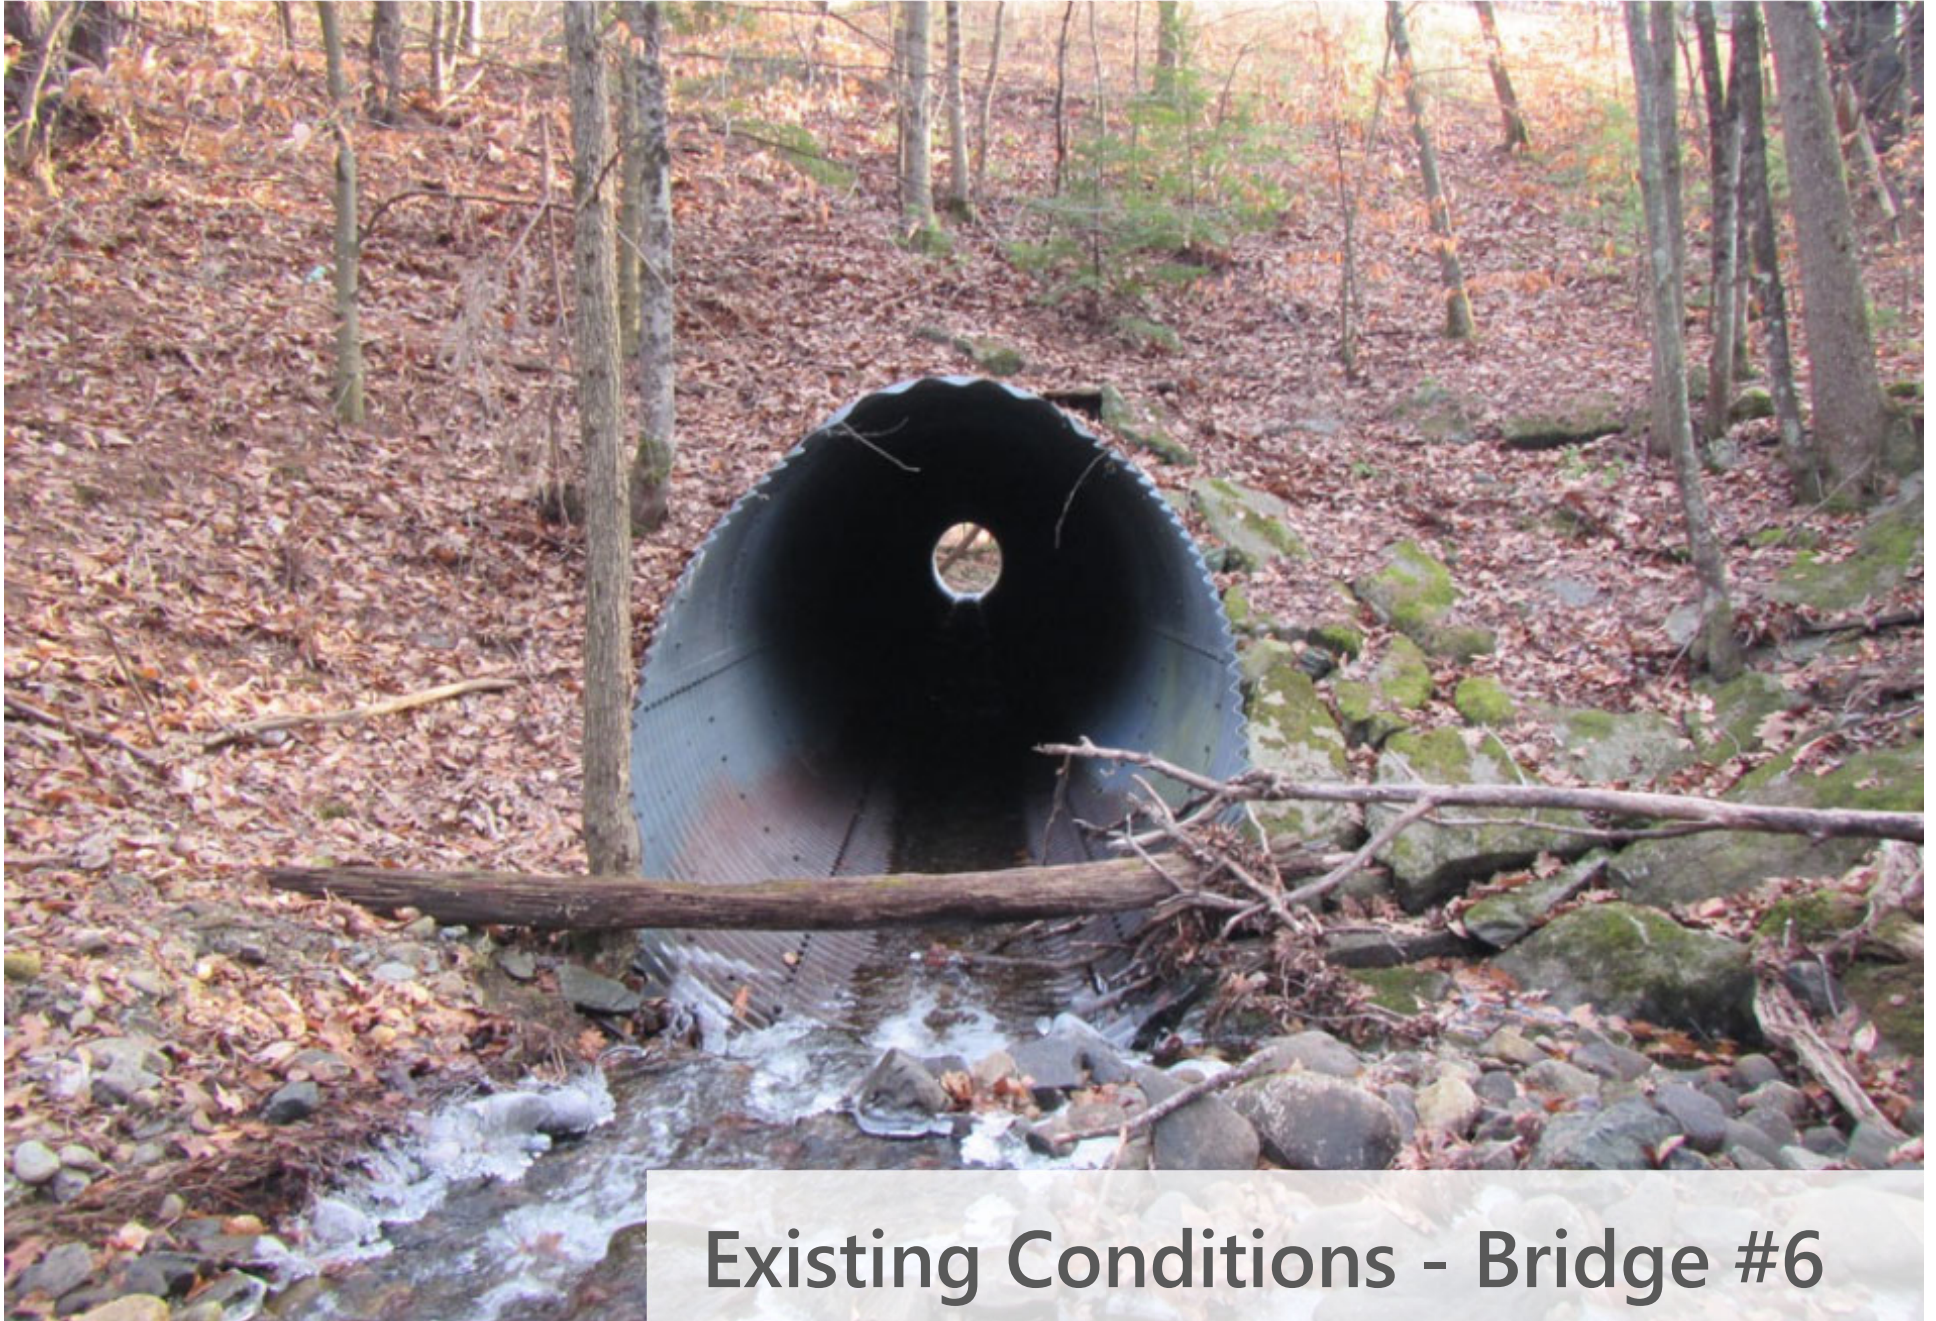
Inlet

Existing Conditions - Bridge #6

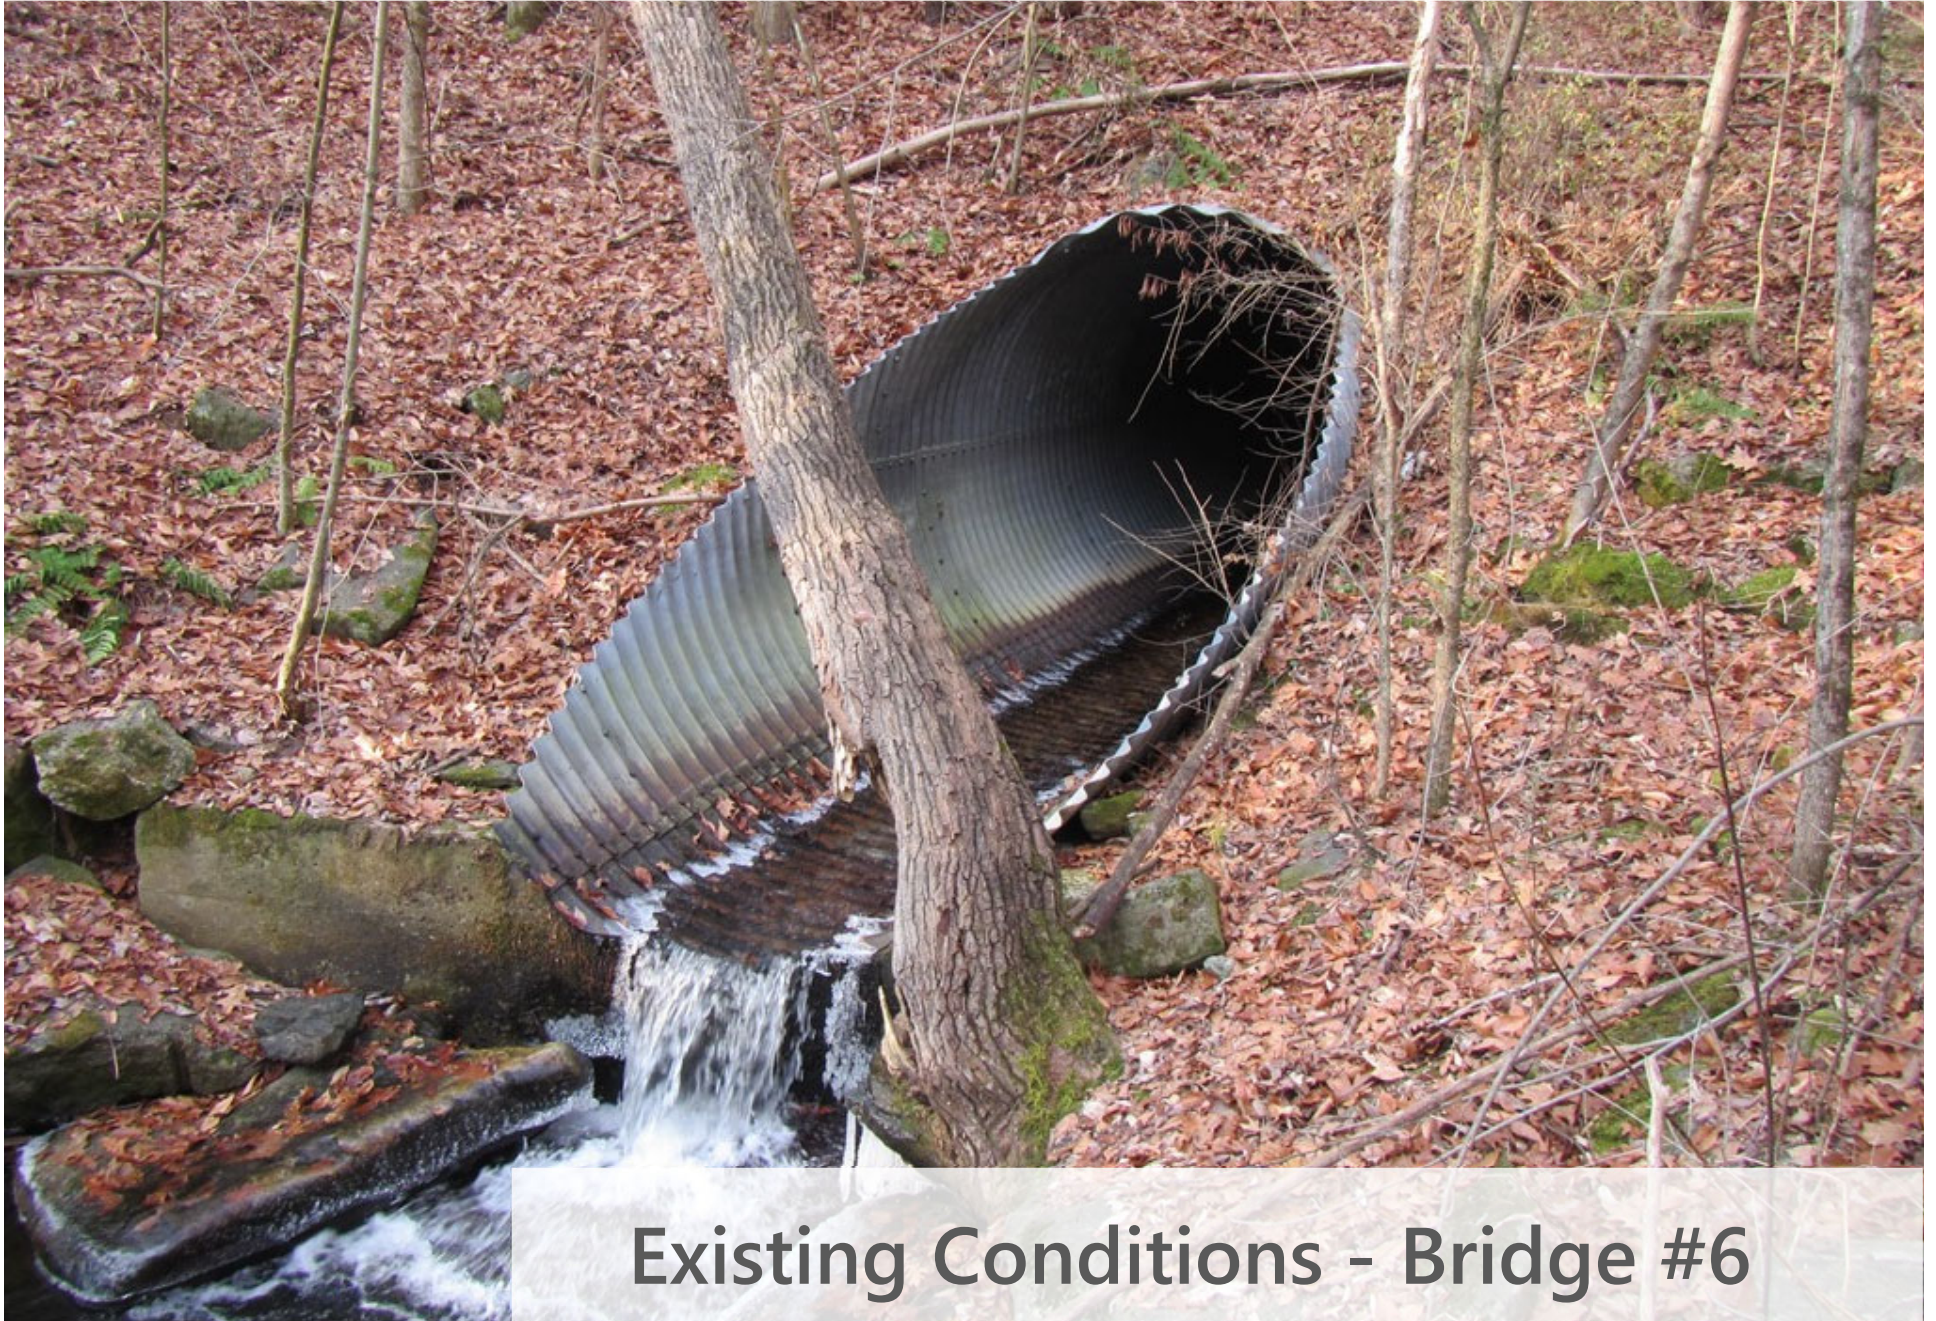
Outlet

Existing Conditions - Bridge #6

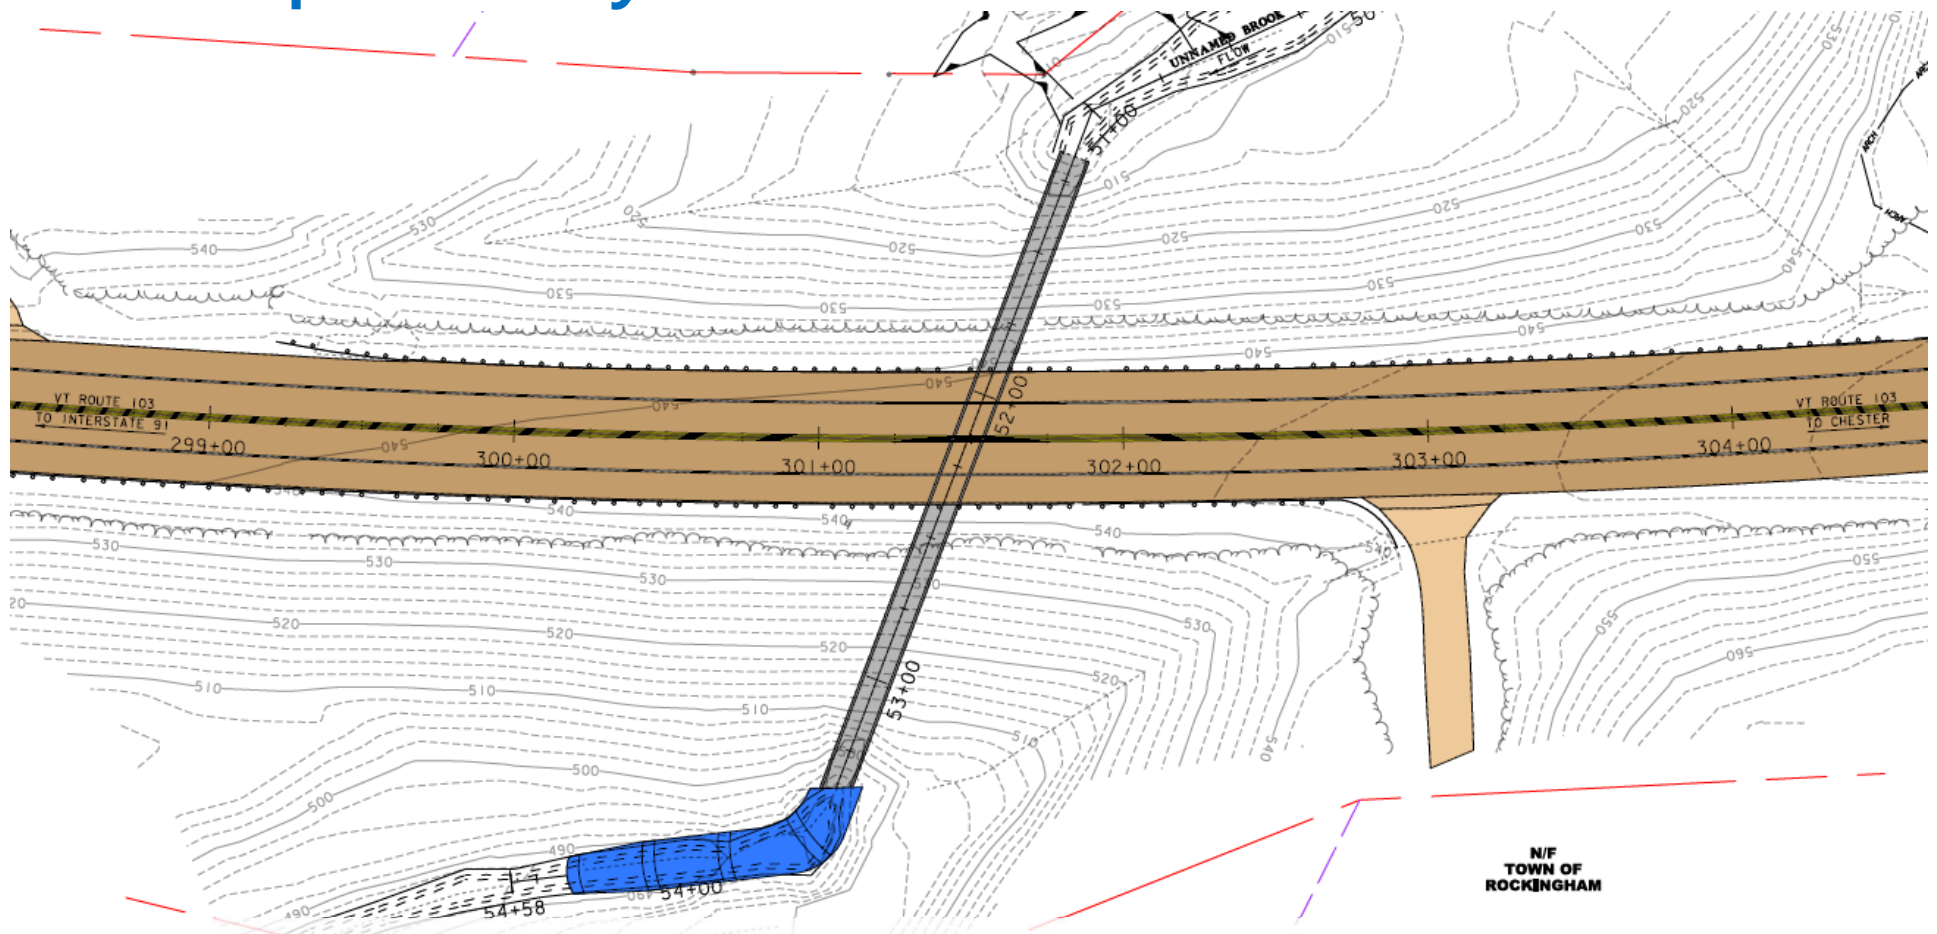
Proposed Layout

New Integral Abutment Bridge - Bridge #6

- 12'/9' typical, 20 to 50-year design life
- Downstream weirs for AOP
- Substandard Bankfull Width

- Culvert Rehabilitation with a Pipe Liner
 - Construct beveled inlet
 - Baffles constructed throughout culvert along with several downstream weirs to satisfy AOP requirements
 - Meets minimum hydraulic standard
 - Does not meet minimum BFW
 - 12'/9' typical to match existing conditions
 - Slightly substandard – acceptable for rehabilitation
 - 50-year design life
 - No Right-of-Way needed

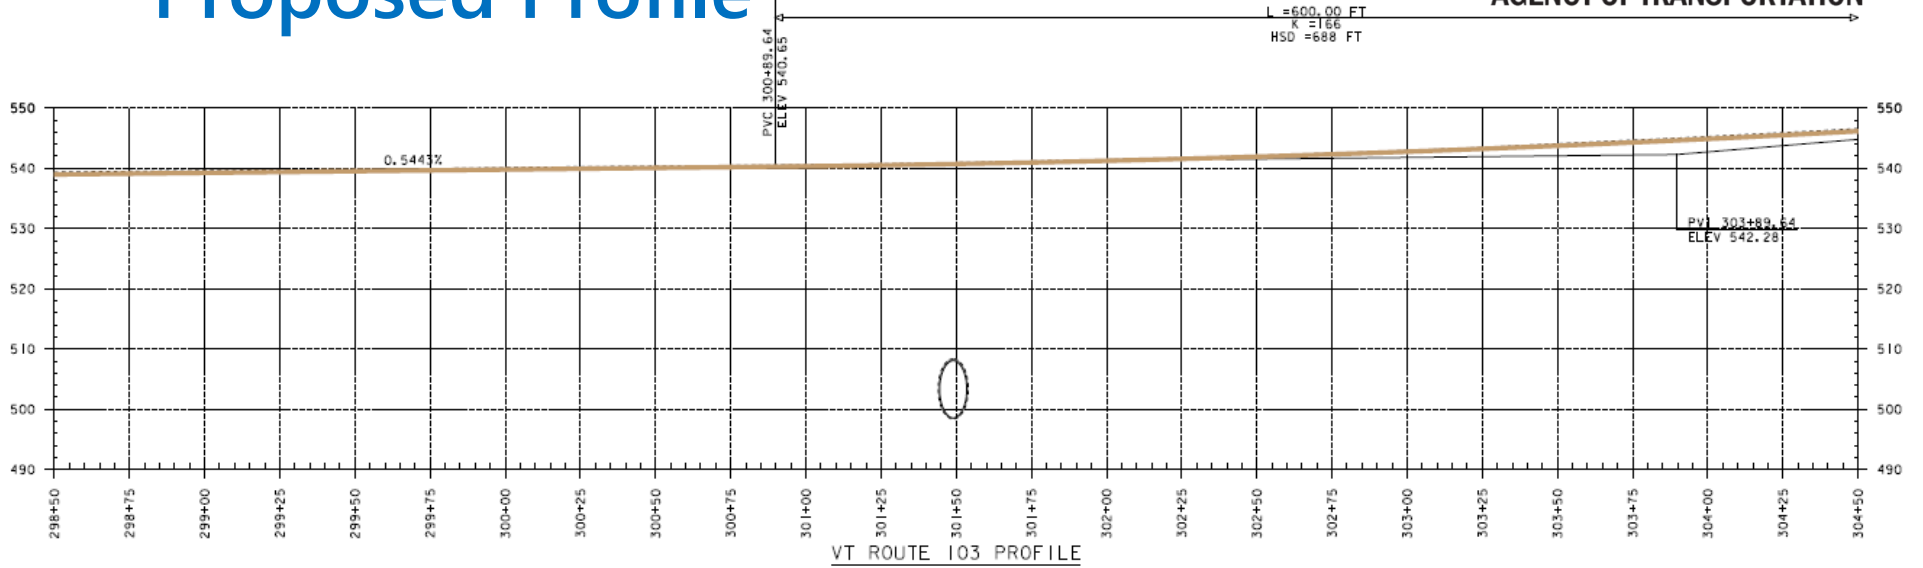
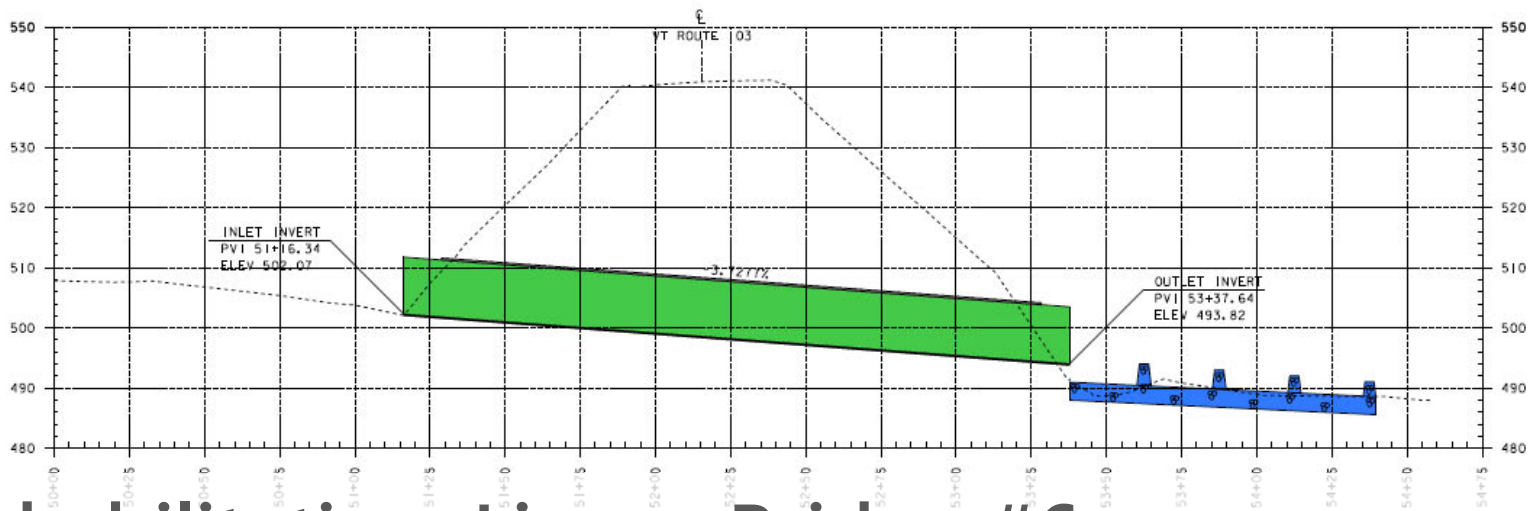
Proposed Profile

Rehabilitation, Liner - Bridge #6

- Downstream weirs for AOP
