Plymouth BF 013-3(17)
Regional Concerns Meeting
VT Route 100– Bridge #114 over Reservoir Brook

September 21, 2020

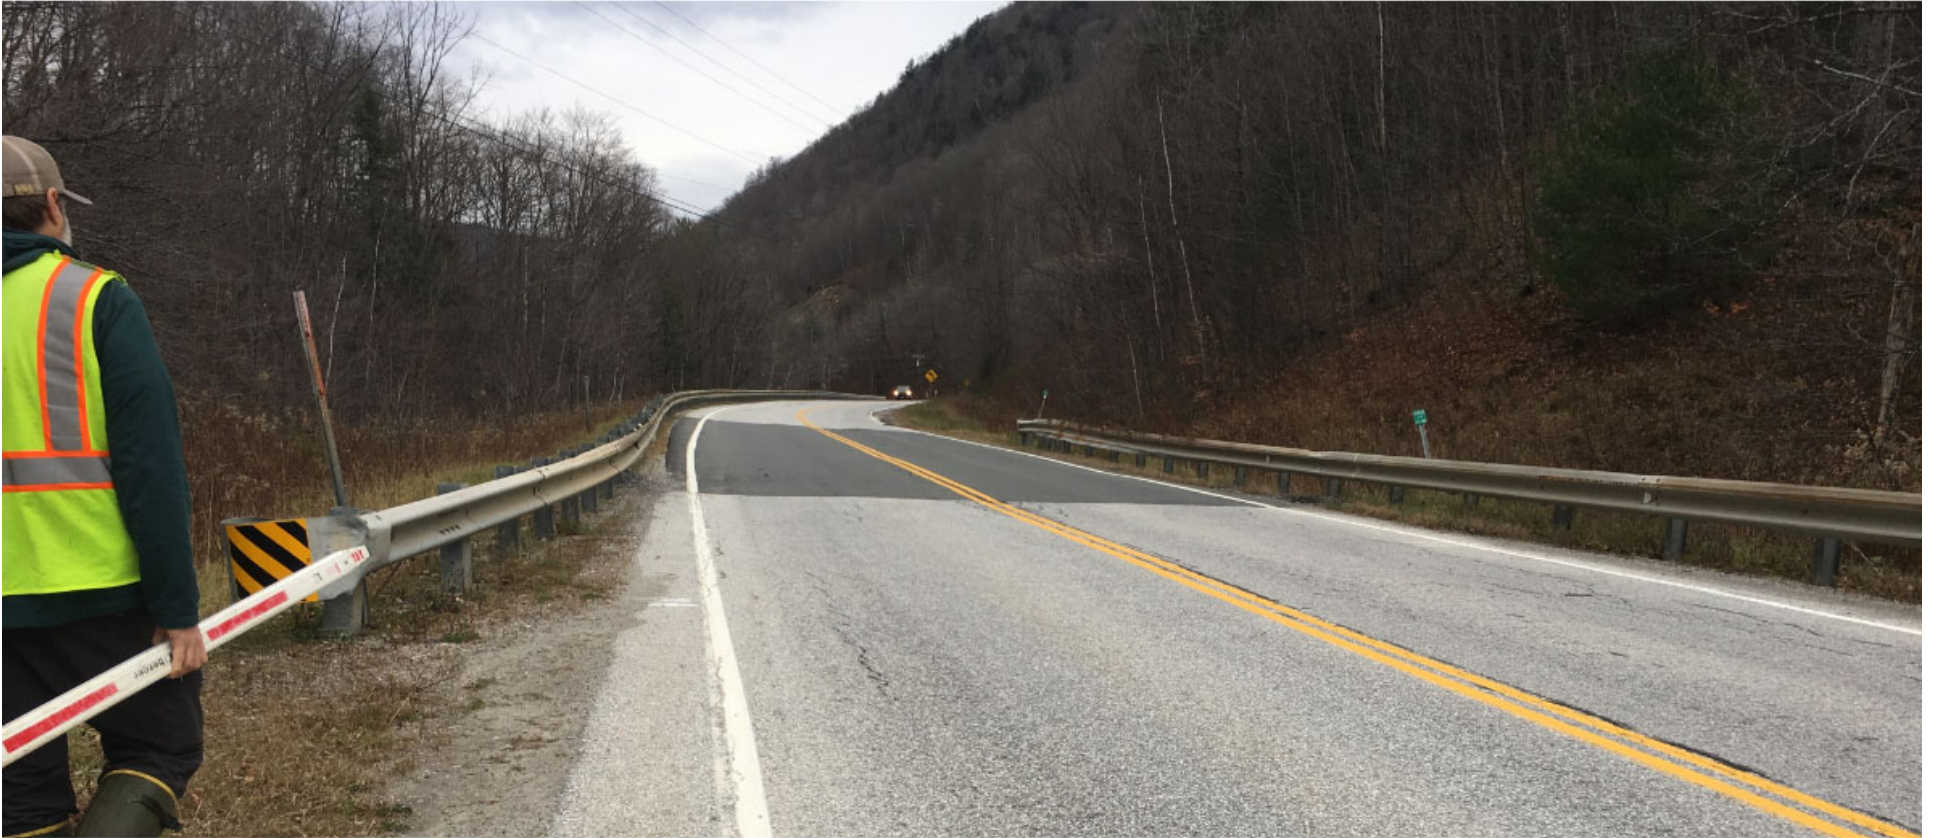
Looking South over Bridge 114

Existing Conditions – Bridge #114

- Aerial Utilities
- Steep slopes upstream and downstream

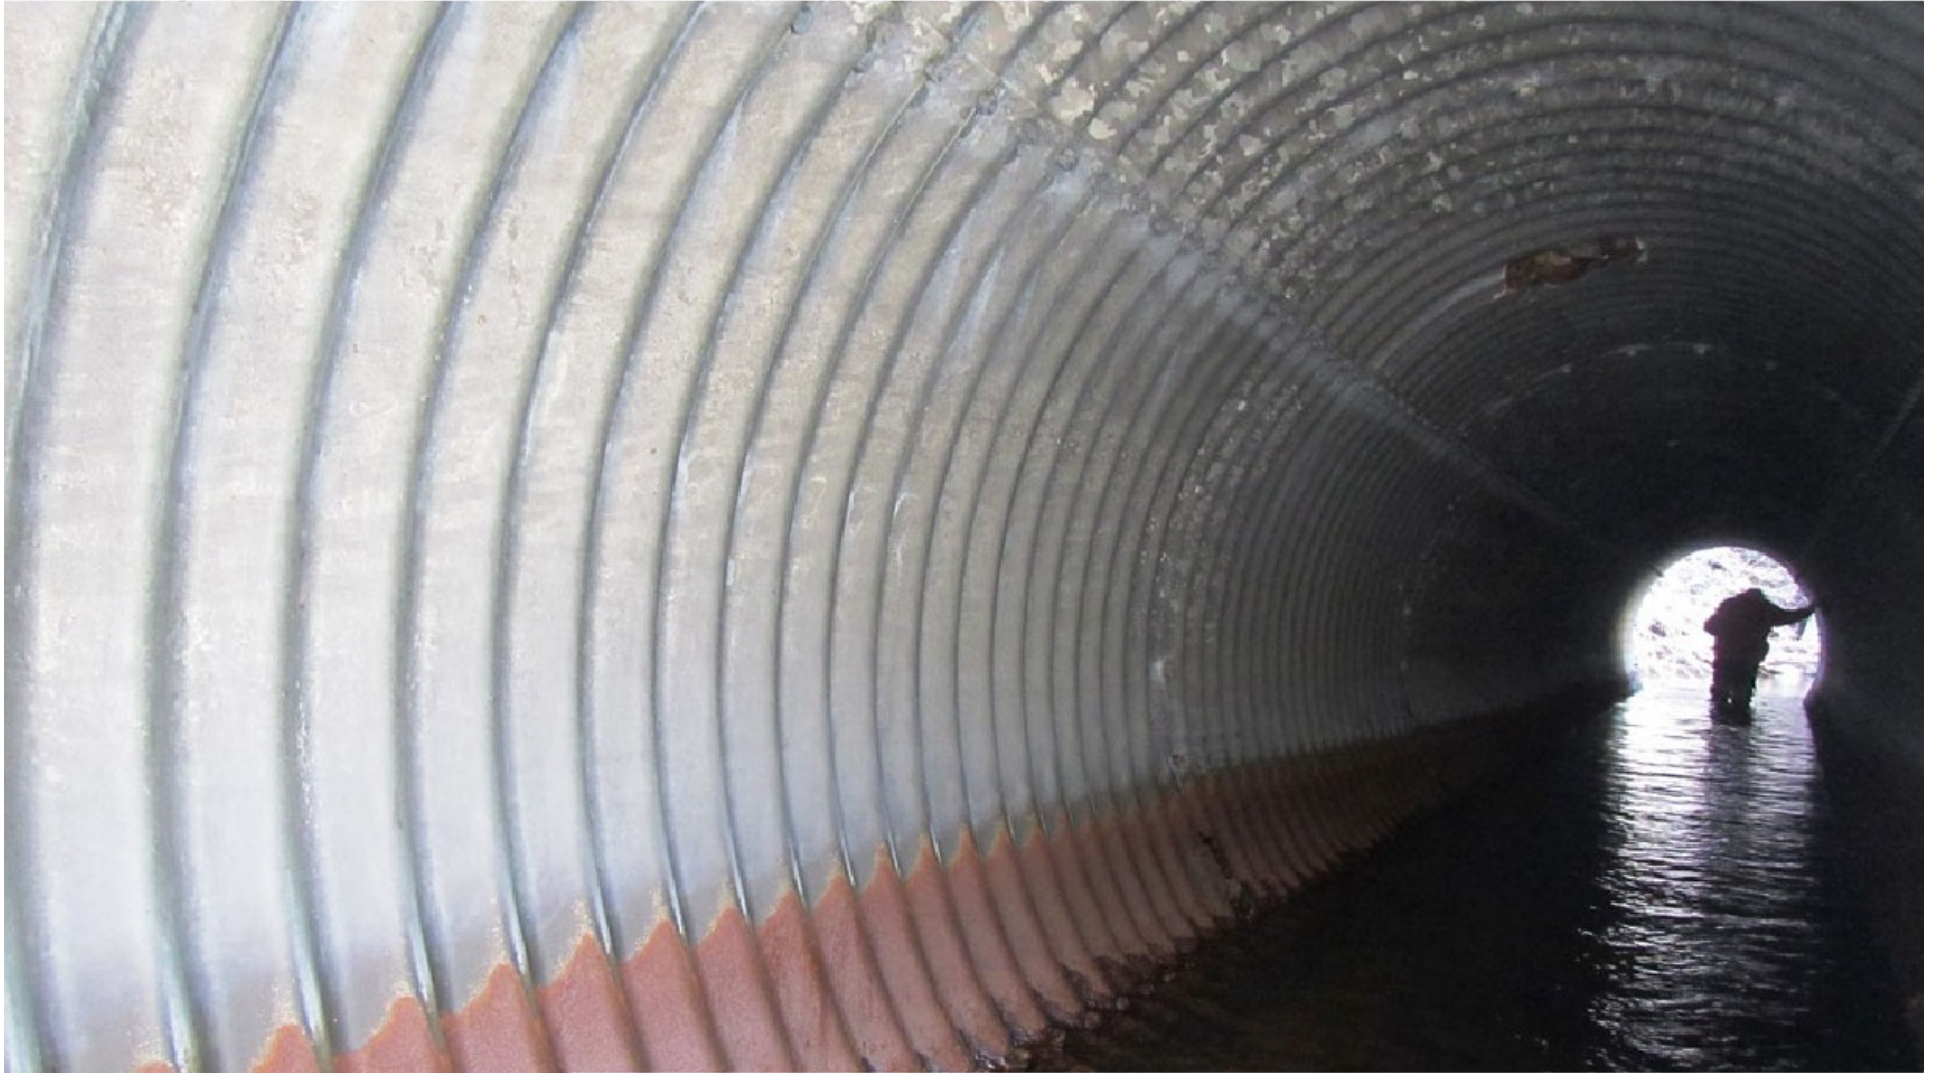
Inlet

- The culvert is in serious condition.
 - There is a hole along the top of barrel toward inlet end.
 - The pipe has some deformation starting along south side of the barrel.
 - Large holes along the haunch areas have been observed throughout and along the invert.
 - The invert has started to crush and has slotted holes and torn out ribs. Piping is occurring along barrel walls and along invert.
 - Crushing is evident at the mid-span and along the invert.
