# Jamaica Weathering Steel Update

DEPOT STREET BRIDGE

JAMAICA BO 1442(42)

TH 19, BRIDGE NO. 32 OVER WEST RIVER

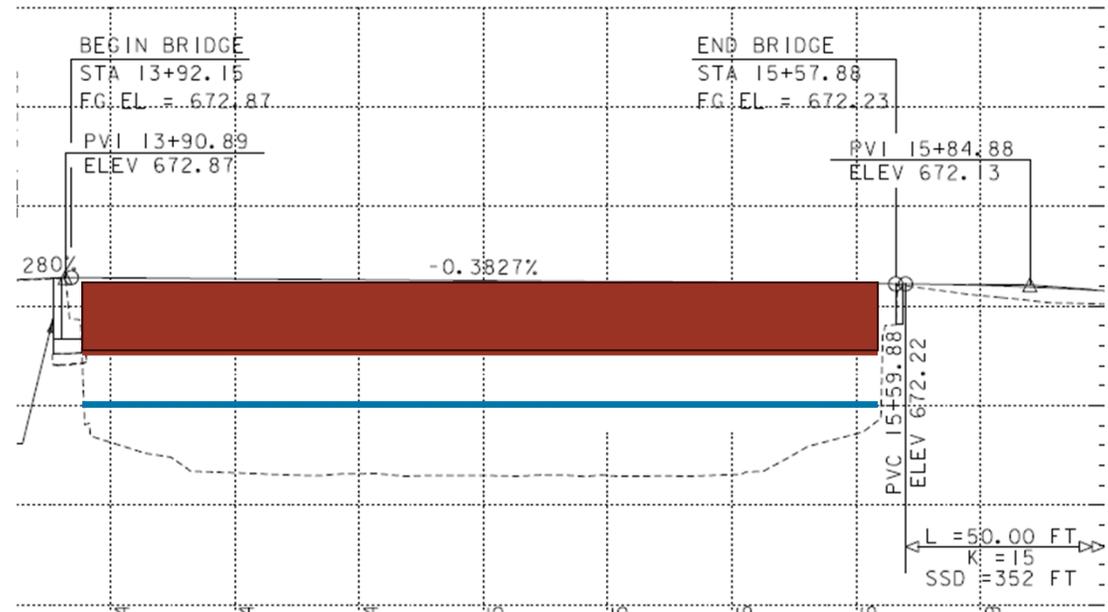
- Water Elevation: 660.4ft
  - 43% AEP storm/Bank Full Width used per Vtrans Guidance
- Low Chord Elevation: 665.9ft
  - Roughly 6'-4" preliminary Superstructure depth
- Distance Above Water: 5.5ft
  - $665.9\text{ft} - 660.4\text{ft} = 5.5\text{ft}$

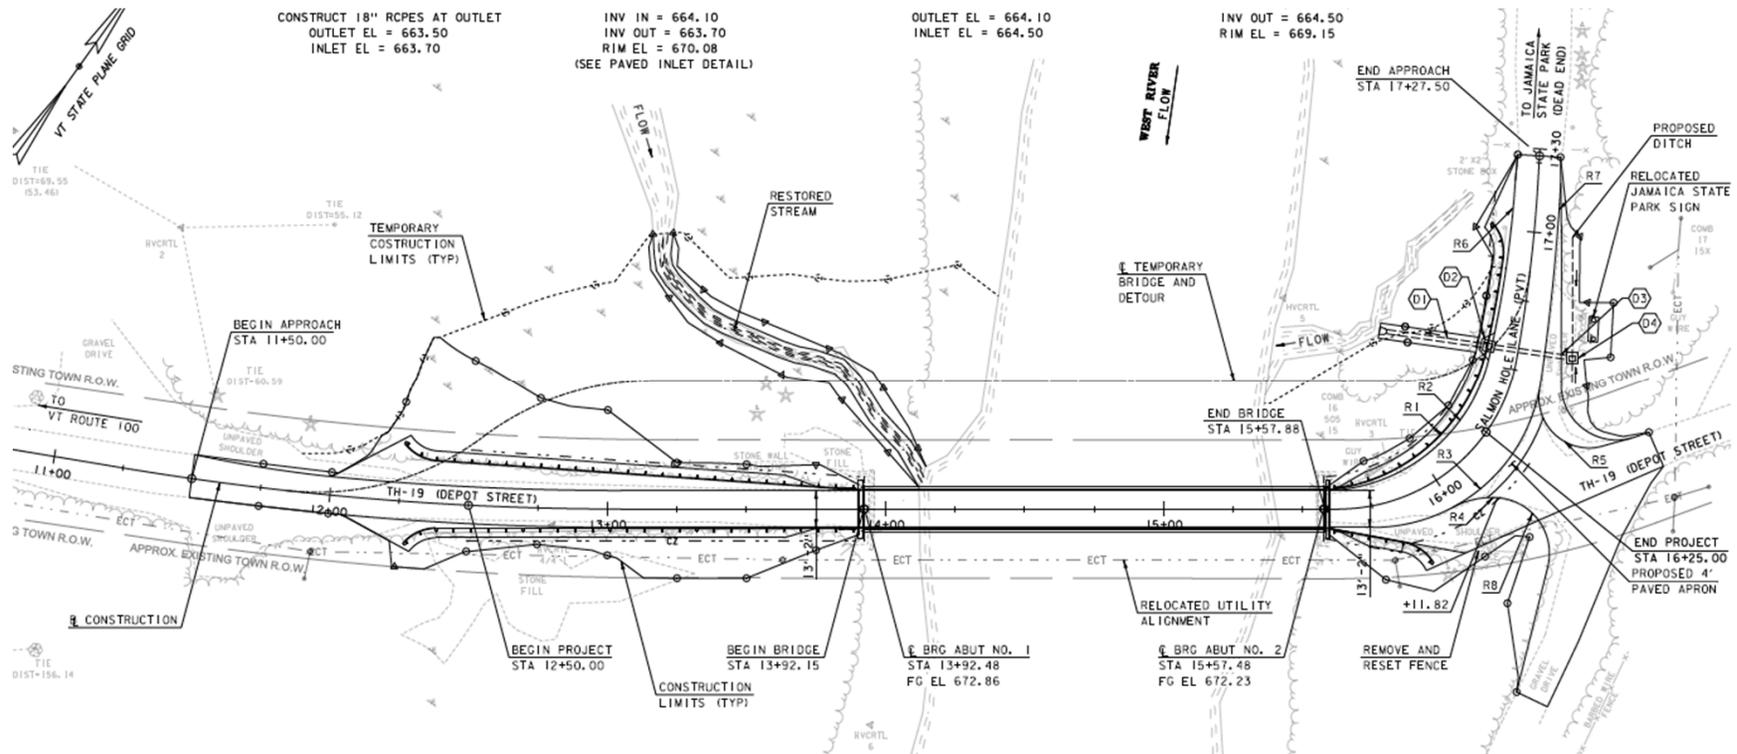
- Can we raise the grade 4.5ft to meet the 10ft minimum requirement?

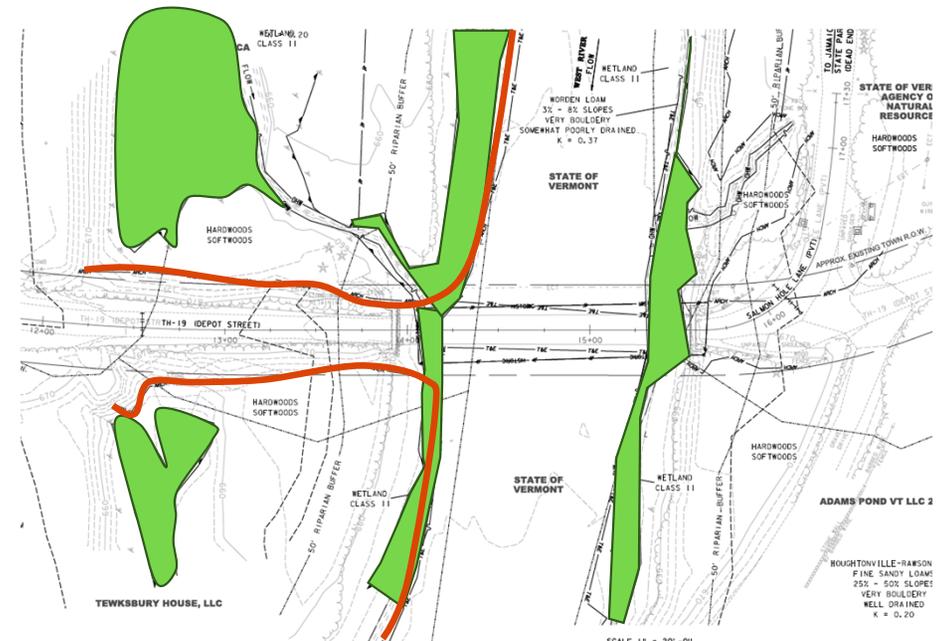
- Can we raise the grade 4.5ft to meet the 10ft minimum requirement?
  - Wetlands
  - Archeological Impacts
  - Driveways to tie into
  - Minimum Grade requirements coming off the bridge
  - Filling a Floodplain, increasing headwater elevations

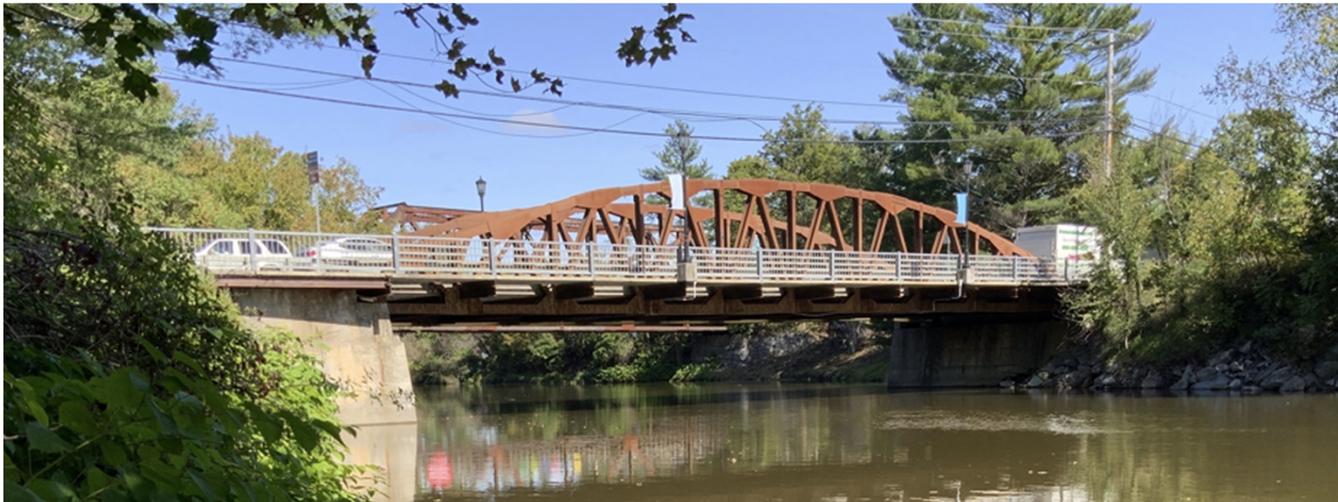
- VTrans Won't Use Weathering Steel for Vehicular Truss Bridges
  - Due to Salt Corrosion Issues and overall performance history
- There is one known Weathering Steel Vehicular Truss in Vermont
  - VT100 Over the Lamoille River

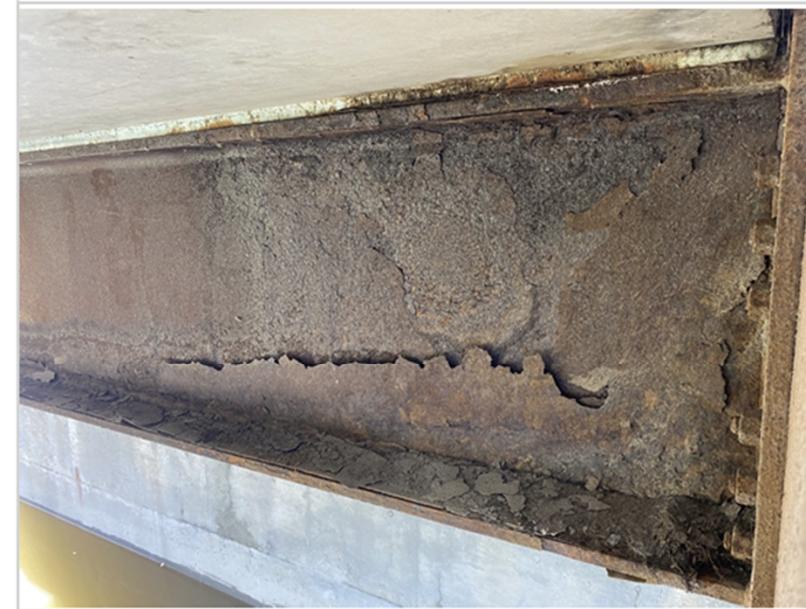
Floorbeam #10 on Upstream Side

Structure is in fairly good to satisfactory condition. The A588 treated welded pony truss has areas of rust scaling forming along multiple verticals and diagonals and along the bottom chord with light to minor pitting present in areas of progressive rust scaling. Floorbeams also have progressing rust scaling along the lower flanges and lower portions of web that is the heaviest near the bottom chord and extends into structure. Superstructure should be cleaned and have a protection layer installed such as grease coating or even painted along the lower portions to help prevent further corrosion. Both abutments have areas of scaling along the lower portions and should be cleaned and patched.

The A588 treated welded pony truss has areas of rust scaling forming along multiple verticals and diagonals and along the bottom chord with light to minor pitting present in areas of progressive rust scaling. Floorbeams also have progressing rust scaling along the lower flanges and lower portions of web that is the heaviest near the bottom chord and extends into structure. Superstructure should be cleaned and have a protection layer installed such as grease coating or even painted along the lower portions to help prevent further corrosion.
