Buel's Gore BF 0200(11)
Regional Concerns Meeting
VT Route 17 – Bridge 29 over Beaver Meadow Brook

June 27, 2022

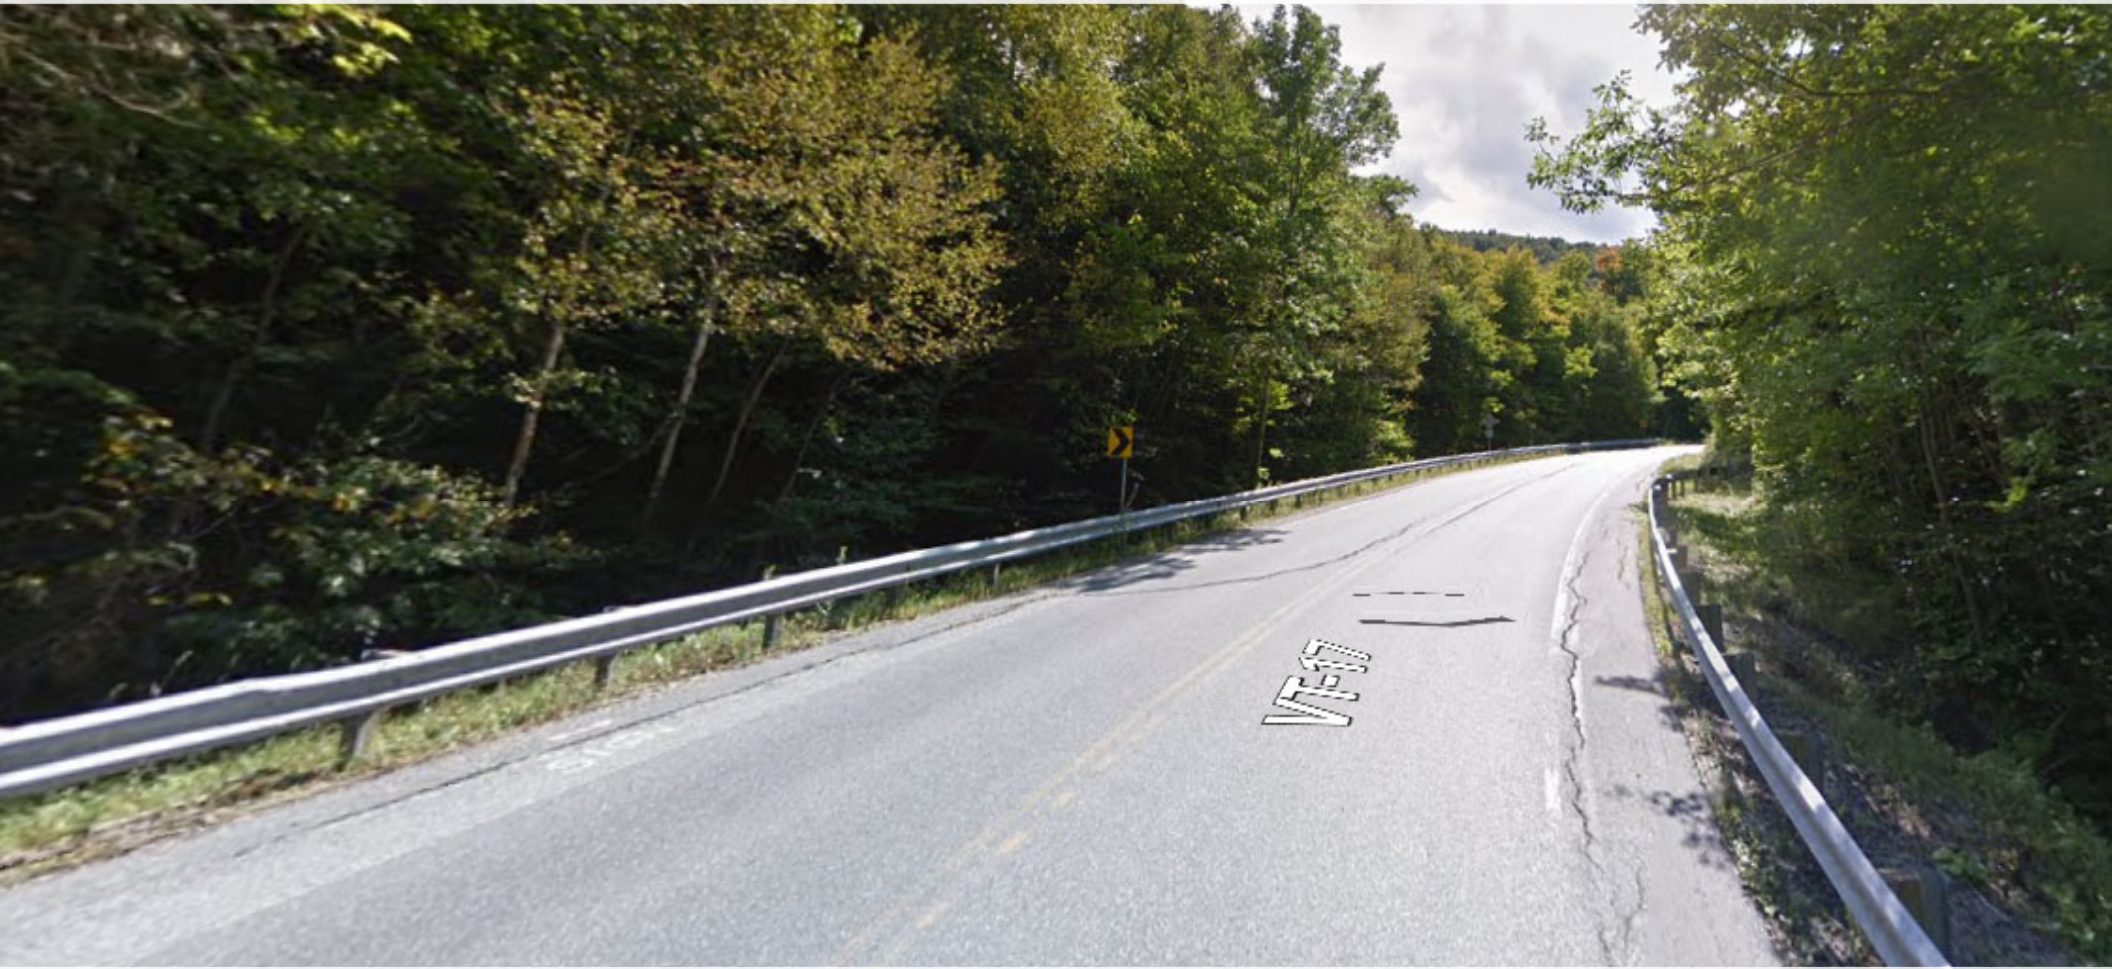
Looking East over Bridge 29

Existing Conditions – Bridge 29

- Roadway Classification – Major Collector
- Bridge Type – 6' span Corrugated Galvanized Metal Plate Pipe (ACCGMPP)
- Ownership – State of Vermont
- Constructed in 1957

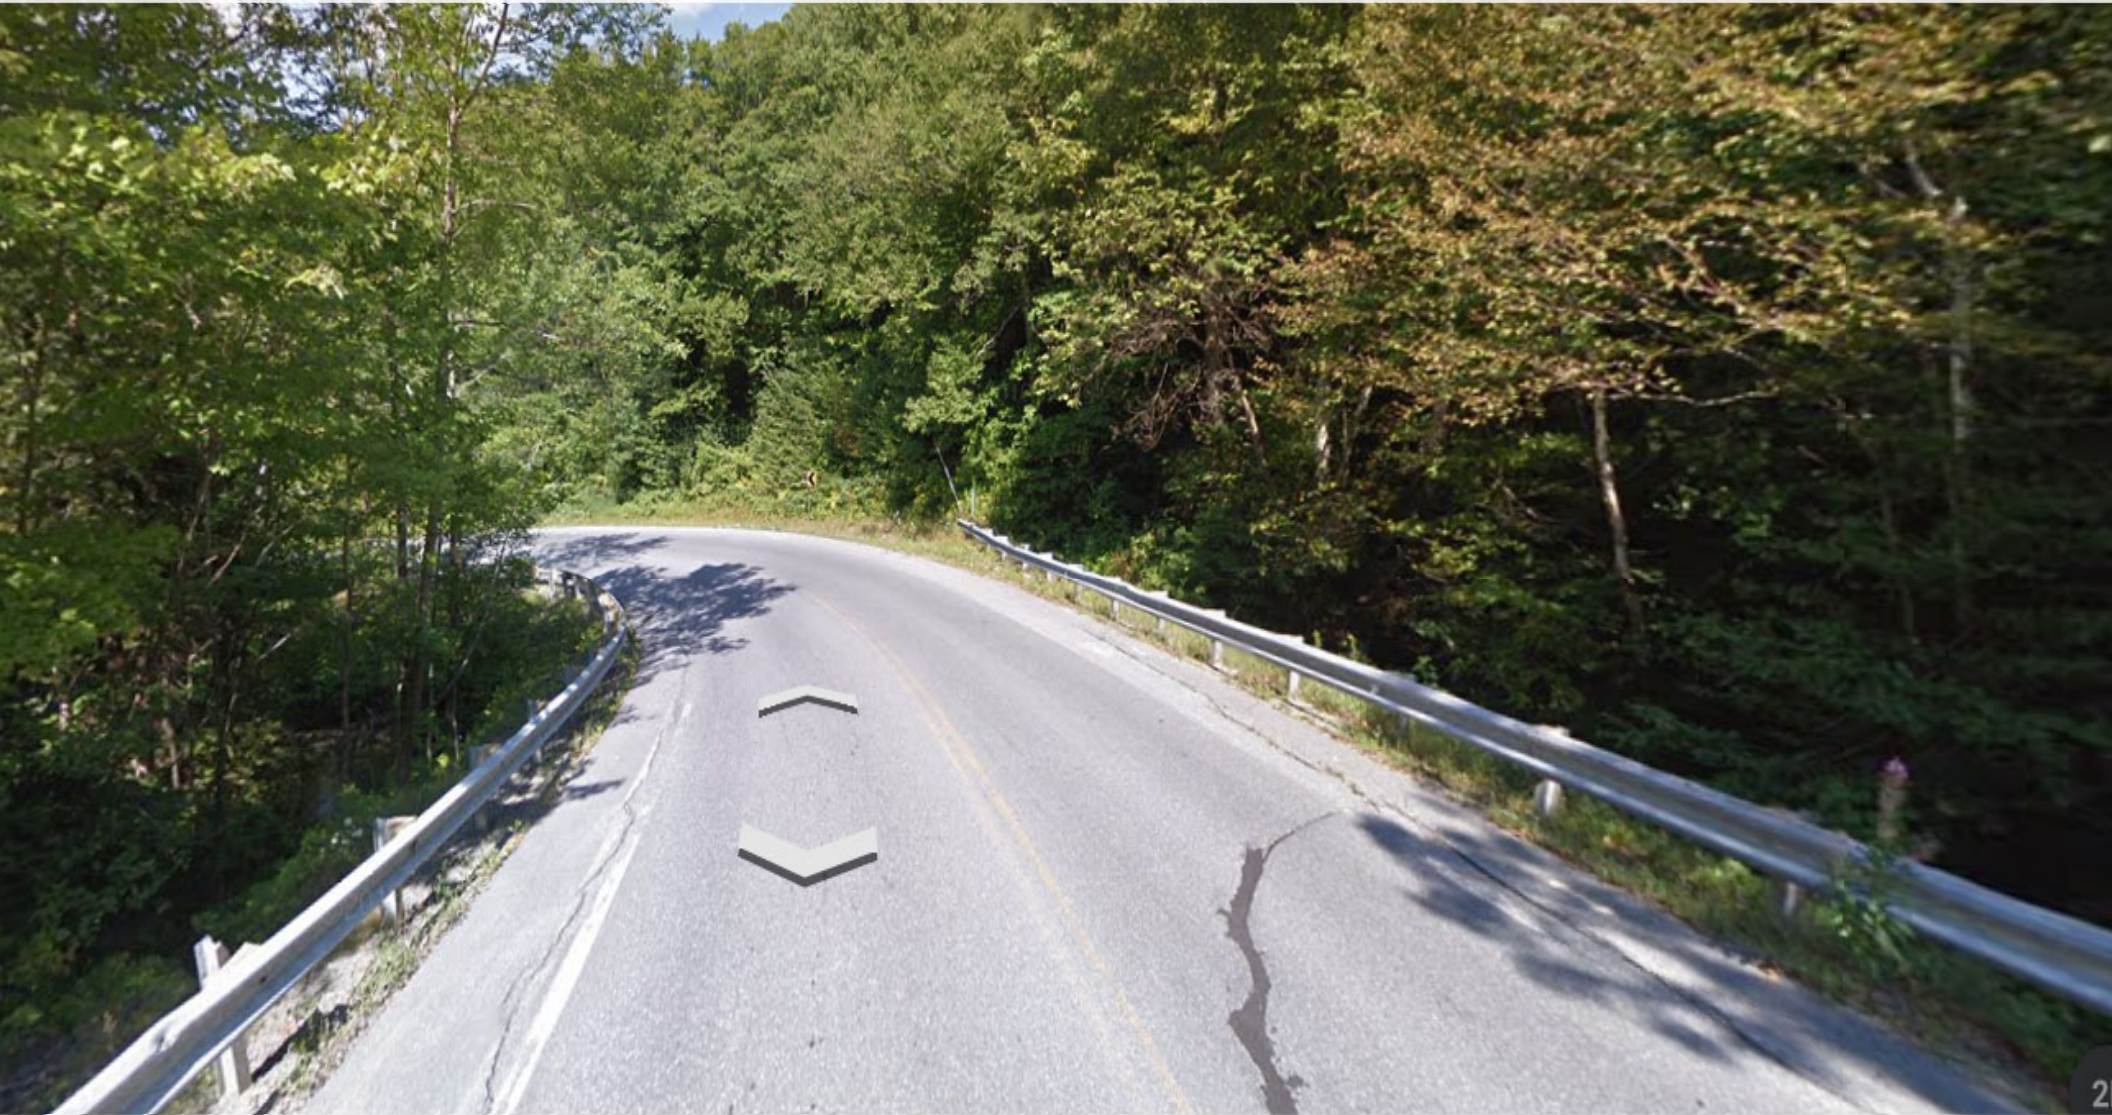
Looking West over Bridge 29

Existing Conditions – Bridge 29

- Utilities - Buried communication line running along the northerly side of the road. This line is approximately 30" deep, in a 1.5" conduit.

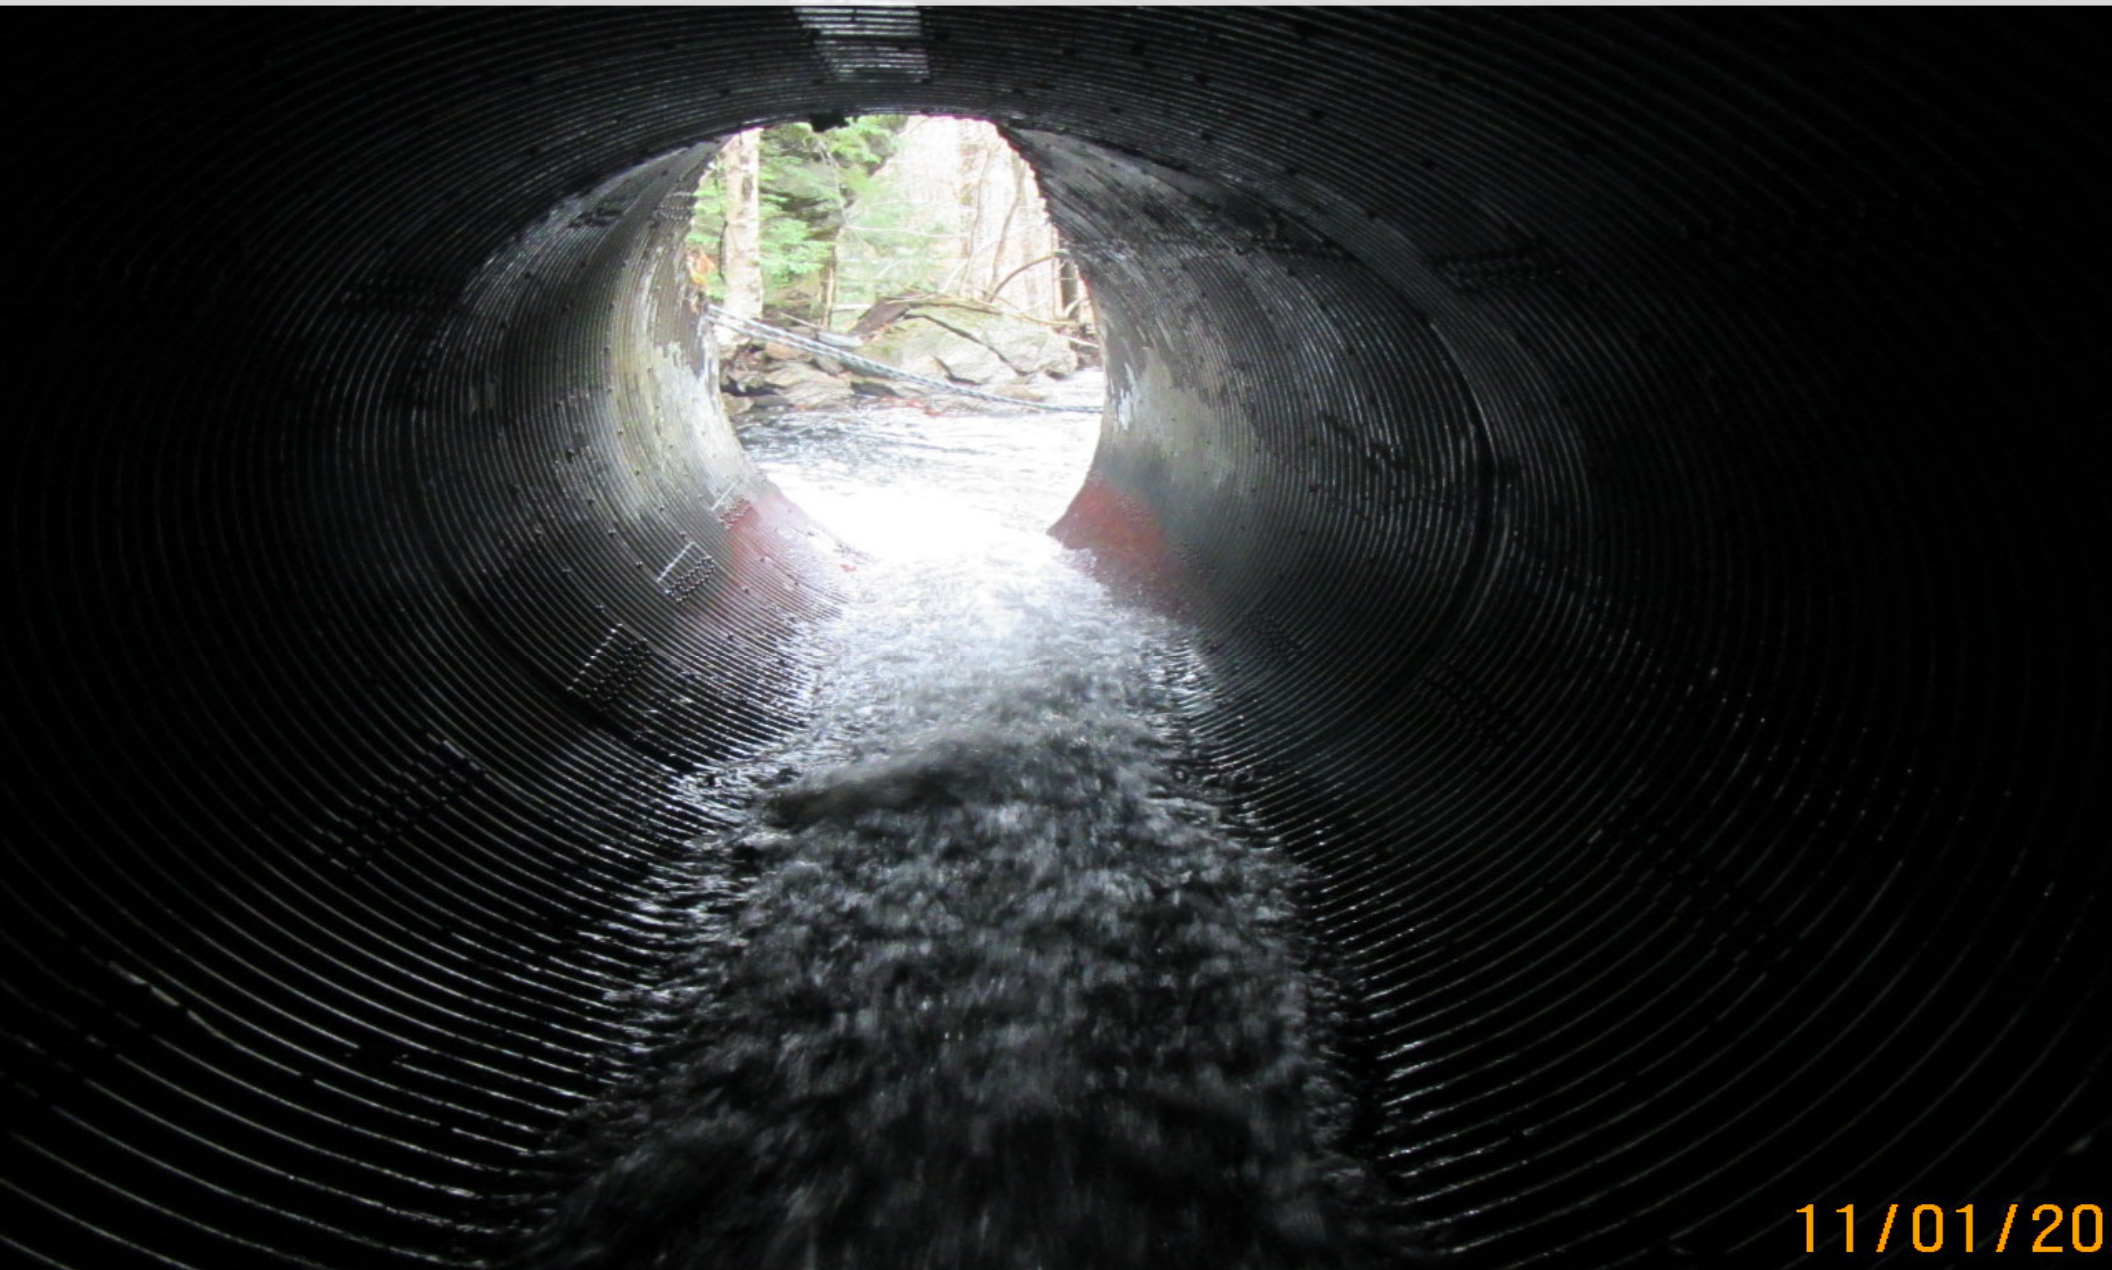
Deformed Barrel (Looking downstream)

11/01/20

- The culvert is in poor condition. The 10/26/2020 bridge inspection states that the structure has scattered perforations throughout, a large hole near the outlet, and is rusted. Furthermore, the barrel has severe deformation occurring. The last section of pipe on outlet end has separated slightly, and has started undermining, causing loss of material in bank above.
- The culvert does meet the minimum hydraulic standard but does not meet the state stream equilibrium standards for bankfull width.
- VT Route 17 through the project area has a substandard radius for the posted speed limit.

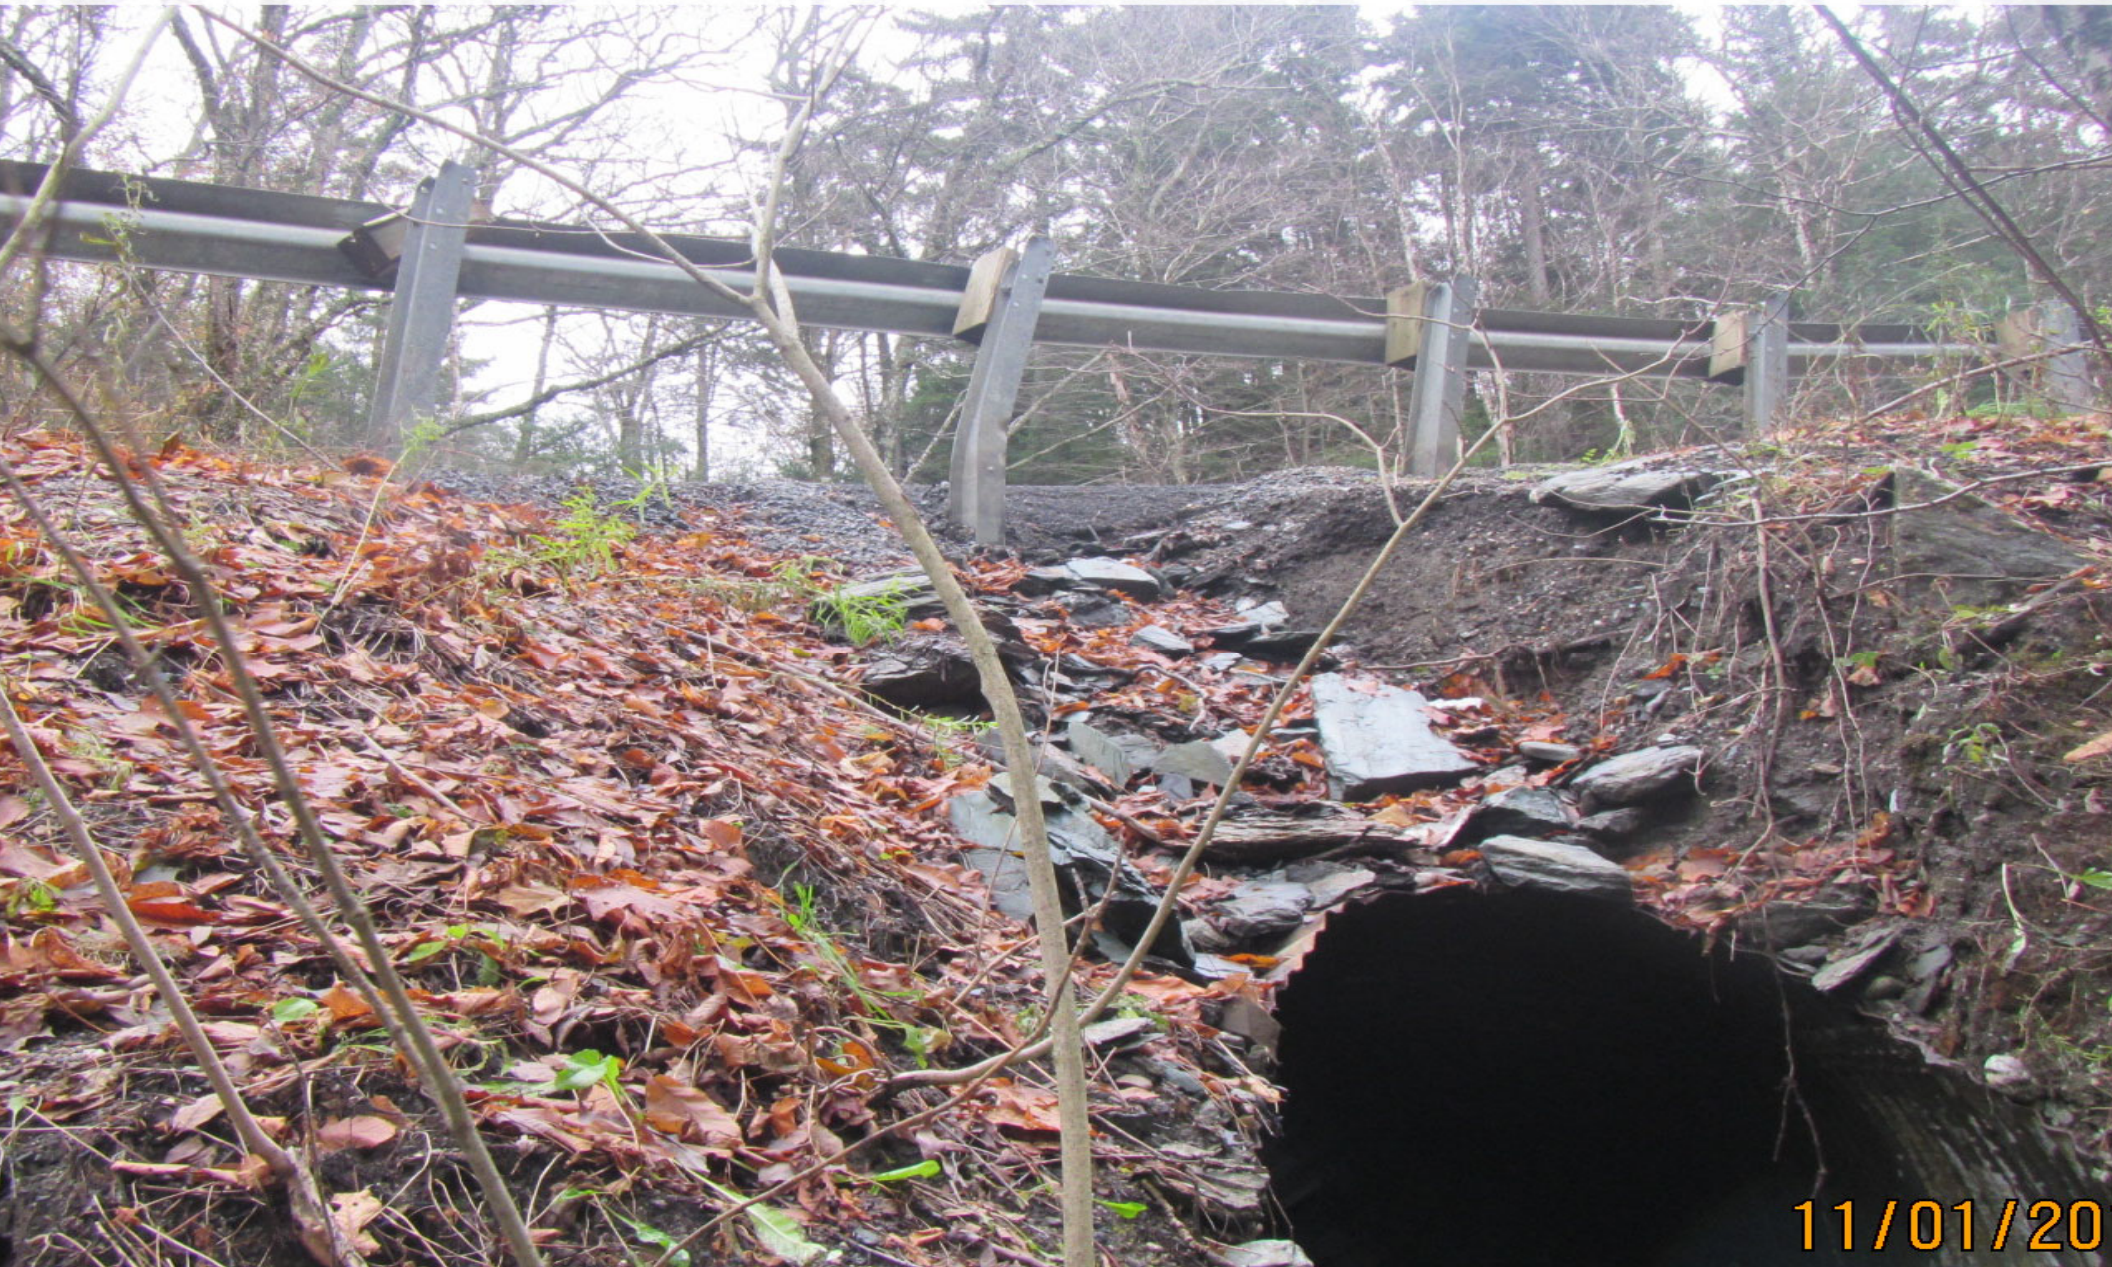
Material Loss at Outlet

11/01/20

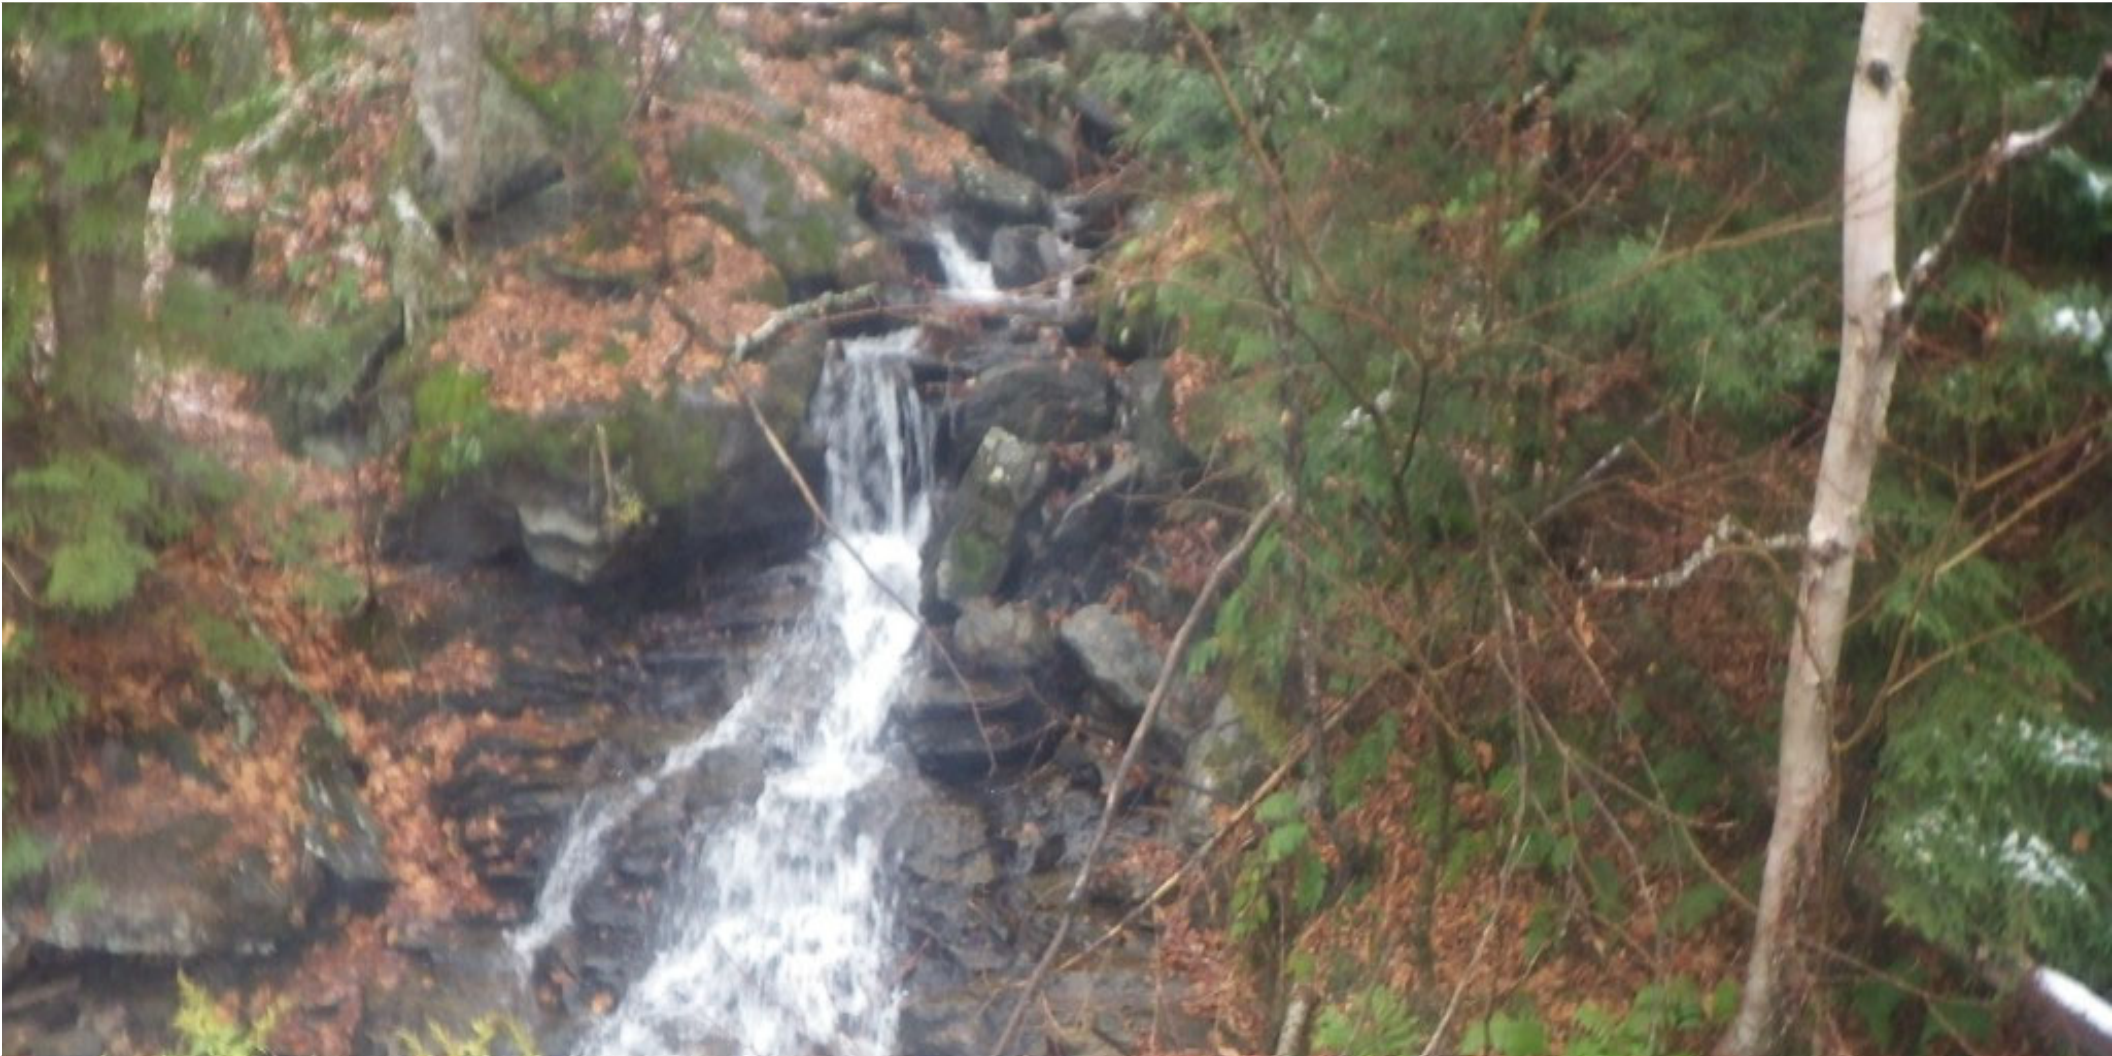
Resources – Looking Upstream

Existing Conditions – Bridge 29

- Wildlife Habitat – AOP not required due to upstream cascades 2020
- Historic Resources – Camel's Hump State Park (4(f) resource)

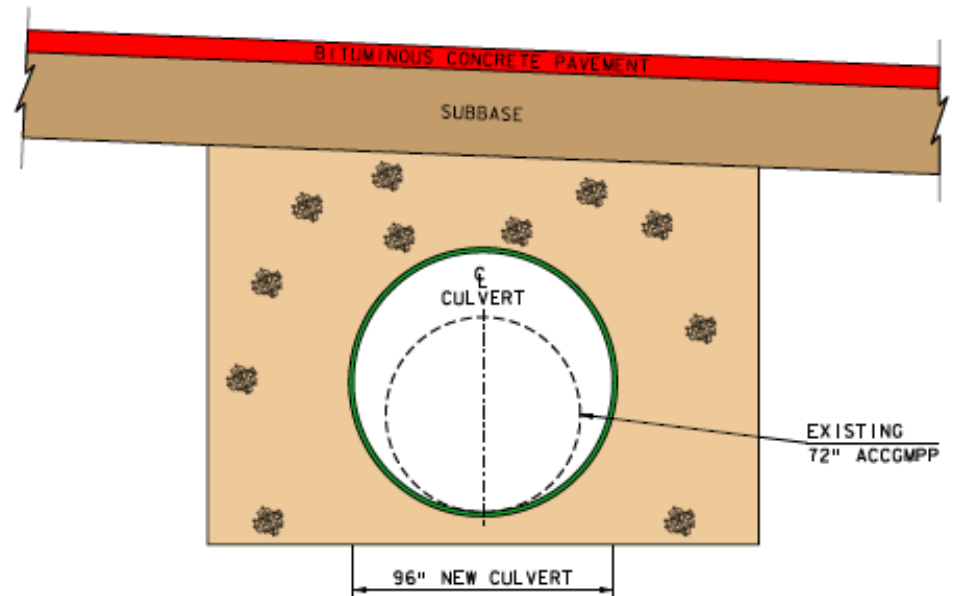
CULVERT TYPICAL SECTION

New Precast Concrete Box - Bridge #29

- 11'3" typical section

- Replace Culvert with a New Buried 8' Pipe
 - Culvert is in poor condition with deformation, and is substandard hydraulically warranting a replacement
 - At-grade 8-foot pipe with the invert buried as much as possible given the shallow ledge
 - An at grade pipe is preferred here for reduced construction time and potential for shallow bedrock
 - 50-year design life
