West Rutland BF 020-1(25&26)

Public Informational Meeting

US ROUTE 4, BRIDGE'S 13E, 13W, 14E, 14W OVER CLARENDON & PITTSFORD RAILROAD (CPR), CASTLETON RIVER, AND VT ROUTE 4A

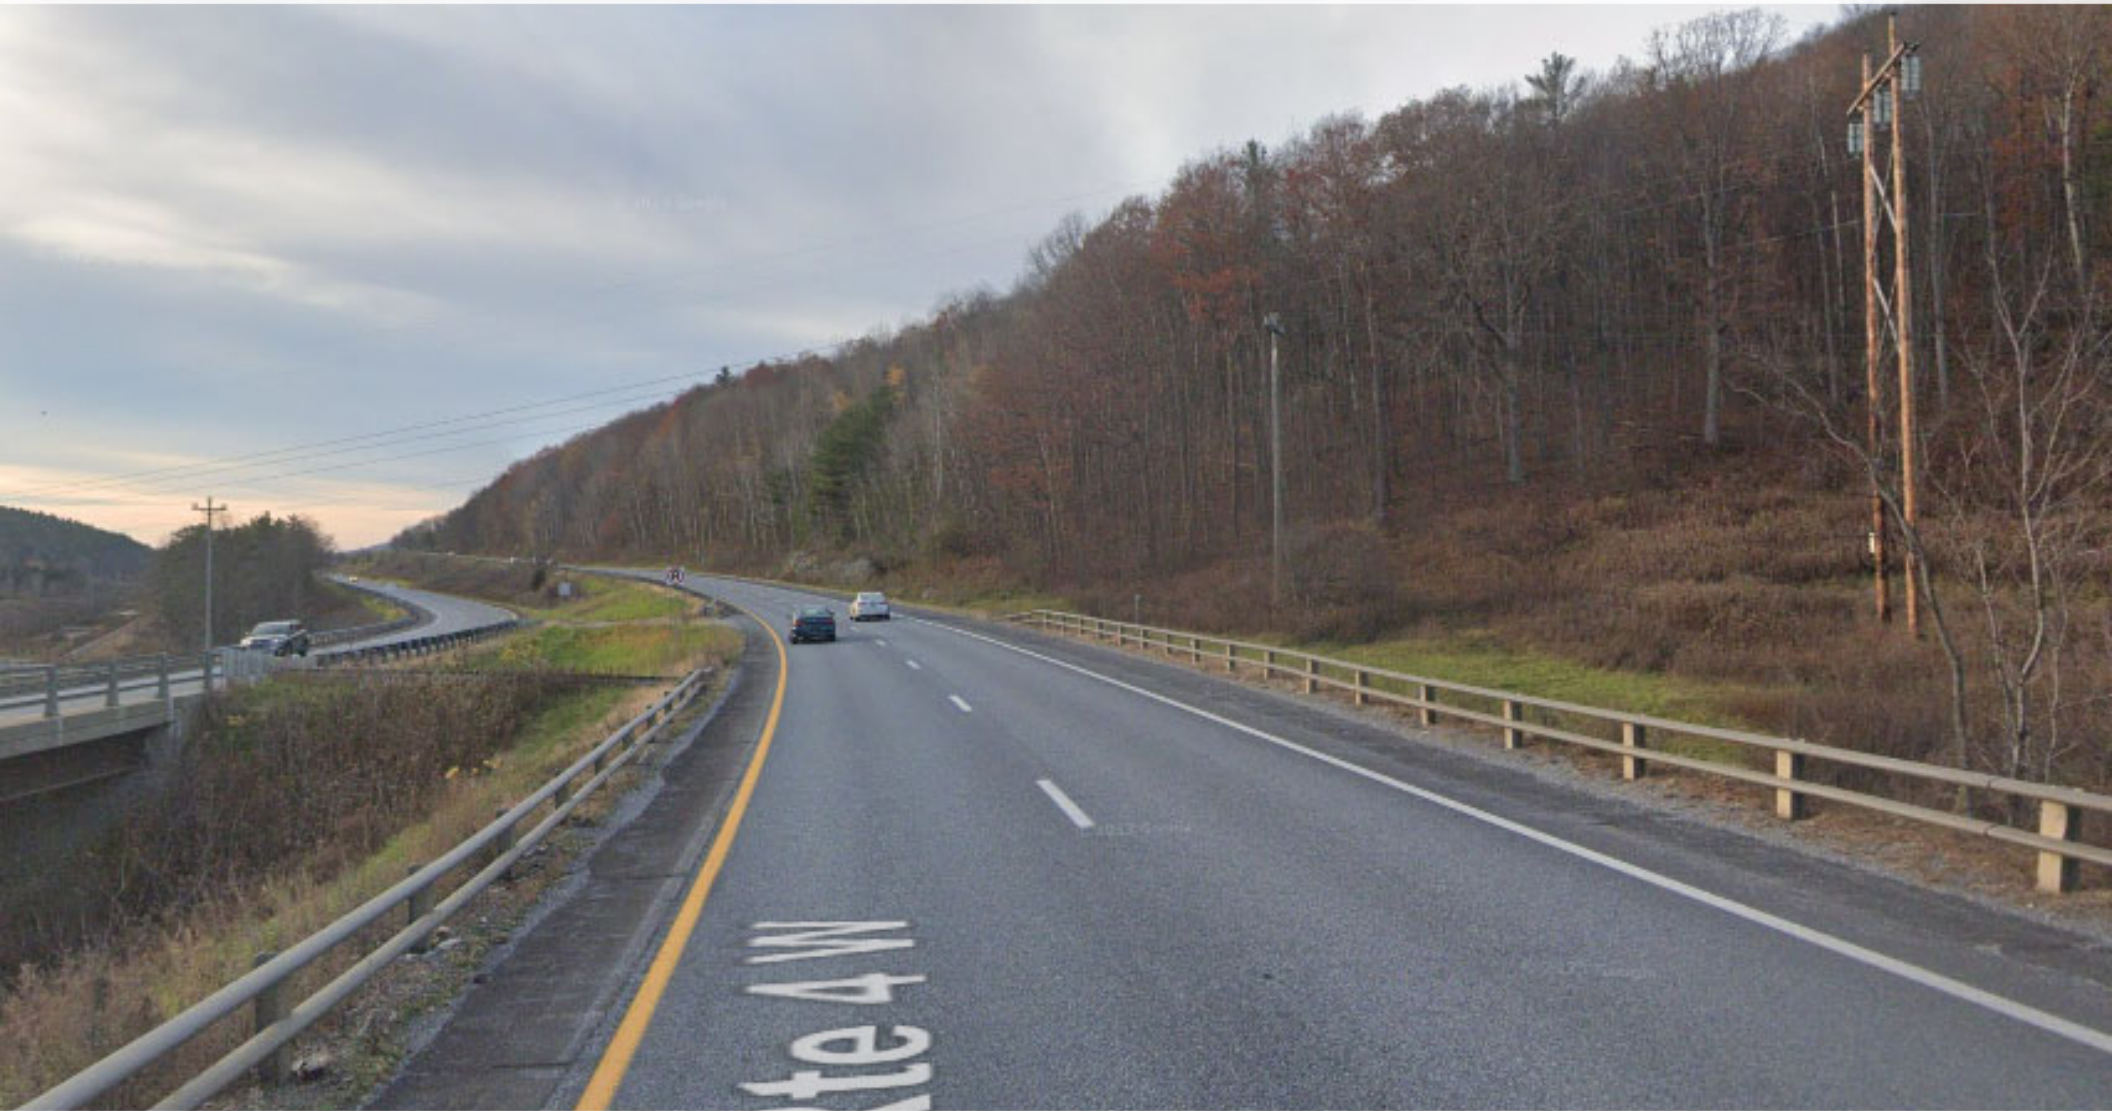
Looking Northwest at Aerial Utilities

- Aerial utilities (electric, communications, and telephone) crossing perpendicular over US4 just north of Bridge 13

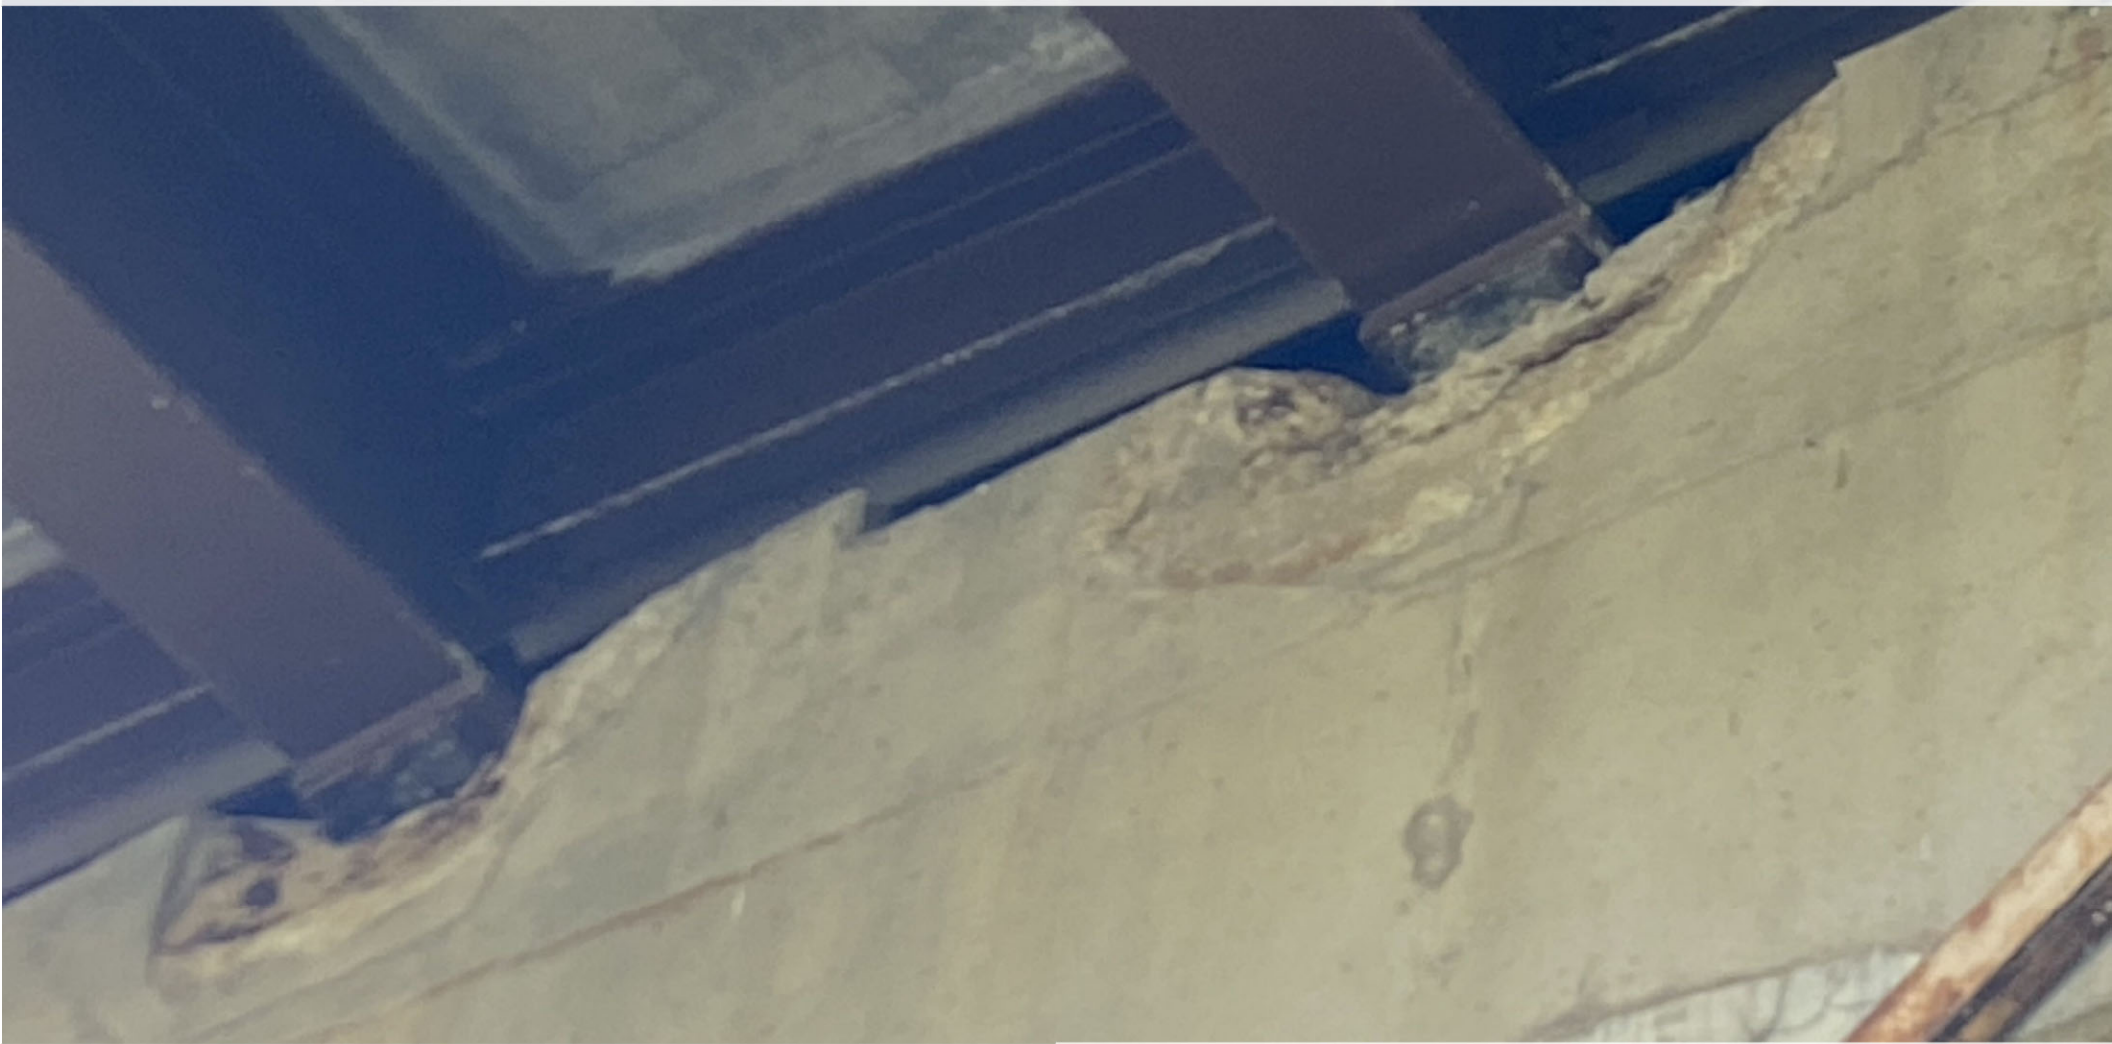
Bridge Inspection Report Ratings (BR13E spalling pier/span #4)

Existing Conditions - Bridge #13E

- Deck Rating 6 (Satisfactory)
- Superstructure Rating 7 (Good)
- Substructure Rating 6 (Satisfactory)
- Channel Rating 8 (Very Good)

- The deck of Bridge 13E is in **satisfactory condition**. Multiple bays have areas of transverse cracks forming small delaminations and efflorescence leakage. Some joints have spalling present with exposed rebar.

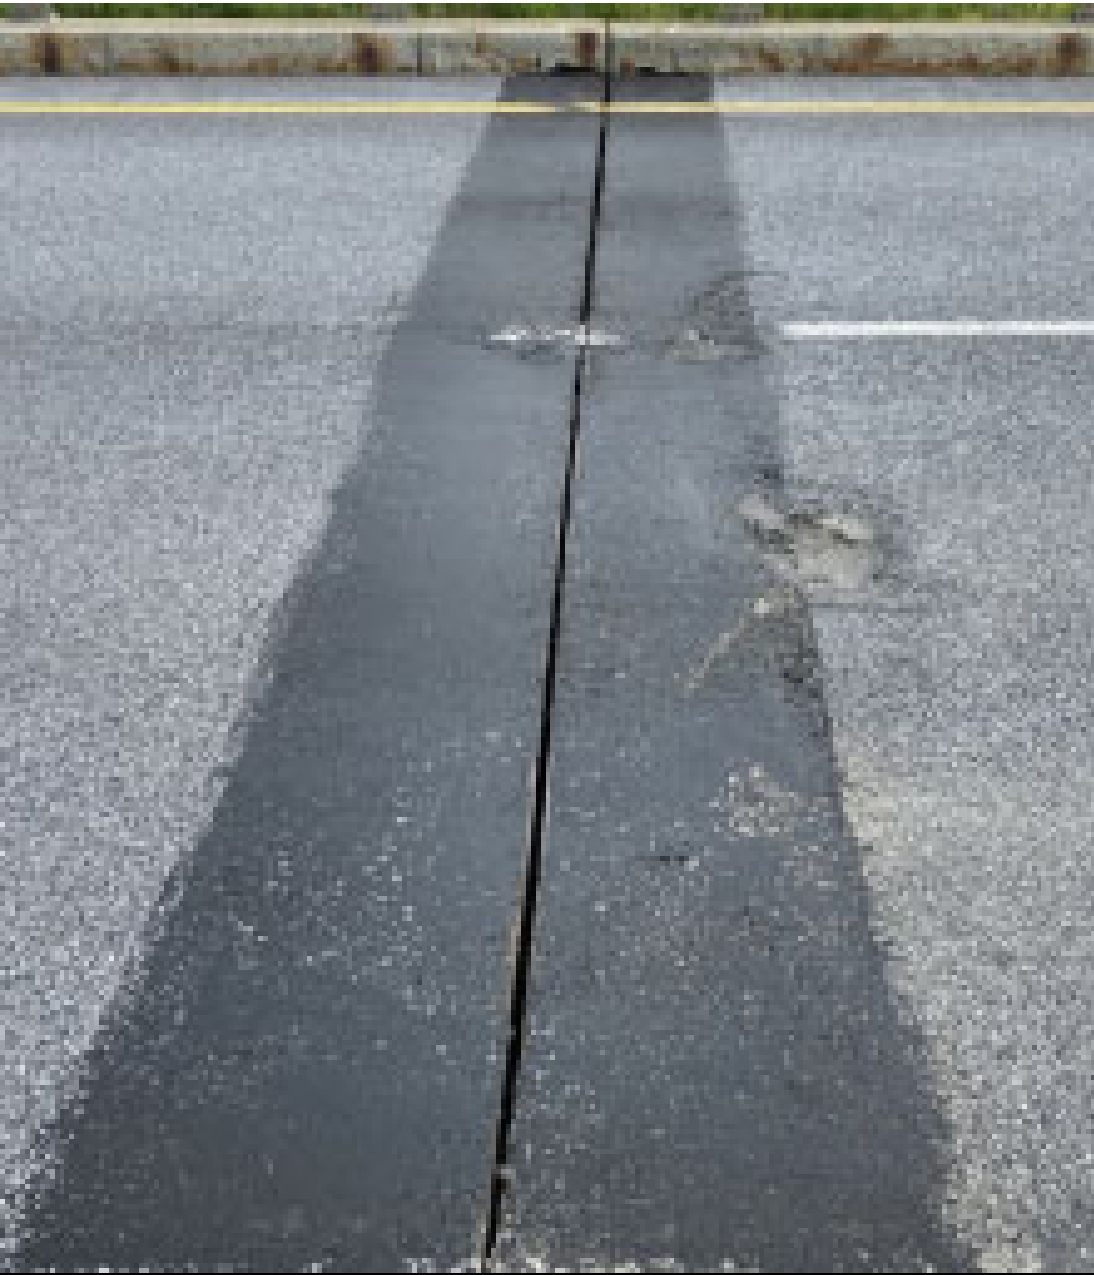
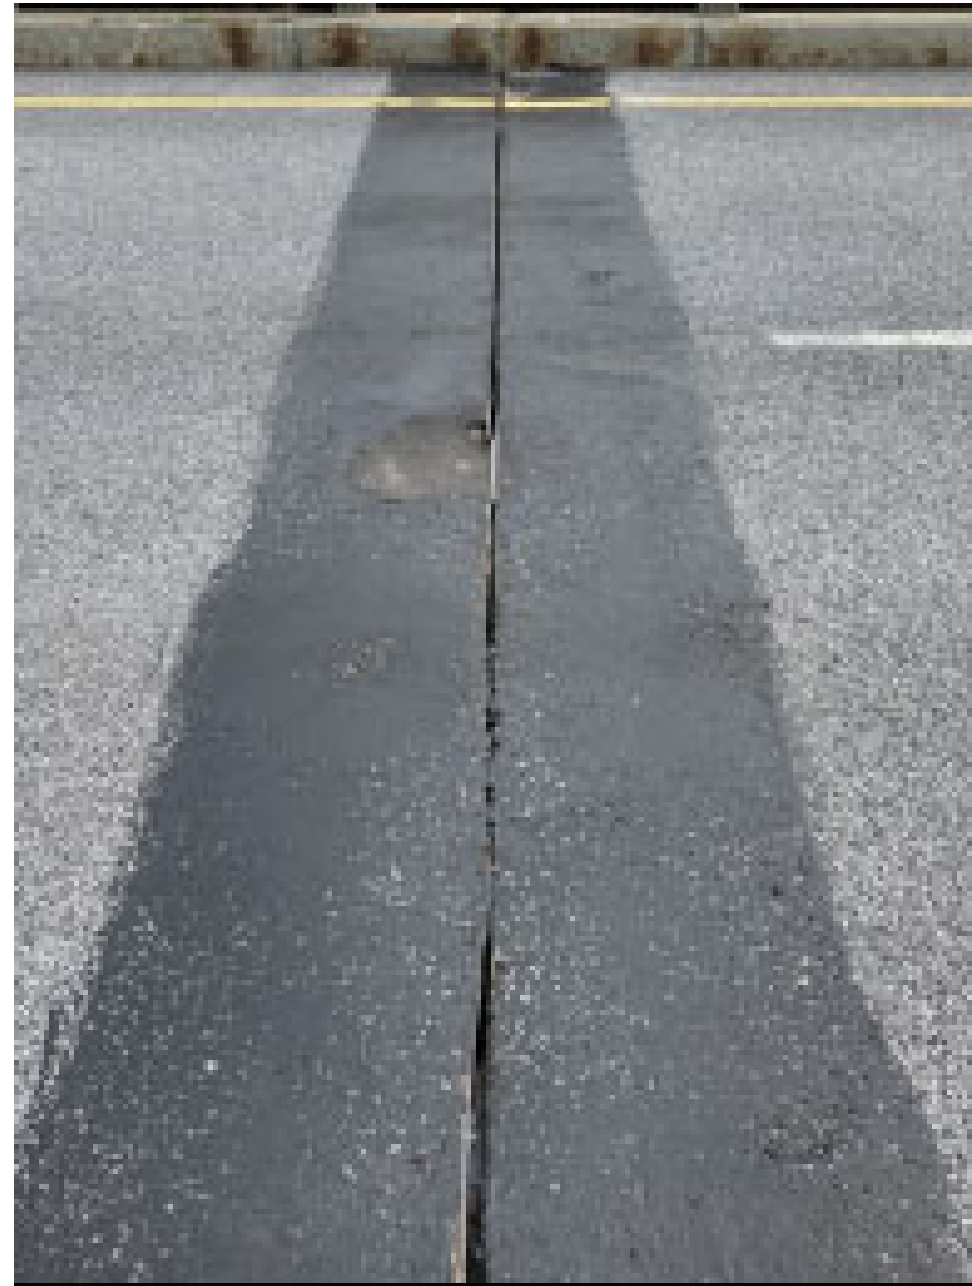
Vertical Steel Plate Joint & Asphaltic Plug over Pier #1 (left) and Pier 3 (right)

Existing Conditions - Bridge #13E

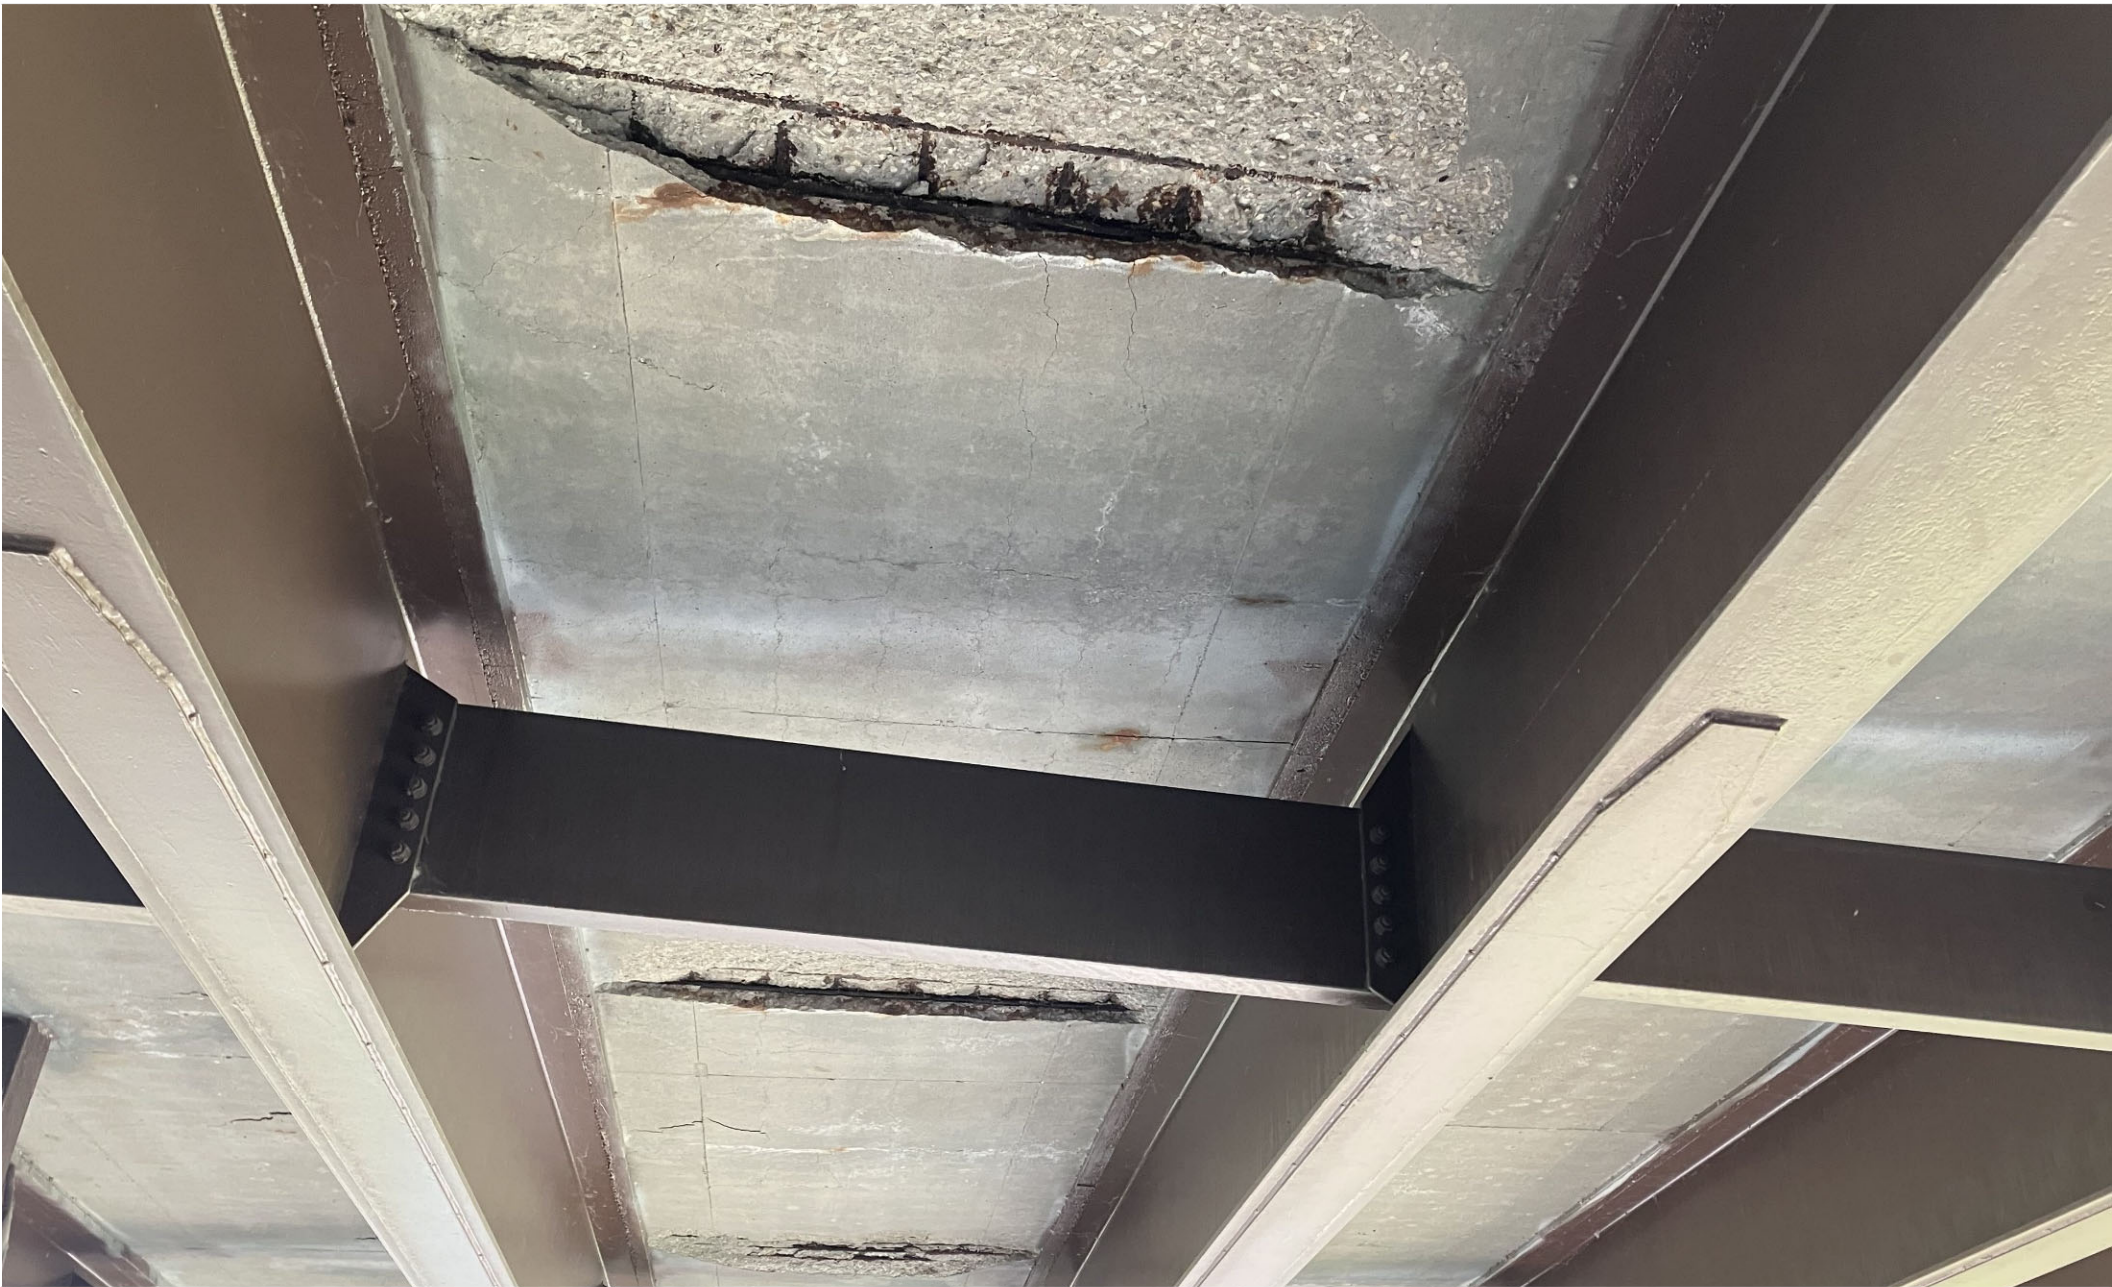
Spalling on Bay 3 from Abutment 2

Existing Conditions - Bridge #13W

- The deck of Bridge 13W is in **fair condition**. Most bays have areas of delaminations and spalling that have exposed the first and second layer of steel reinforcing with minor rust scaling present along the steel. The deck underside has efflorescence leakage build up and small rust stains surrounding cracking and deck delaminations.

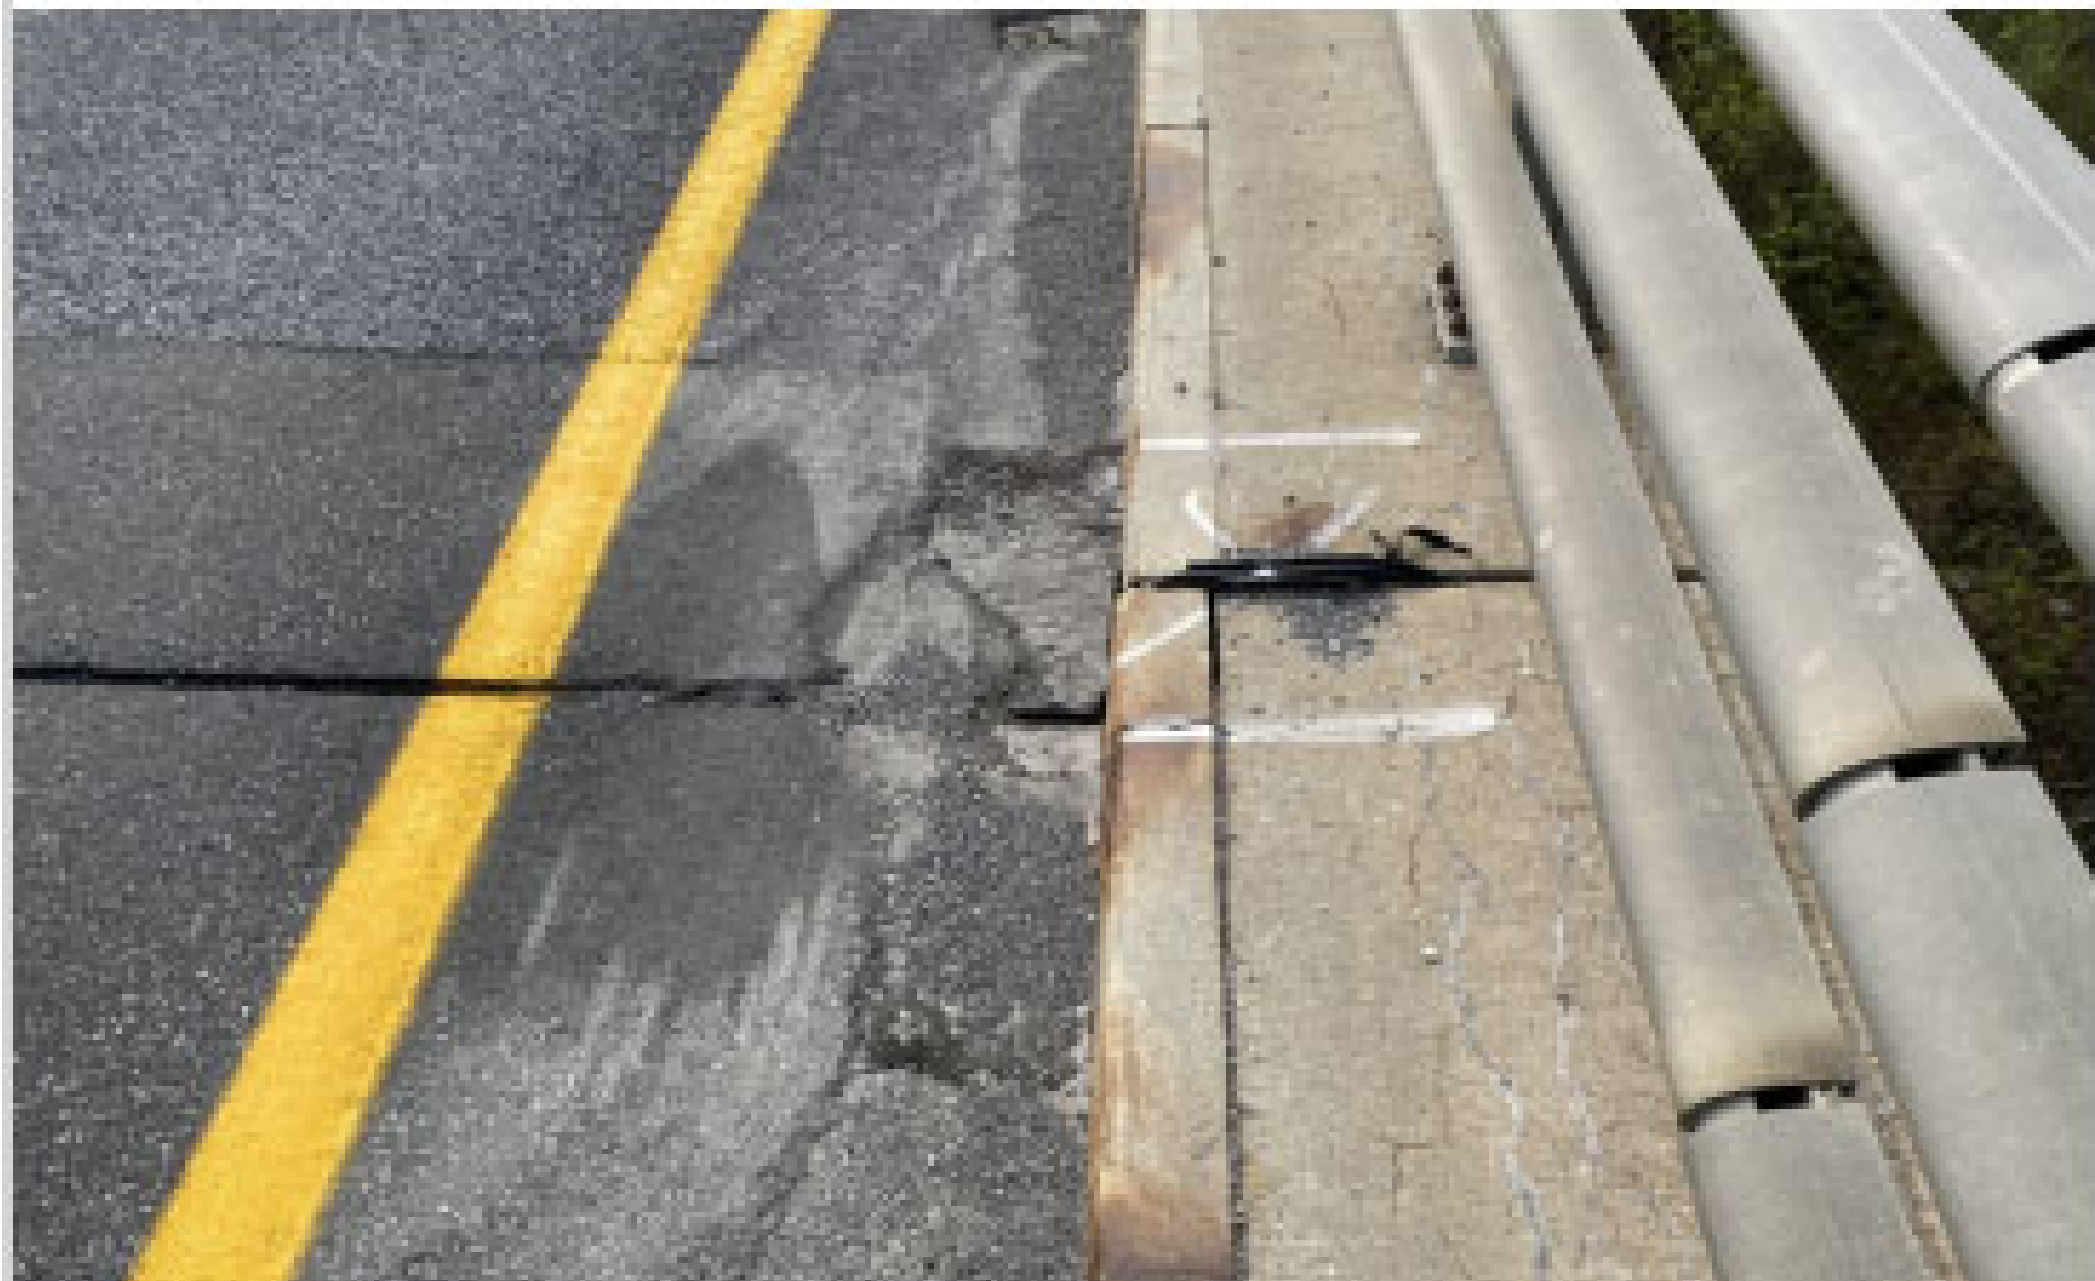
Southern curb at Pier #3

Existing Conditions - Bridge #13W

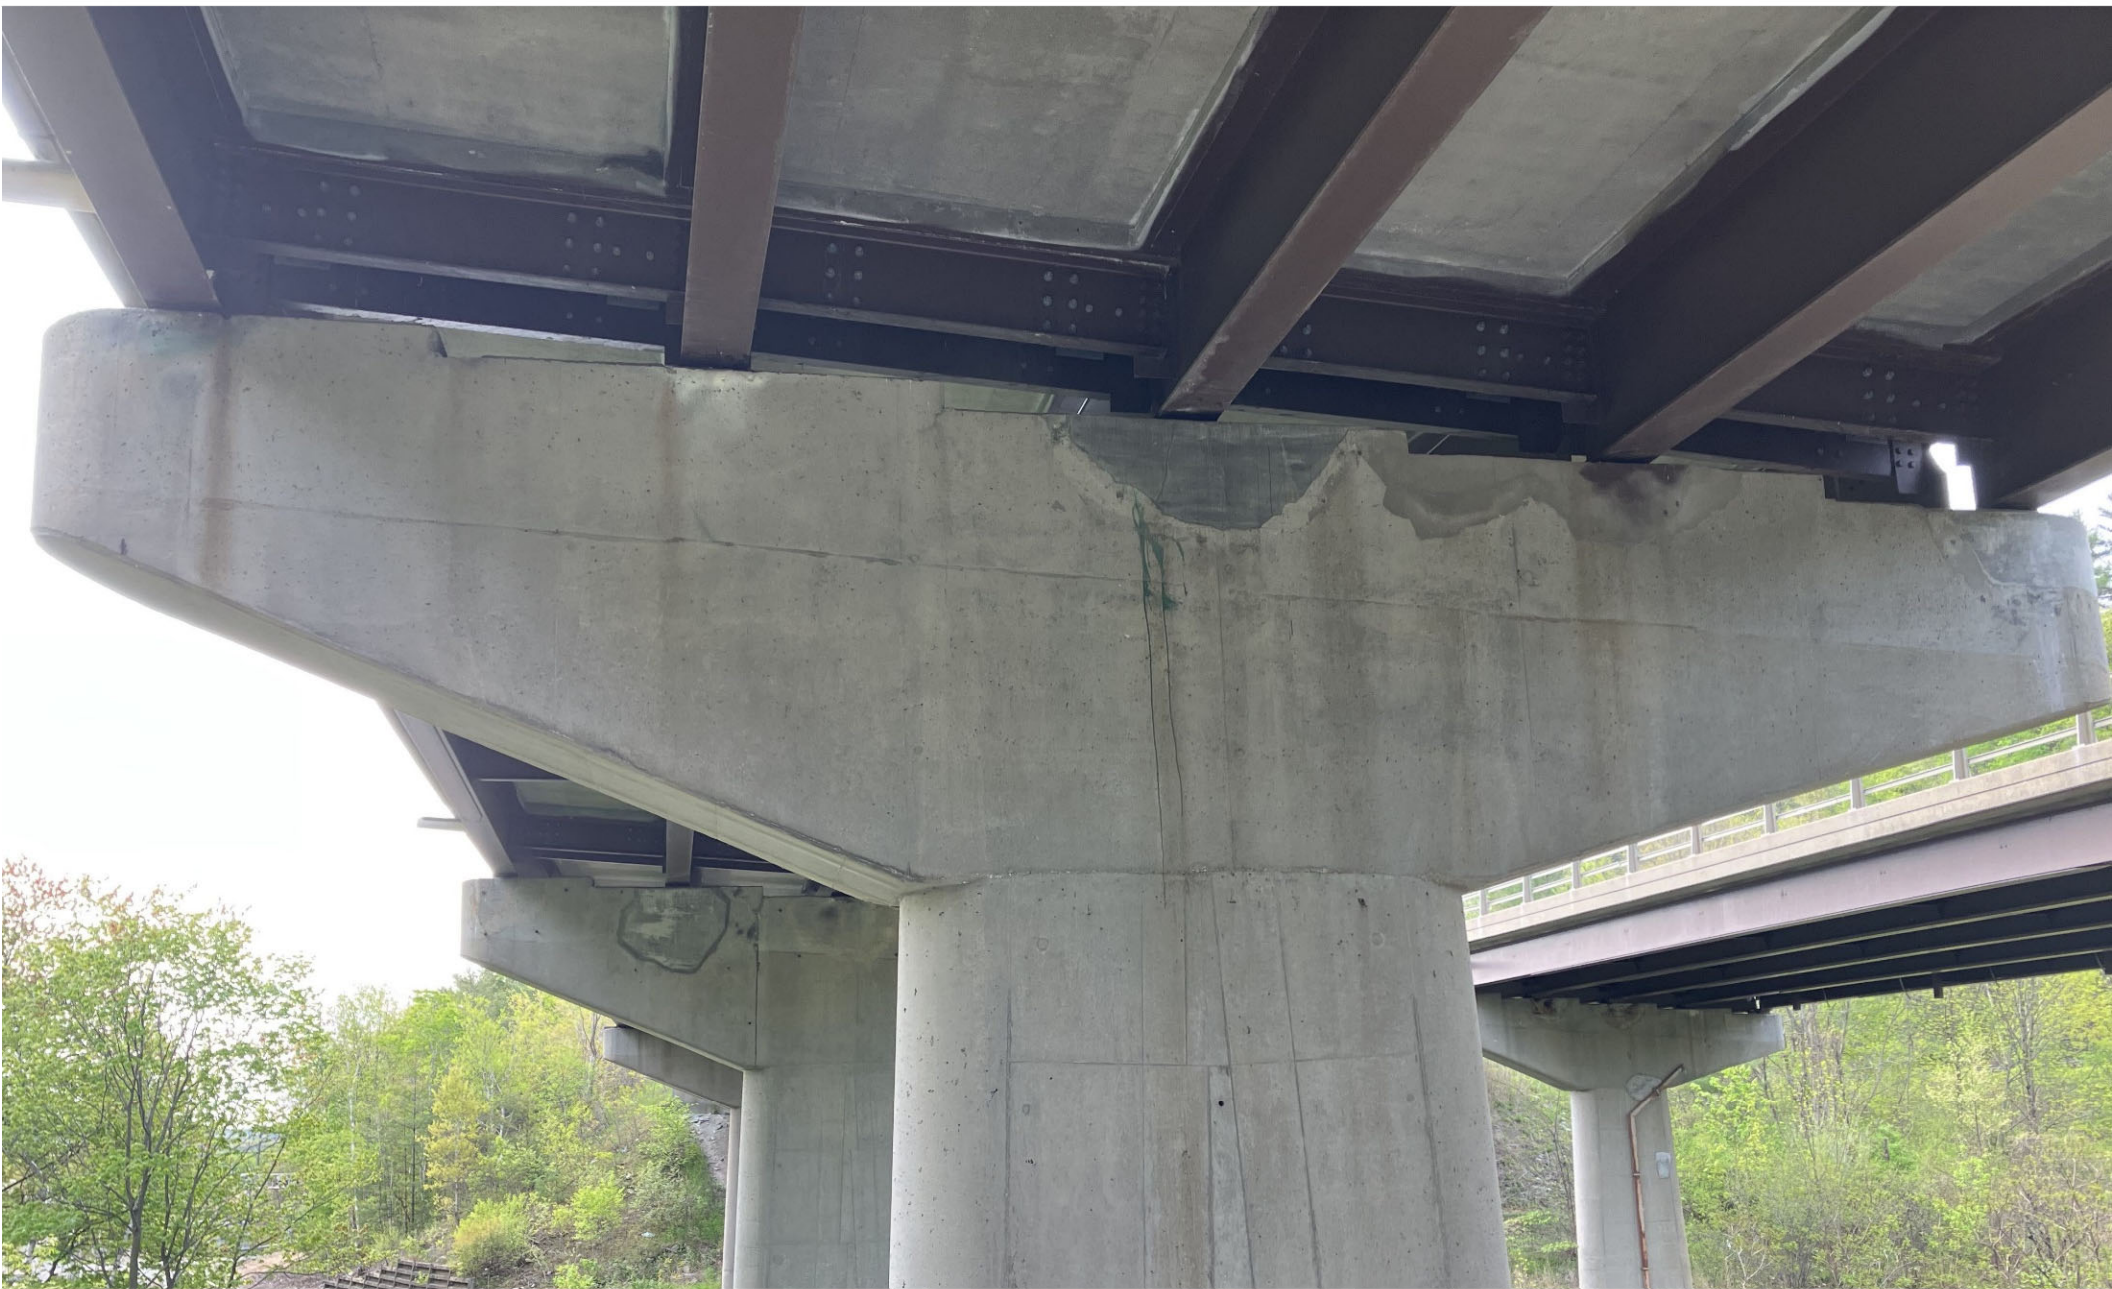
Pier #1 from abutment #1

Existing Conditions - Bridge #13W

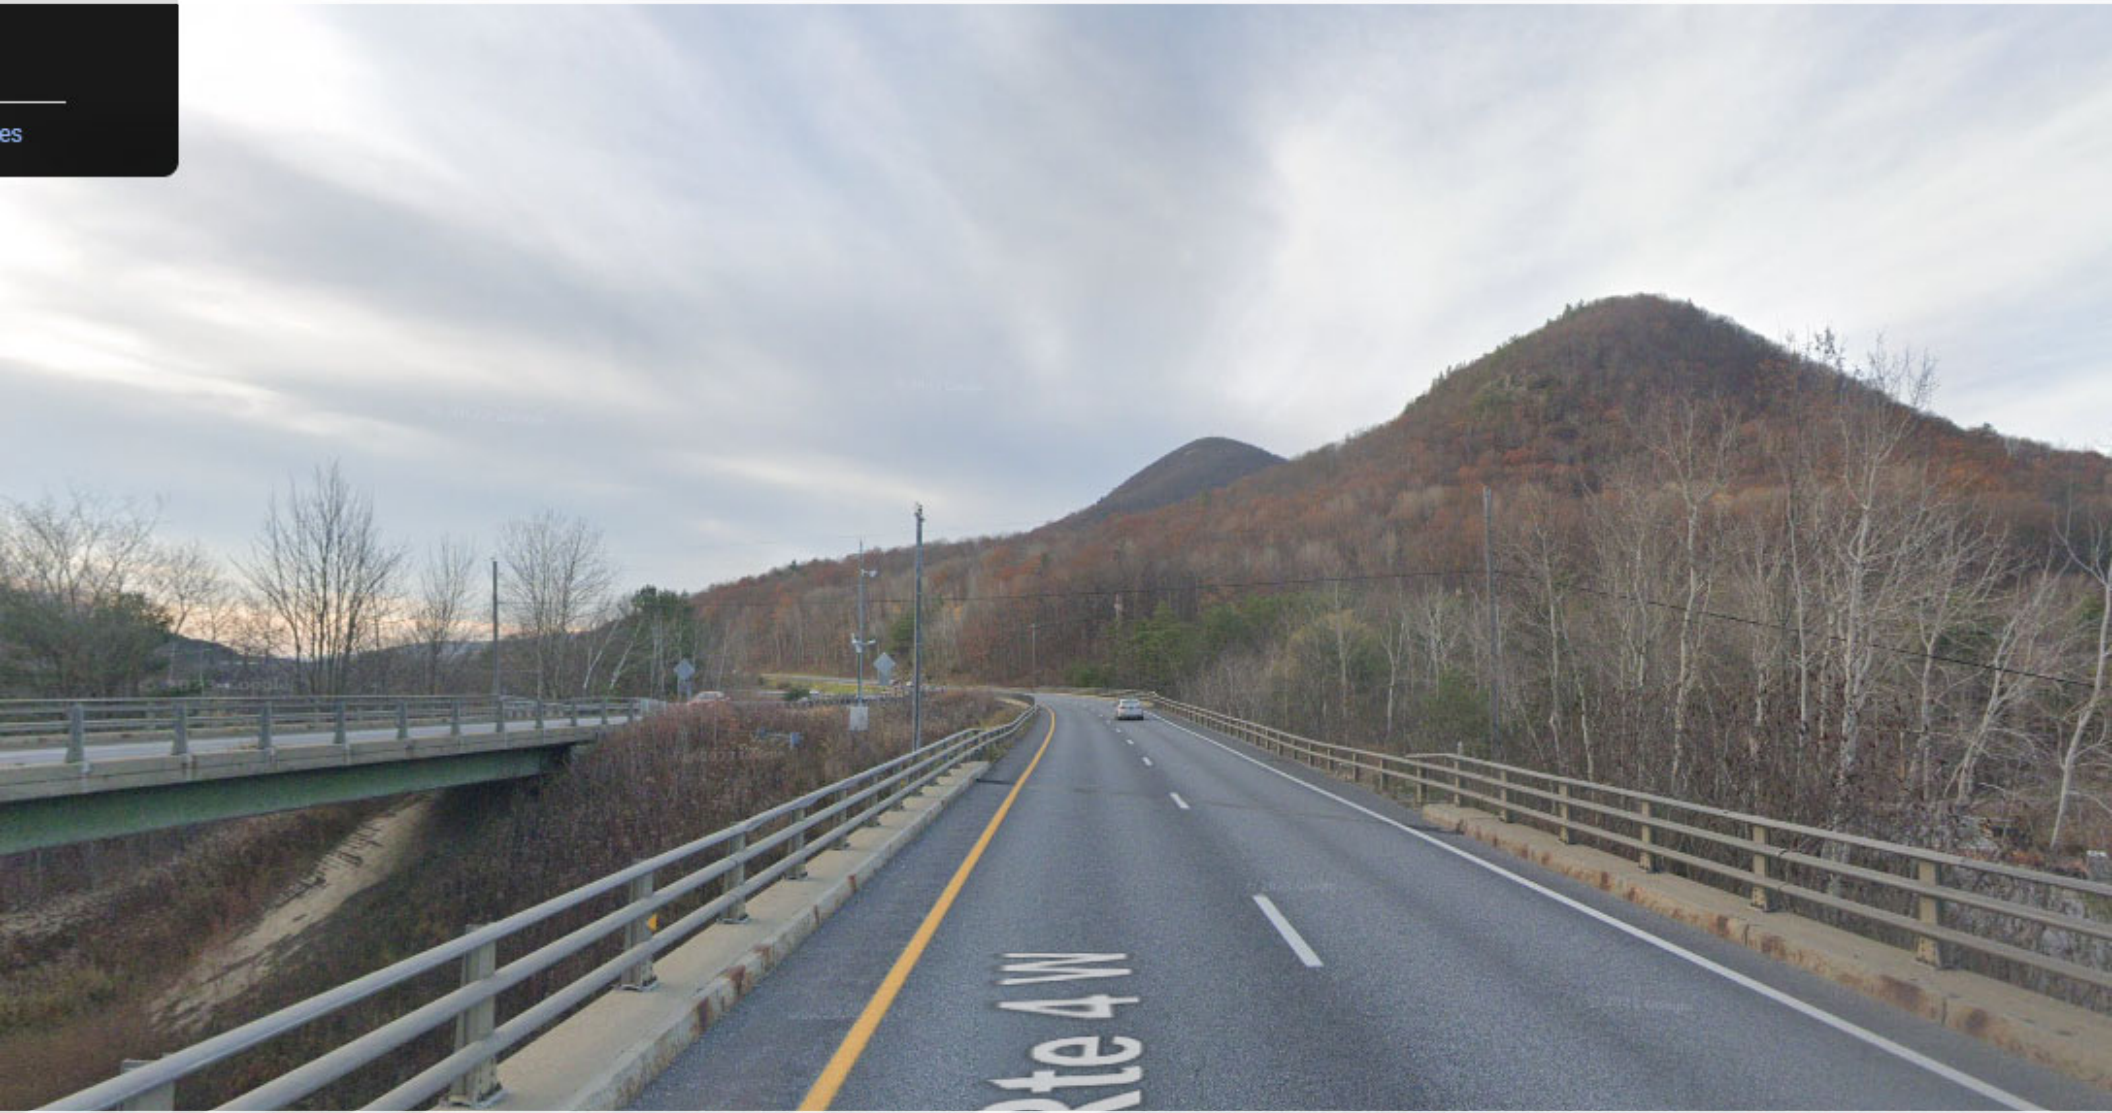
Looking Northwest at Aerial Utilities

- Aerial utilities (electric, communications, and telephone) crossing perpendicular over US4 just north of Bridge 14

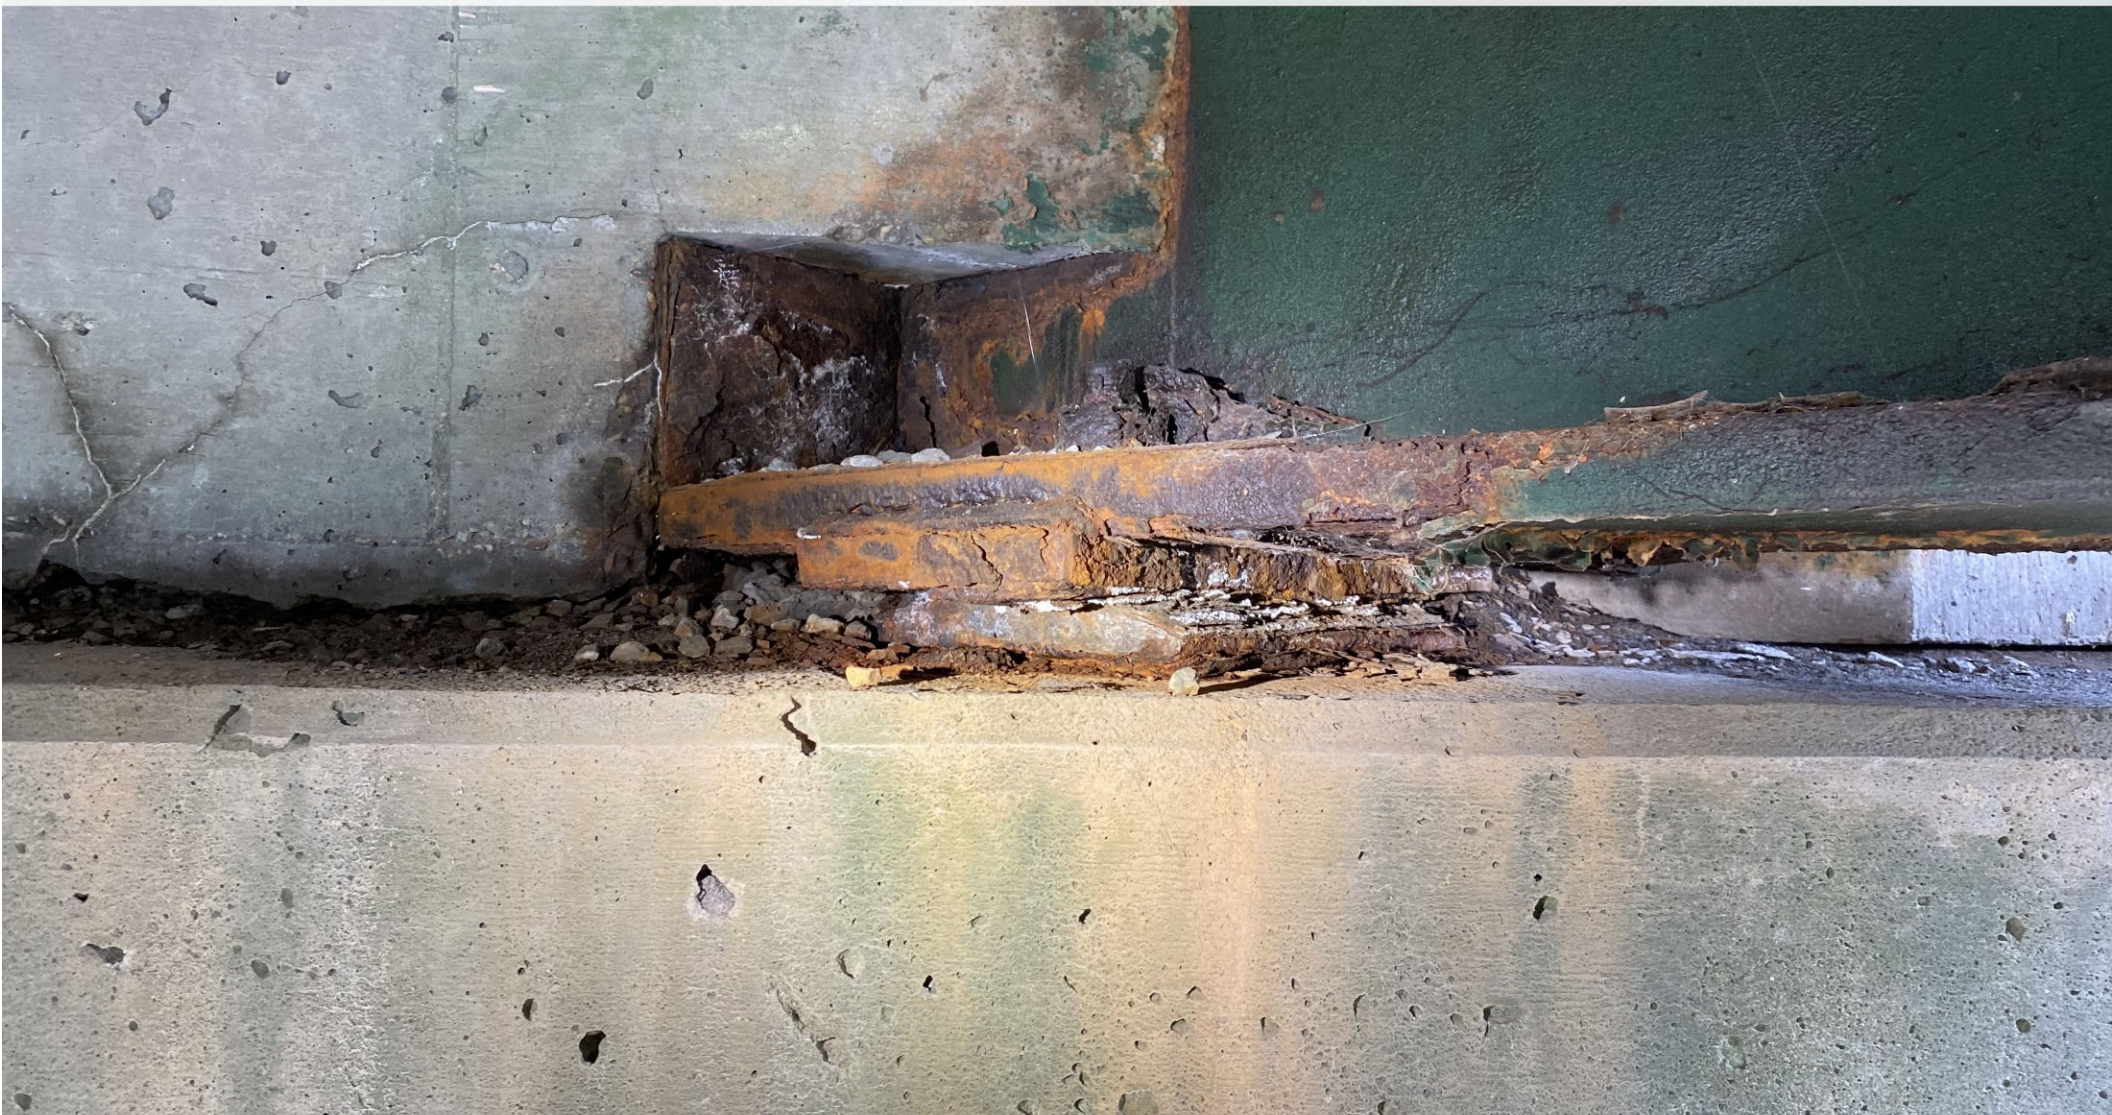
Bridge Inspection Report Ratings (BR14E - bearing #1 abutment #1)

Existing Conditions - Bridge #14E

- Deck Rating 5 (Fair)
- Superstructure Rating 7 (Good)
- Substructure Rating 6 (Satisfactory)

- Beam ends have minor rust scaling present where paint has failed. Superstructures have minor to moderate paint distress throughout with paint bubbling, peeling and flaking causing surface corrosion of steel and heavier corrosion along beam ends. Substructures have minor cracking and rust staining present.
