West Rutland BF 020-1(25&26)

Public Informational Meeting

US ROUTE 4, BRIDGE'S 13E, 13W, 14E, 14W OVER CLARENDON & PITTSFORD RAILROAD (CPR), CASTLETON RIVER, AND VT ROUTE 4A

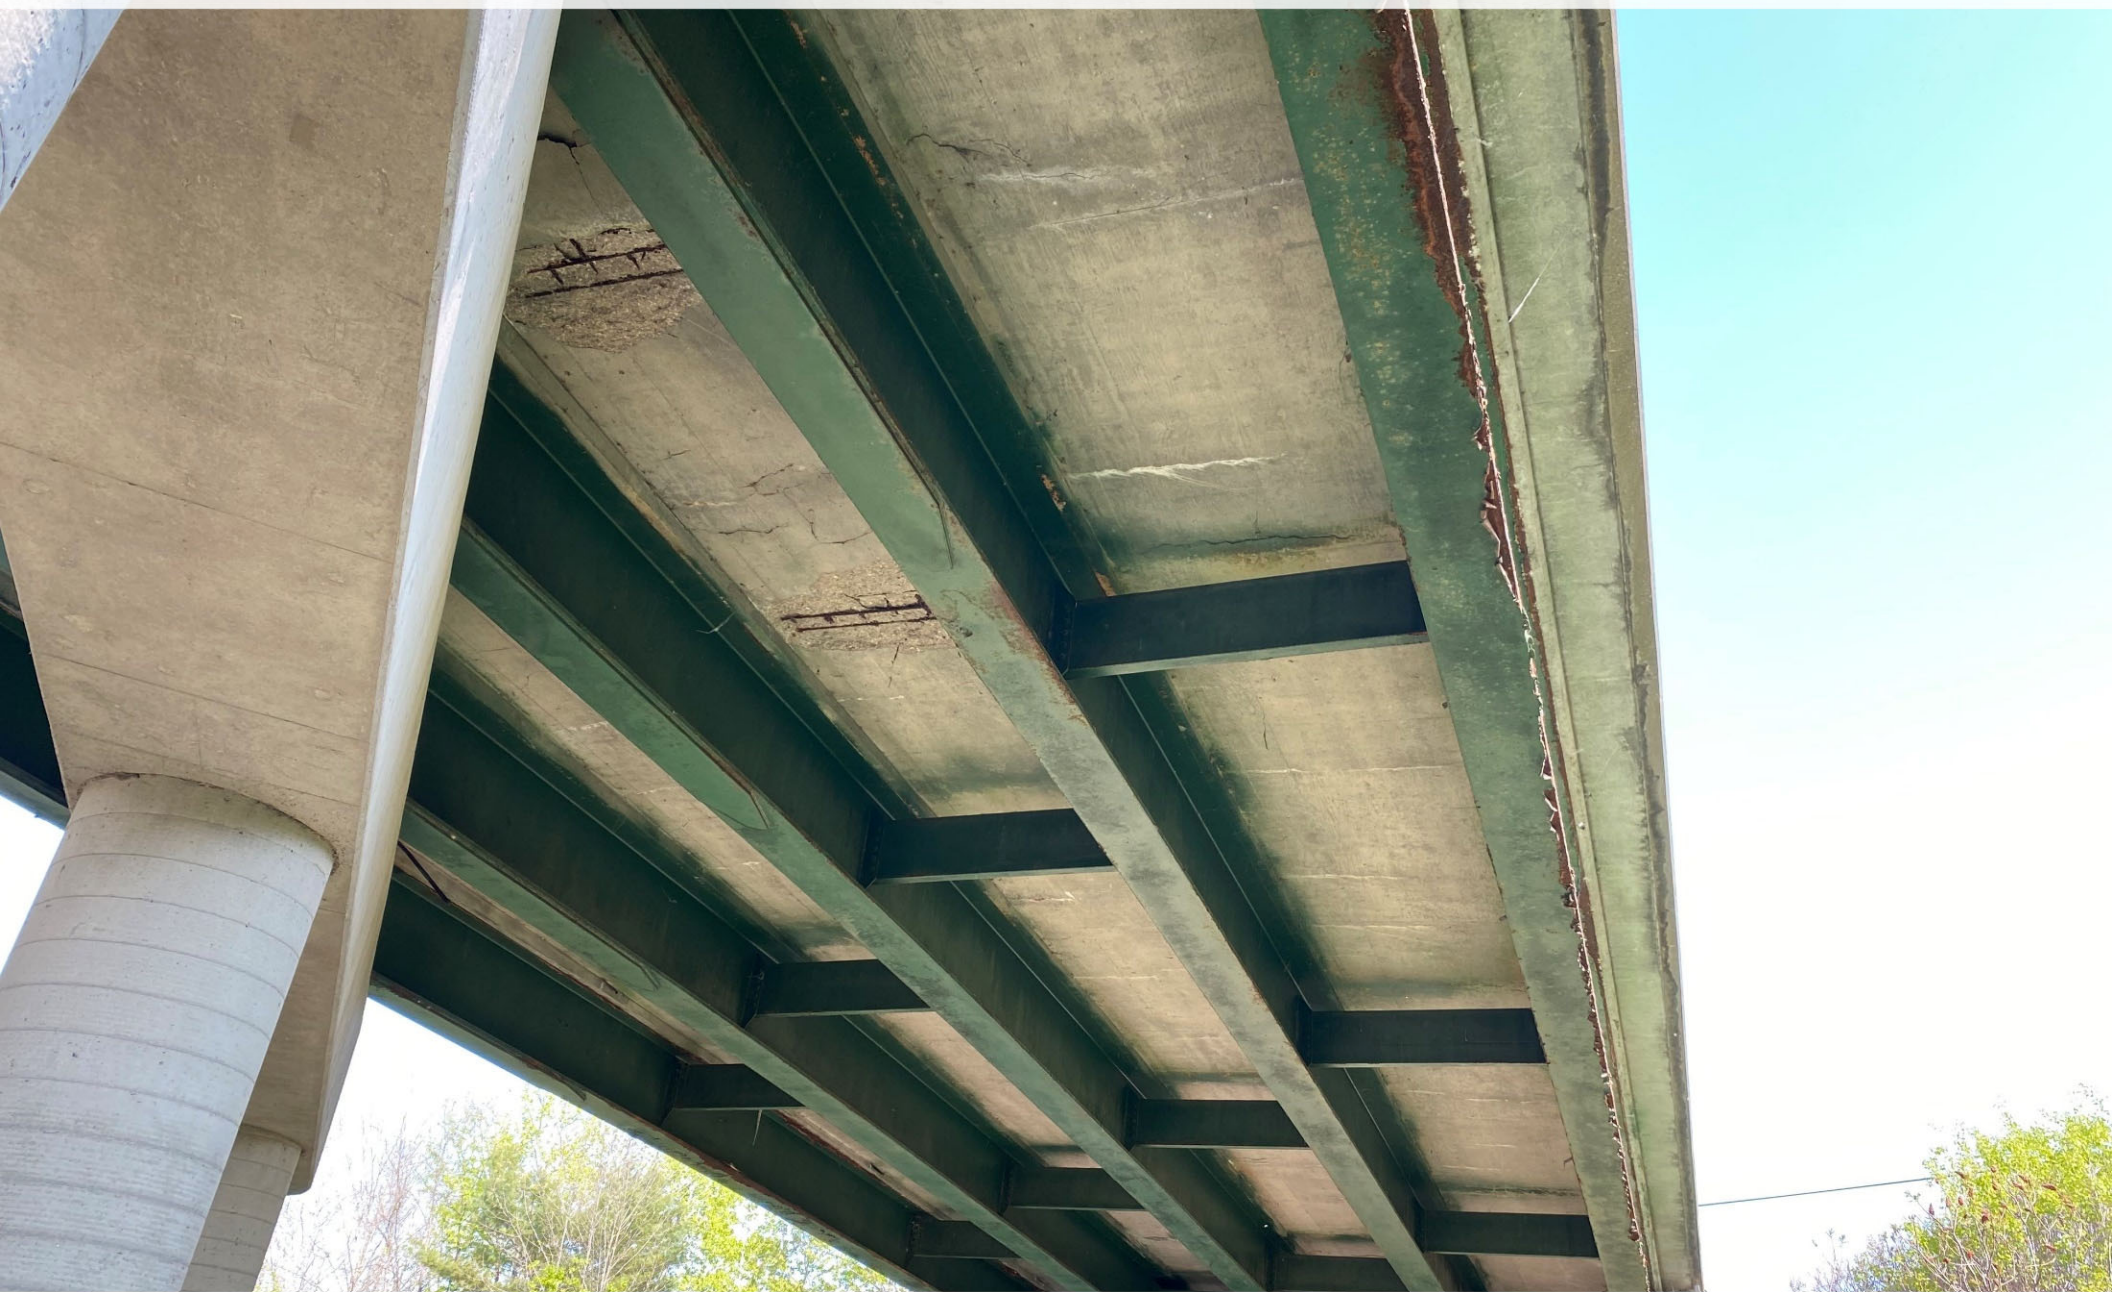
Deck Underside in Span #1 Bays #1 and #2

Existing Conditions - Bridge #14E

- The deck of Bridge 14E is in **fair condition**. The deck has many areas of transverse cracking with efflorescence leakage that have formed into large delaminated areas. Spalling is present in multiple bays that has exposed steel reinforcing that has minor rust scale.

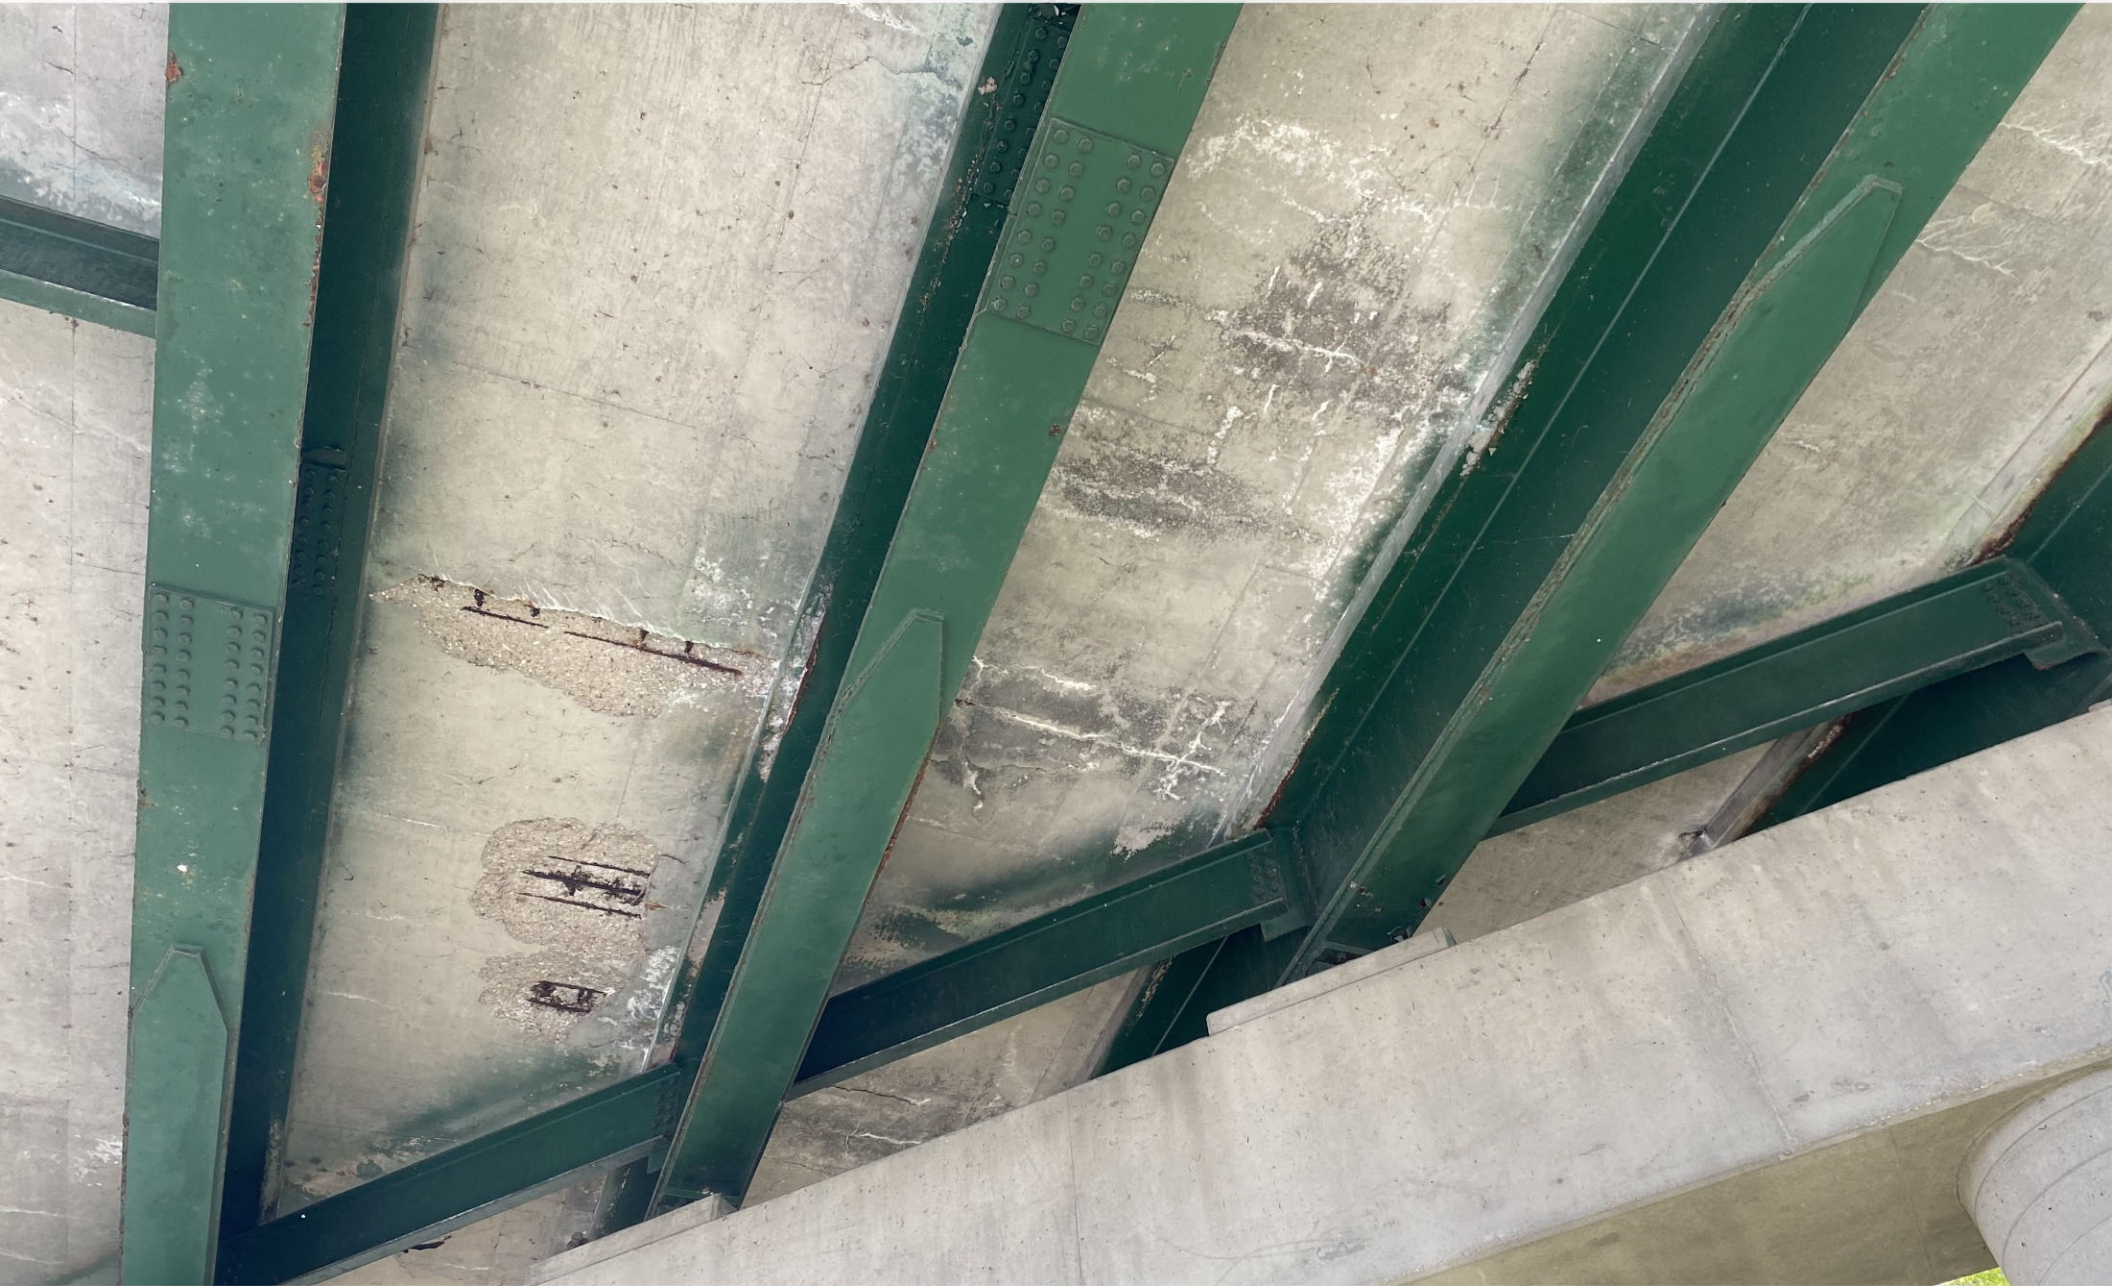
Bays #2 and #3 in Span #2 over Pier #2

Existing Conditions - Bridge #14E

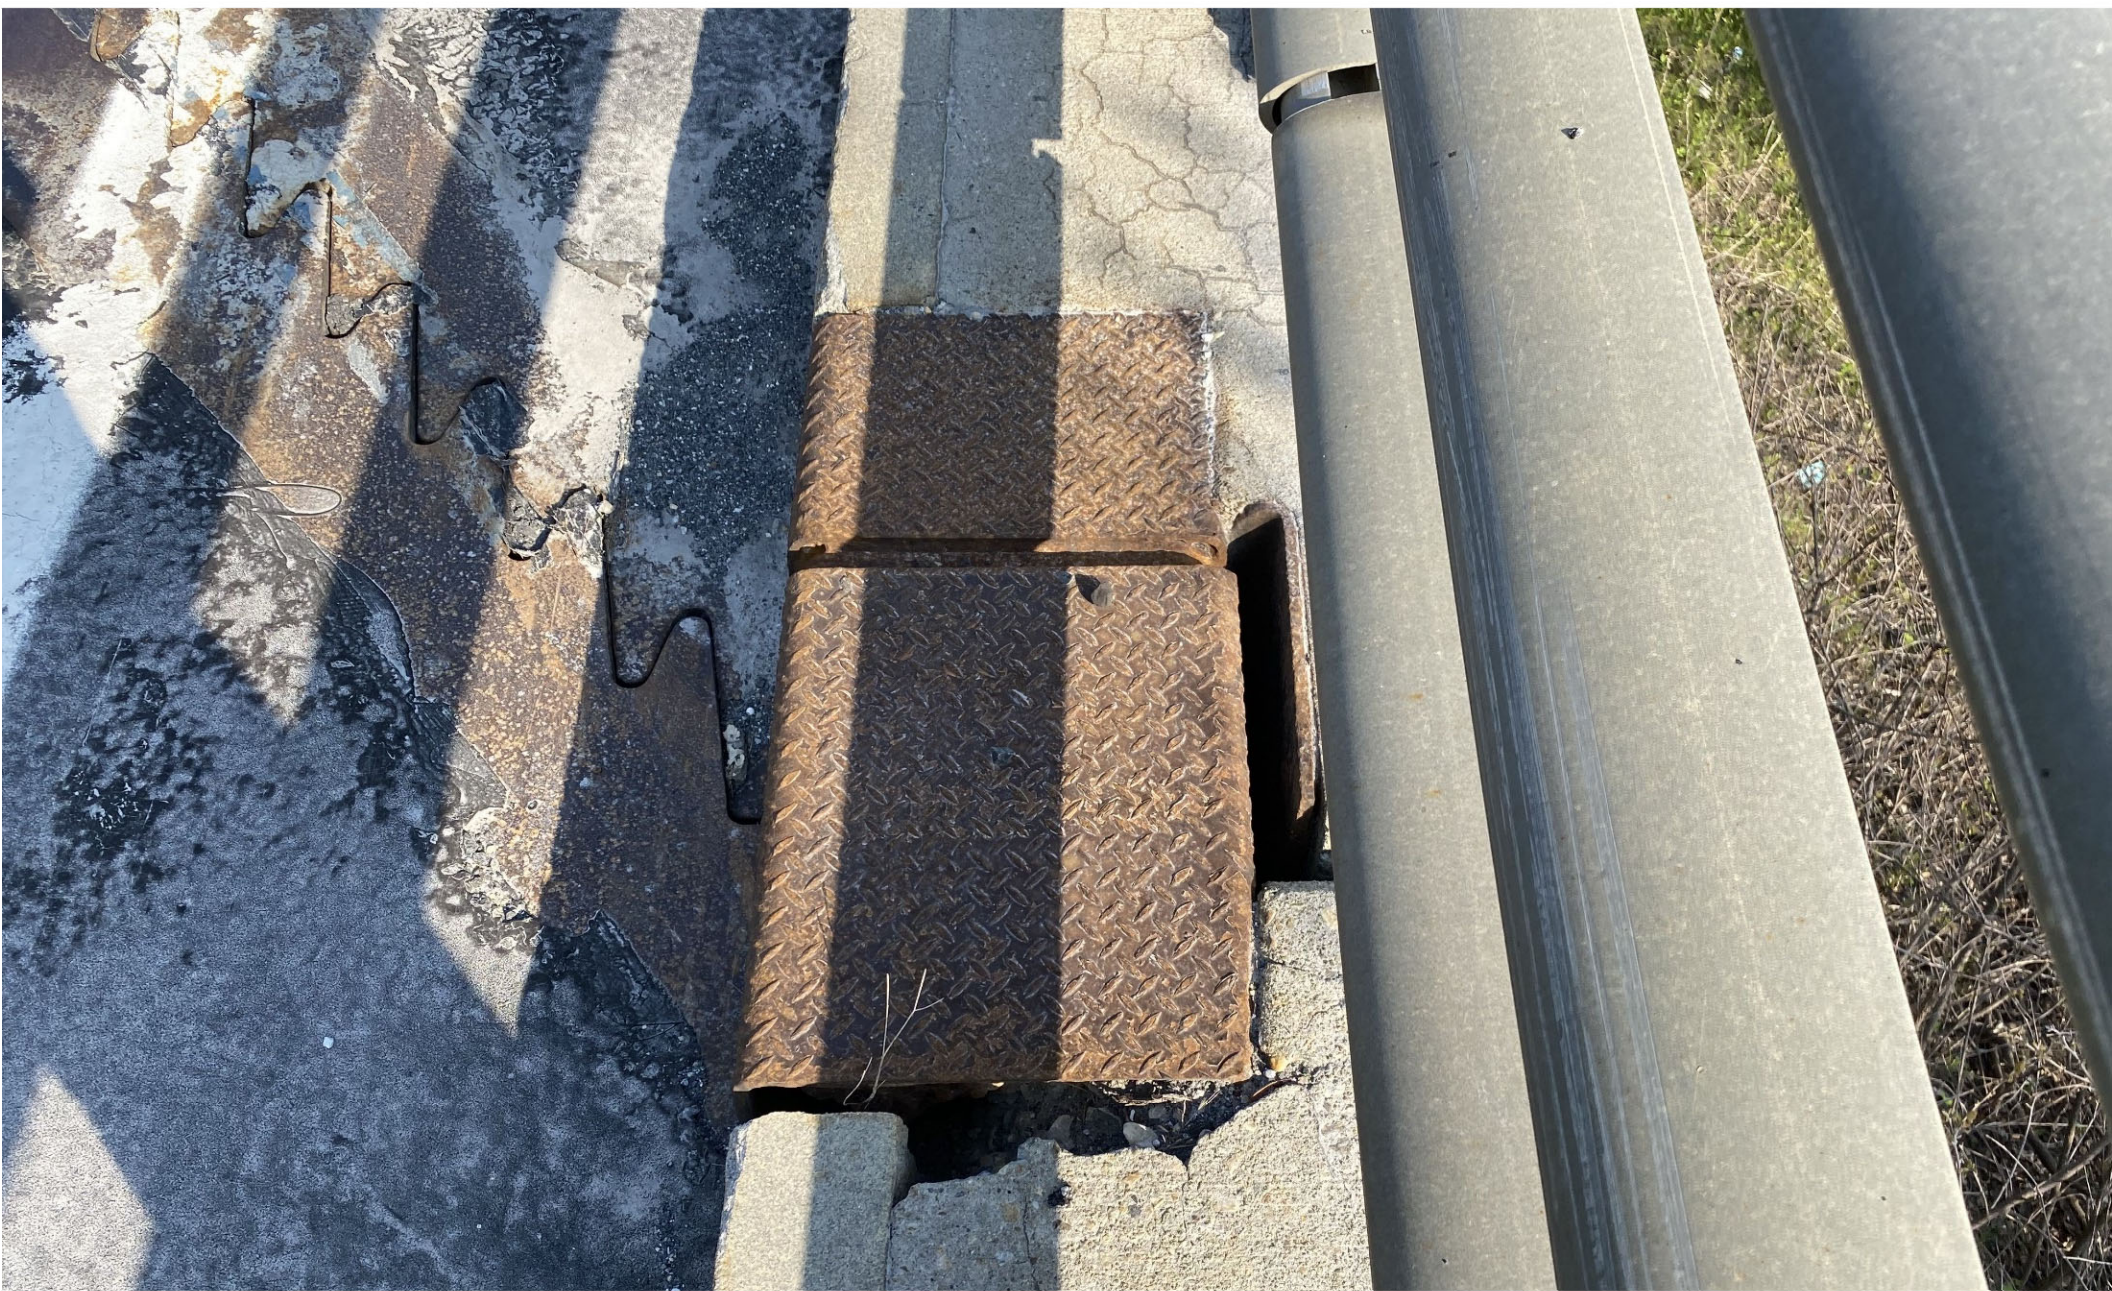
Concrete Spalling Surrounding Steel Joint at Abutment #2 on North Side

Existing Conditions - Bridge #14W

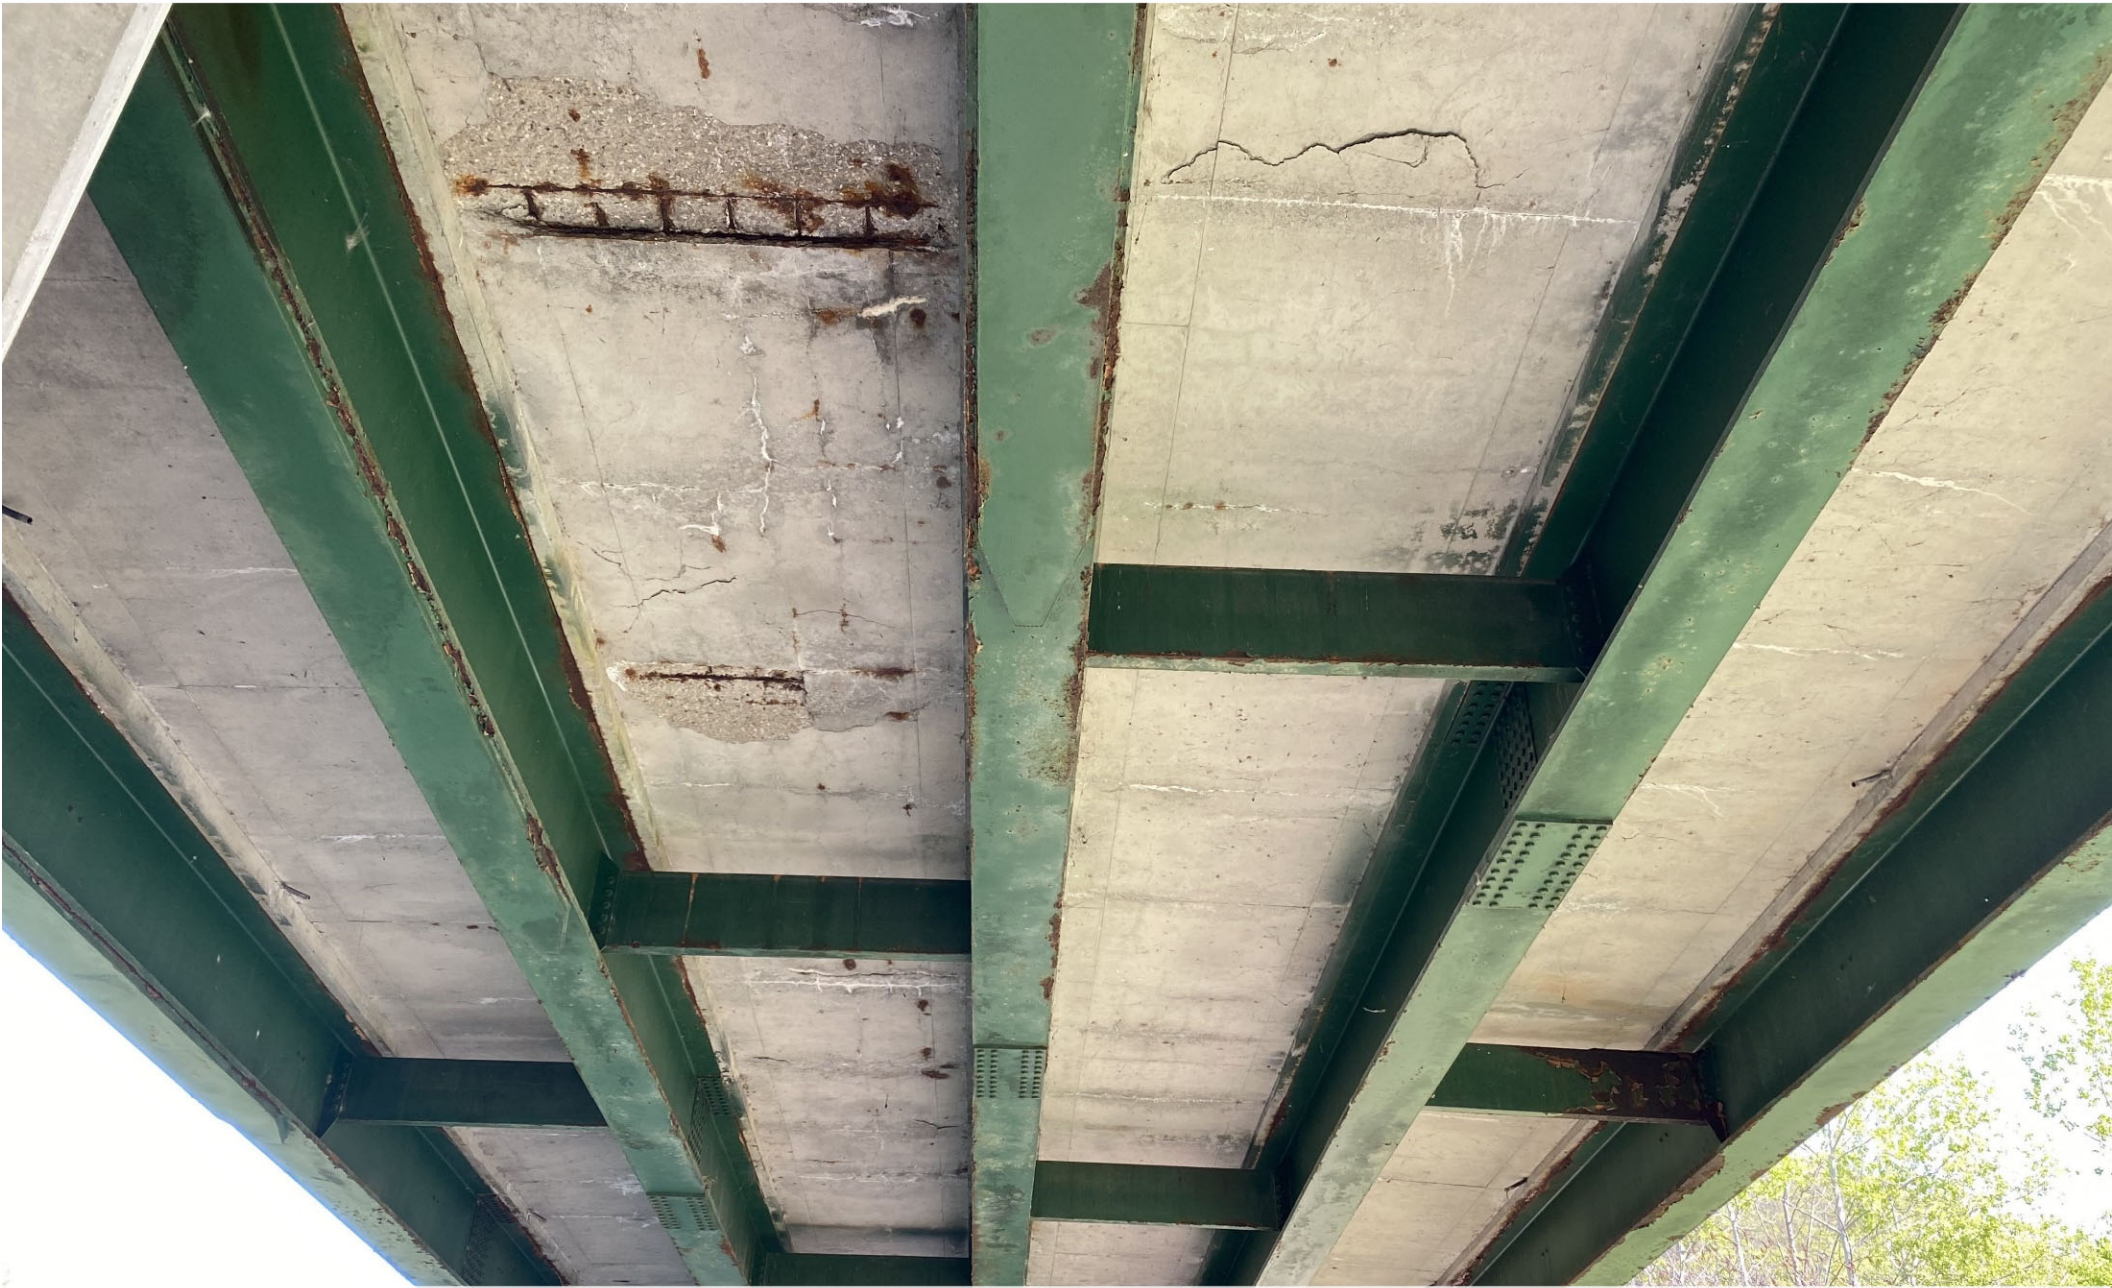
Span #1 Deck underside

Existing Conditions - Bridge #14W

- The deck of Bridge 14W is in **fair condition**. Deck underside is littered with spalling that has exposed steel reinforcing that has minor rust corrosion and delaminations along multiple bays. Areas of interior and exterior bays have areas of transverse cracking with efflorescence leakage.

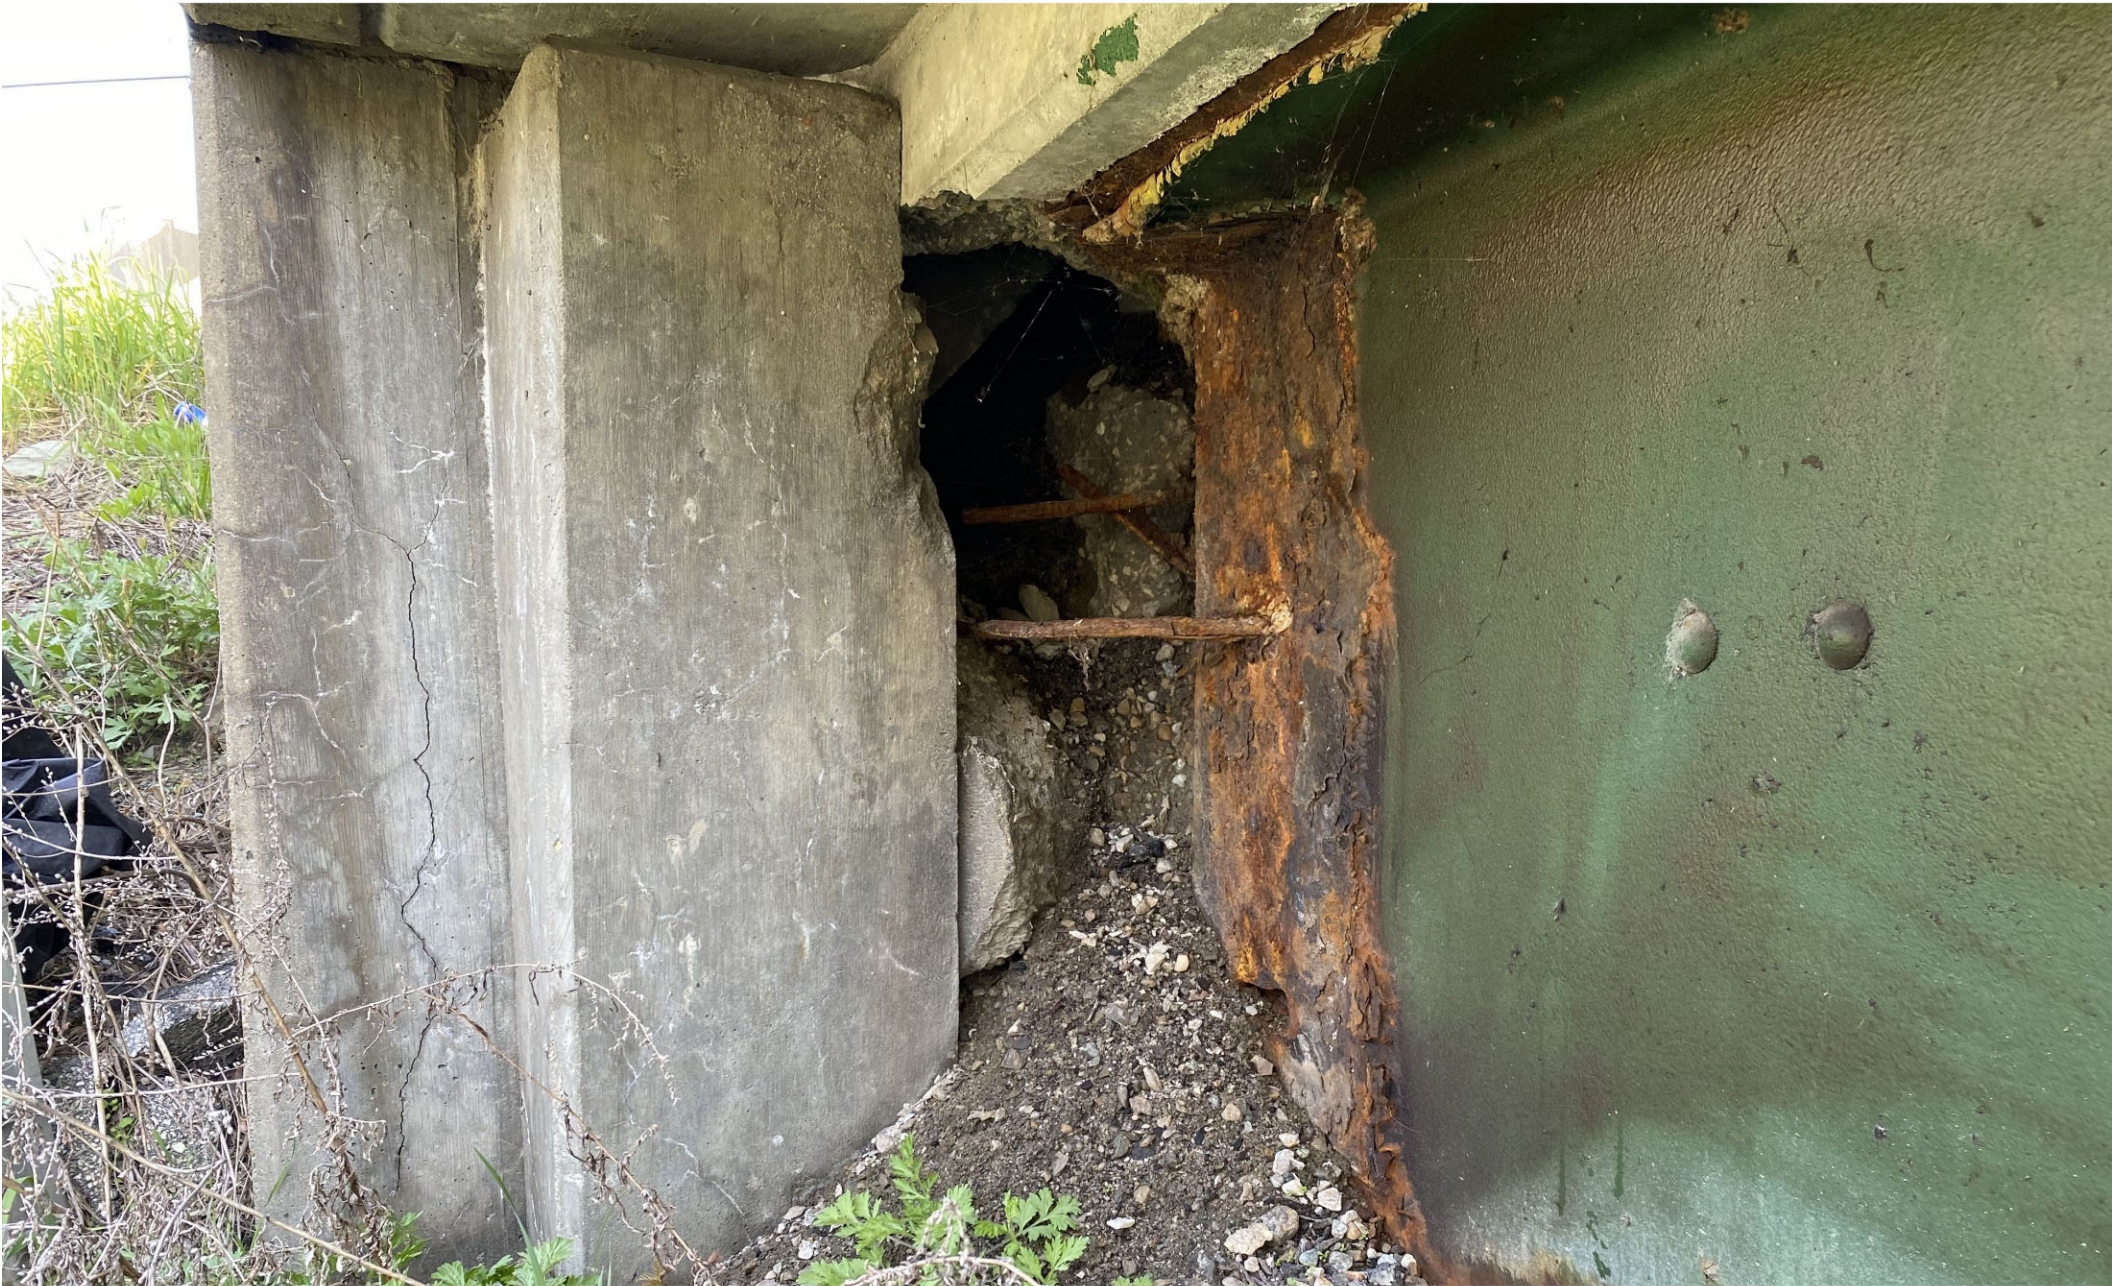
Backwall along Southern Side of Abutment #1 past Beam #5

Existing Conditions - Bridge #14W
