### 2022 School Facilities Inventory Report

Facility Name: **GRAND ISLE SU | ISLE LA MOTTE ELEM SCHOOL | 534 SCHOOL ST, ISLE LAMOTTE 5463 - Combination - Main Building**

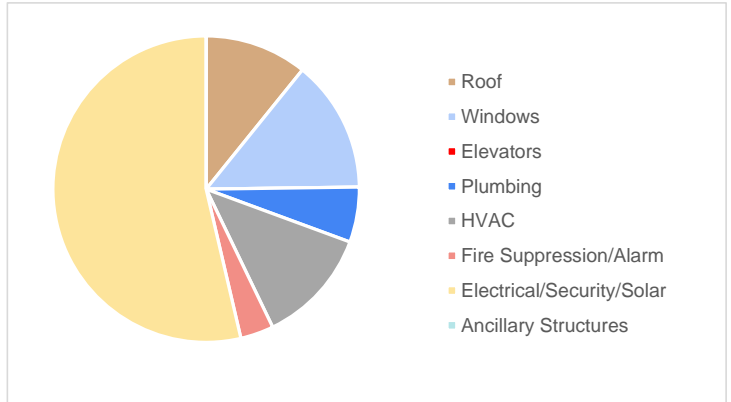
#### Relative Asset Values

Value of Assets/GSF **\$120.23**

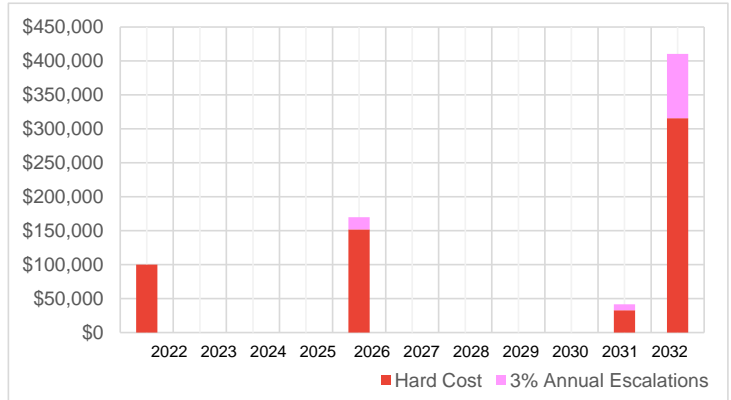
#### Projected Capital Planning Cash Flow

<b>Projected Capital Planning Cash Flow</b>	The estimated replacement costs of systems as they expire annually.
<b>Facility Condition Index (FCI)</b>	The cost -weighted depleted value of the building compared to the total value of all its systems; overall percent of building useful life consumed by years in service.
<b>Total Value of Assets</b>	The total estimated replacement cost of all the assets listed in the form.
<b>Value of Assets per GSF</b>	The Total Value of all Assets in the form divide by the Gross Square Footage (GSF) of the building.
<b>Facility Condition Index (FCI) Compared to Portfolio</b>	The Facility Condition Index (FCI) of the building overlayed on the chart of FCI's for all buildings in the portfolio. Indicated by a red line in the chart.
<b>Calculated Remaining Useful Life( C-RUL)</b>	The current number of remaining years a system may be expected to perform in designed service.

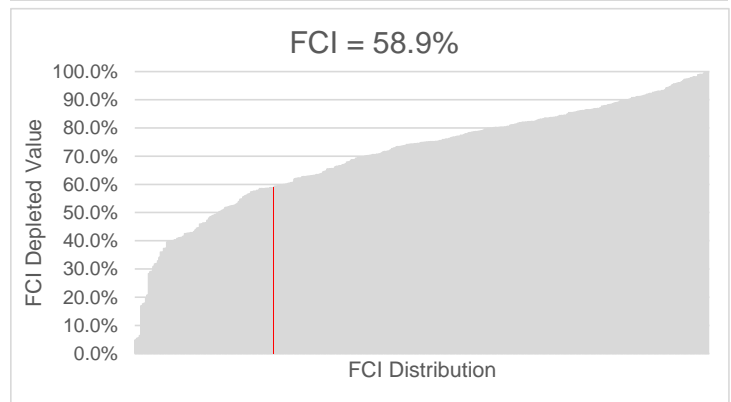
#### Facility Condition Index (FCI) Compared to Portfolio

(See Last Page for Explanation of Terms)
