# Searsburg BF 010-1(50)

**VT Route 9 – Bridge #20 over Unnamed Brook**

April 14th, 2016

**Accelerated  
Bridge  
Program**  
VTRANS

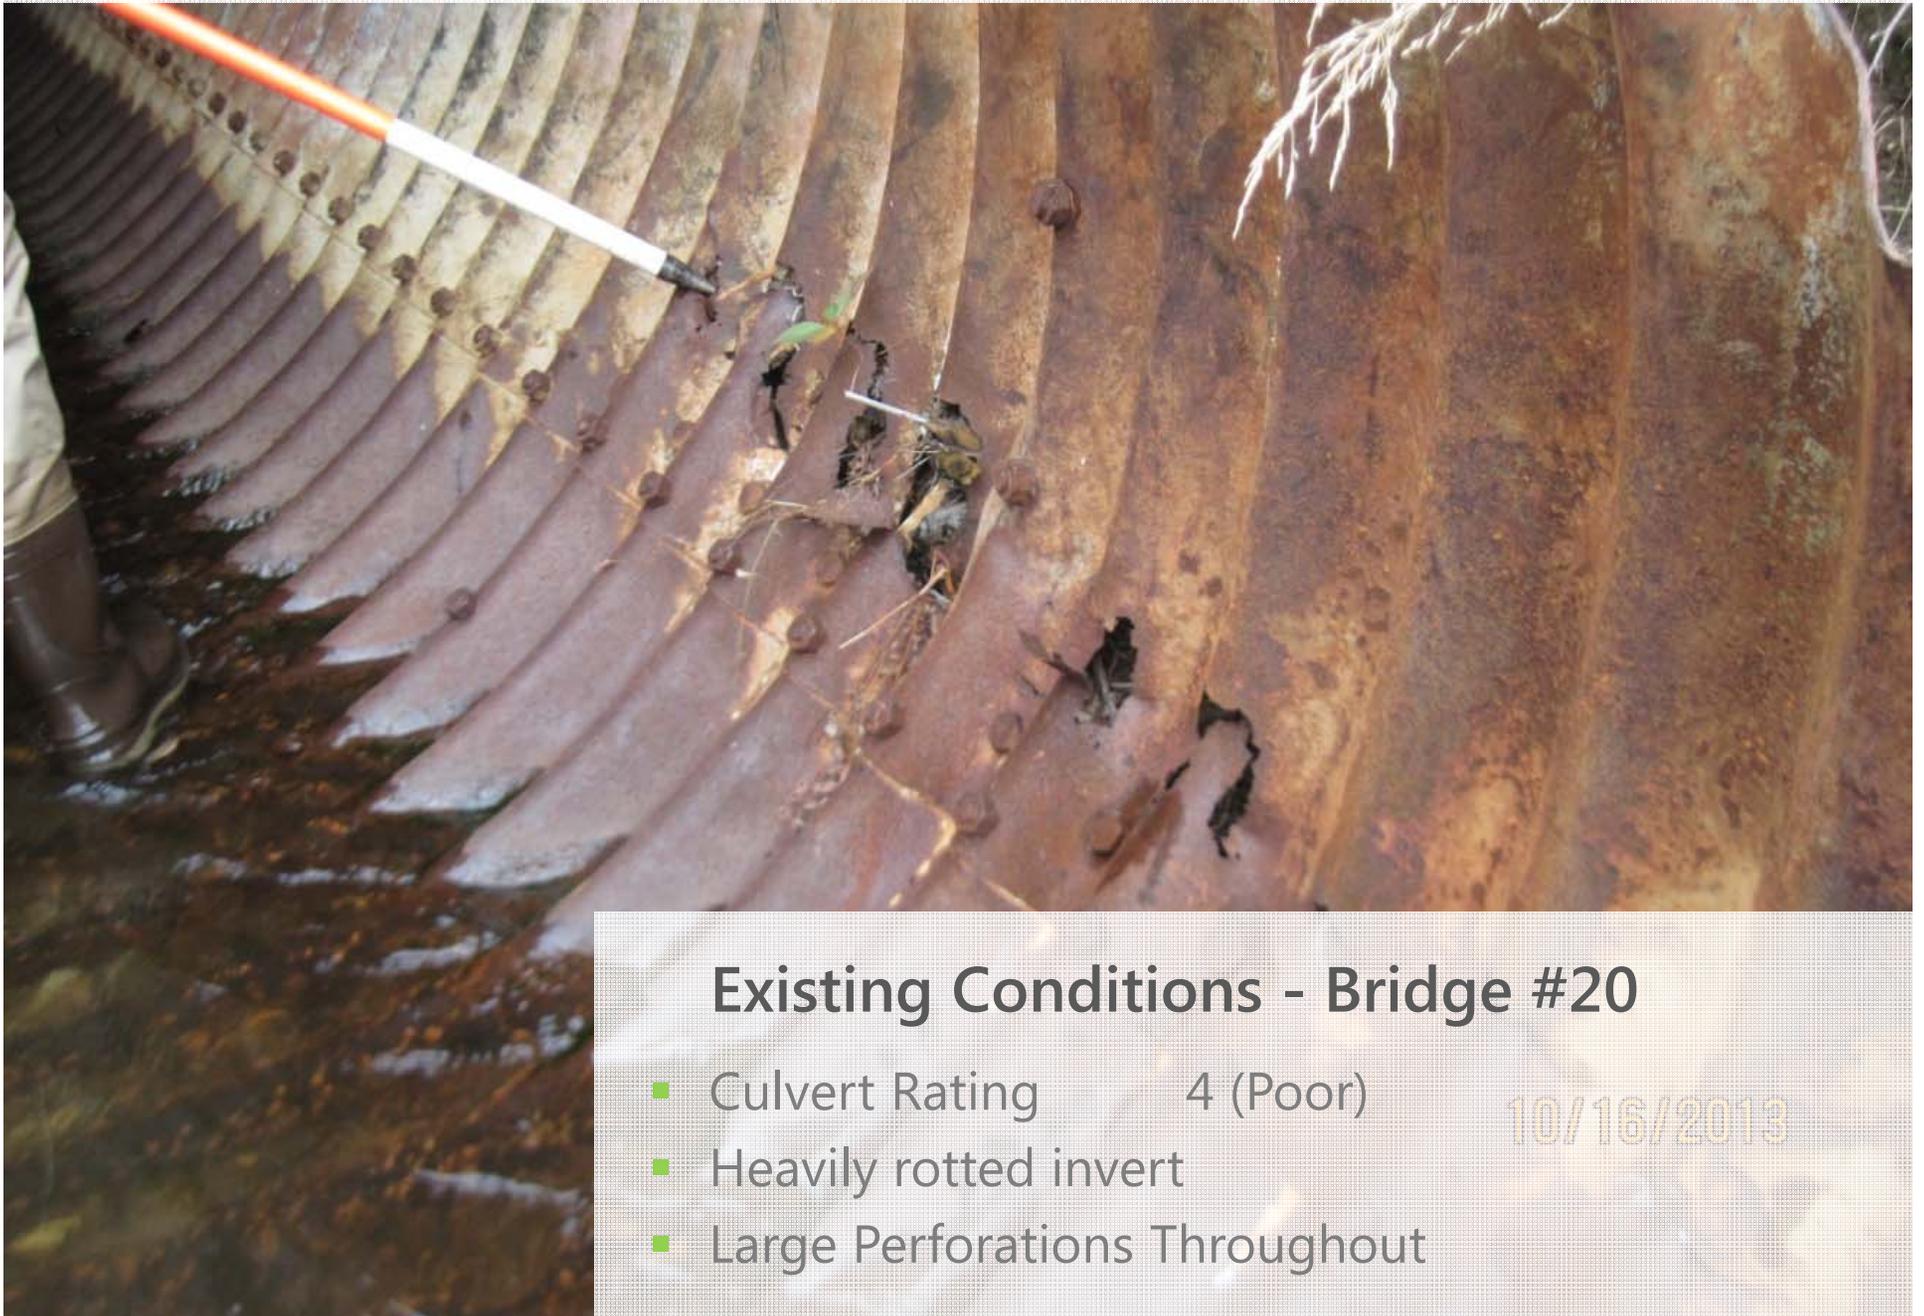
## Significant Deterioration

### Existing Conditions - Bridge #20

- Culvert Rating 4 (Poor)
- Heavily rotted invert
- Large Perforations Throughout

10/16/2013

- The existing culvert is rated “poor” and there is evidence of squashing at midspan. There are perforations throughout the culvert that are greater than 2 inches in width
- The bottom of the culvert is heavily rusted and rotted out
- The culvert does not meet the minimum bank full width standards
- The shoulders on VT 100 are substandard by 1.5 feet throughout the project area where there is guardrail

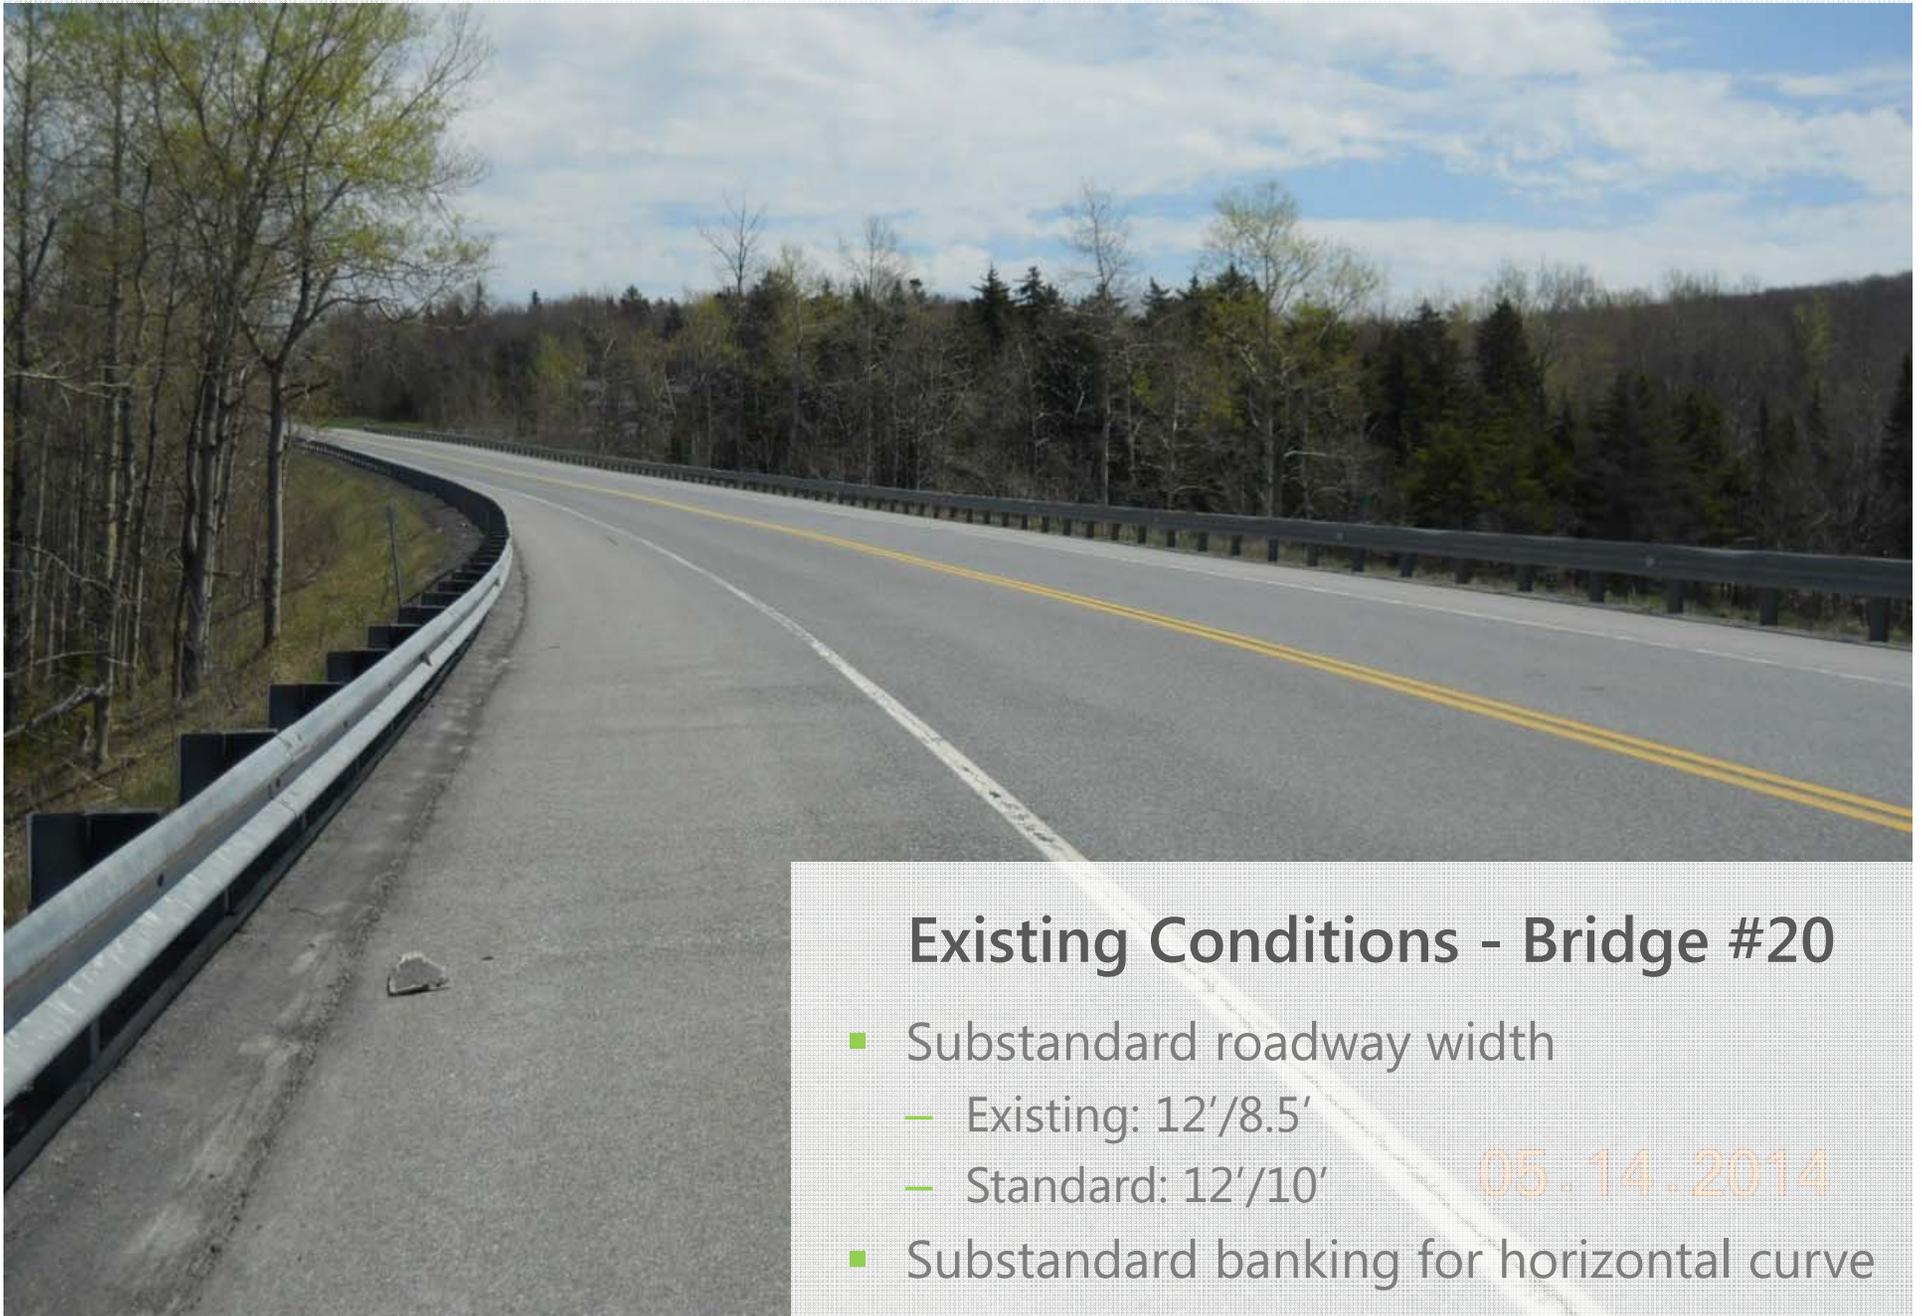
## Looking East Over the Culvert

### Existing Conditions - Bridge #20

- Substandard roadway width
  - Existing: 12'/8.5'
  - Standard: 12'/10'
- Substandard banking for horizontal curve

05.14.2014

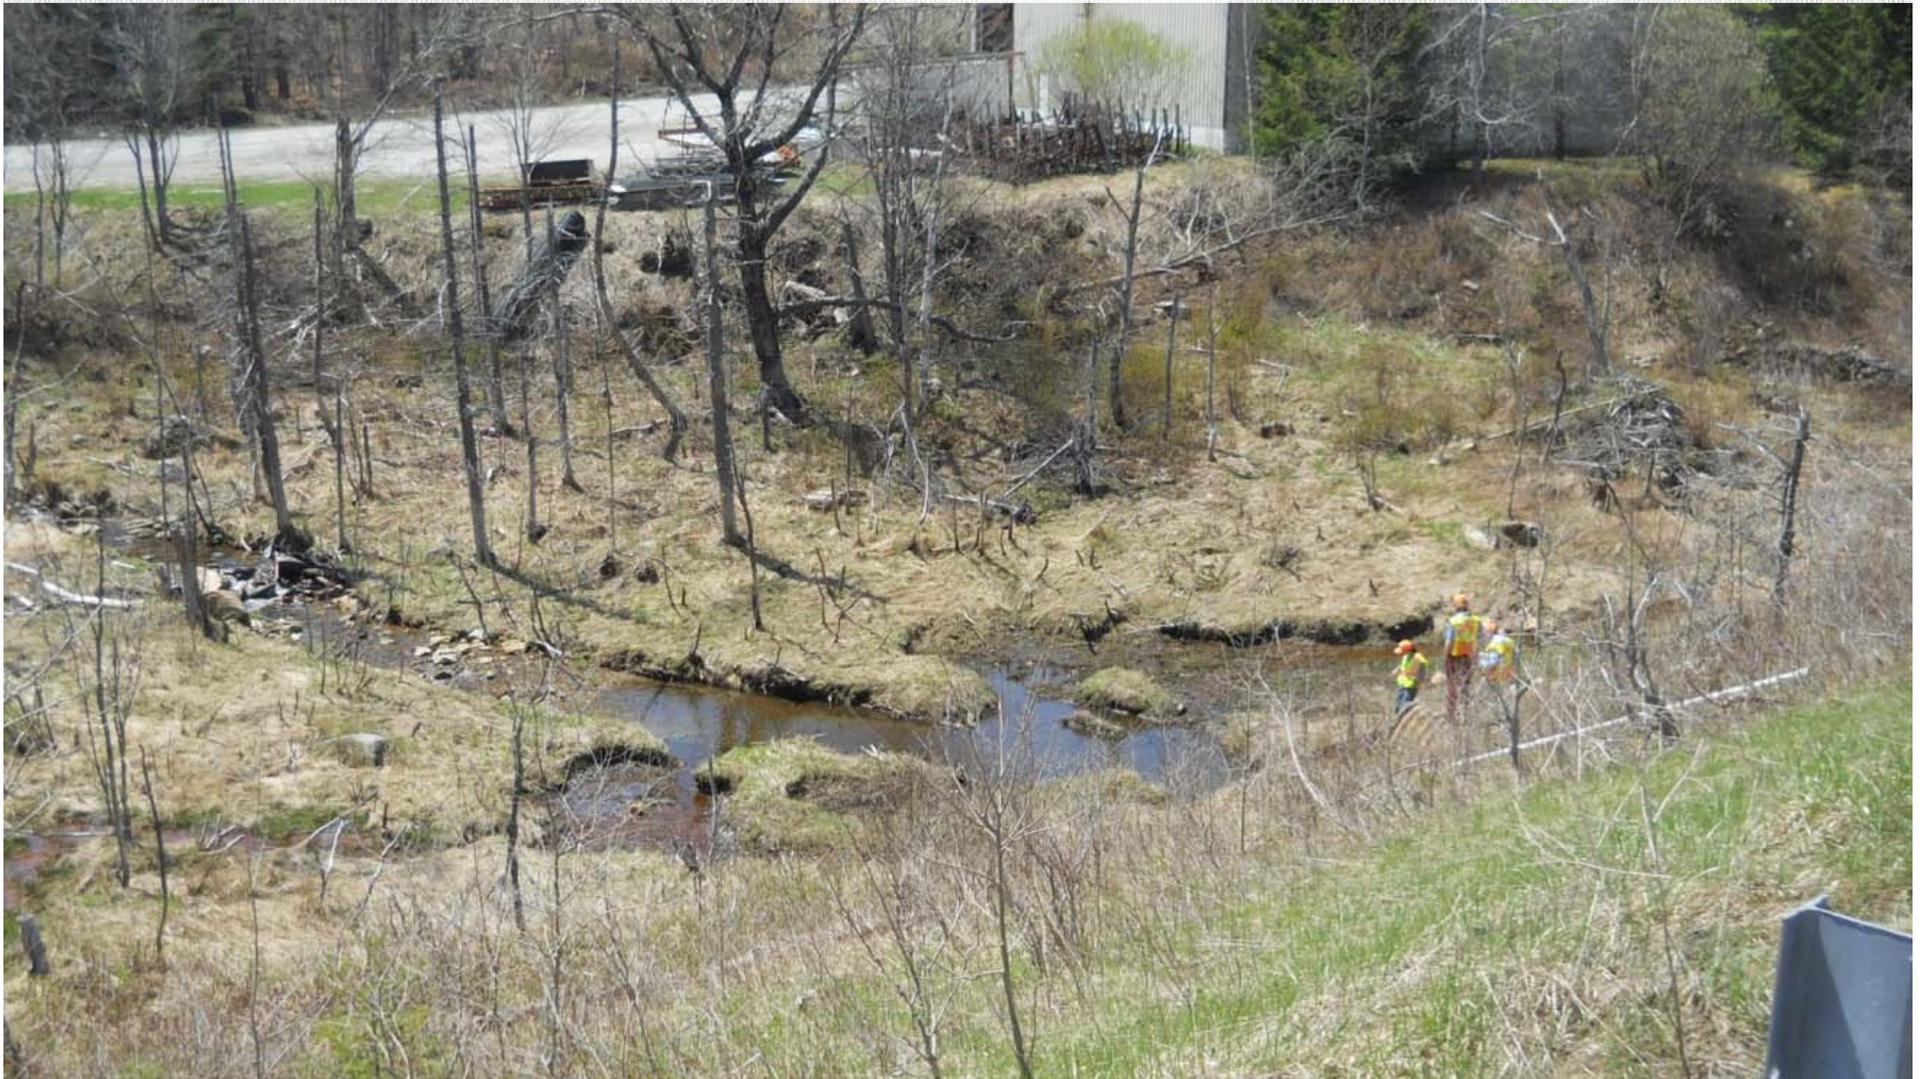
## Resource Constraints

### Existing Conditions - Bridge #20

- Wetlands upstream

05.14.2014

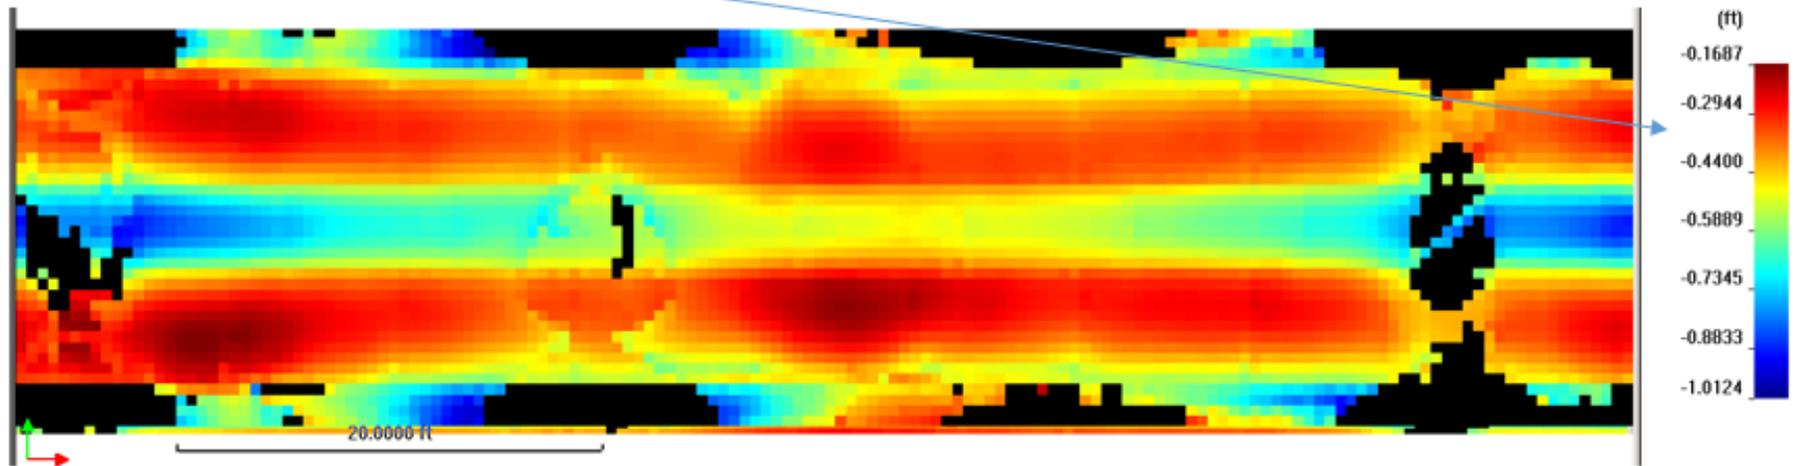
## Comparative cross-sections of a 6 foot outer-diameter insert to existing culvert wall

Each cross-section includes a surface to model map that displays where on the pipe this cross-section lies, and is colored to indicate overall distance of the insert to the culvert wall (example below)

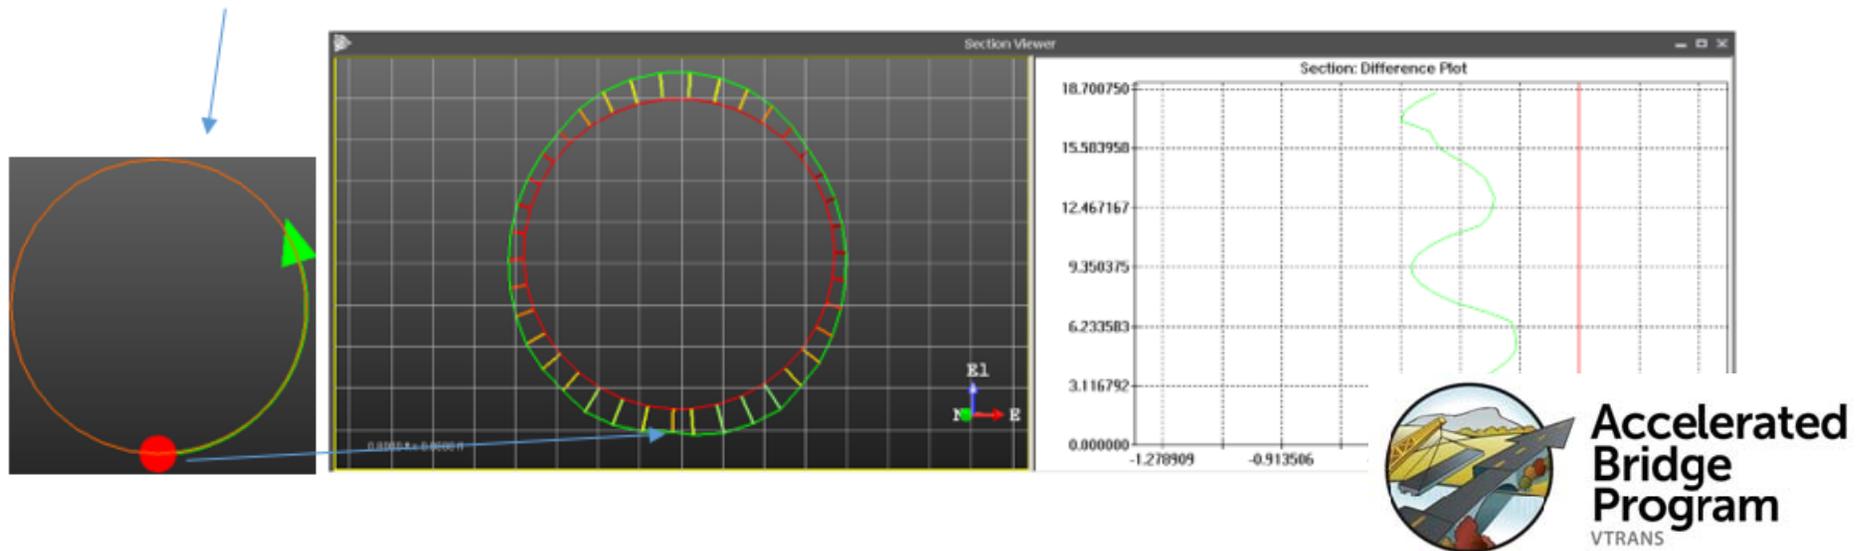
The cross-sections themselves are partitioned into half-foot intervals around the pipe, and a plot indicating the distance of each interval is included to the right of each cross-section. The plot begins at the base of the culvert and moves counter clock-wise around the pipe

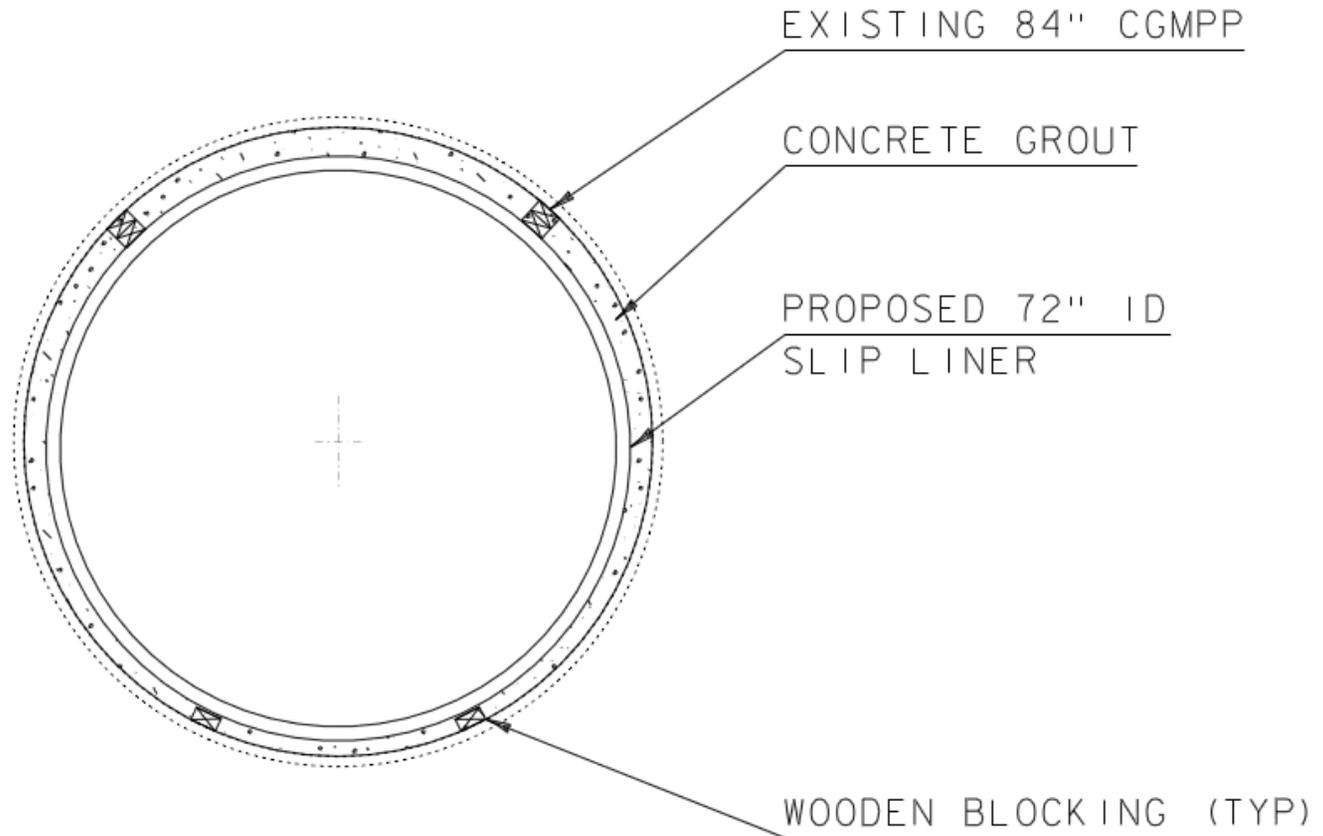
# Typical Section

ALTERNATIVE IB TYPICAL SECTION

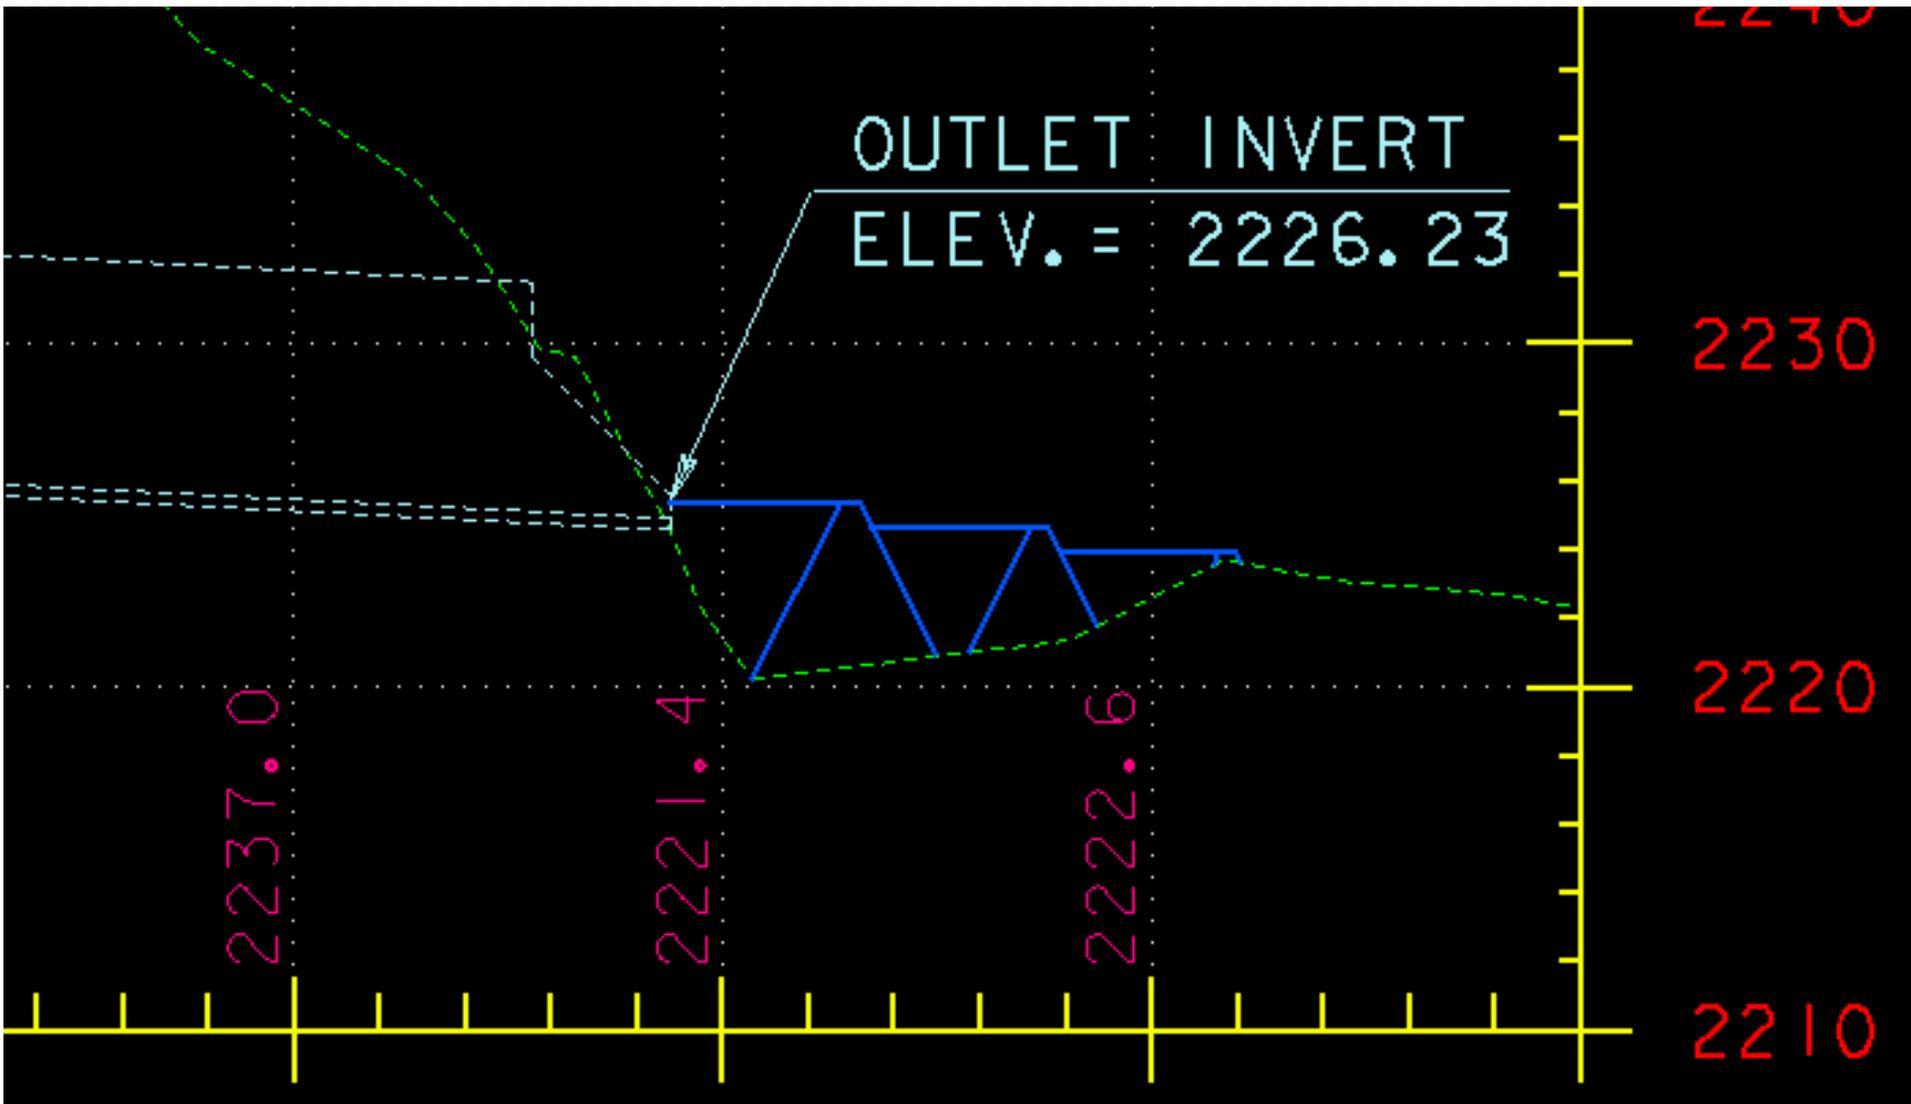
### ALTERNATIVE 1B IMPACTS

- Minimum of 3 weirs
- Approximately 40' Downstream Required

52+75

53+00

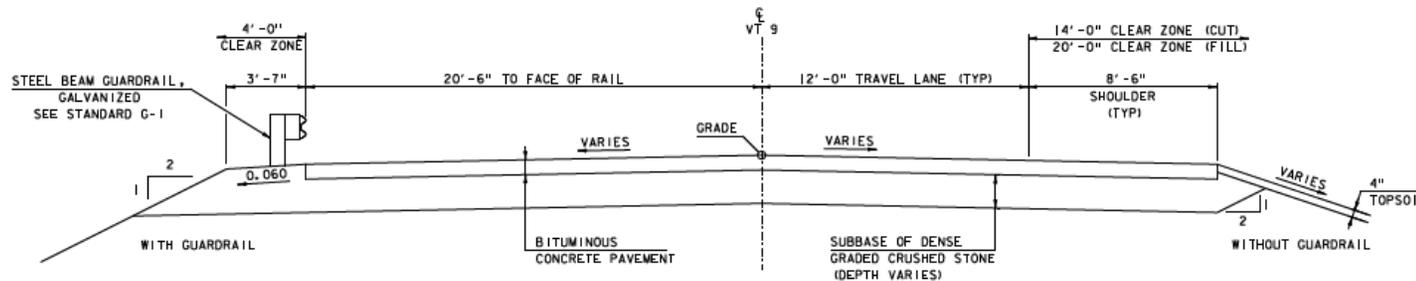
# Typical Sections

EXISTING VT 9 TYPICAL SECTION  
SCALE 3/8" = 1'-0"

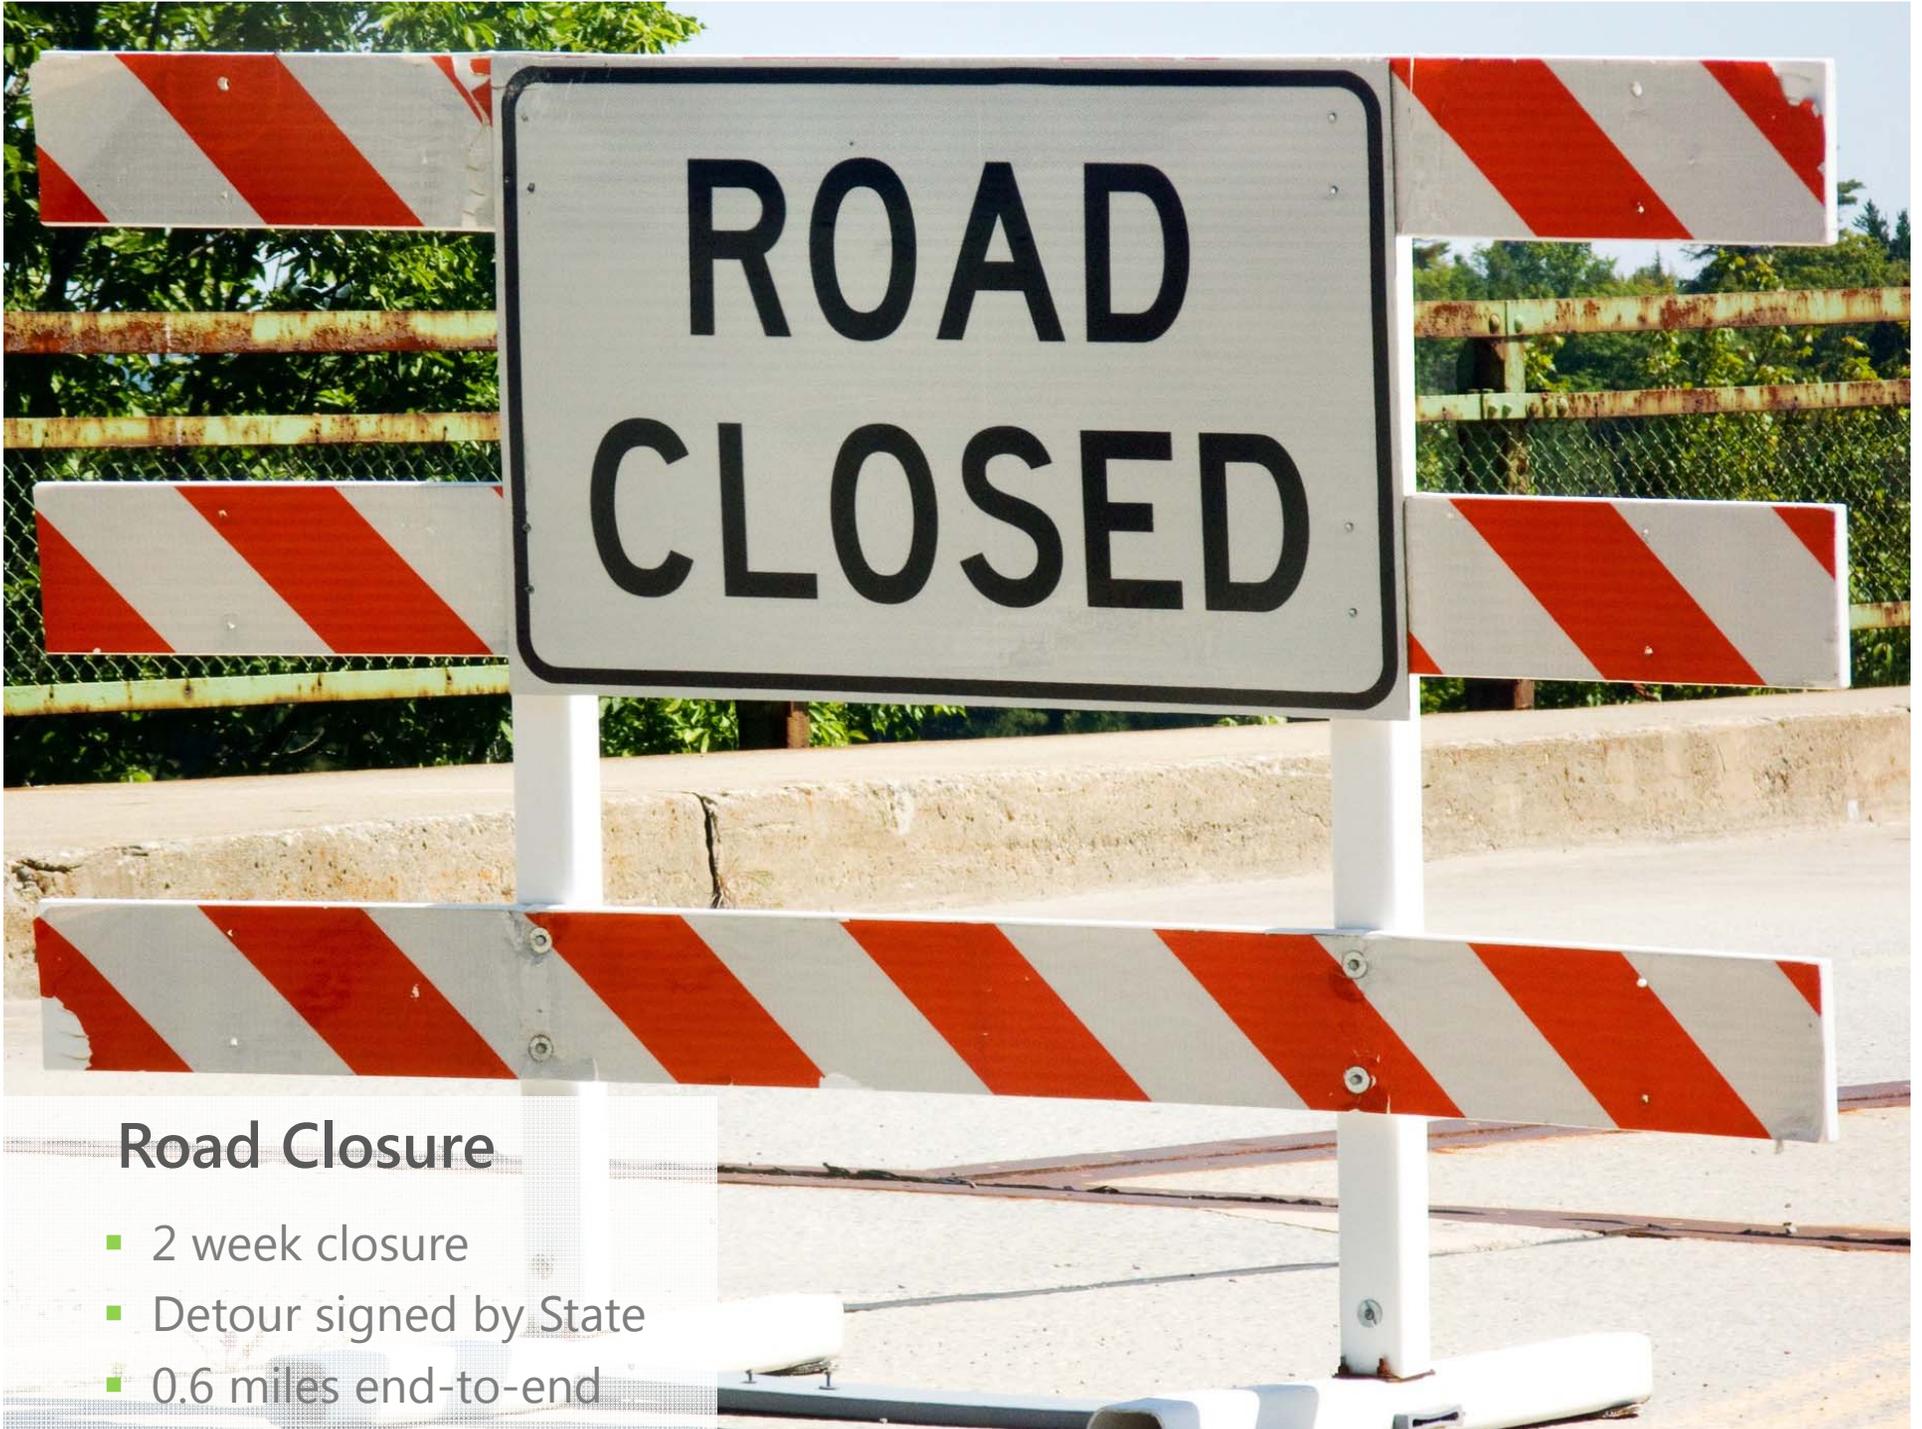
## Road Closure

- 2 week closure
- Detour signed by State
- 0.6 miles end-to-end

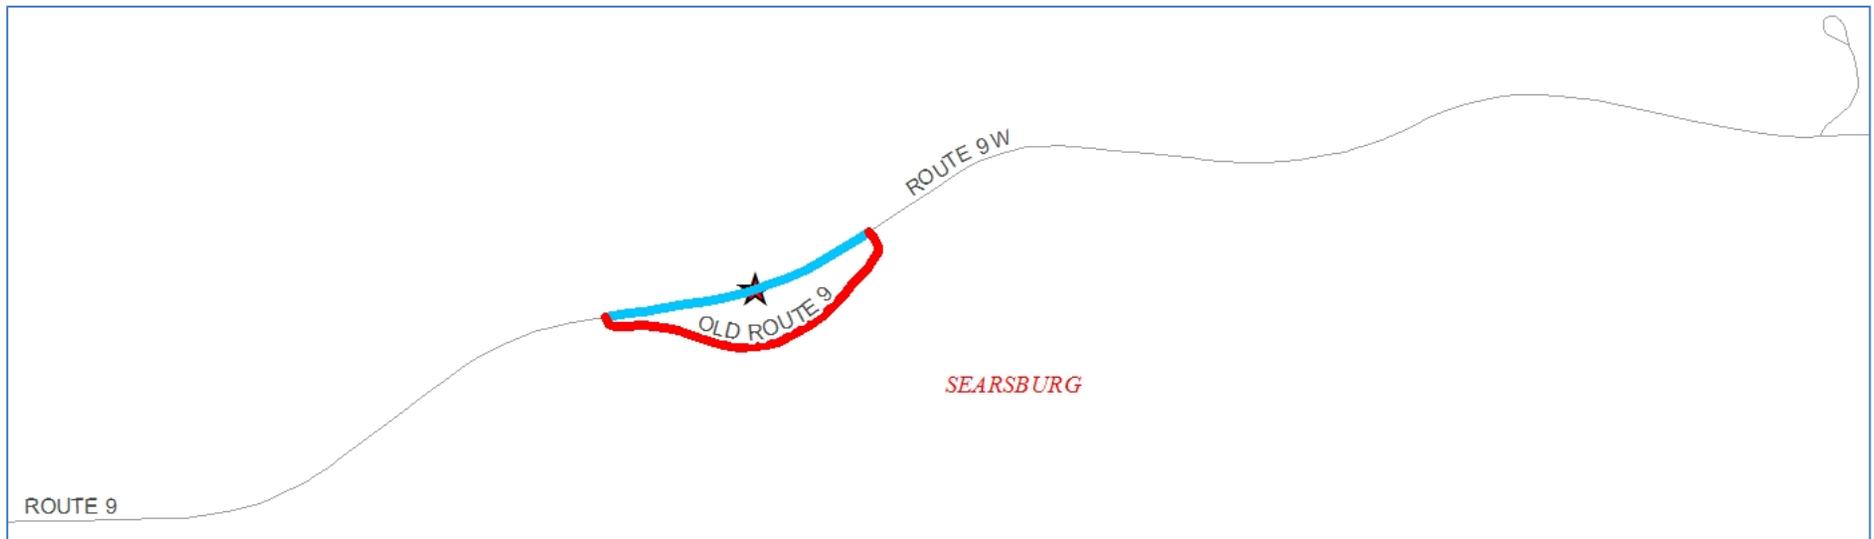
# Traffic Control – Offsite Detour

- Short Term Road Closure w/ Offsite Detour

- Signed by State, detour route parallel to VT Route 9 and adds no distance to travel

- VT Route 9 to Old VT Route 9 back to VT Route 9

- Through Route: 0.3 Miles
- Detour Route: 0.3 Miles
- Added Miles: 0 Miles
- End-to-End: 0.6 Mile
