Danby BF 0130(4) Scope Collaboration Meeting FAS Route 130 (TH 1/Brook Road) – Bridge 7 over Mill Brook May 12, 2022

Existing Conditions – Bridge #7

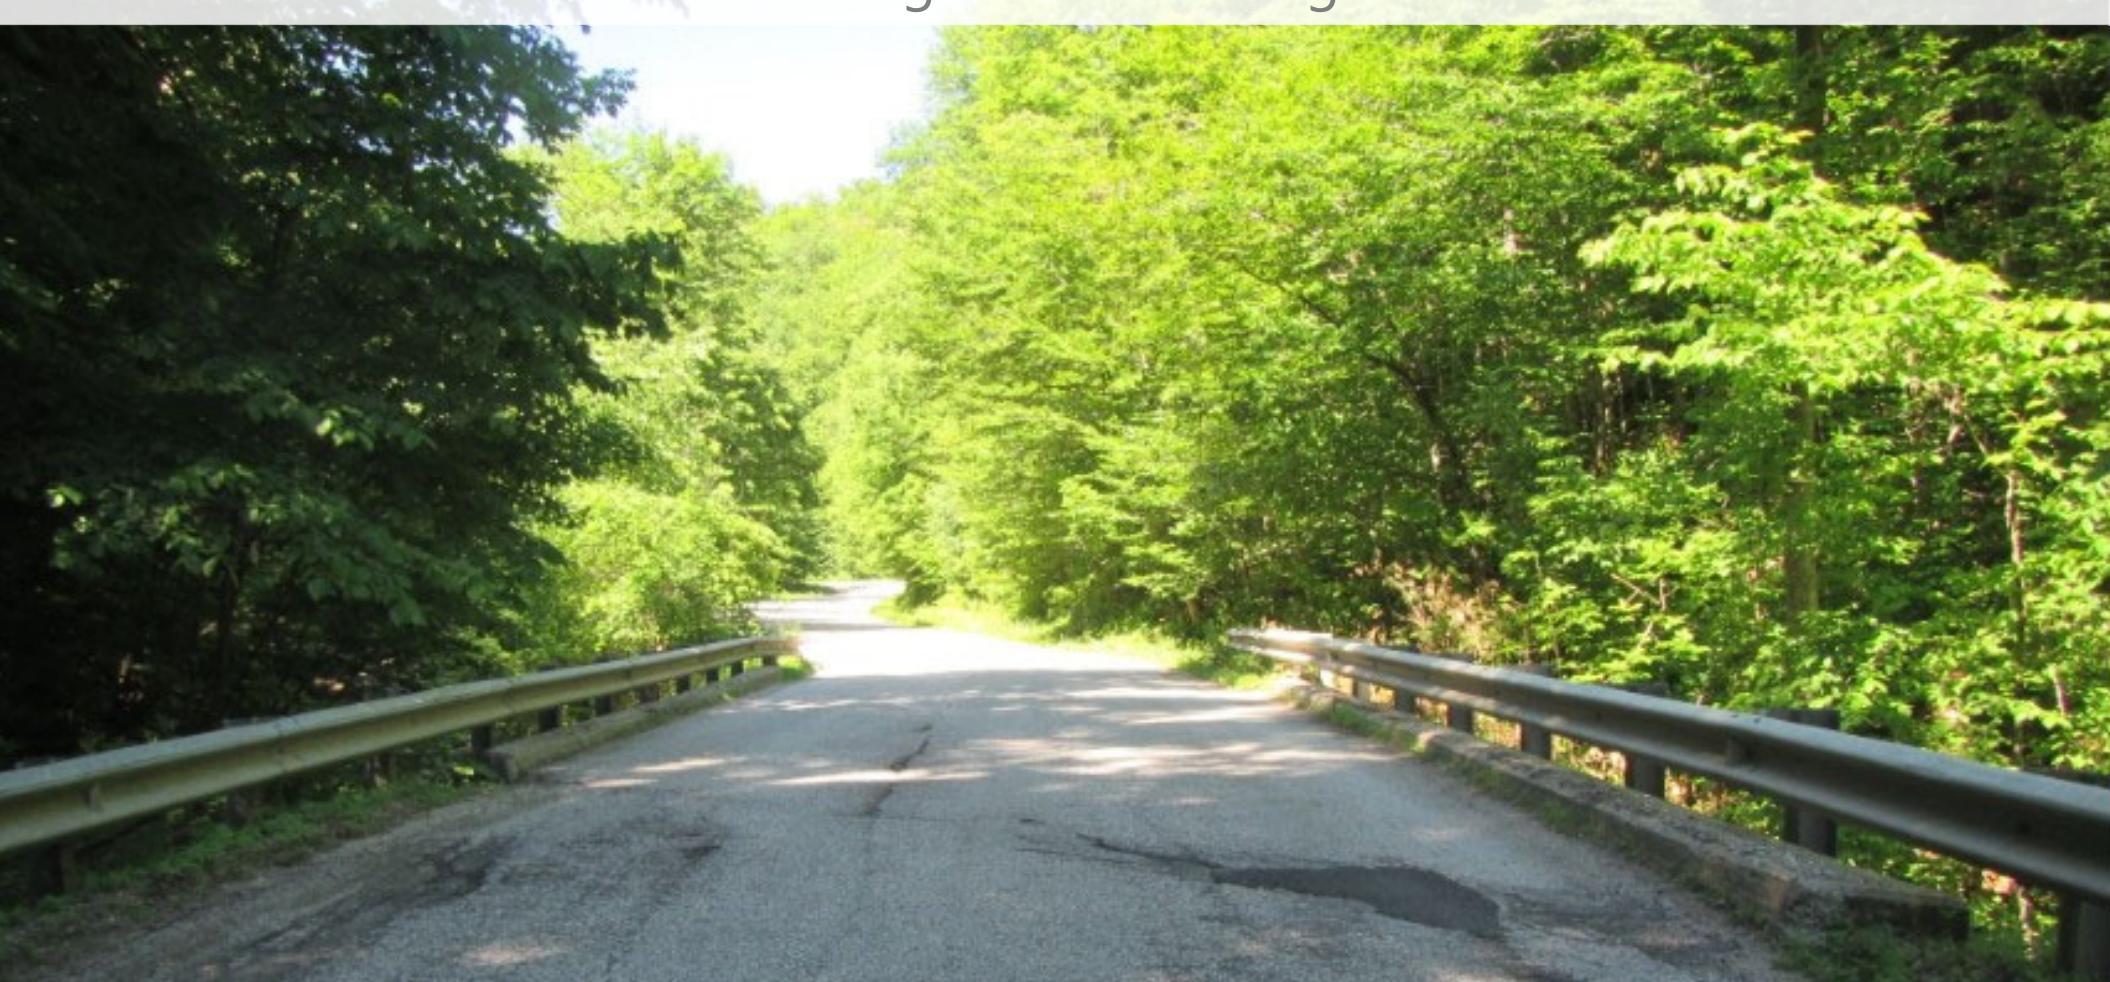
Looking East over Bridge 7

- Roadway Classification Rural Major Collector
- Bridge Type 40' Span Concrete T-Beam
- Ownership Town of Danby
- Constructed in 1928

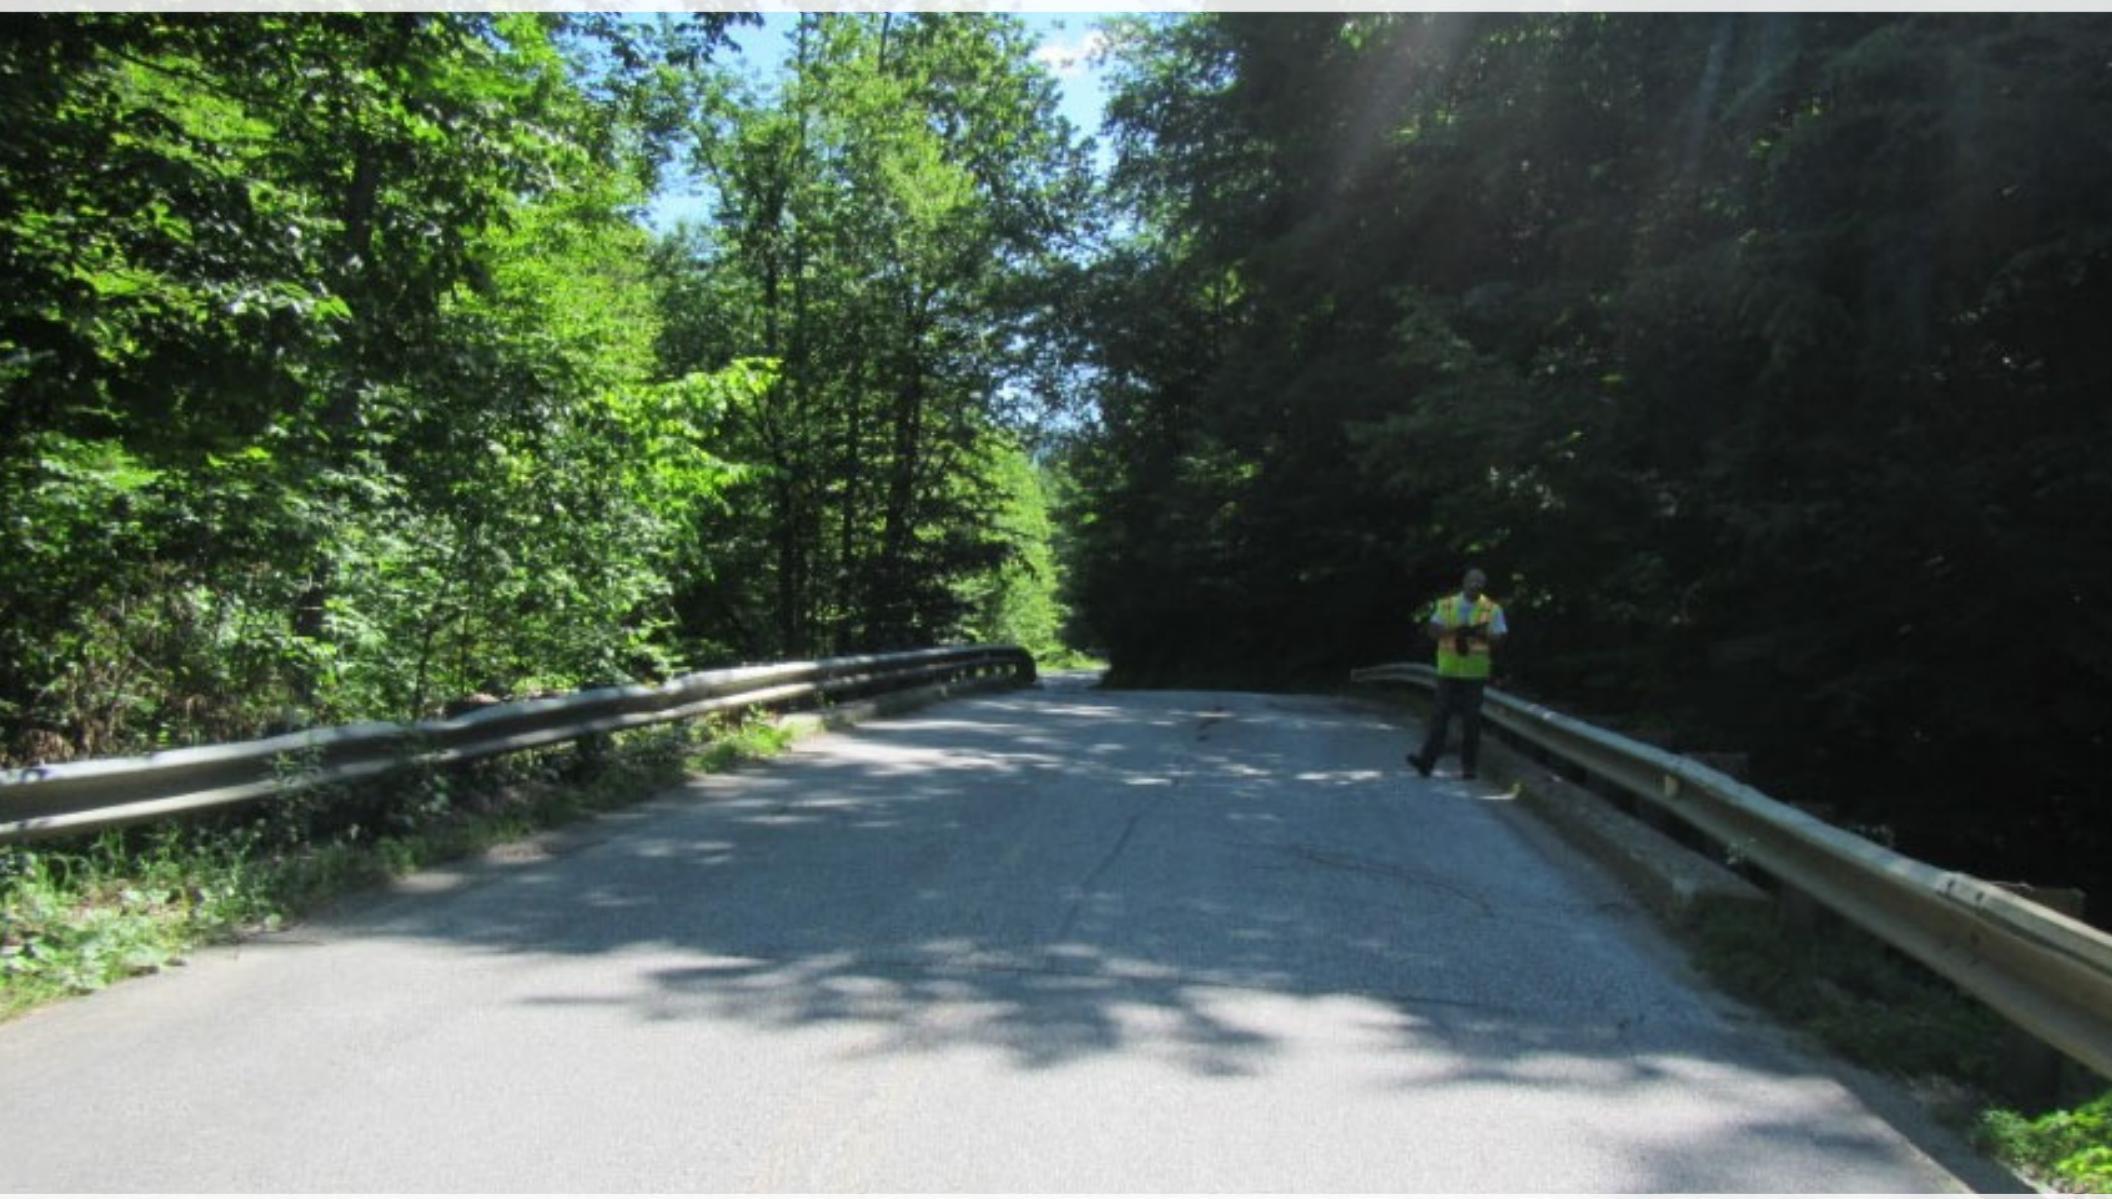
Looking West over Bridge 7

- The existing concrete T-beams have patched areas throughout, small pop outs and areas of spalling with exposed reinforcing in the beam ends
- The substructures are in good condition with only some minor abrasion along the base with some small, voided spalls. The is some map cracking in the ends with efflorescence staining.
- The existing bridge width is too narrow for the roadway classification and traffic volumes and does not provide adequate shoulder space for shared use.
- The horizontal and vertical curves through the project area are substandard.
- The bridge does not meet the minimum bank full width requirements.

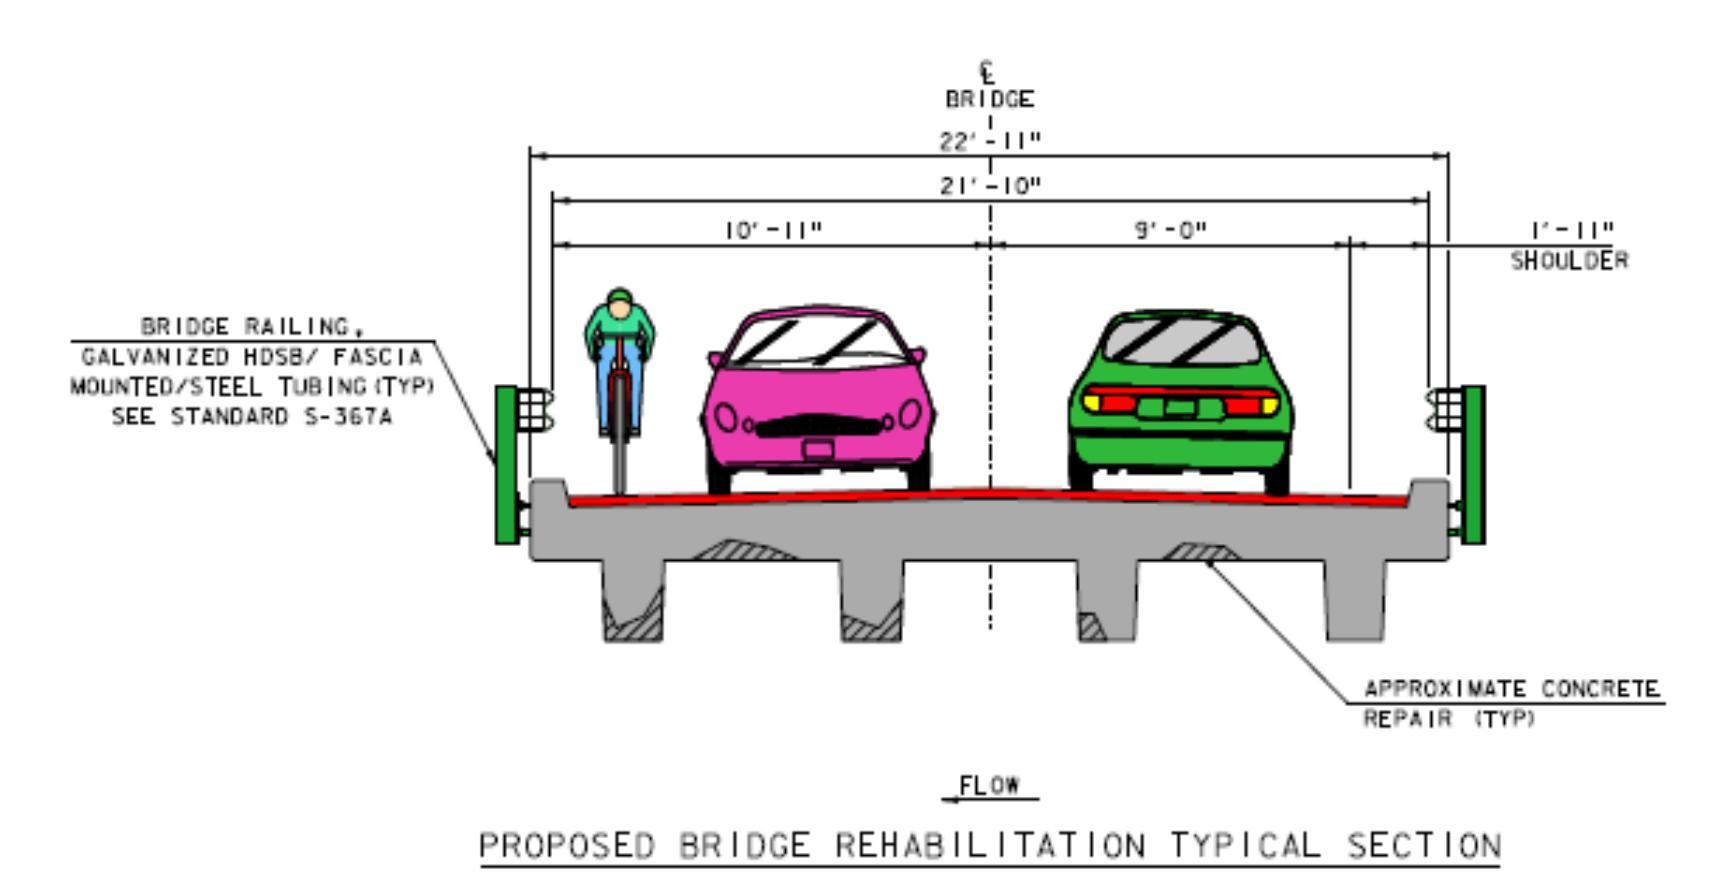
Alternative 1 Typical Section

• 9' travel lanes with 1'-11" shoulders

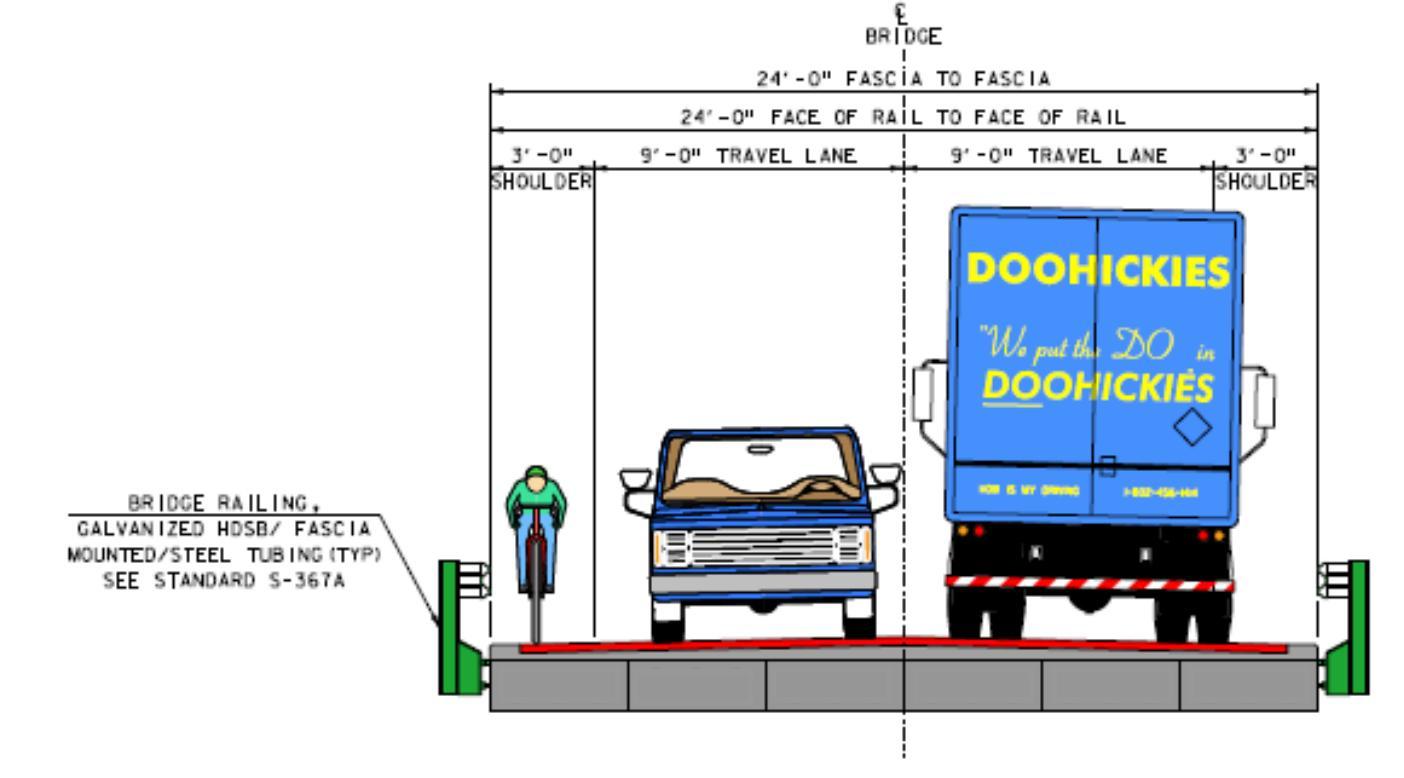
Alternative 2 Typical Section

FLOW PROPOSED SUPERSTRUCTURE REPLACEMENT TYPICAL SECTION

- Widen to meet minimum standard bridge width (3'-9'-9'-3')

- Superstructure Replacement
 - -Addresses deteriorating condition of the T-beams.
 - Existing T-beams replaced with a shallow superstructure type, such as solid slabs to improve freeboard for hydraulics.
 - Bridge typical section widened 2-feet to meet the minimum standard for width
 - 9'/3' typical
 - 50-year design life

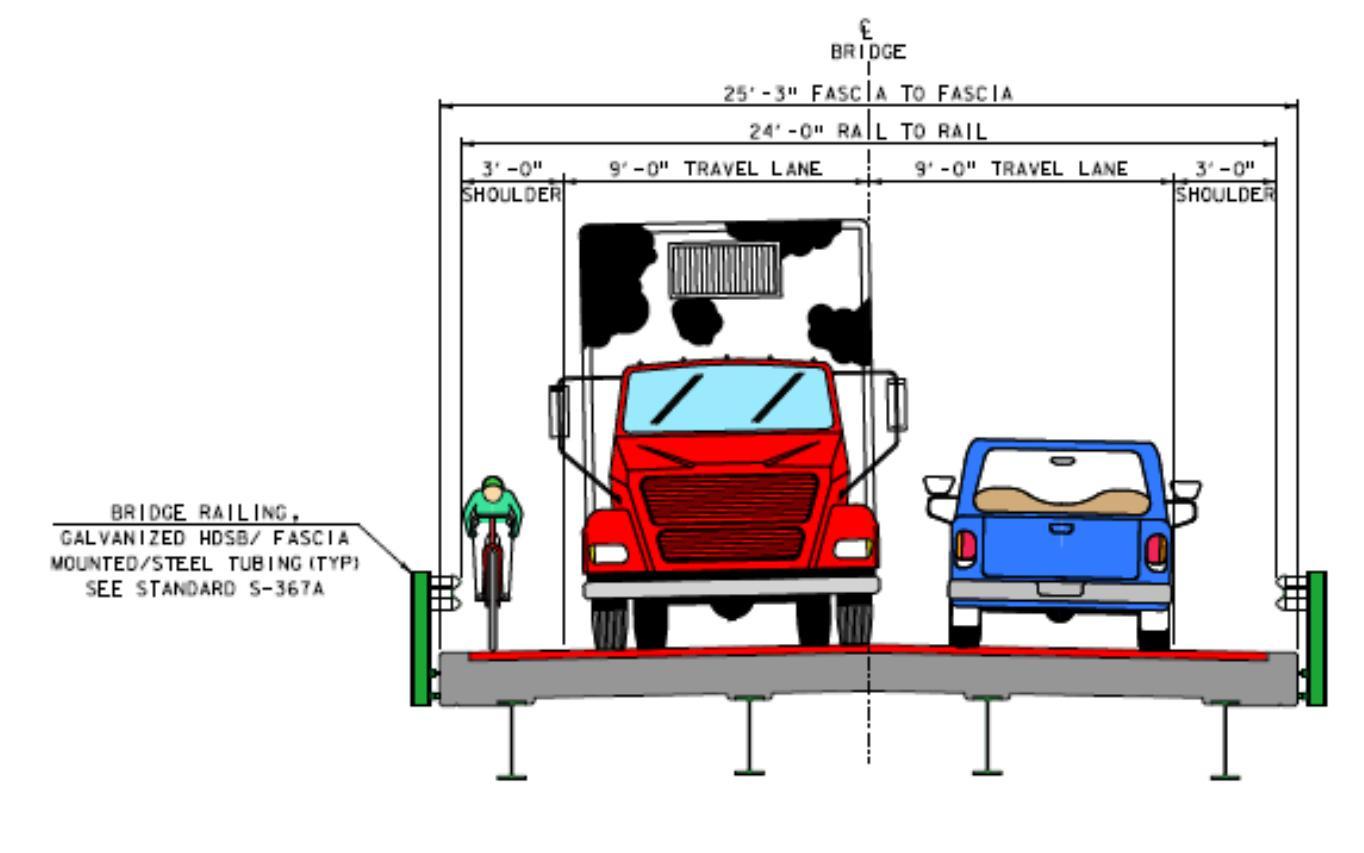
Alternative 3 Typical Section

- Widen to meet minimum standard bridge width (3'-9'-9'-3')

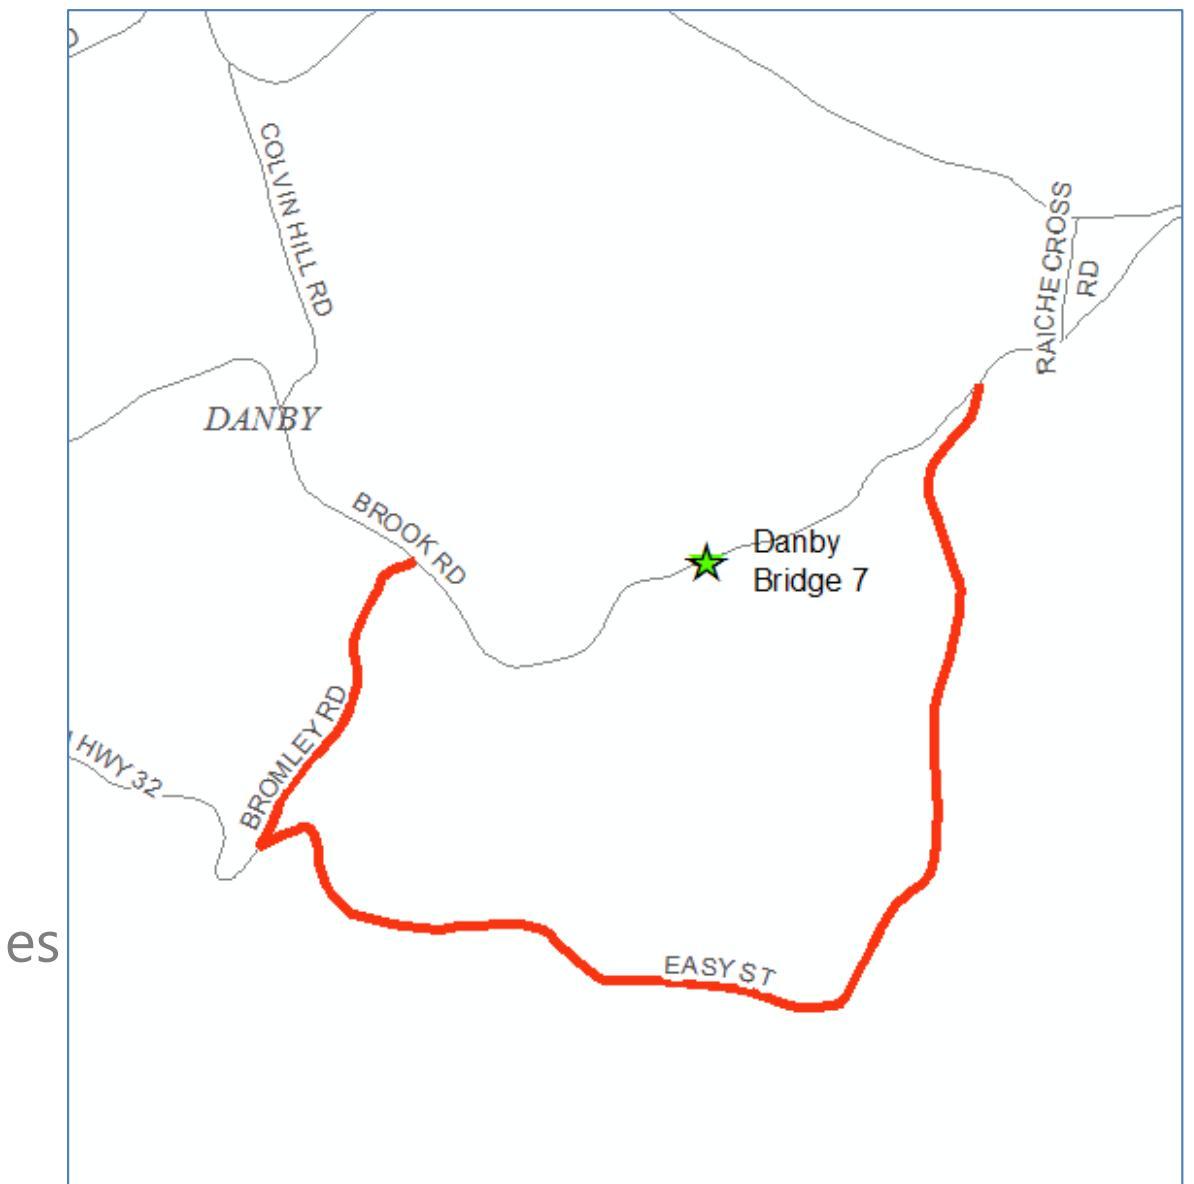
Traffic Control – Detour 1

Detour Route: Brook Road (FAS 130/TH 1), to Bromley Road and Easy Street, back to Brook Road (3.0 mi end-toend)

- Detour Distance: 2.1 miles
- Thru Route: 0.9 miles
- End-to-End Distance: 3.0 miles
- Added Distance: 1.2 miles

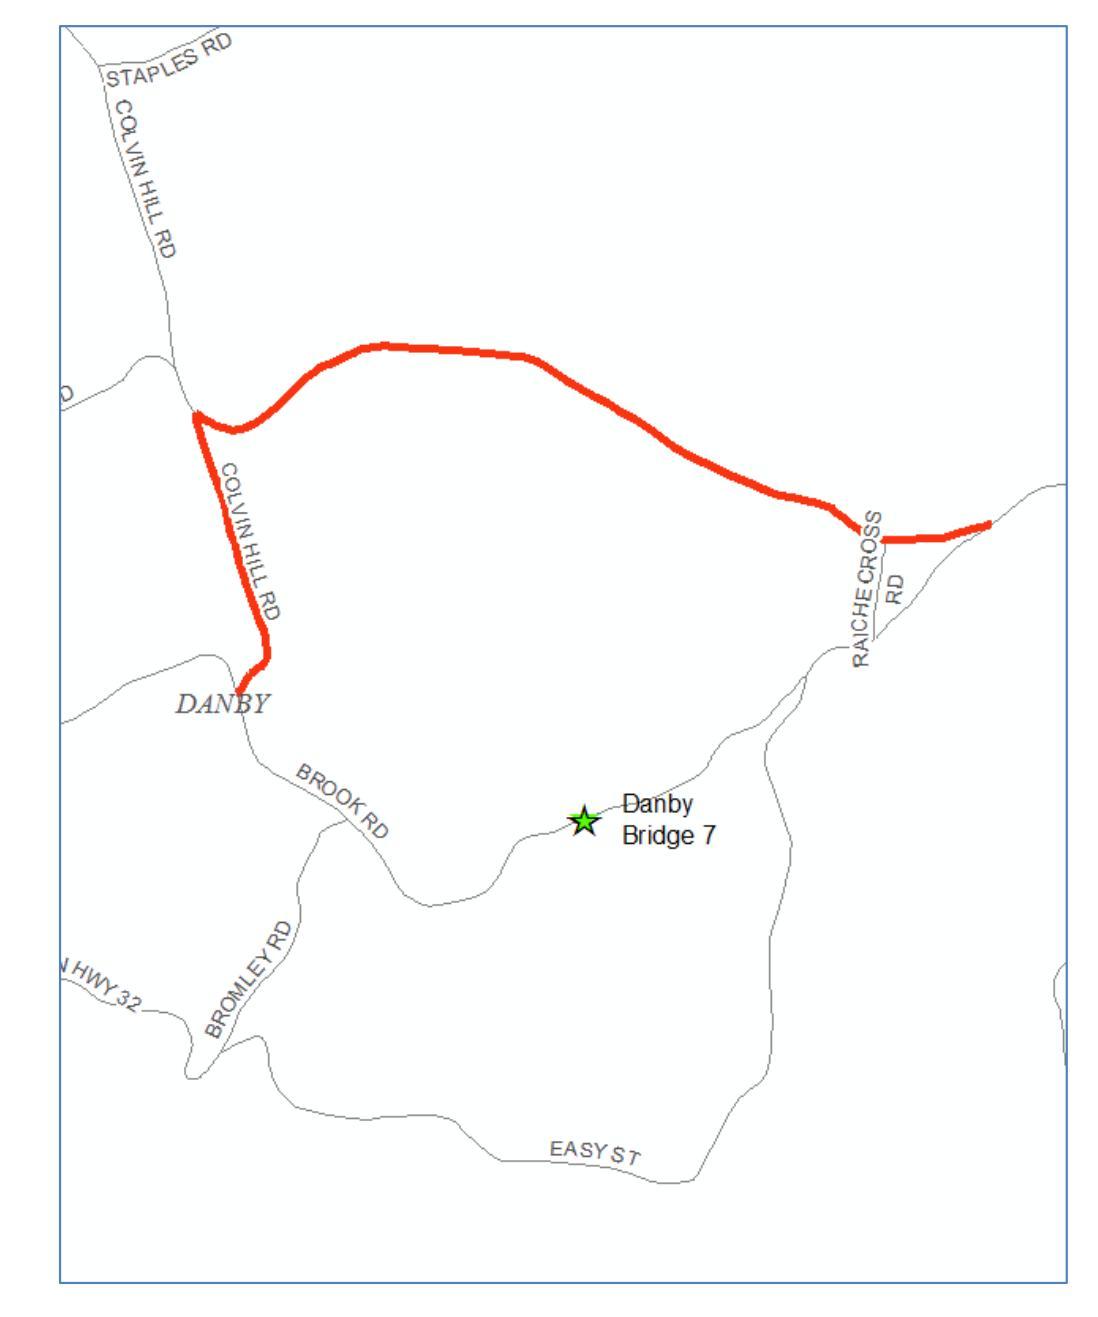
Traffic Control – Detour 2

Detour Route: Brook Road (FAS 130/TH 1), to Colvin Hill Road and Danby Hill Road, back to Brook Road (3.4 mi end-to-end)

- Detour Distance: 1.8 miles
- Thru Route: 1.6 miles
- End-to-End Distance: 3.4 miles
- Added Distance: 0.2 miles

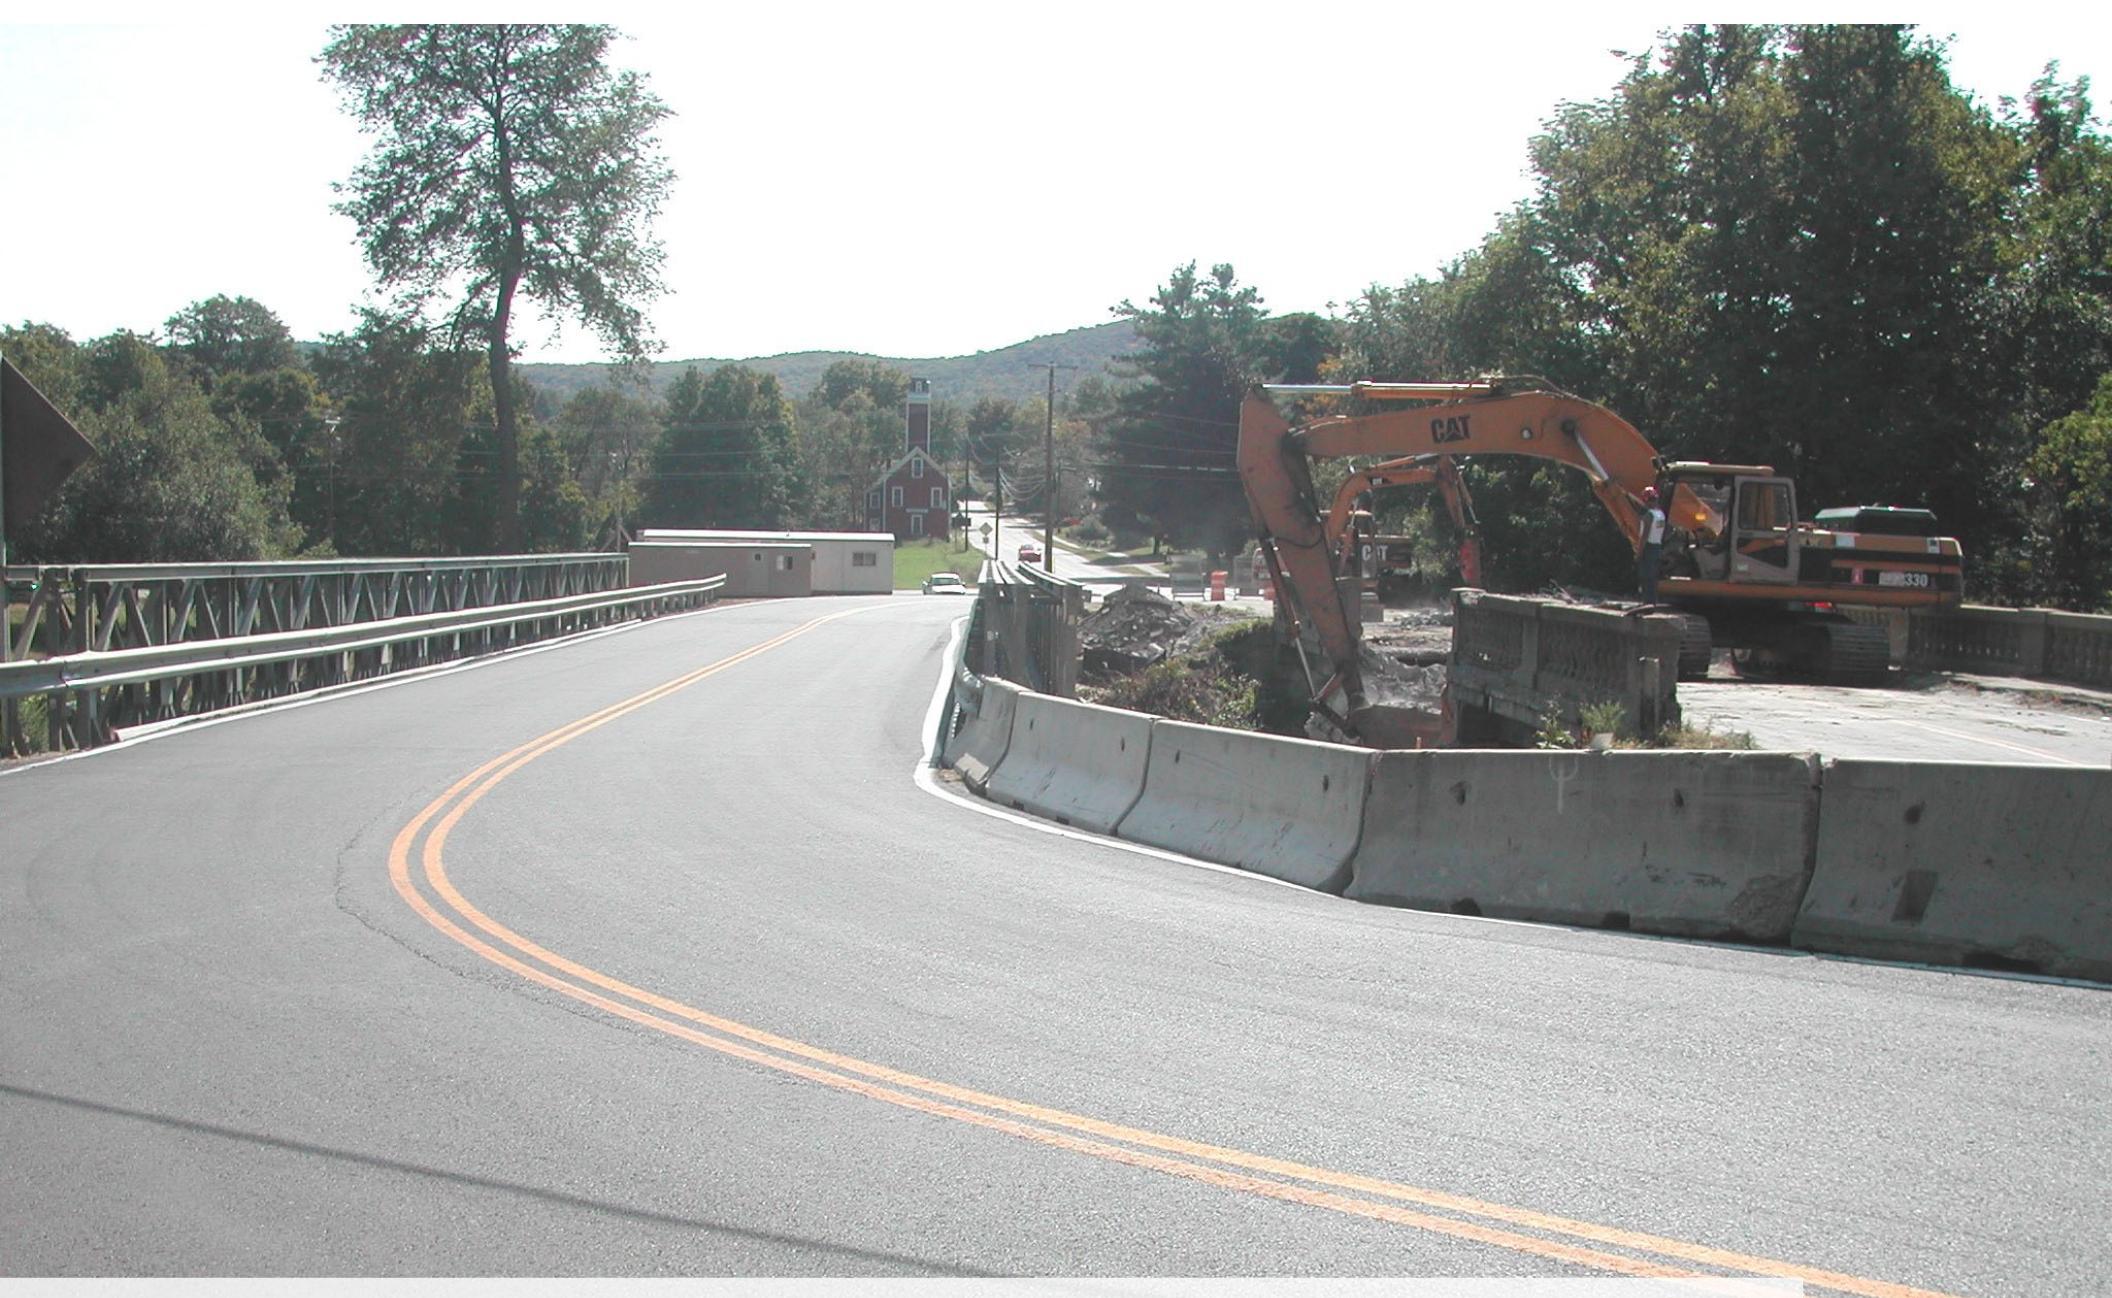
Phased Construction

Road too narrow for phased construction

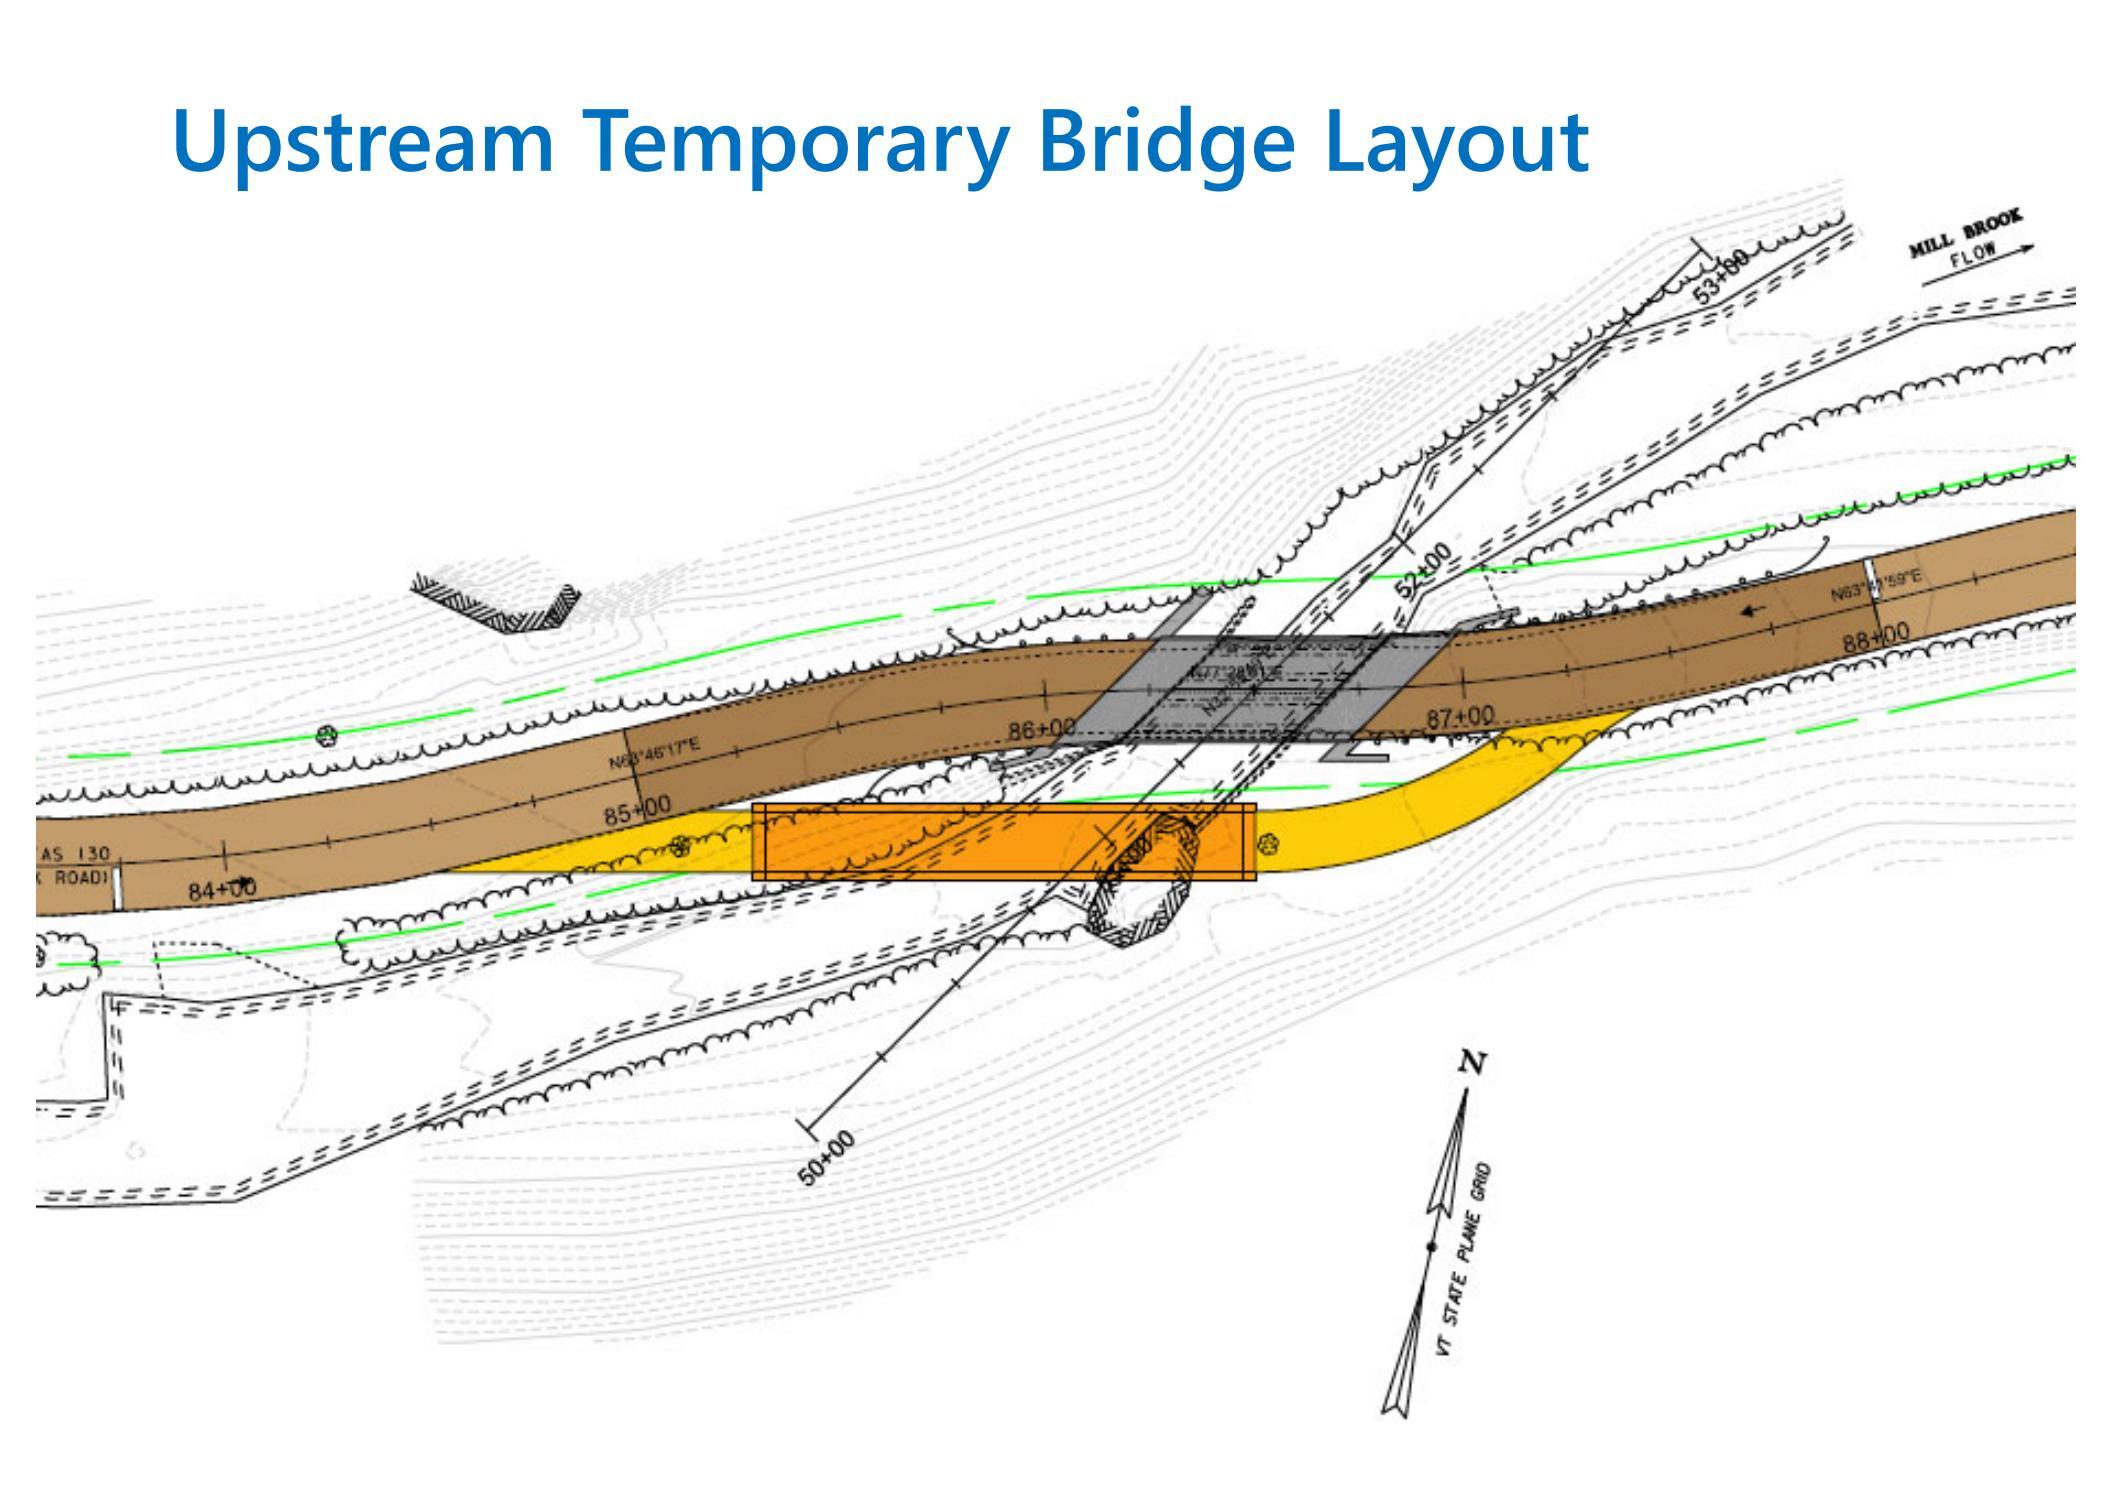
One Lane Temporary Bridge constructed either Upstream or Downstream side of Brook Road
