#### Stowe BO 1446(39) Alternatives Presentation Meeting Nebraska Valley Road (TH 43) – Bridge #48 over Miller Brook

June 8, 2020

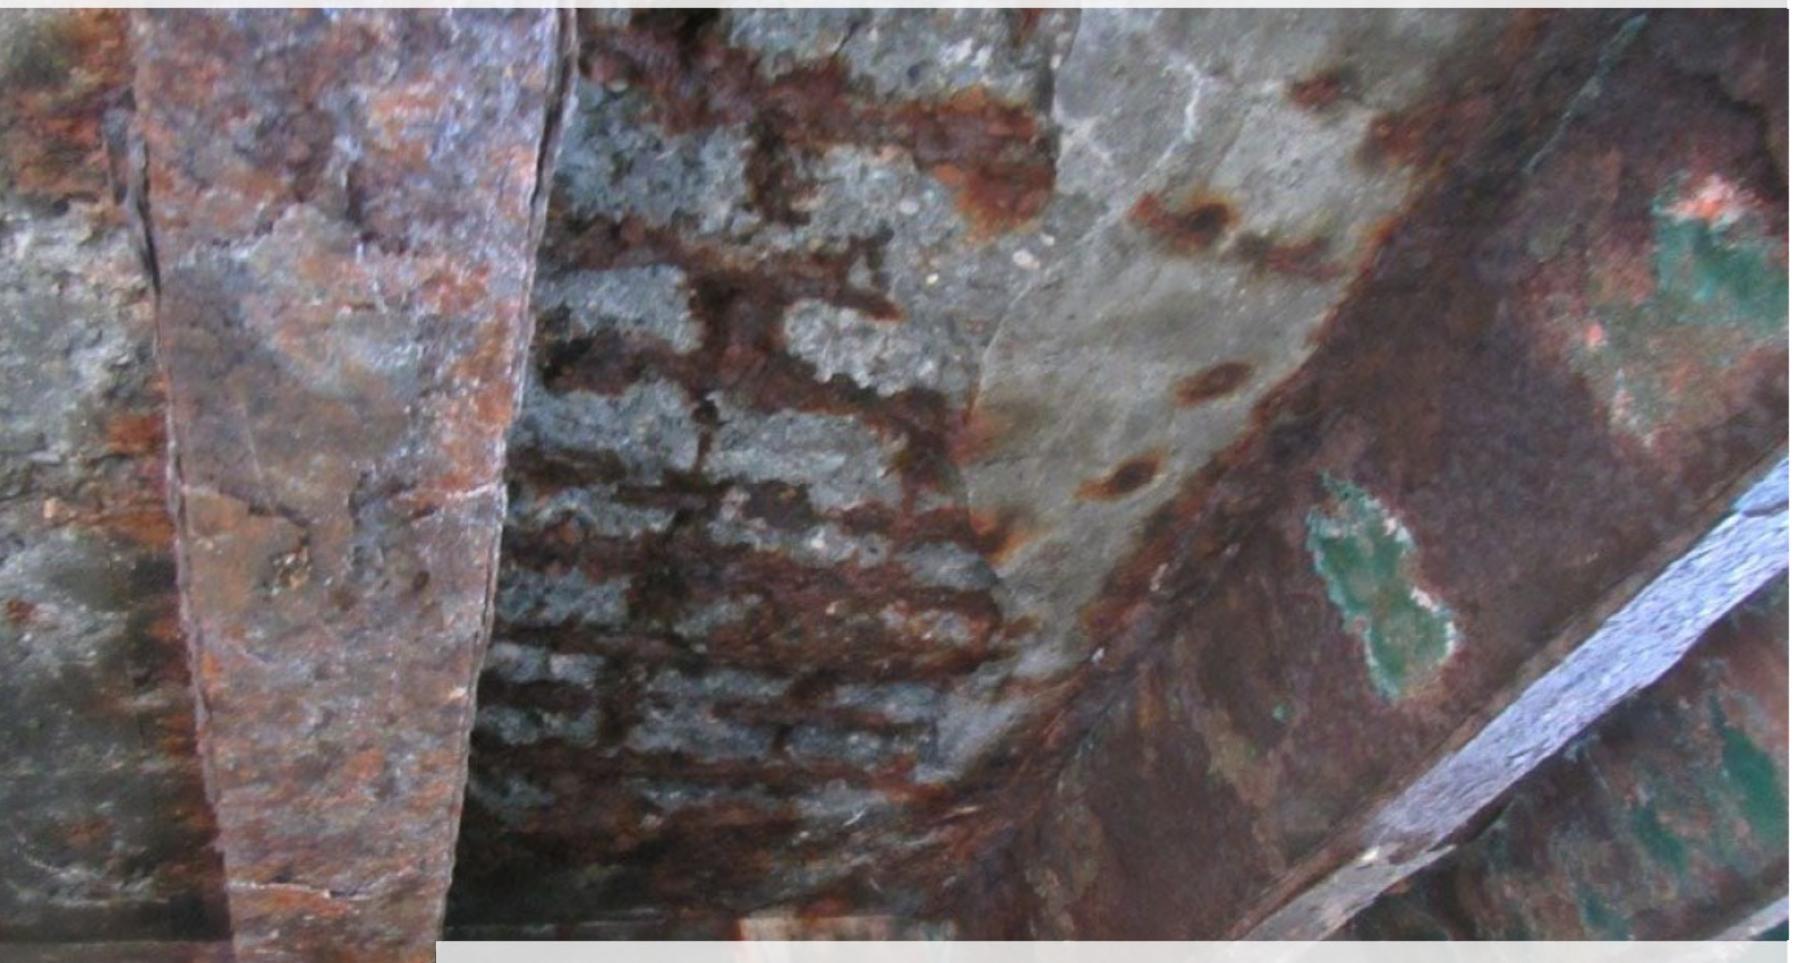
#### **Condition Ratings**

- Deck Rating
- Superstructure Rating
- Substructure Rating
  6 (Satisfactory)
- 5 (Fair) 5 (Fair) 6 (Satisfacto

- The deck and superstructure are deteriorating at an accelerated rate
  - Deck: The underside of the deck has some heavy saturation, leakage, and staining. A large spall exposing corroded rebar has formed along with some additional delaminations.
  - Superstructure: The 6 rolled beams have negative camber. There are areas of rust scale build-up with minor section loss. It is anticipated that holes will develop in the webs over the next 10 years.
- The Eastern abutment has some minor to moderate distress. There is a pop-out below the fourth beam at the east abutment exposing the front portions of the two anchor bolts for the bearing.
- The existing bridge width is too narrow for the roadway classification and traffic volumes present.

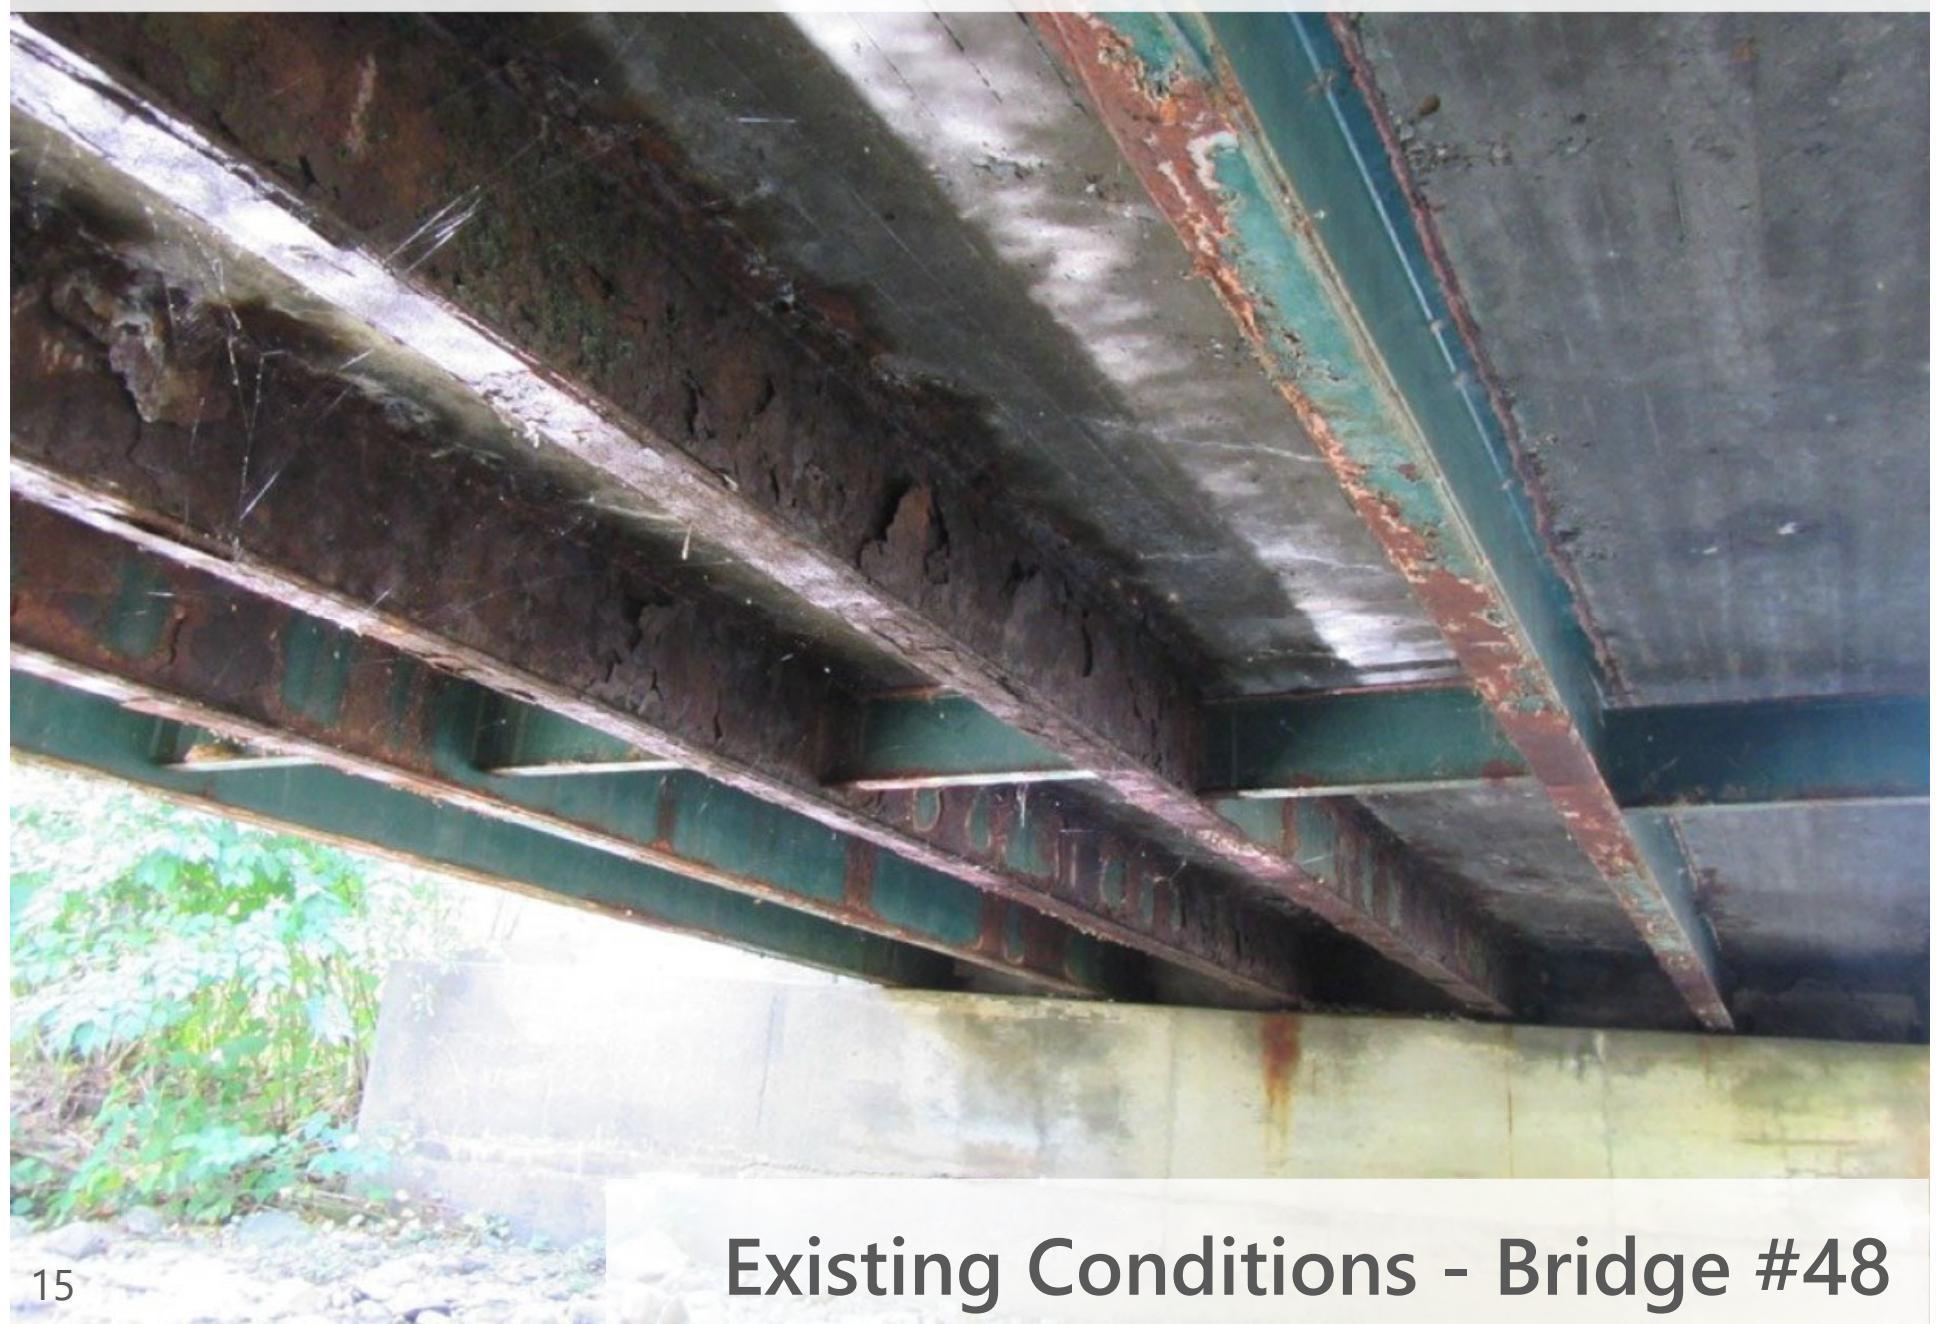
#### **Steel Beam Section Loss**

Rust scale build-up with minor section loss

#### Heavily Rusted Superstructure

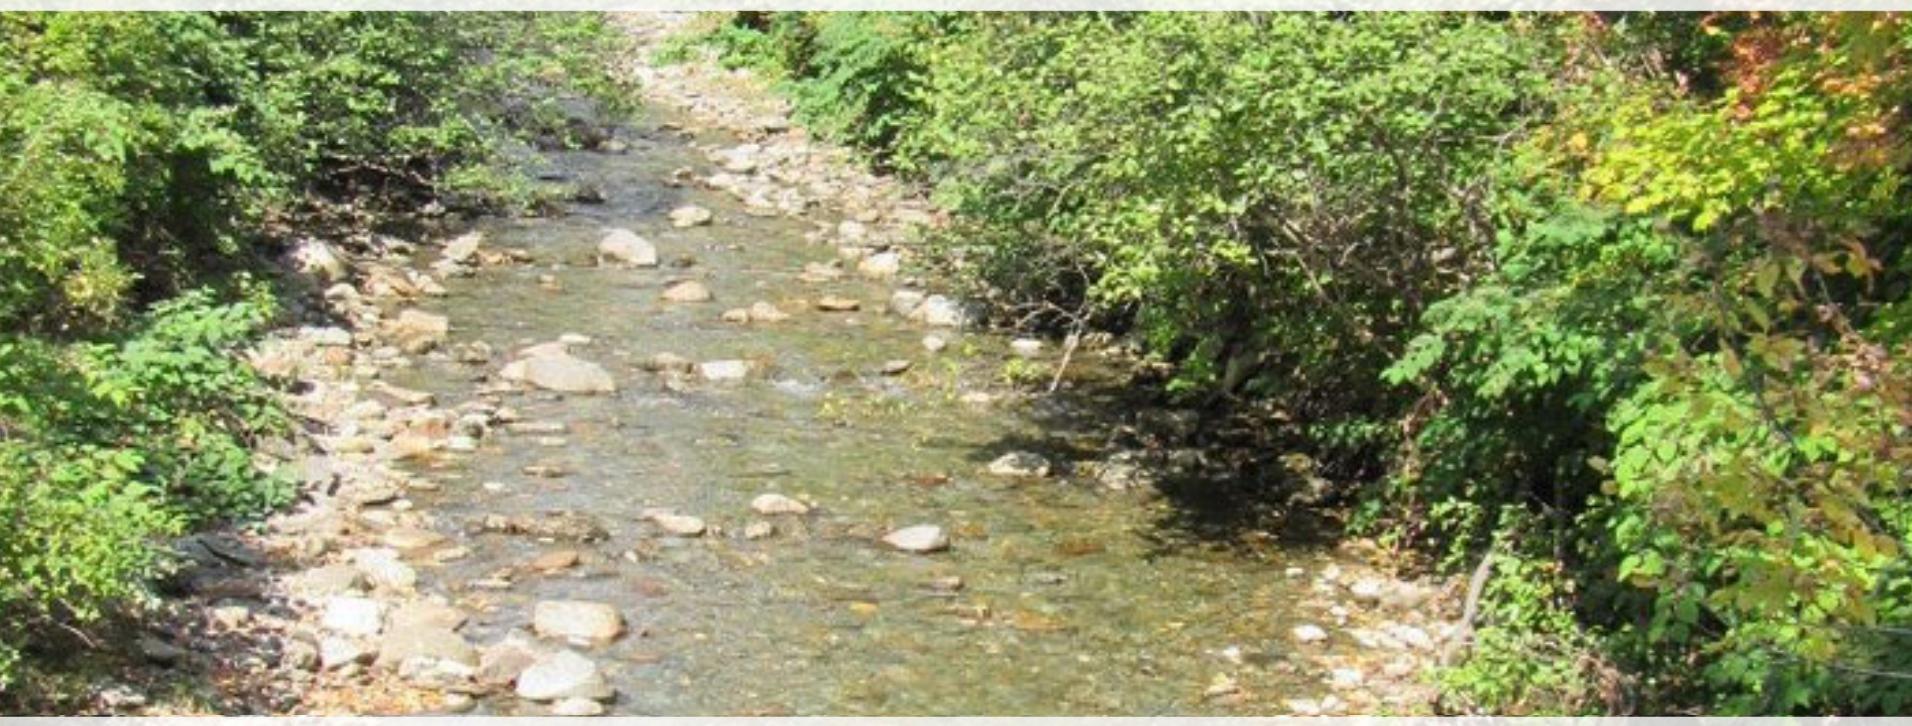
#### Resources – Looking Upstream

- Northern Long-Eared Bat
- Statewide Significant Agricultural soils
- Historic Resources
  - Selden Adams House and related agricultural buildings on Nebraska Valley Road
  - 4(f) resource adjacent to the survey area: Mount Mansfield State Forest.
- 18 Archaeological sensitivity in southwest quadrant due to old schoolhouse

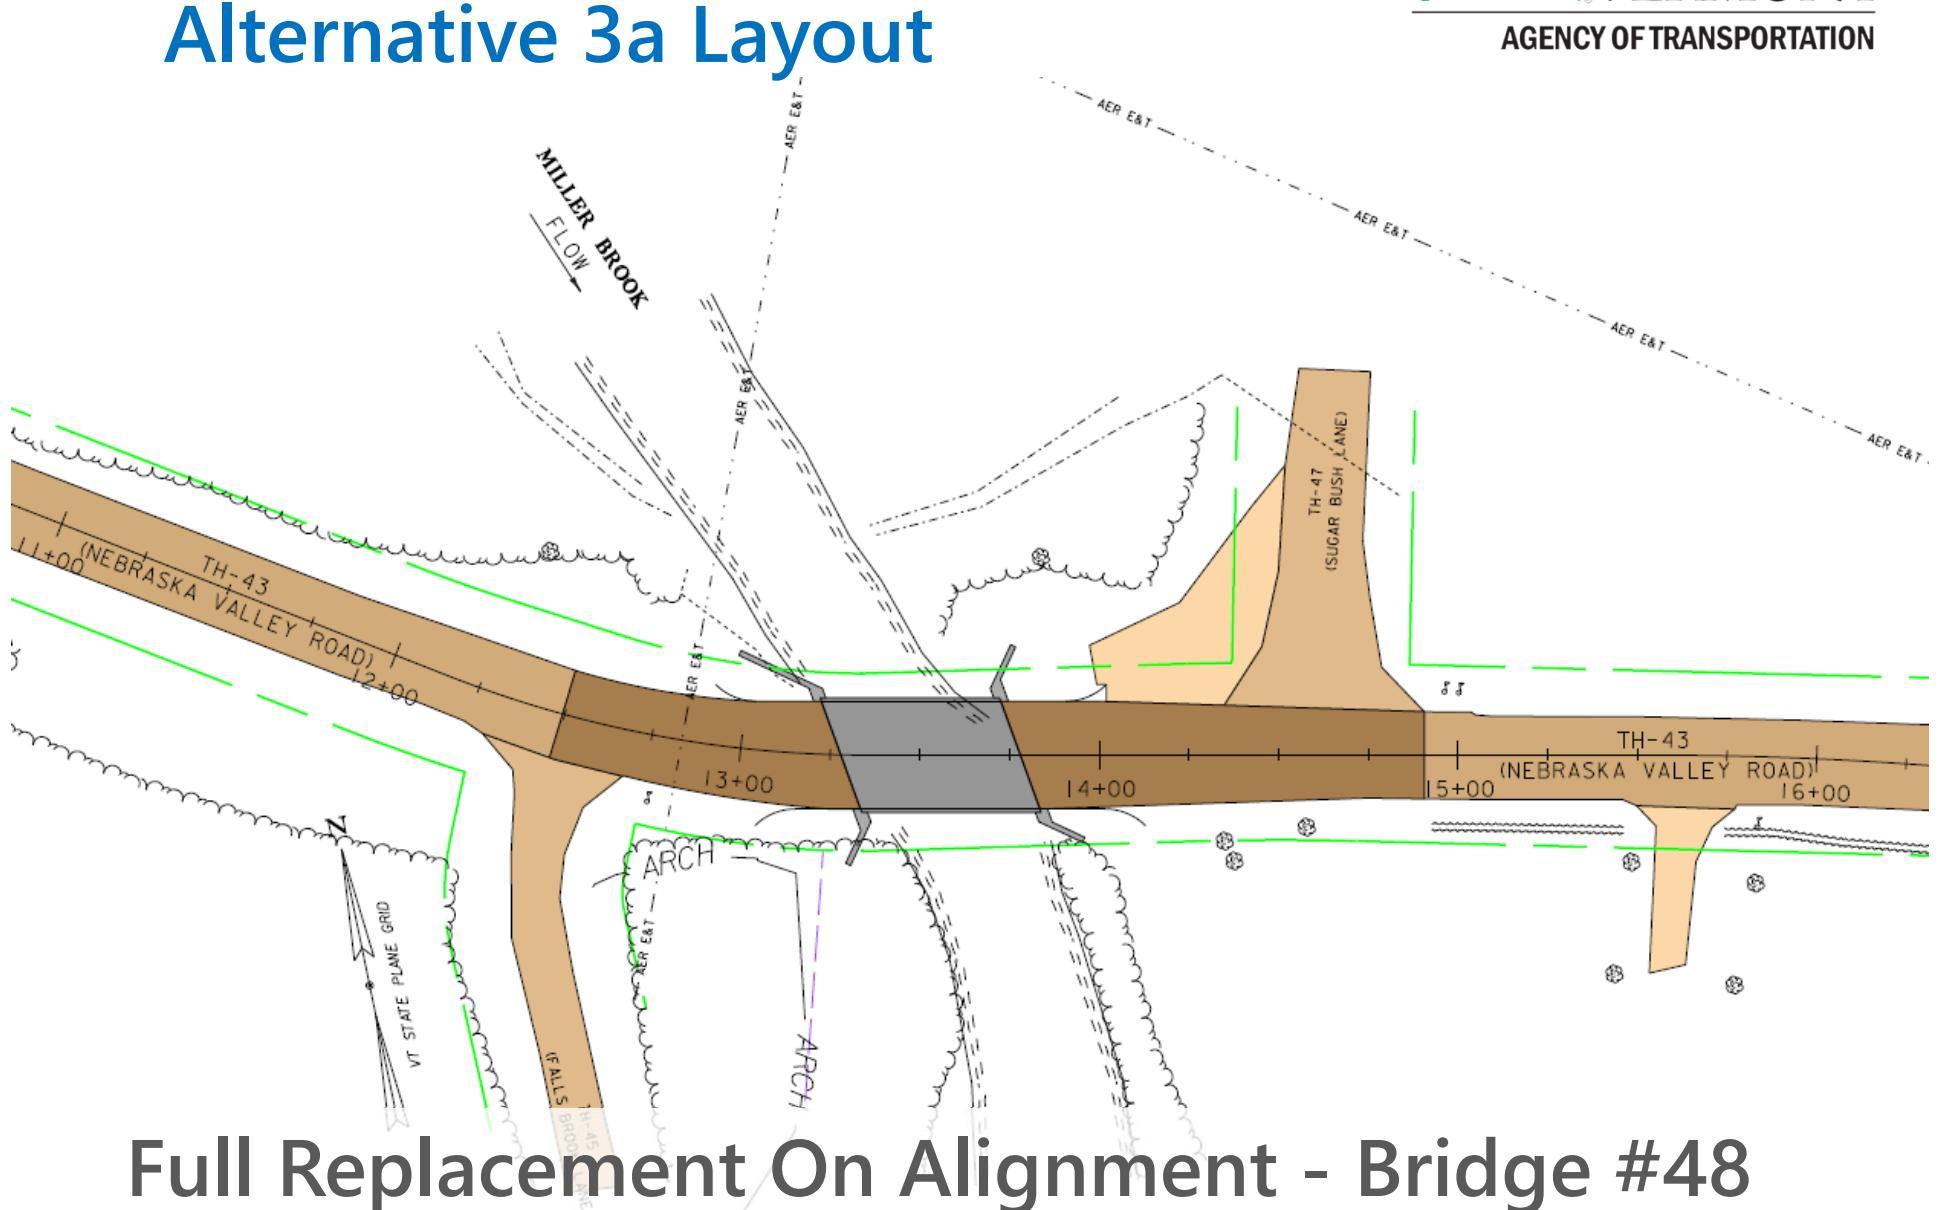
■ 10′/5′ typical, 75-year design life, **phasing**

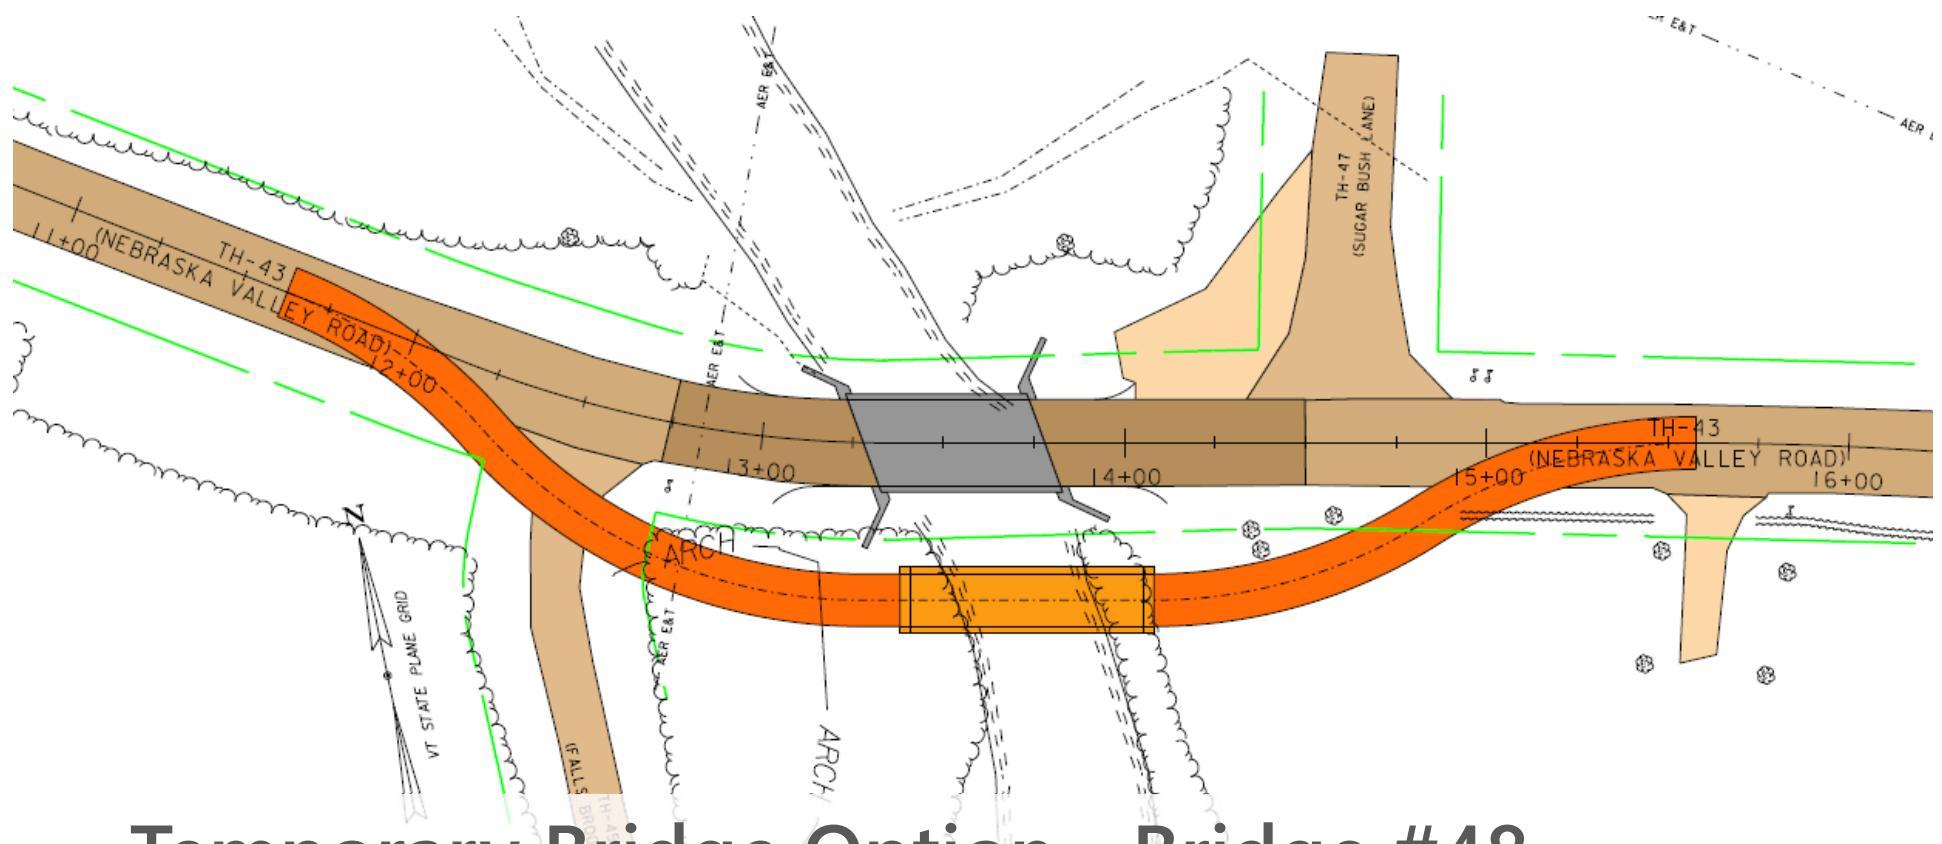
#### **Downstream Temporary Bridge Layout**

- Downstream temp bridge would have impacts to potentially archaeologically sensitive area
- Aerial utility relocation may not be needed
- **one Lane Temporary Bridge with Traffic Signal**

- One Lane Temporary Bridge with Traffic Signal
- Downstream temporary bridge would impact archaeologically sensitive area
- 33 Both upstream and downstream would require ROW acquisition

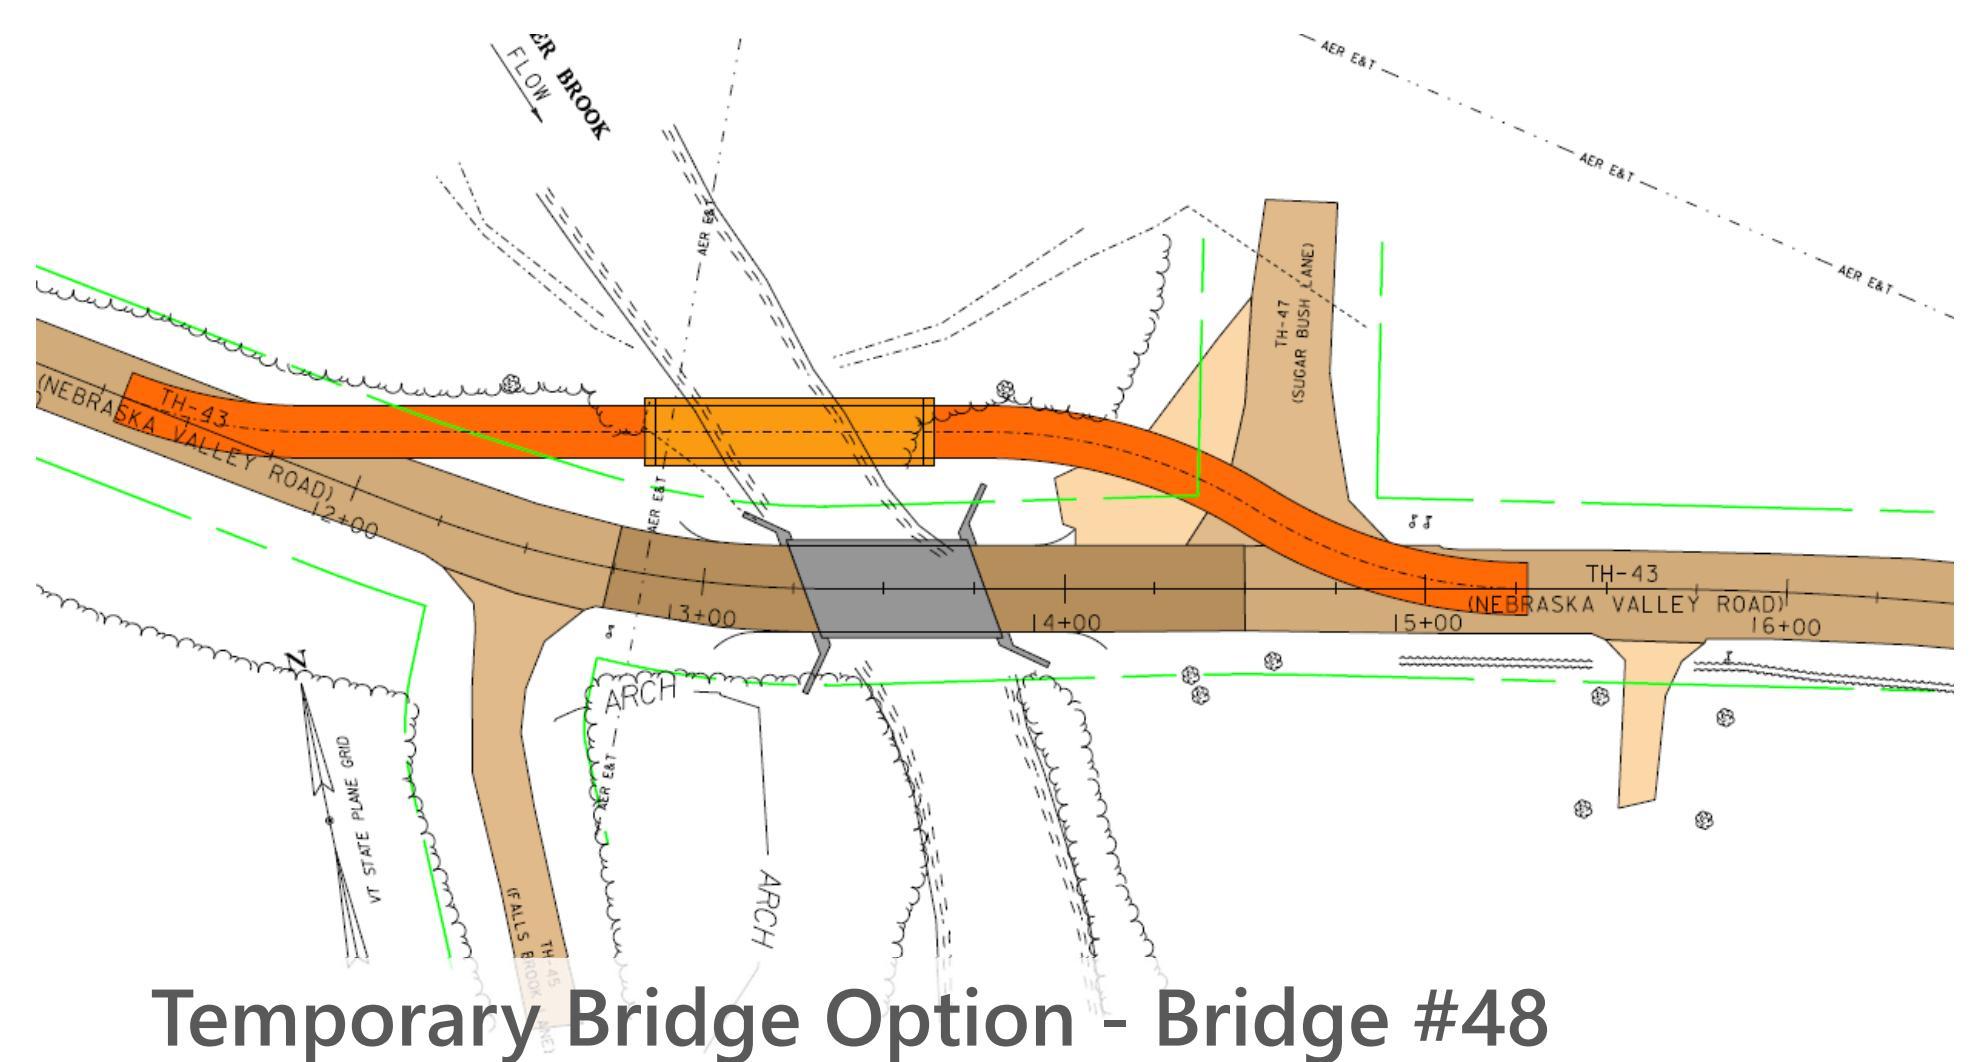
#### **Upstream Temporary Bridge Layout**

- Upstream temporary bridge will require relocation of aerial utilities
- <sup>35</sup> One Lane Temporary Bridge with Traffic Signal
