Living with Roaring Branch

Bennington Case Study

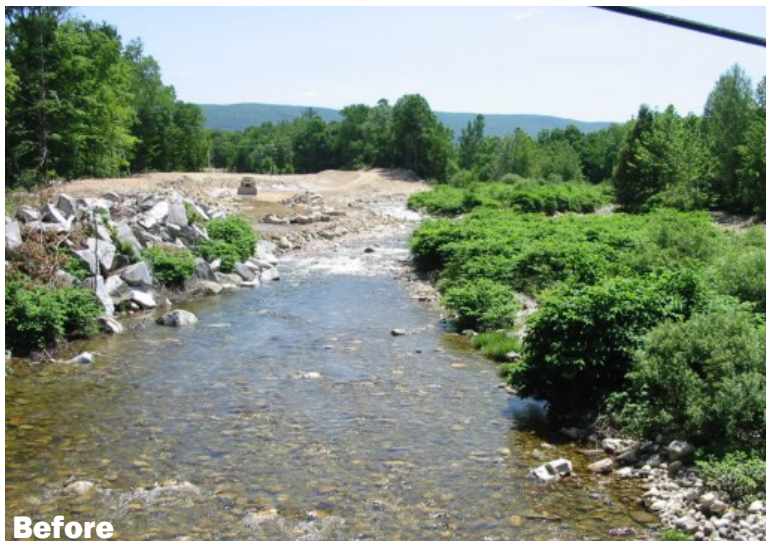
Before

Next came floodplain restoration activities. A four-foot rock wall was constructed to stabilize the riverbank. Thirteen acres of floodplain were reconnected to the river channel, and the river was given more room in which to flow and flood. Together these actions serve to reduce flood risk by slowing the river and lessening its destructive power – protecting existing properties and minimizing mud and silt build-up on roads.
