**National Register of Historic Places Multiple Property Documentation Form**

Metal Truss, Masonry and Concrete Bridges of Vermont, 1820-1978

- I. Metal Truss, Masonry, and Concrete Bridges in Vermont: 1820-1940 (Rudge 1989)
- II. Bridge Construction in Vermont: 1940-1978
- III. Vermont Bridge Engineers

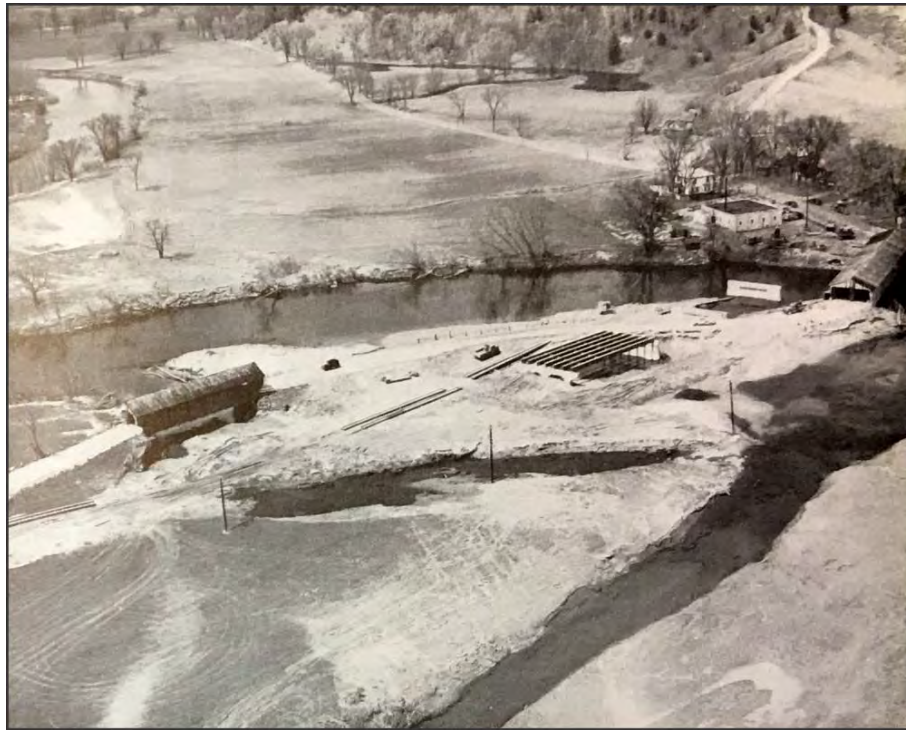
FIGURE 1: Replacement of Covered Bridges in Cambridge, 1950 (Vermont State Highway Board 1948-1950)

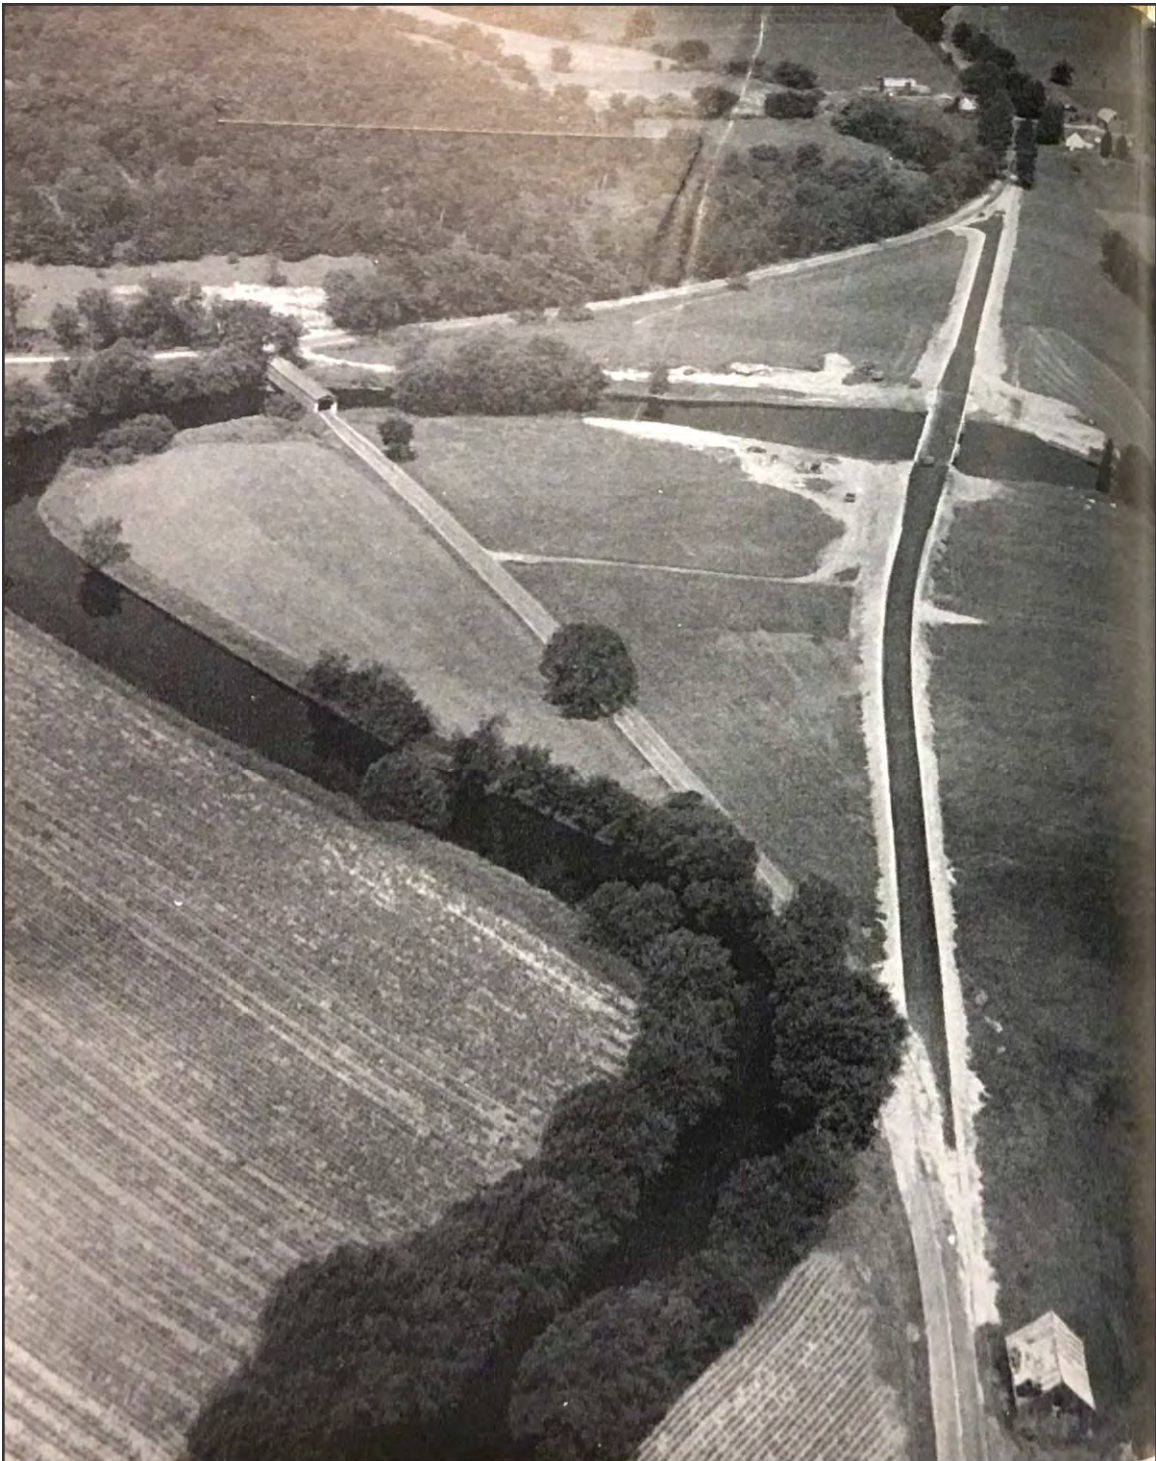
FIGURE 2: New Road Alignment Bypassing the Miller Bridge in Sudbury (Vermont State Highway Board 1950-1952)

After the war the Department of Highways began a program to replace deficient bridges, most of which had been built in the late nineteenth and early twentieth centuries and had a legal gross load limit of 10 tons.<sup>49</sup> Many of these were covered bridges. The program began in 1944, but very few, if any, bridges had been replaced by 1948. In 1949 the legislature authorized a state bond issue of \$2.8 million to replace "weak, unsafe and deficient" bridges on the state highway system.<sup>50</sup> The first five bridges replaced under the program were two drawbridges over Lake Champlain on U.S. Route 2 between Alburgh and North Hero and Grand Isle and North Hero, two covered bridges on VT Route 15 over the Lamoille River in Cambridge, and the VT 30 Holland Bridge over the West River in Townshend (Figure 1).<sup>51</sup> Once these were completed, 12 more bridges were slated for replacement (Table E-4). In some cases, such as the Miller Bridge in Sudbury, the covered bridge was merely bypassed with a new road alignment and bridge (Figure 2).

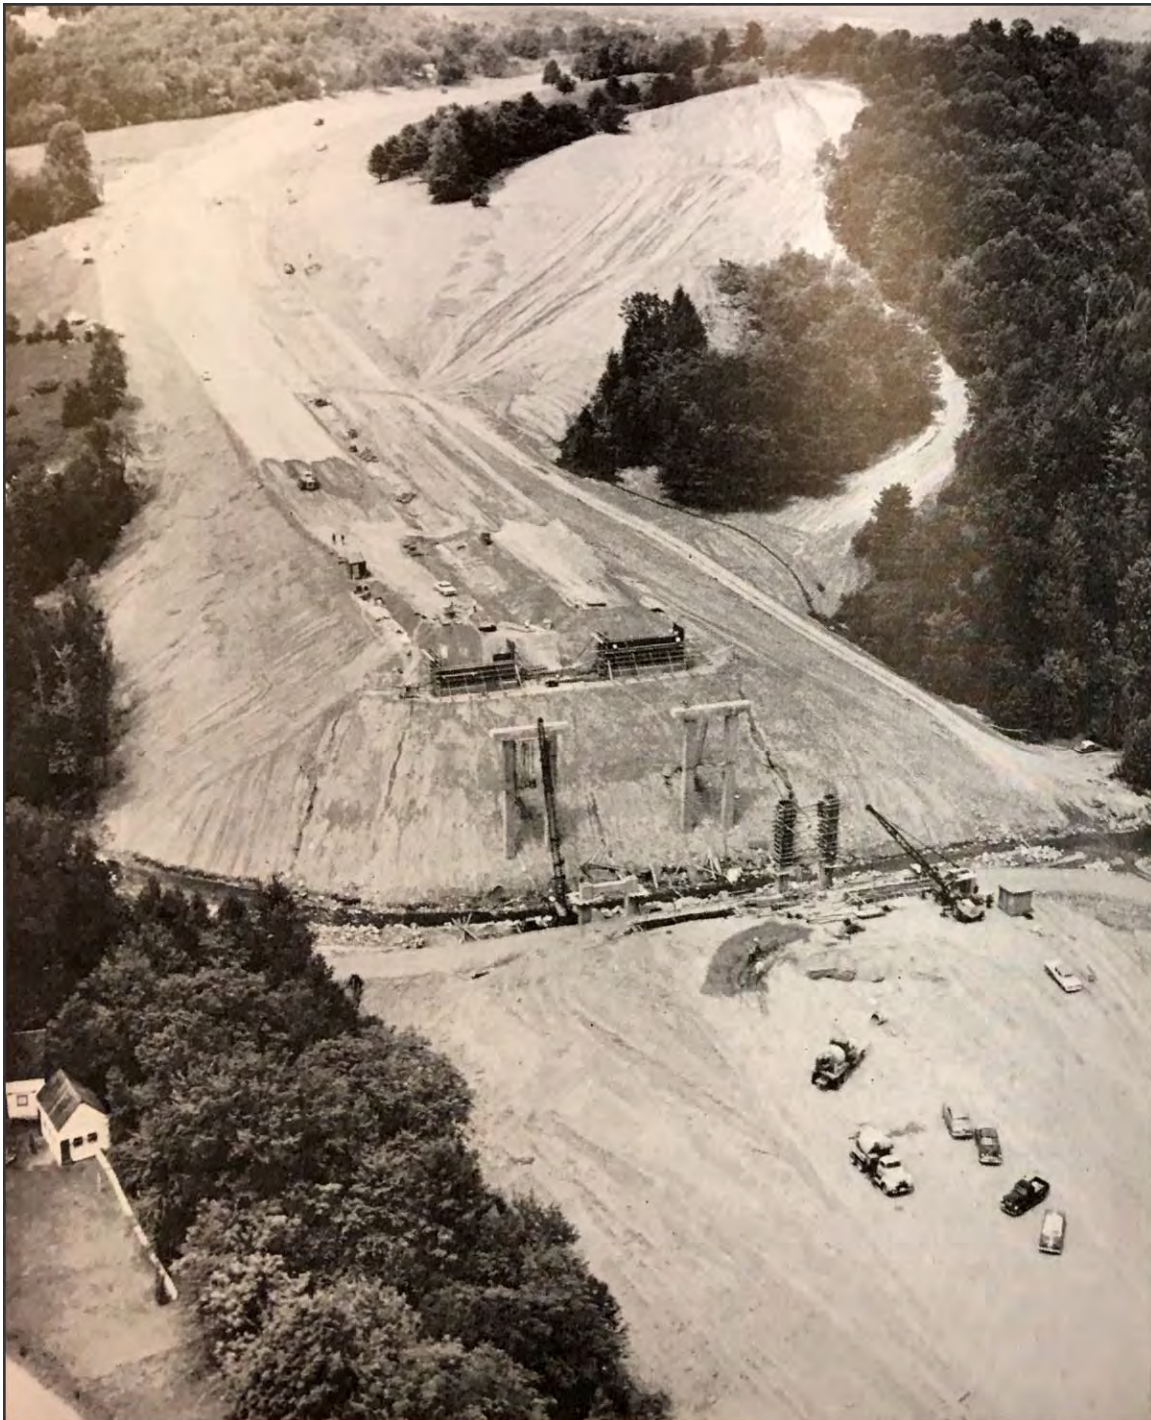
FIGURE 3: Construction of Twin Bridges over Broad Brook on the Brattleboro Bypass (Vermont State Highway Board 1956-1958)
