Add - Bridport STP MM21(4)

Scoping Report – Draft  
Middle Road Over East Branch Dead Creek  
Middle Road Culvert Replacement  
Bridport, VT

### Middle Road Culvert Replacement

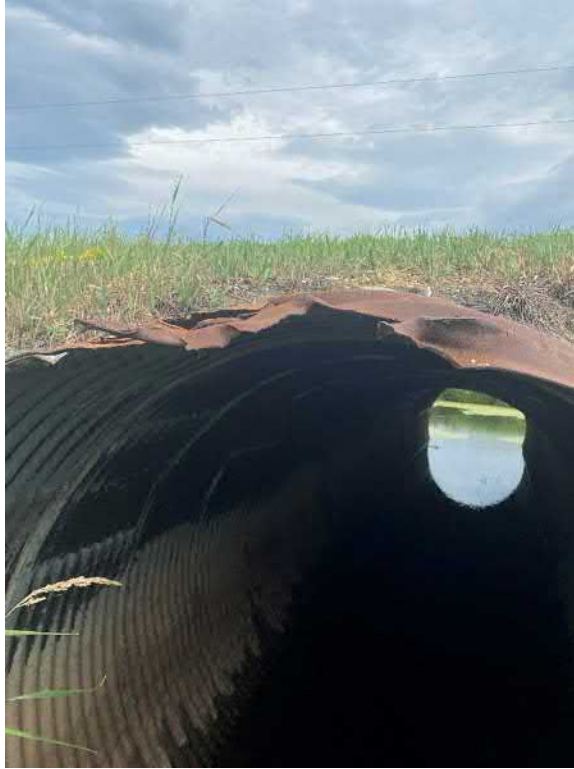
Photo 5: Culvert Outlet Corrosion Dated: 06/29/2021

The Middle Road Over East Branch Dead Creek twin 72-inch diameter corrugated metal pipes (CMPs) are in poor condition with corroded inverts. In addition, the road at the crossing is subject to overtopping due to the creek's large drainage area. This overtopping results in temporary road closures and potential damage to the road and culverts. Replacement of the twin CMPs with a larger structure is necessary to replace the corroded culverts prior to collapse and to eliminate or reduce the frequency of overtopping events to maintain vehicular and pedestrian traffic through the project location.

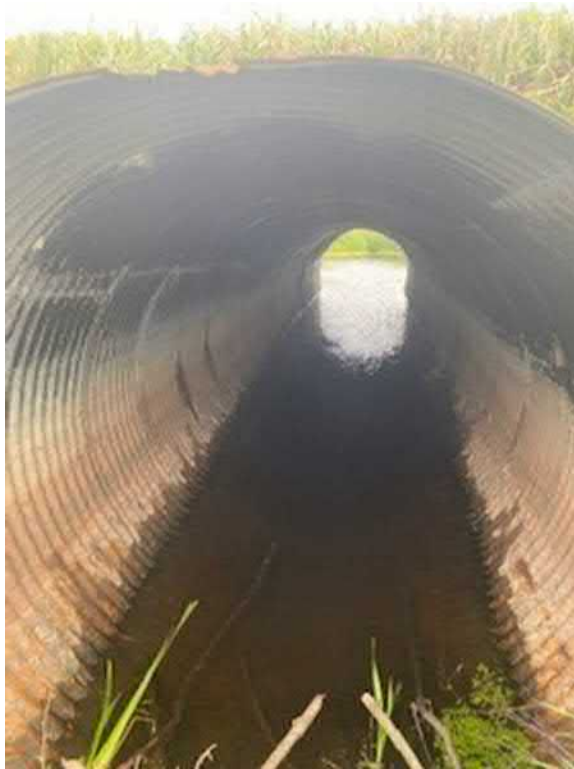
Photo 6: Culvert Interior Dated: 06/29/2021

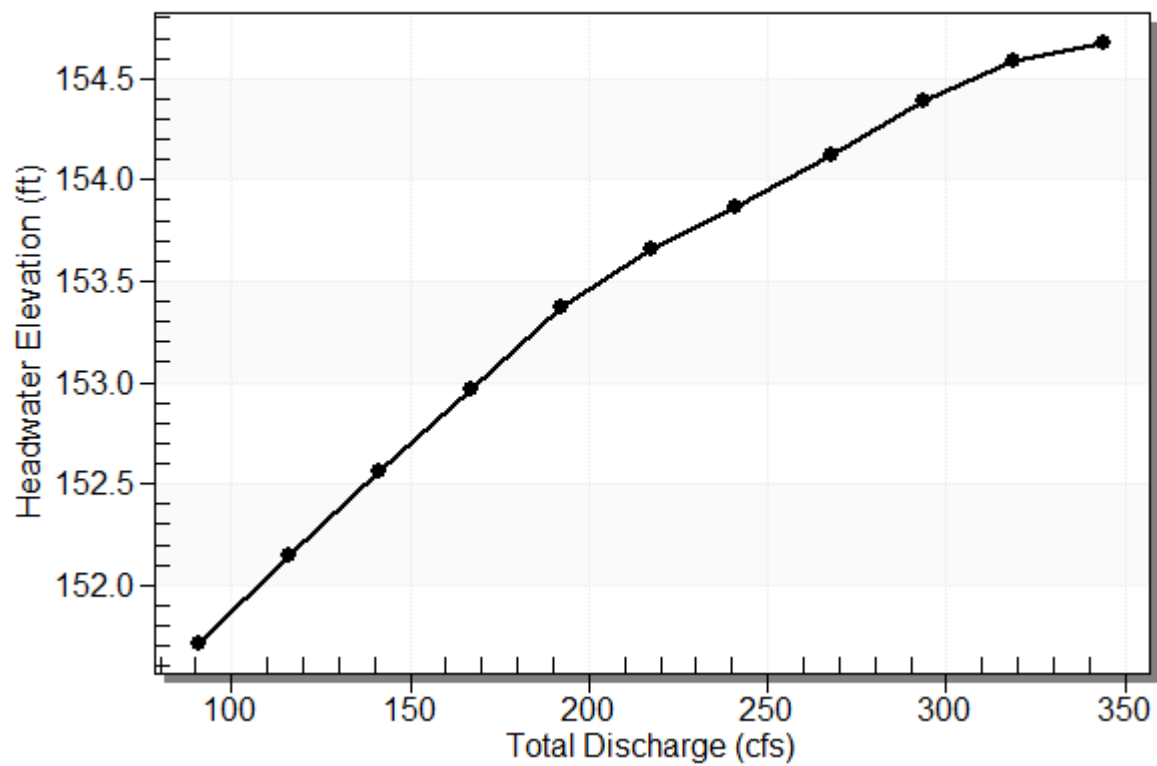
### Total Rating Curve

Crossing: Existing

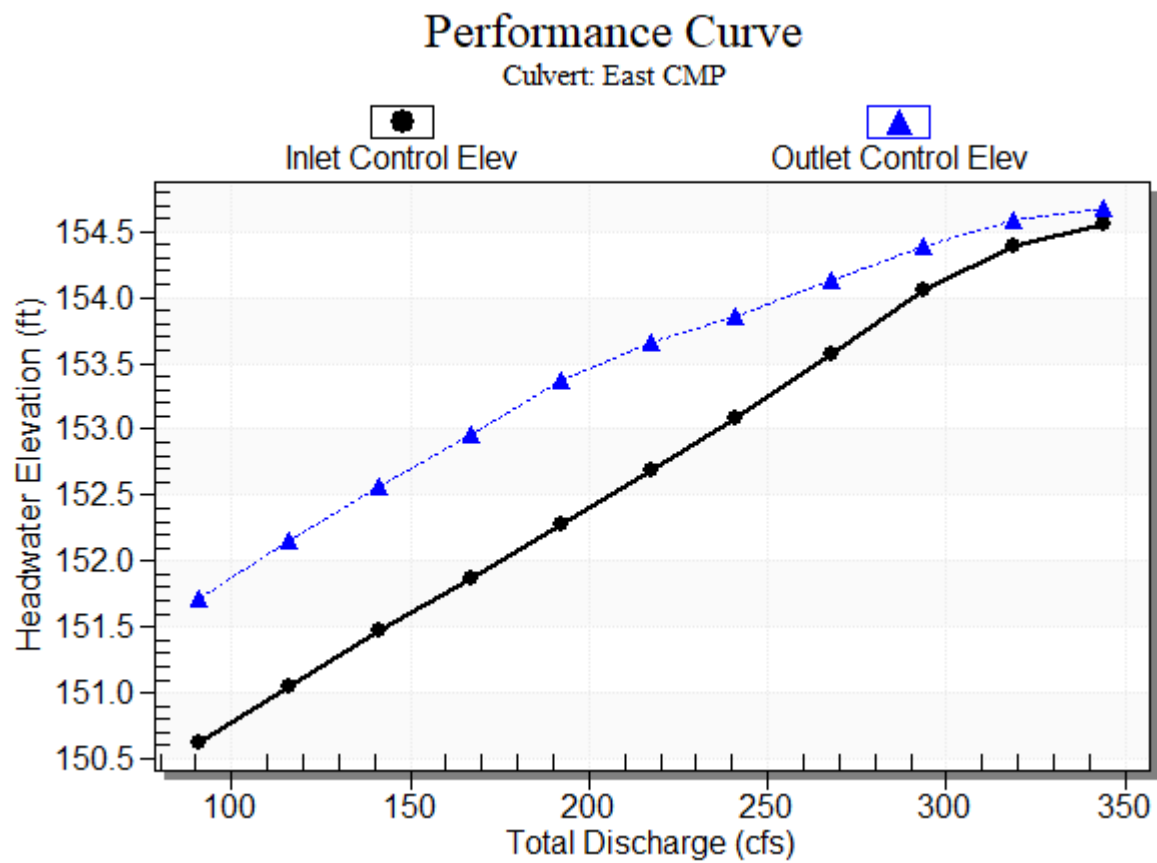
## Culvert Performance Curve Plot: East CMP

\*\*\*\*\*  
Straight Culvert  
Inlet Elevation (invert): 147.80 ft,    Outlet Elevation (invert): 149.00 ft  
Culvert Length: 40.02 ft,    Culvert Slope: -0.0300  
\*\*\*\*\*

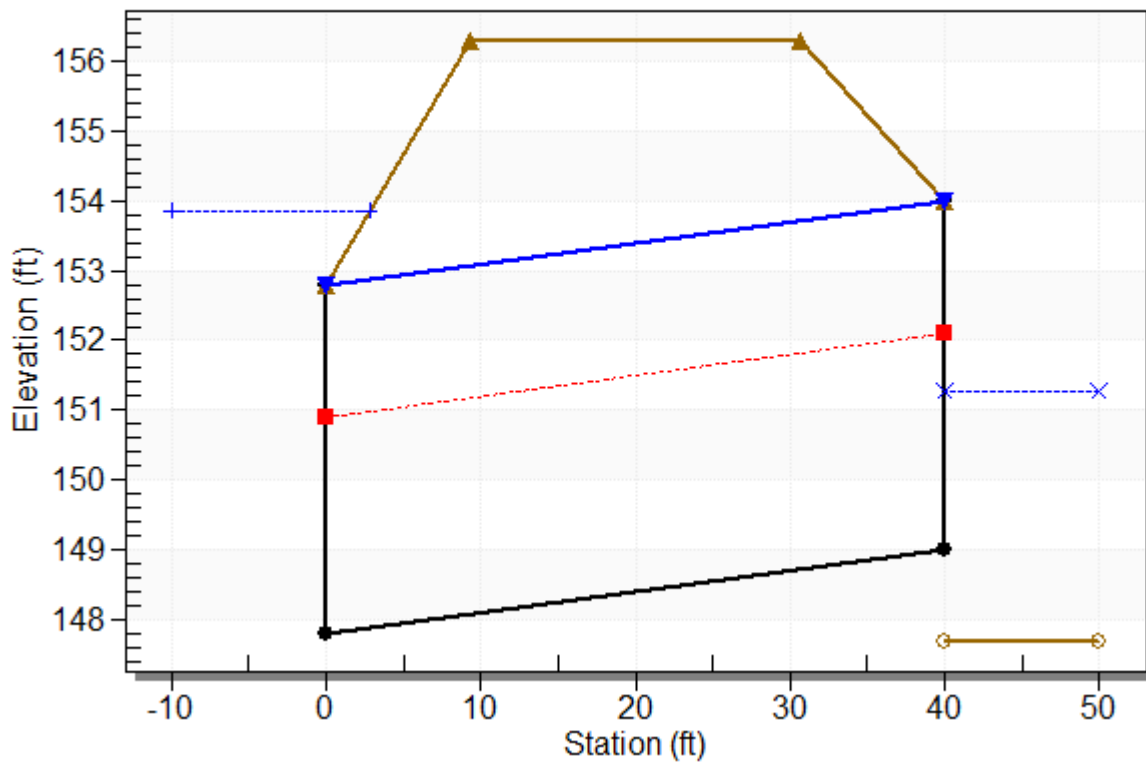
## Water Surface Profile Plot for Culvert: East CMP

Crossing - Existing, Design Discharge - 241.0 cfs

Culvert - East CMP, Culvert Discharge - 117.8 cfs

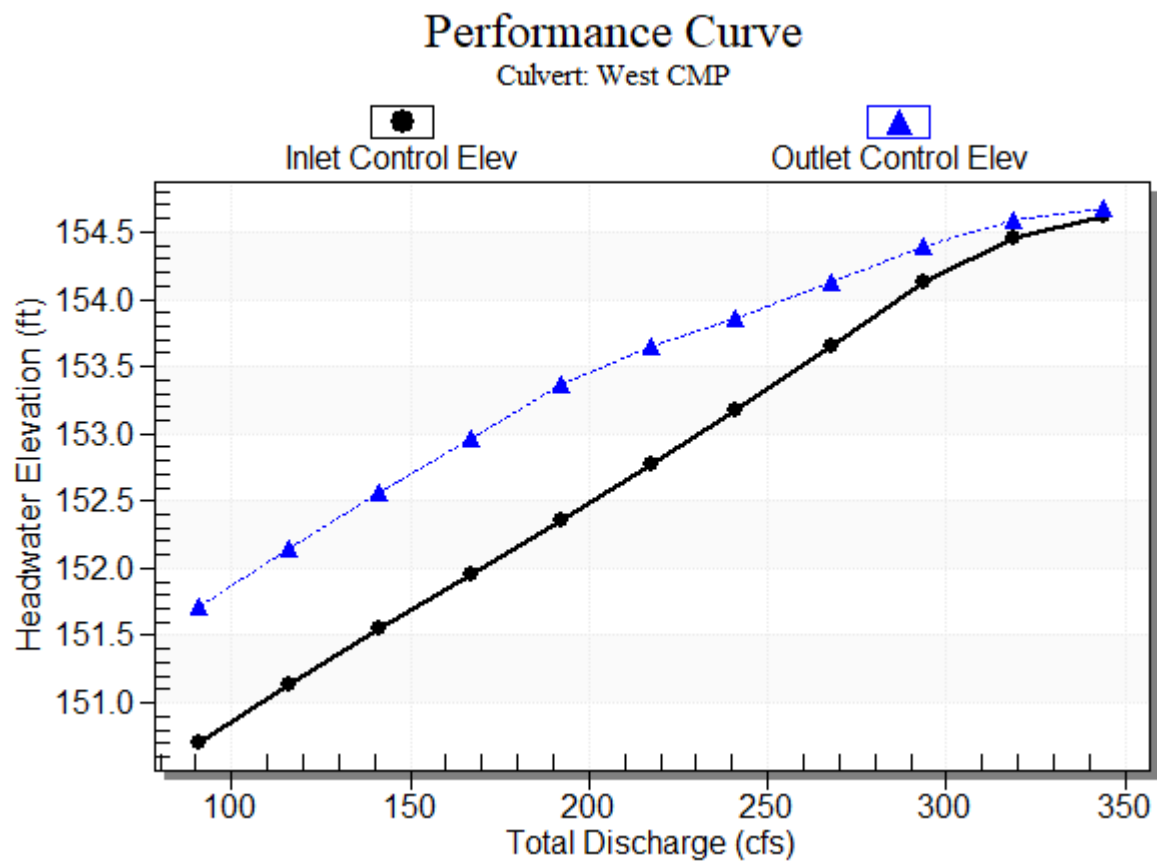
## Culvert Performance Curve Plot: West CMP

\*\*\*\*\*  
Straight Culvert  
Inlet Elevation (invert): 147.70 ft,    Outlet Elevation (invert): 148.80 ft  
Culvert Length: 40.02 ft,    Culvert Slope: -0.0275  
\*\*\*\*\*

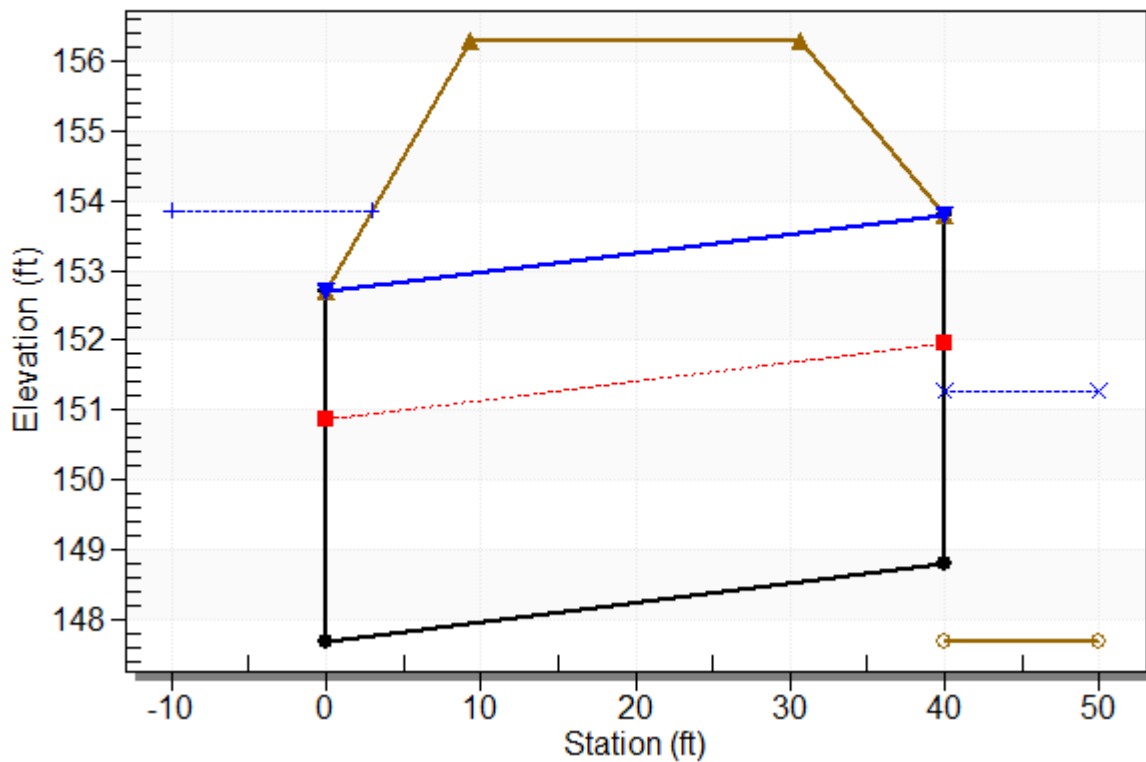
## Water Surface Profile Plot for Culvert: West CMP

Crossing - Existing, Design Discharge - 241.0 cfs

Culvert - West CMP, Culvert Discharge - 123.2 cfs

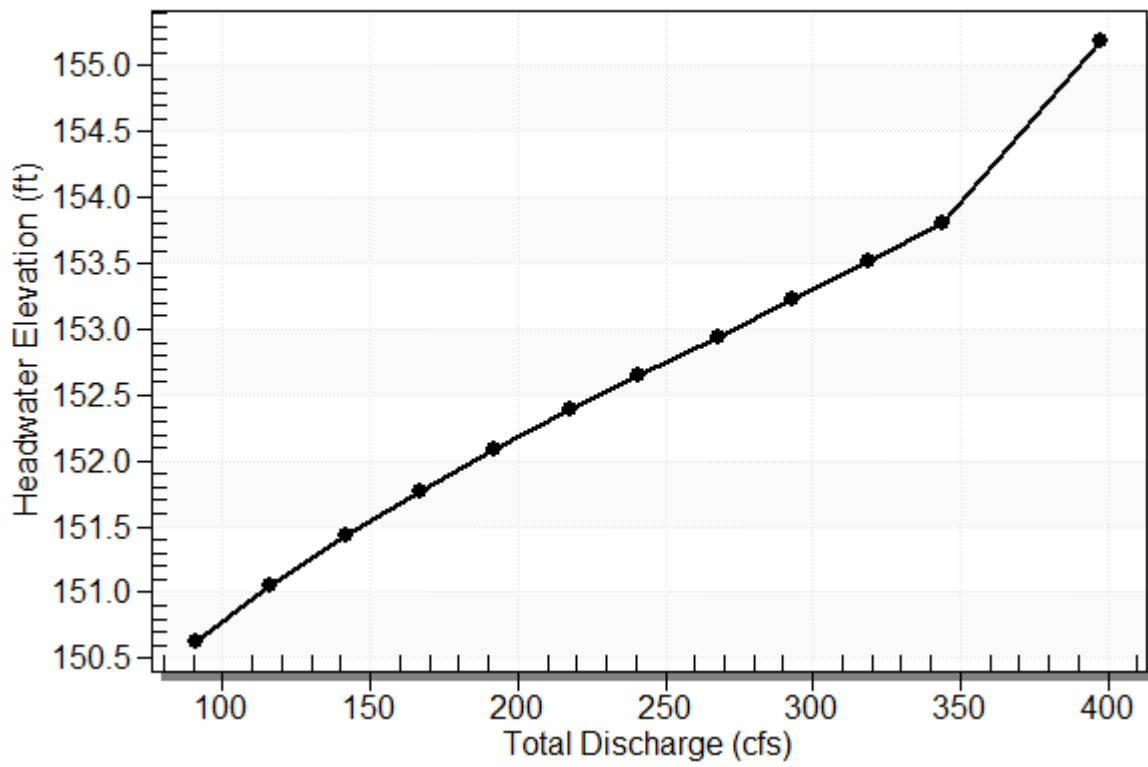
**Total Rating Curve**  
Crossing: Proposed Box Culvert (16' Span)

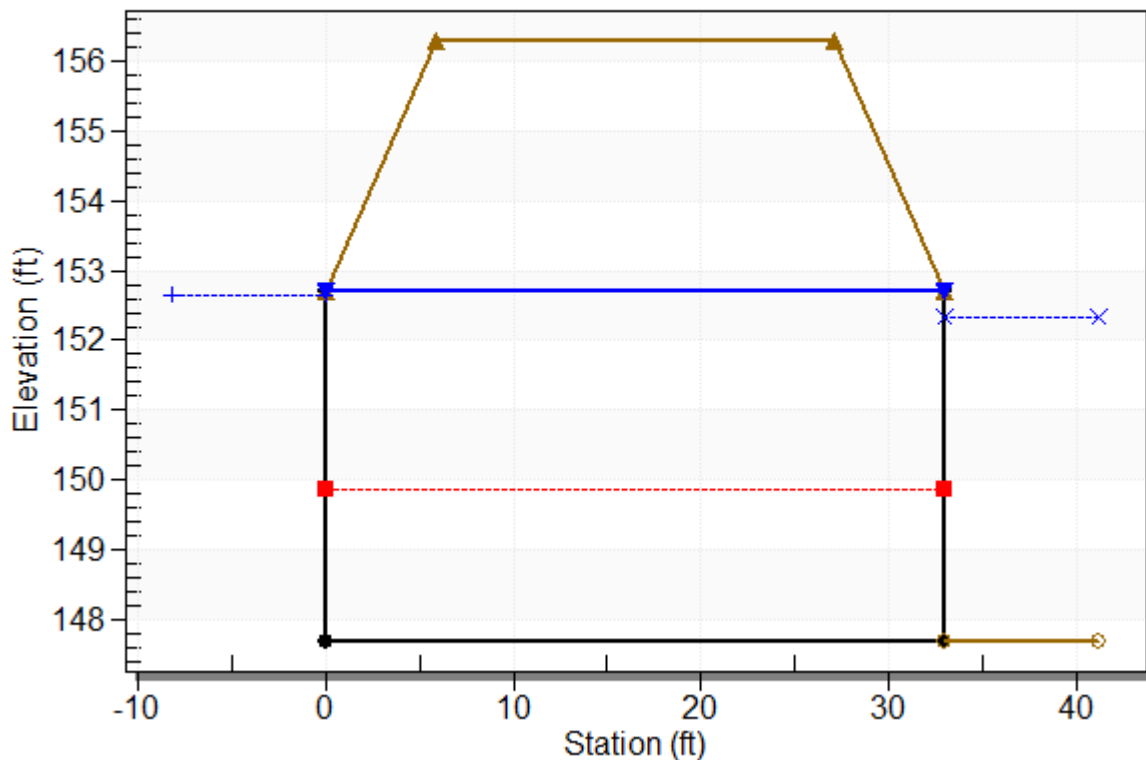
## Water Surface Profile Plot for Culvert: Box Culvert

Crossing - Proposed Box Culvert (16' Span), Design Discharge - 241.0 cfs

Culvert - Box Culvert, Culvert Discharge - 241.0 cfs

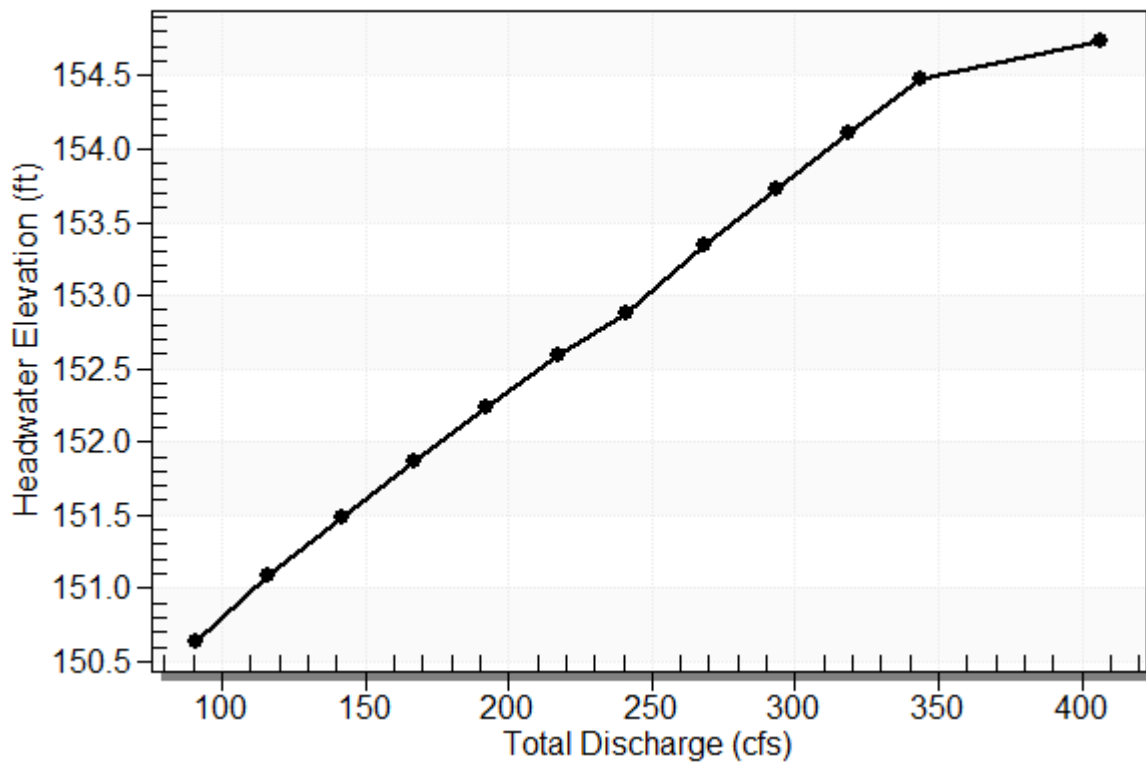
**Total Rating Curve**  
Crossing: Proposed Buried Arch (20' Span)

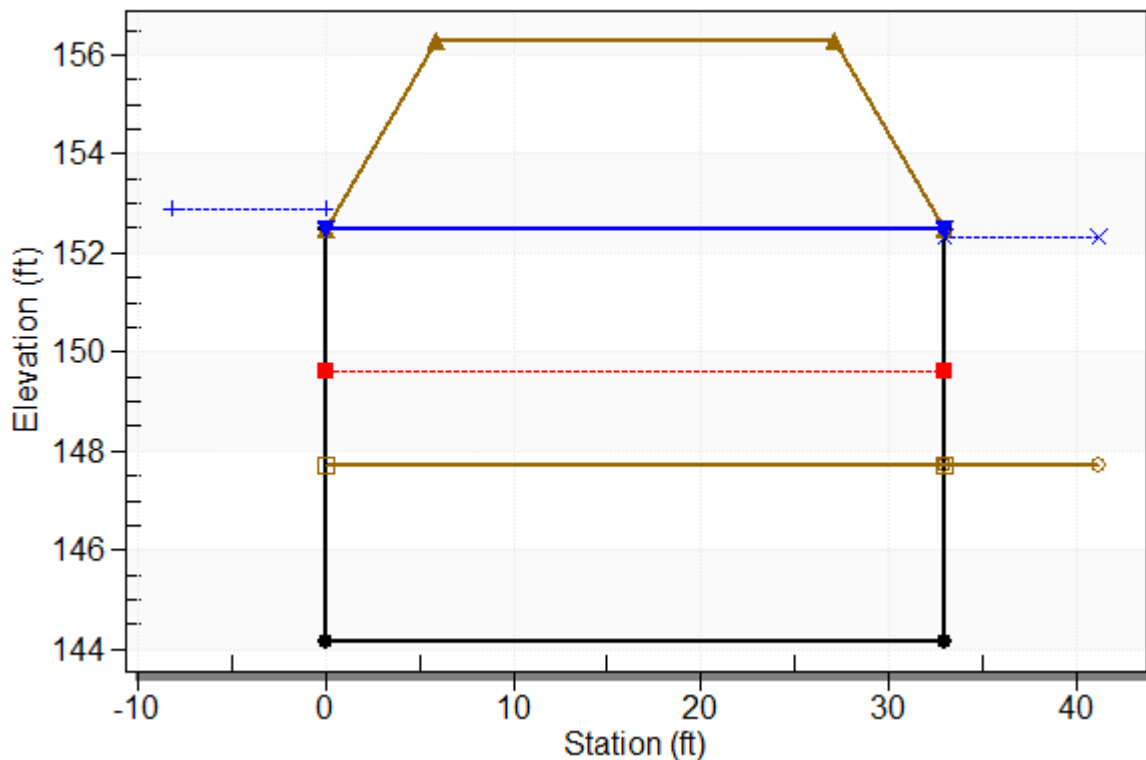
## Water Surface Profile Plot for Culvert: Arch\_OpenBottom

Crossing - Proposed Buried Arch (20' Span), Design Discharge - 241.0 cfs  
Culvert - Arch\_OpenBottom, Culvert Discharge - 241.0 cfs

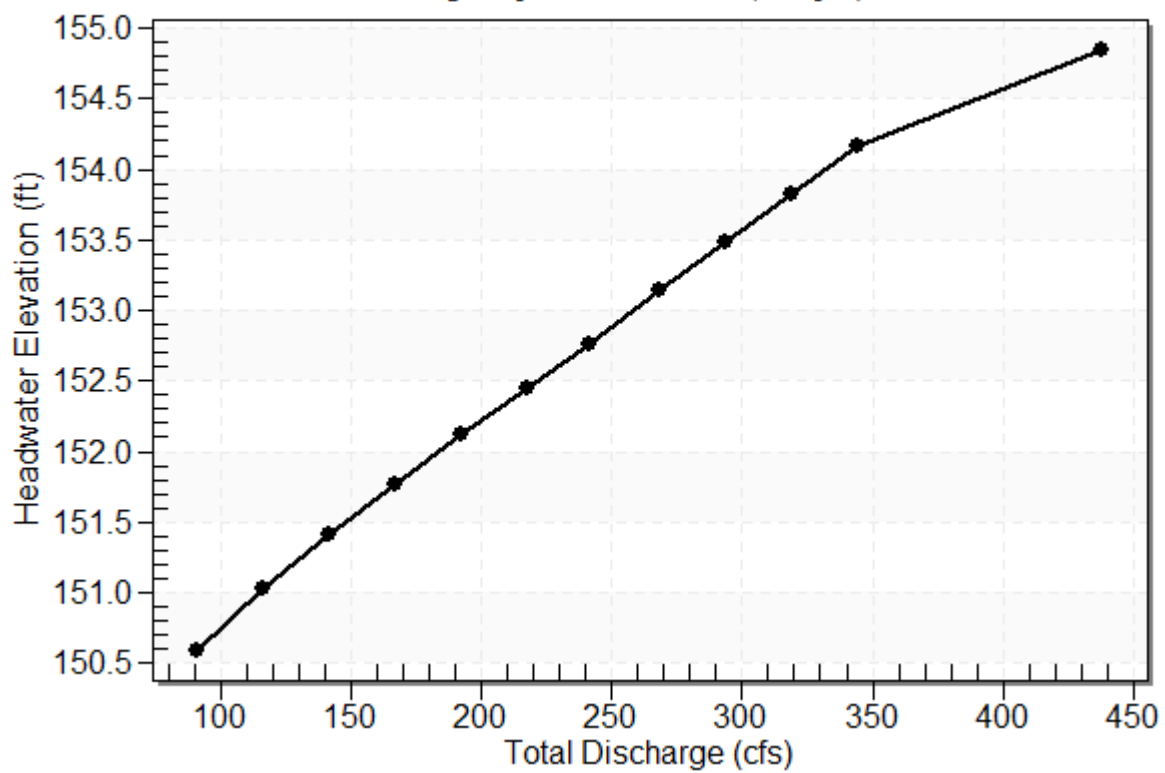
Total Rating Curve  
Crossing: Proposed Buried Arch (25' Span)

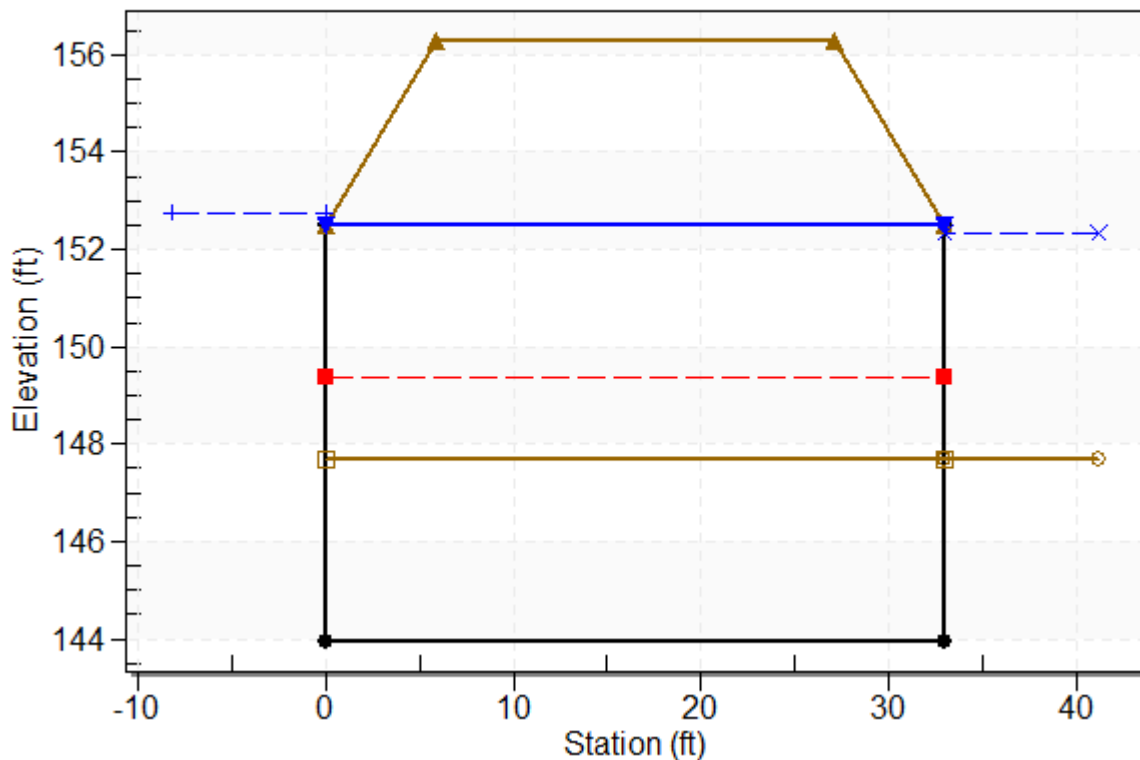
## Water Surface Profile Plot for Culvert: Arch\_LowProfile

Crossing - Proposed Buried Arch (25' Span), Design Discharge - 241.0 cfs  
Culvert - Arch\_LowProfile, Culvert Discharge - 241.0 cfs

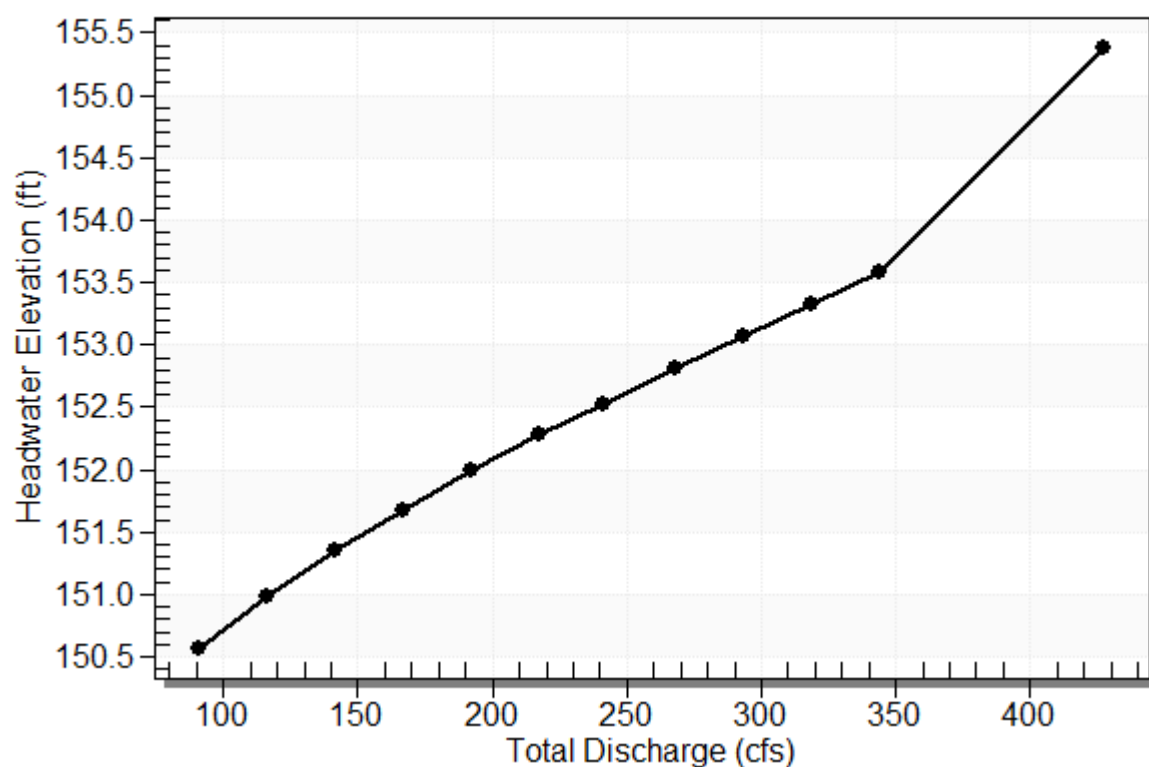
Total Rating Curve  
Crossing: Proposed Rigid Frame (20' Span)

for this alternative. As the 16-foot span comes close to submerging the low chord of the frame, a 20-foot span is recommended for this alternative to minimize the potential for pressure flow to develop, which can increase the scour potential at the crossing. It should be noted that the roadway for this alternative is not anticipated to be overtopped up to and including the 100-year peak flow rate.

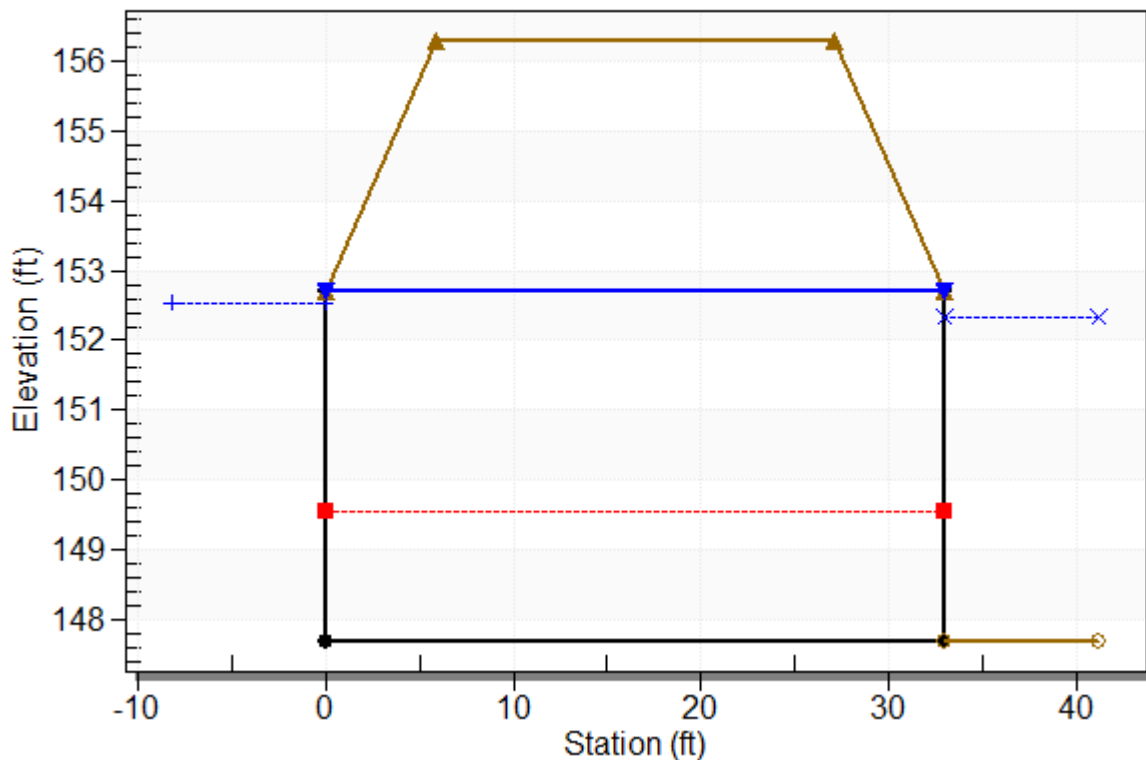
## Water Surface Profile Plot for Culvert: Rigid Frame

Crossing - Proposed Rigid Frame (20' Span), Design Discharge - 241.0 cfs

Culvert - Rigid Frame, Culvert Discharge - 241.0 cfs

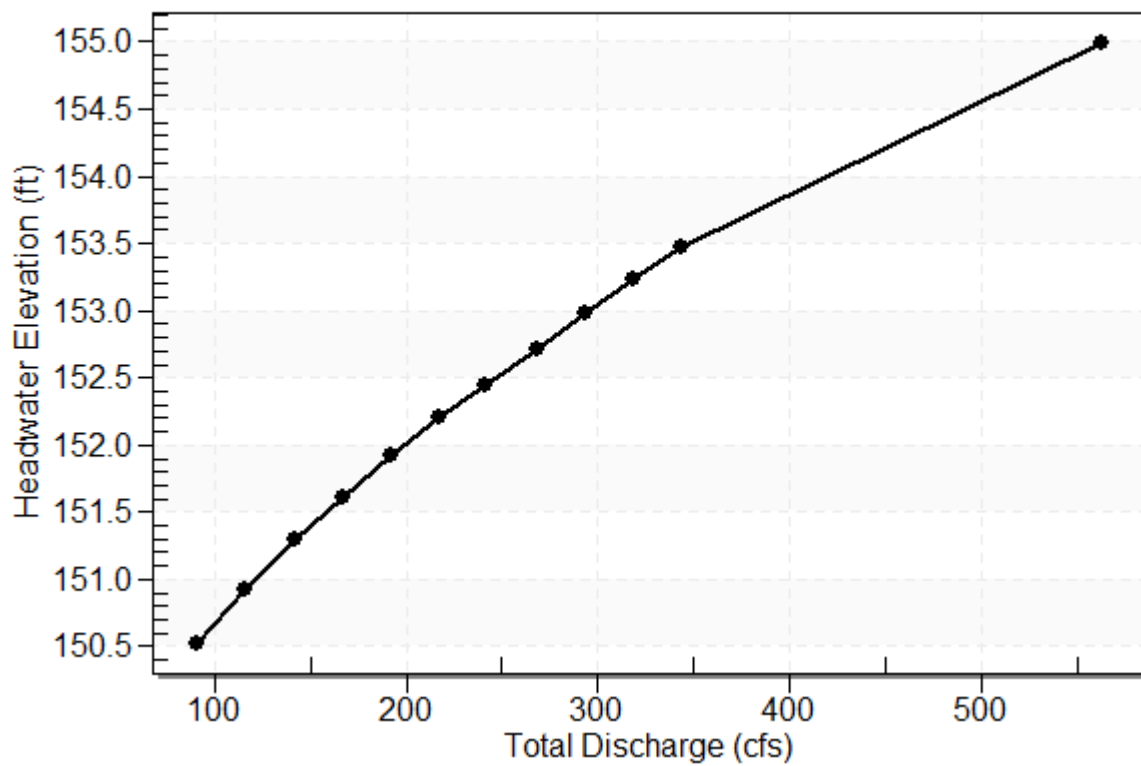
**Total Rating Curve**  
Crossing: Proposed Rigid Frame (25' Span)

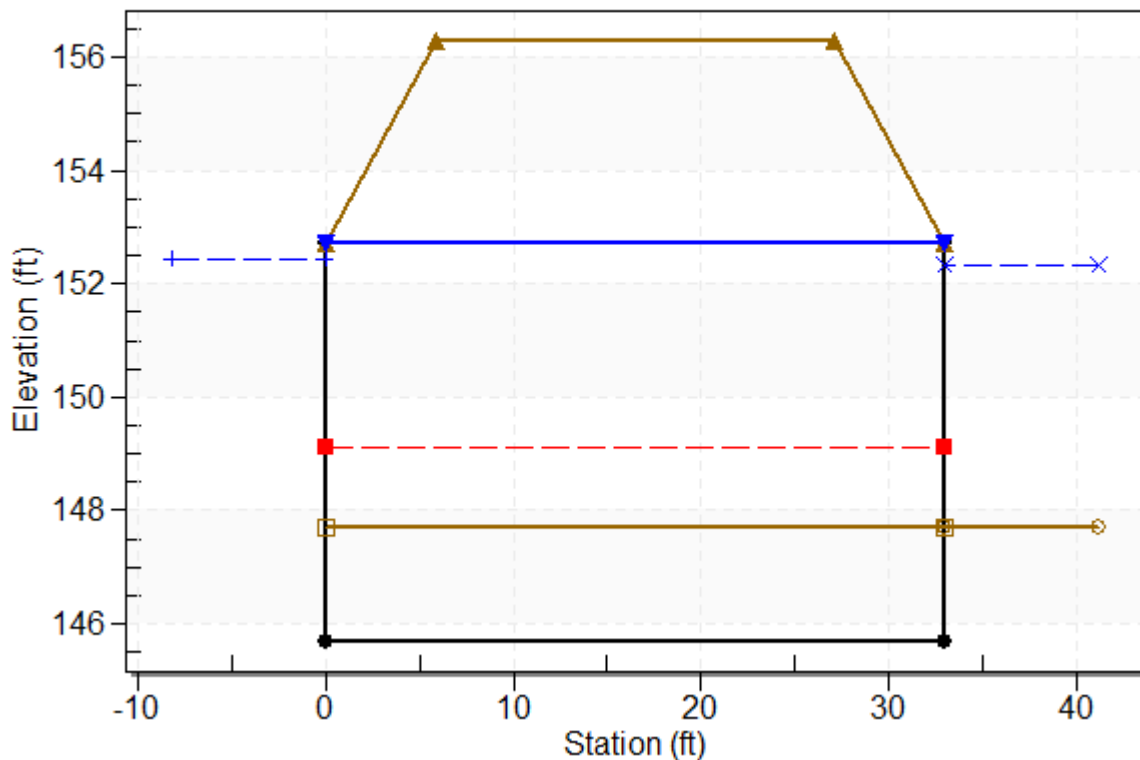
## Water Surface Profile Plot for Culvert: Rigid Frame

Crossing - Proposed Rigid Frame (25' Span), Design Discharge - 241.0 cfs  
Culvert - Rigid Frame, Culvert Discharge - 241.0 cfs

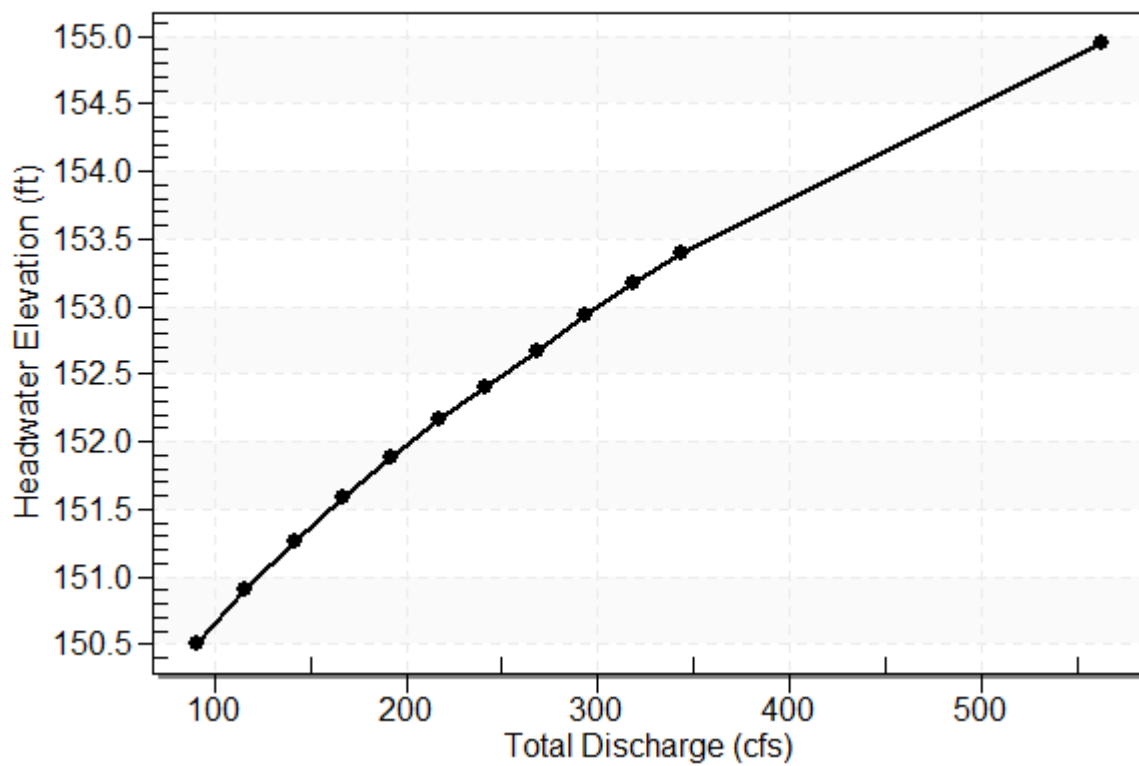
## Total Rating Curve

Crossing: Proposed Rigid Frame (30' Span)

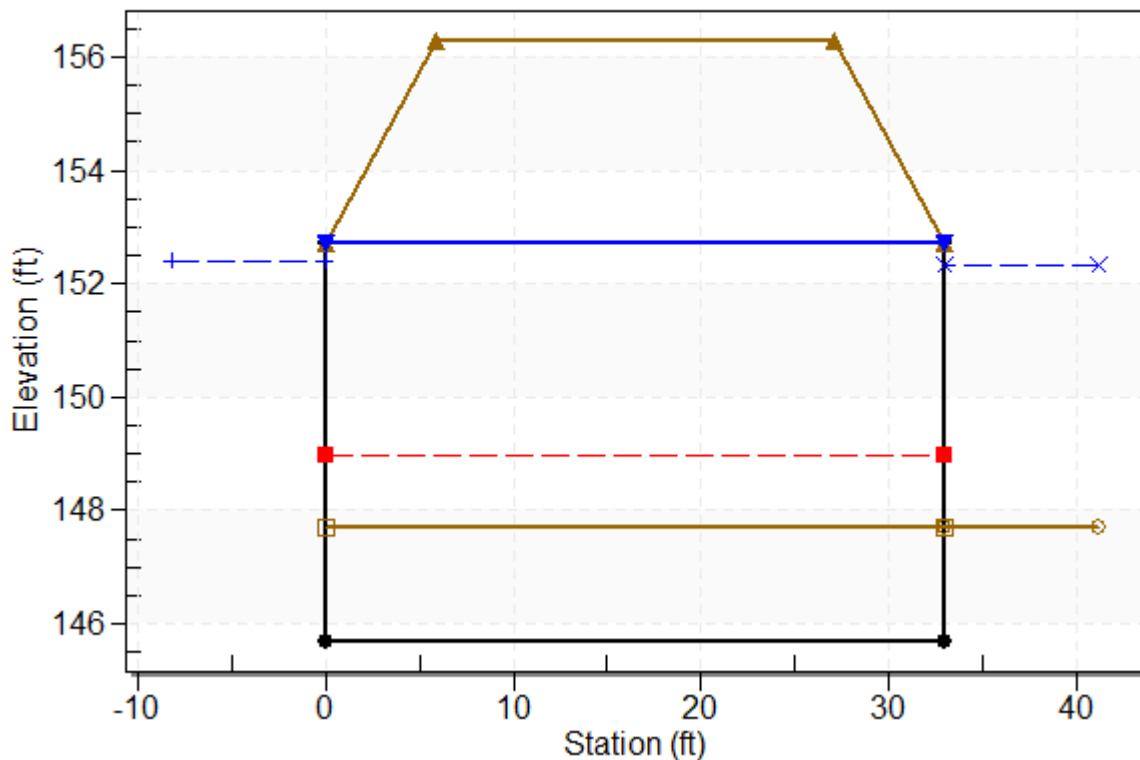
## Water Surface Profile Plot for Culvert: Rigid Frame

Crossing - Proposed Rigid Frame (30' Span), Design Discharge - 241.0 cfs

Culvert - Rigid Frame, Culvert Discharge - 241.0 cfs

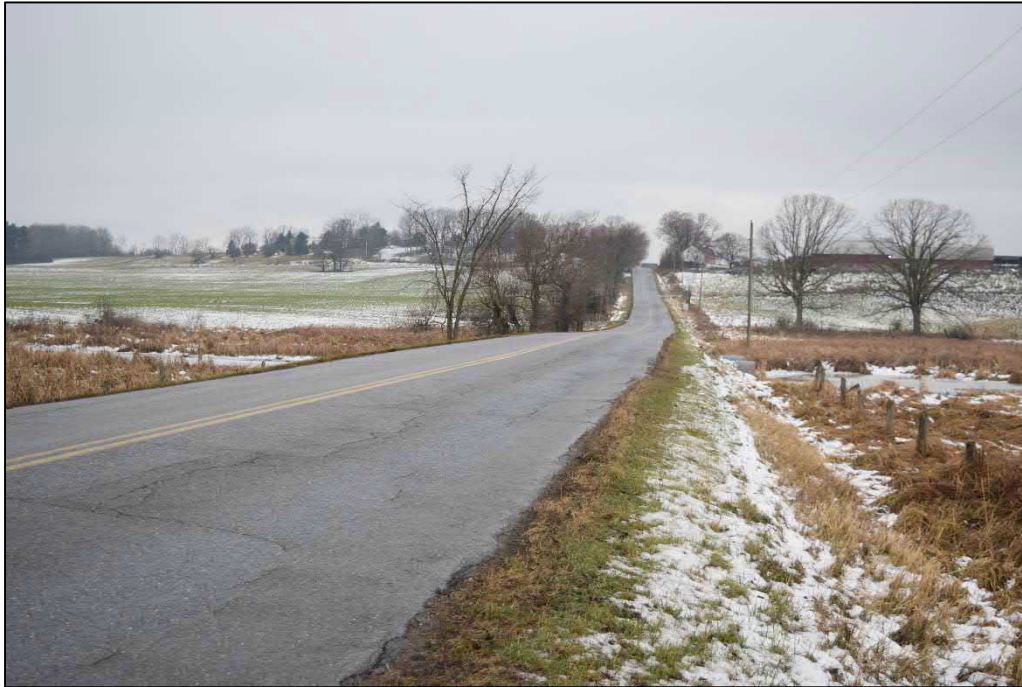
Photo 1. Project APE. Note twin culverts on the right middle view with marshy areas on either side of Middle Road. View to the west.

The project APE is currently used only for Middle Road and the culverts to allow the East Branch of Dead Creek to pass under the road (Photos 1 and 2). The APE is an area of marsh not suited to any agricultural use.
