Londonderry BF 016-1(33)

MAOS Meeting

Vermont Route 11 – Bridge #24 over Unnamed Brook

June 1, 2015

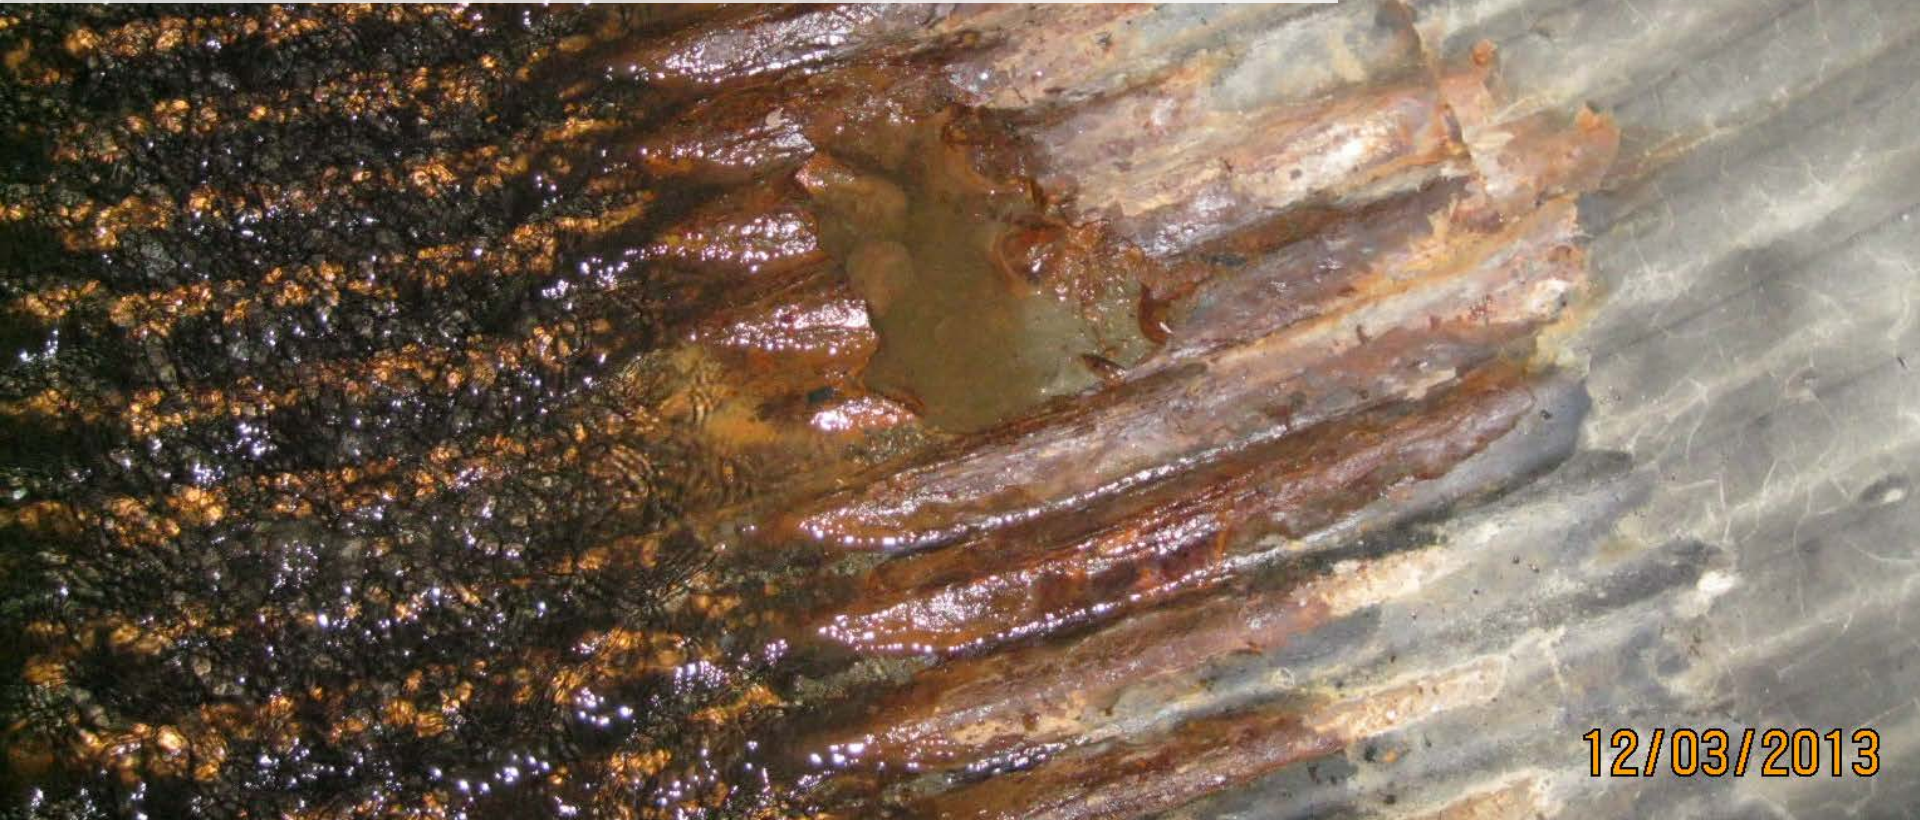
12/03/2013

Typical corrosion deterioration

Bridge 24 Looking West

- Culvert Rating 3 (Serious)
- Channel Rating 6 (Satisfactory)
- Inspector's comments state that action is needed in the near future.

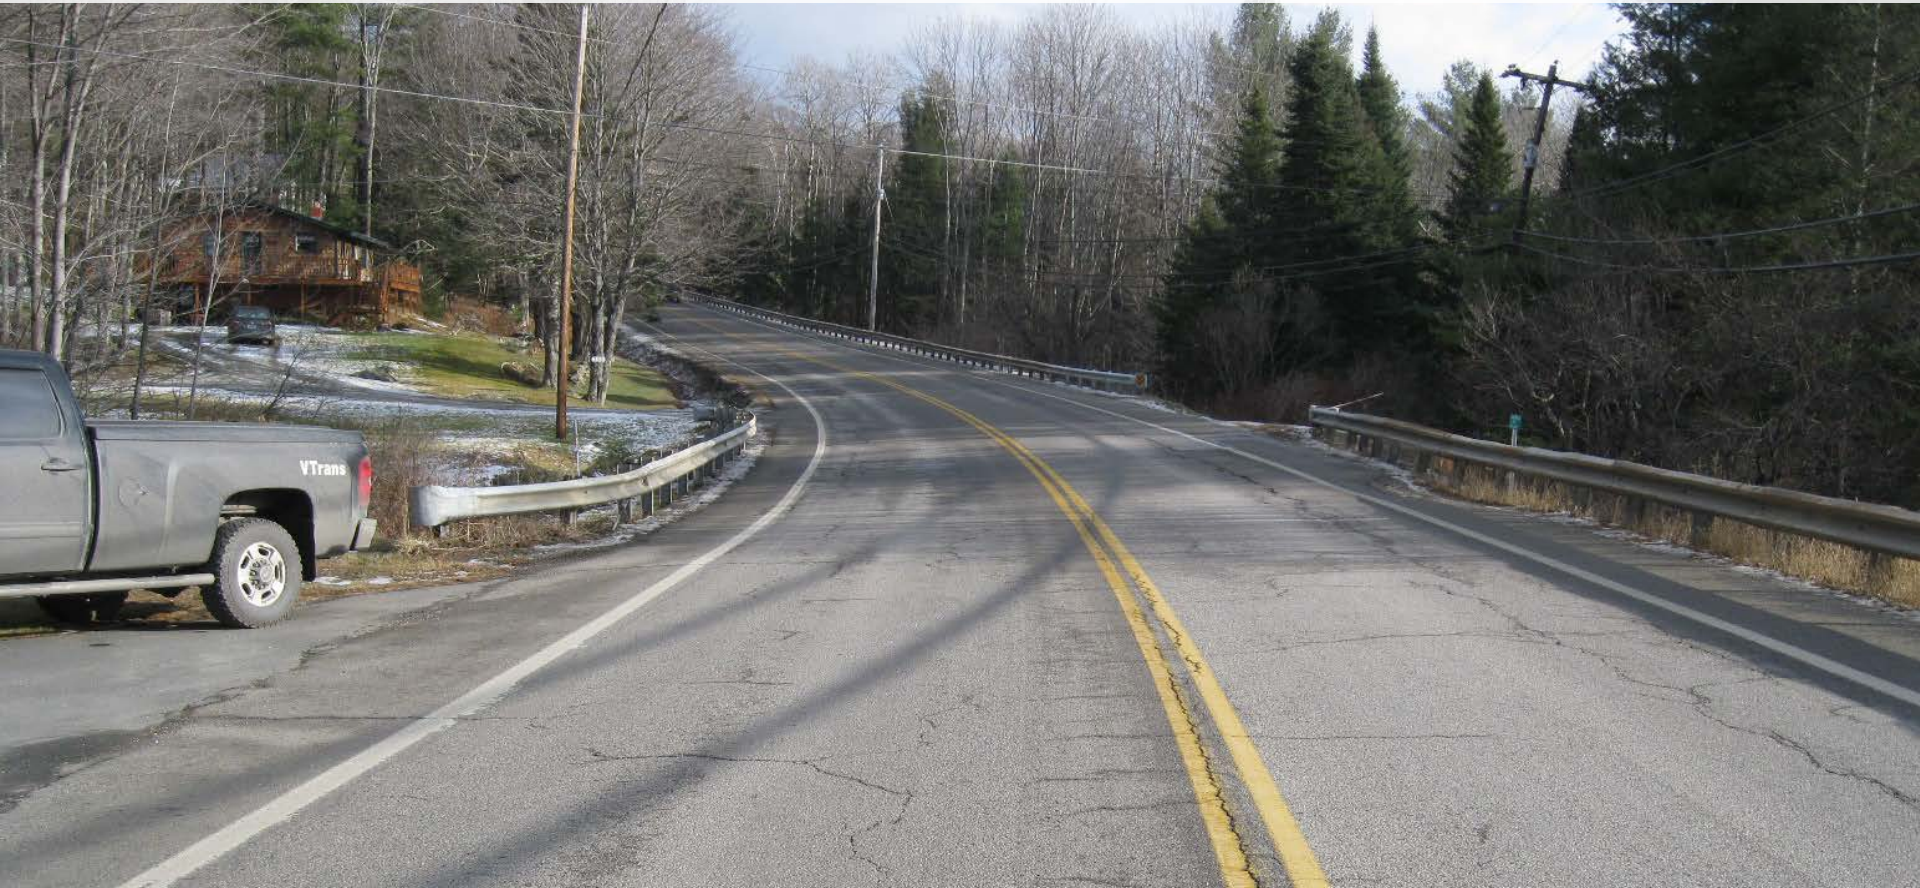
Existing Conditions - Bridge #24

- Banking, K values, and sight distance in the roadway are substandard.
- It is estimated that the road would have to be raised approx. 2' to correct these deficiencies.

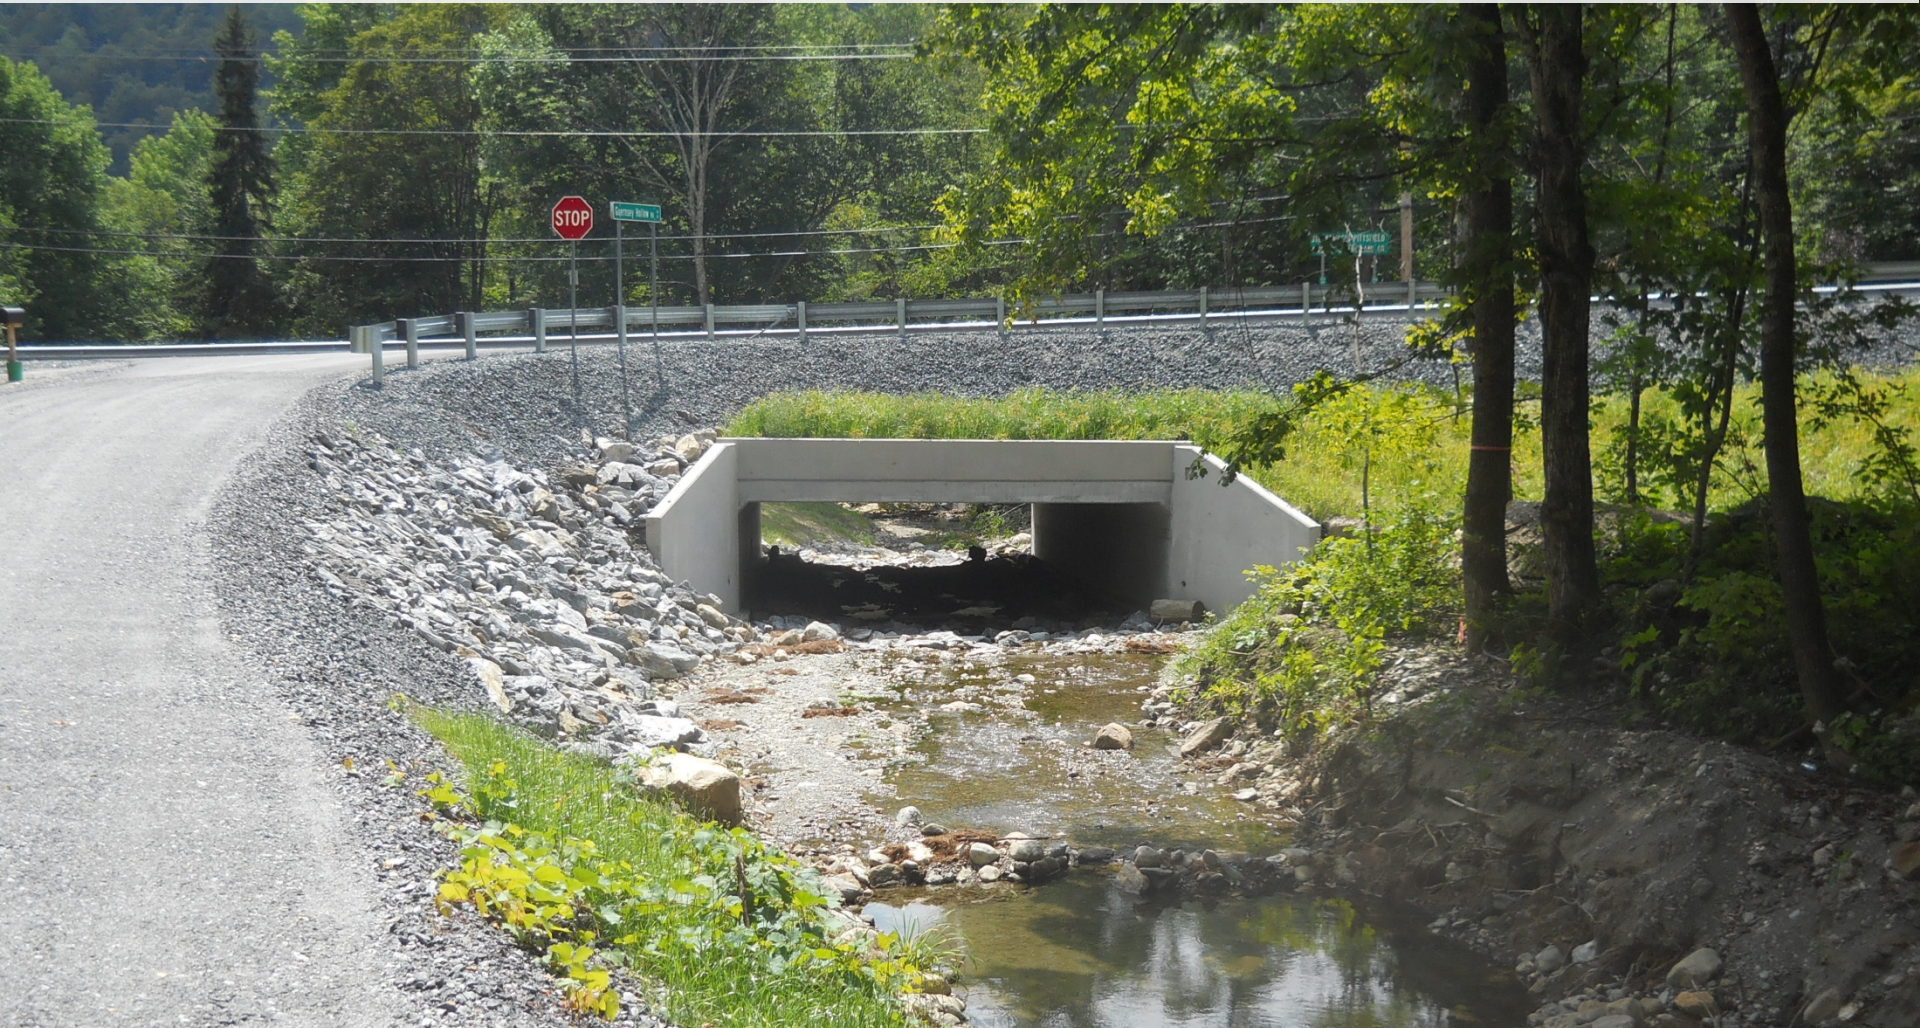
What Will the New Bridge Look Like?

Proposed Example - Bridge #24

- Reinforced Concrete Box
- Buried inlet for AOP not required here

- Replace entire structure with a reinforced concrete box:
 - Traffic Maintained on offsite detour during 5 day closure
 - Meets hydraulic standards
 - 5' wide x 6' tall inside dimensions
 - Utility relocation needed
 - No ROW needed

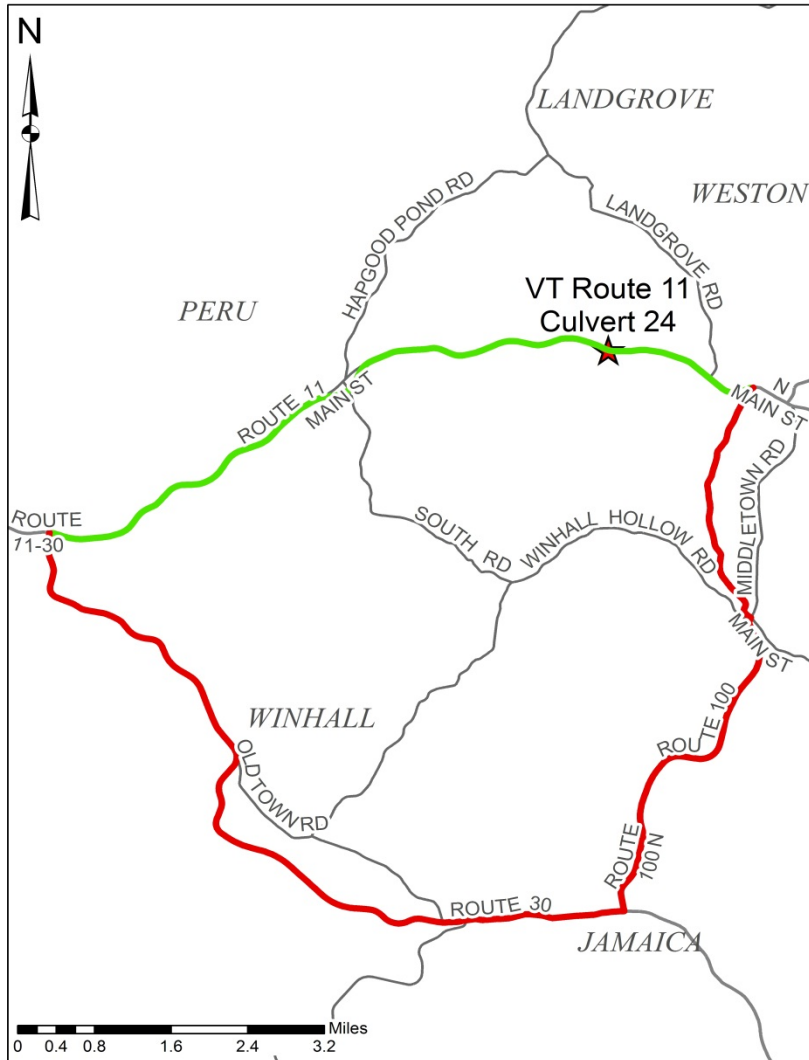
- 5 Day Road Closure w/ Offsite Detour
 - Signed by State
 - Approx. 30 minutes to drive end-to-end
- VT 100 south to VT 30 west, then back to VT 11

Through Route: 8.3 Miles
Detour Route: 15.7 Miles
Added Distance: 7.4 Miles
End-to-End Distance: 24 Miles
