Swanton BF 036-1(16)
Alternatives Presentation Meeting
VT Route 78 – Bridge 6 Over Missisquoi River
July 14, 2025

Existing Conditions – Bridge #6

Alternatives Considered – Bridge #6

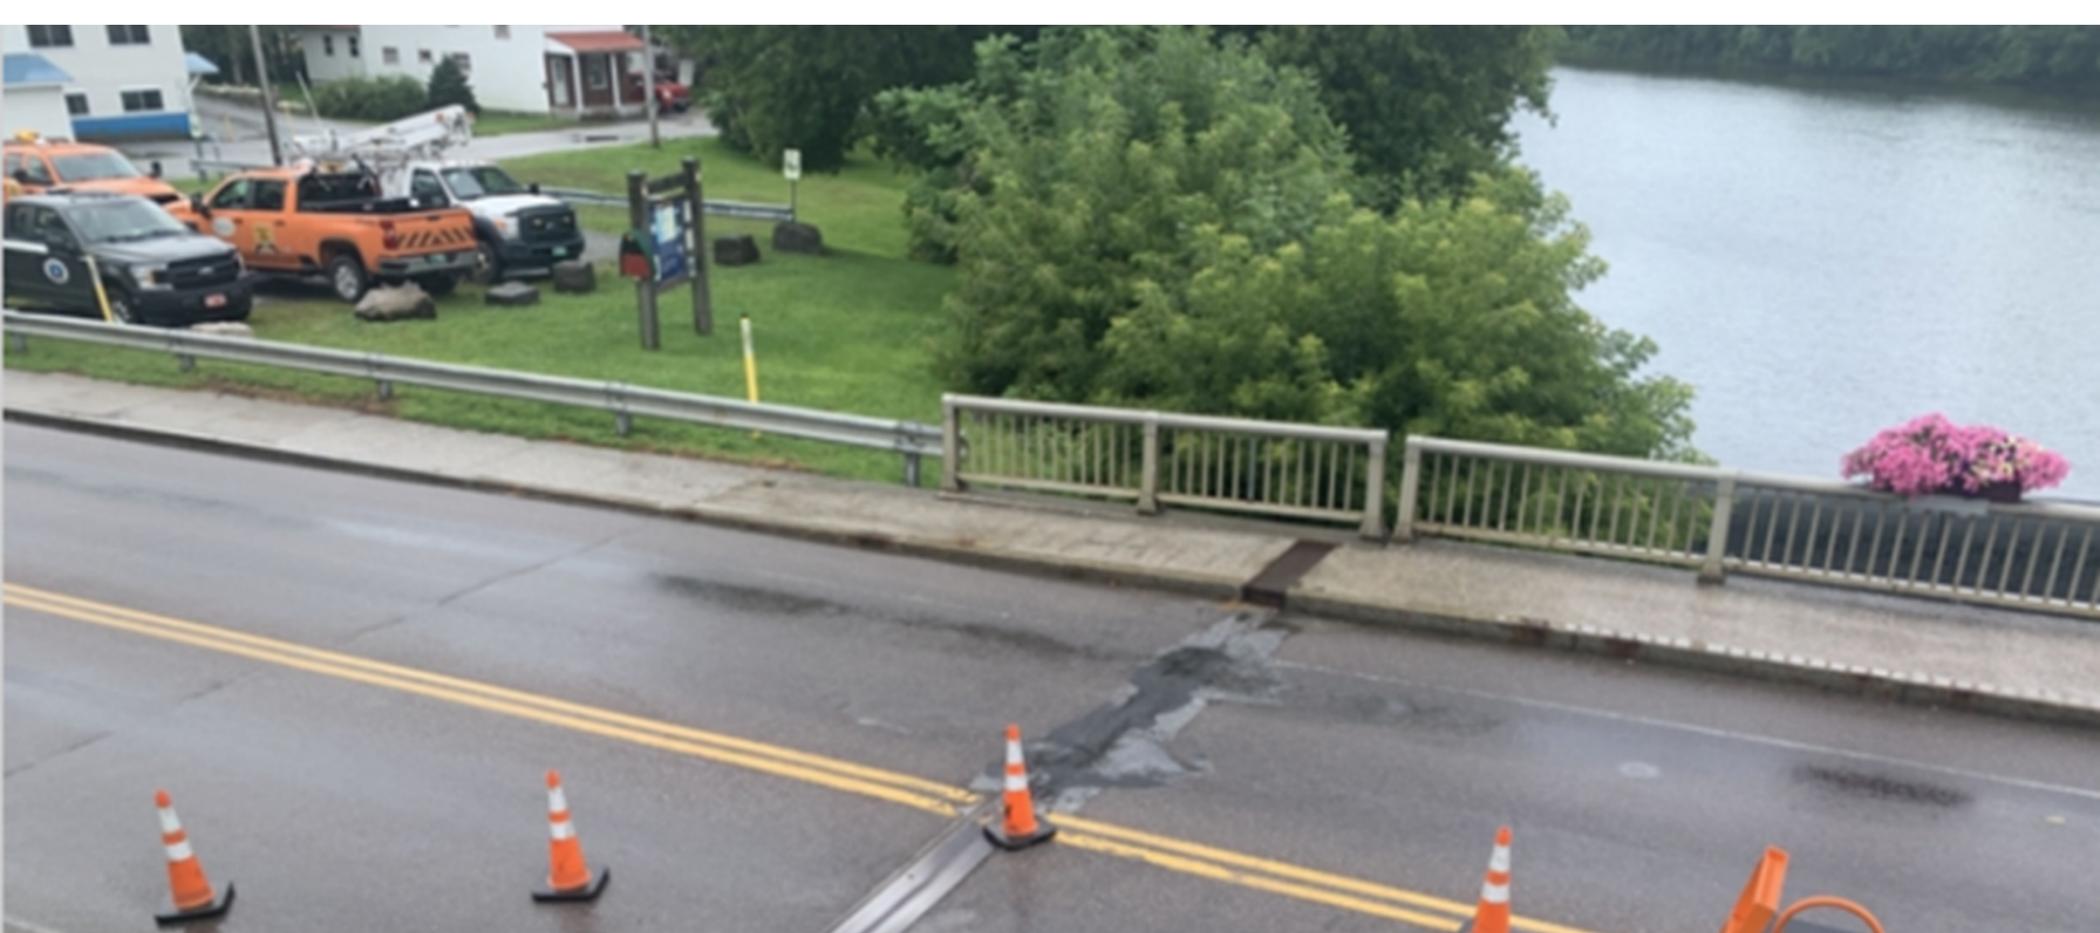
Typical Top of Deck and Abutment Joint Condition

Typical Underside of Deck – Span 2

- Advanced deterioration of the abutment joints
- Beam ends and end diaphragms at abutments have notable rust and section loss
- Abutment bearings have significant rust and pier bearings have missing anchor bolts
- North fascia beam has significant rust with section loss in the lower web and bottom flange
- Bridge railing and approach guardrail is substandard
- Deck drains have significant perforations and leakage

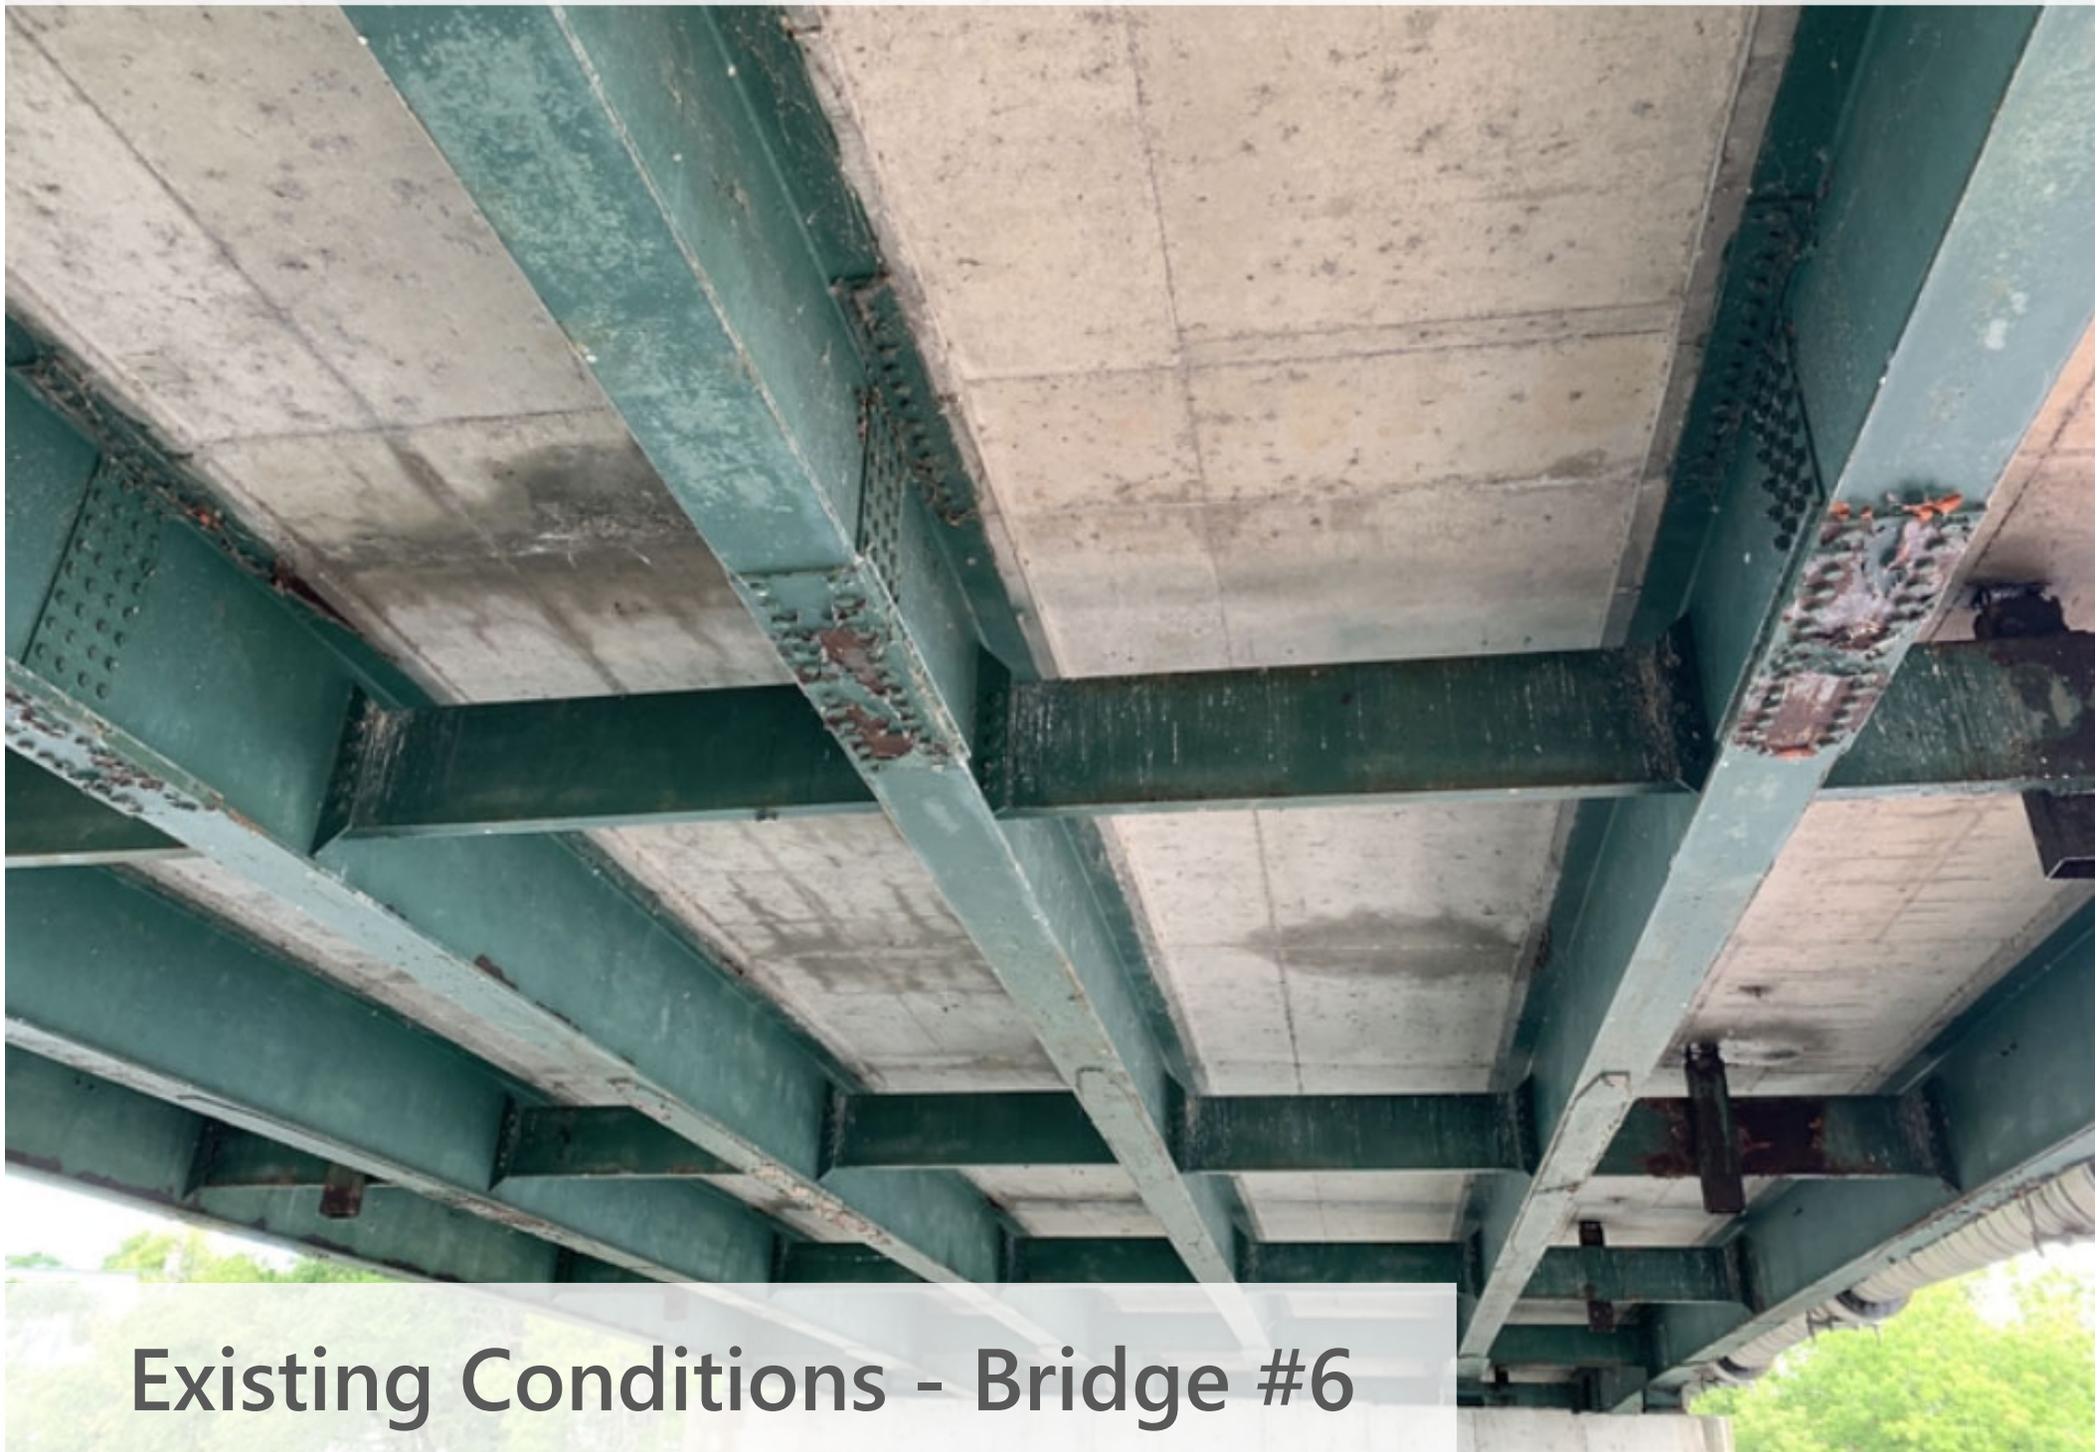
Beam 6 at Abutment 1
