2022 School Facilities Inventory Report

Facility Name: **FRANKLIN WEST SU | BELLOWS FREE ACADEMY ELEMENTARY (FAIRFAX) | 75 HUNT STREET, FAIRFAX 5454 - Elementary (PreK thru 4) - Main Building**

March 29, 2022

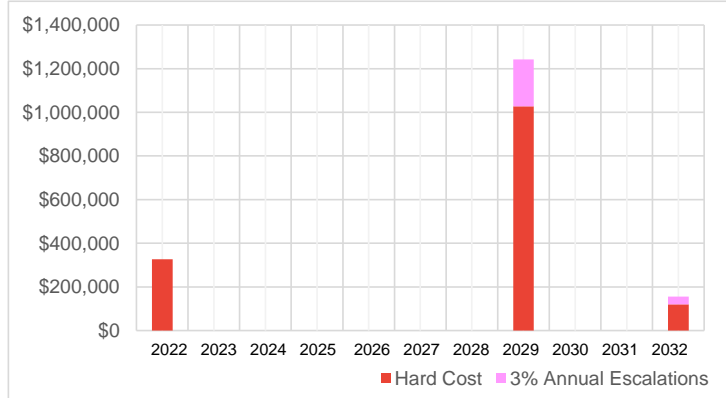
Projected Capital Planning Cash Flow	The estimated replacement costs of systems as they expire annually.
Facility Condition Index (FCI)	The cost -weighted depleted value of the building compared to the total value of all its systems; overall percent of building useful life consumed by years in service.
Total Value of Assets	The total estimated replacement cost of all the assets listed in the form.
Value of Assets per GSF	The Total Value of all Assets in the form divide by the Gross Square Footage (GSF) of the building.
Facility Condition Index (FCI) Compared to Portfolio	The Facility Condition Index (FCI) of the building overlaid on the chart of FCI's for all buildings in the portfolio. Indicated by a red line in the chart.
Calculated Remaining Useful Life(C-RUL)	The current number of remaining years a system may be expected to perform in designed service.
Expected Useful Life (EUL)	The total number of years a system can be expected to perform in designed service when new.

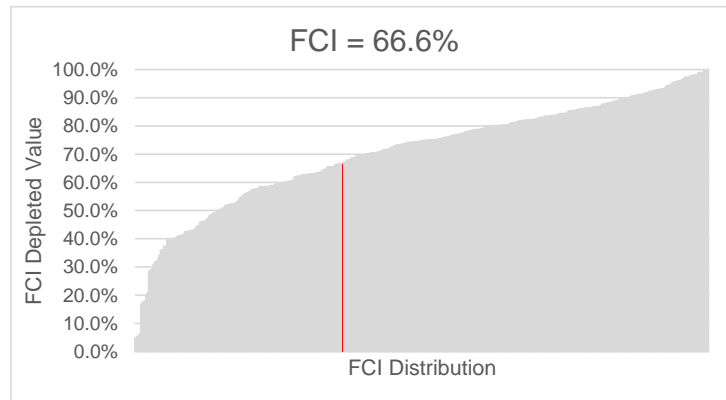
Facility Condition Index (FCI) Compared to Portfolio

School Type **Elementary (PreK thru 4)**
 Building Identification **Main Building**
 Stories **2**
 Building Area **38880 (Gross Square Footage - GSF)**
 Year Constructed **2000**
 Year of Last Major Renovation **N/A**
 FCI (Depleted Value) **66.6%**
