Vermont Better Roads Grant Program Application

Project Name: Ahead of the Storm, Thorp Brook Restoration, Bio-Retention

EXISTING CONDITIONS
AHEAD OF THE STORM
THORP BROOK HEADWATERS RESTORATION
 EAST THOMPSON POINT ROAD
 CHARLOTTE, VERMONT

LAYOUT
AHEAD OF THE STORM
THORP BROOK HEADWATERS RESTORATION
EAST THOMPSON POINT ROAD
CHARLOTTE, VERMONT

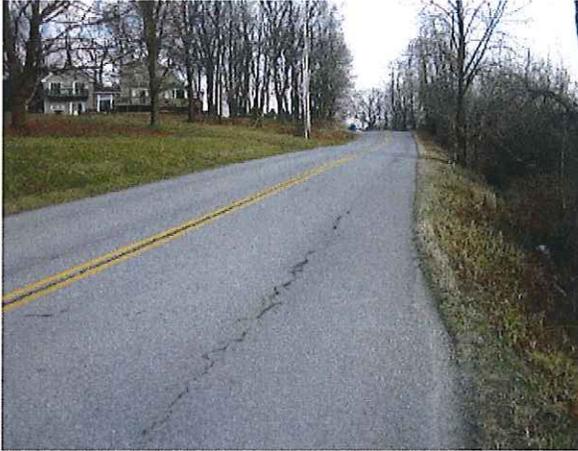
Figure 1: Runoff from Greenbush Road and homes on the far side of the road travels through the adjacent farm fields to Mack's farm field.

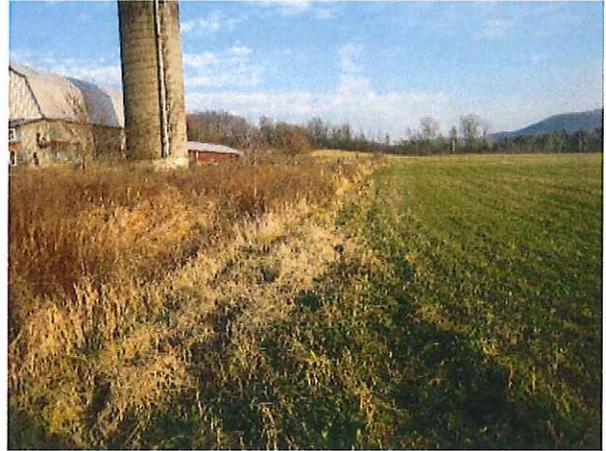
Figure 3: A swale runs from north to south along the west edge of the Mack's farm field, carrying water to the East Thompson Point Road swale.

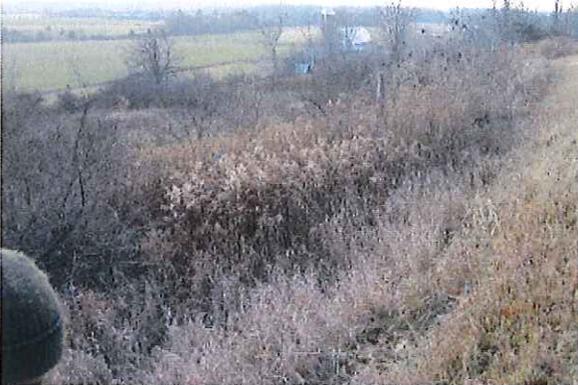
Figure 2: Runoff from fields and Greenbush Road travel through farm fields down to the site.

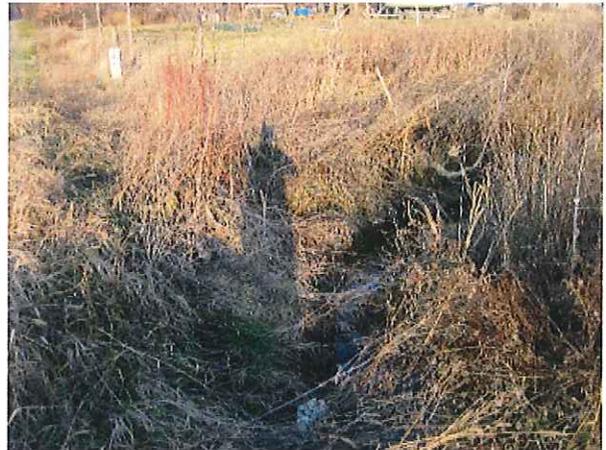
Figure 4: The swale from the north turns sharply to the east, joining the East Thompson Point Road swale.

REALIGN SWALE AT CORNER TO ELIMINATE SHARP BEND AND PROVIDE FOR MORE SNOW STORAGE

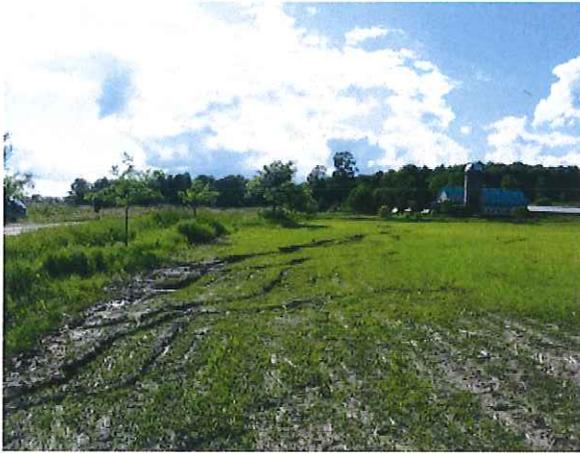
Figure 5: Rill erosion has occurred in the Mack farm field when water in the swale traveling from the north leaves the swale and cuts across the field to the road swale.

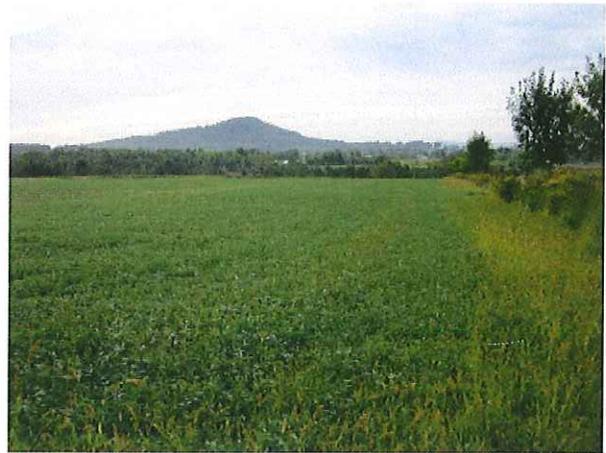
Figure 7: The Mack farm field is harvested close to the edge of the swale. The trees in this photo have been moved.

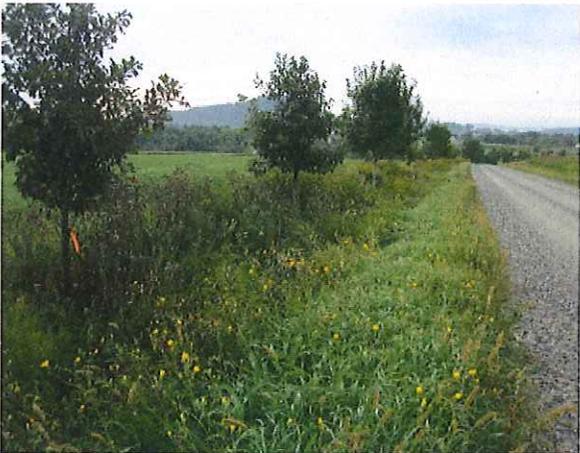
Figure 6: A vegetated swale travels along East Thompson Point Road. The trees in this photo have been moved.

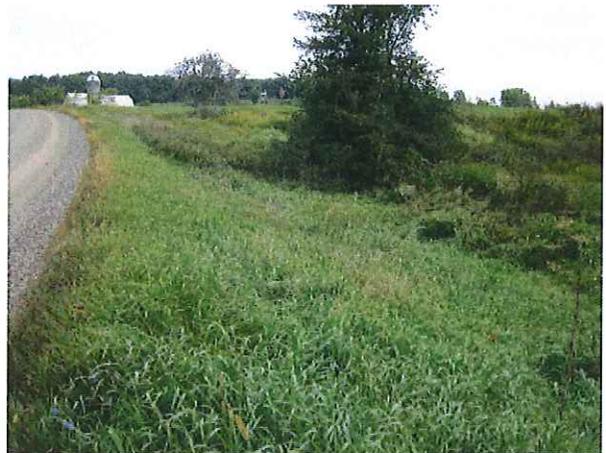
Figure 8: Possible location of a bioretention area adjacent to East Thompson Point Road, prior to water entering Thorp Brook

A bio-retention area will be constructed including three stone filter berms to create three bio-retention cells immediately prior to the swale water entering Thorp Brook. Concurrent with this work the Town is seeking a separate BBR grant to accomplish installation of 785' of swale improvements, installation of check dams, and improvements to a farm access. These practices would be upstream of the proposed bio-retention. +

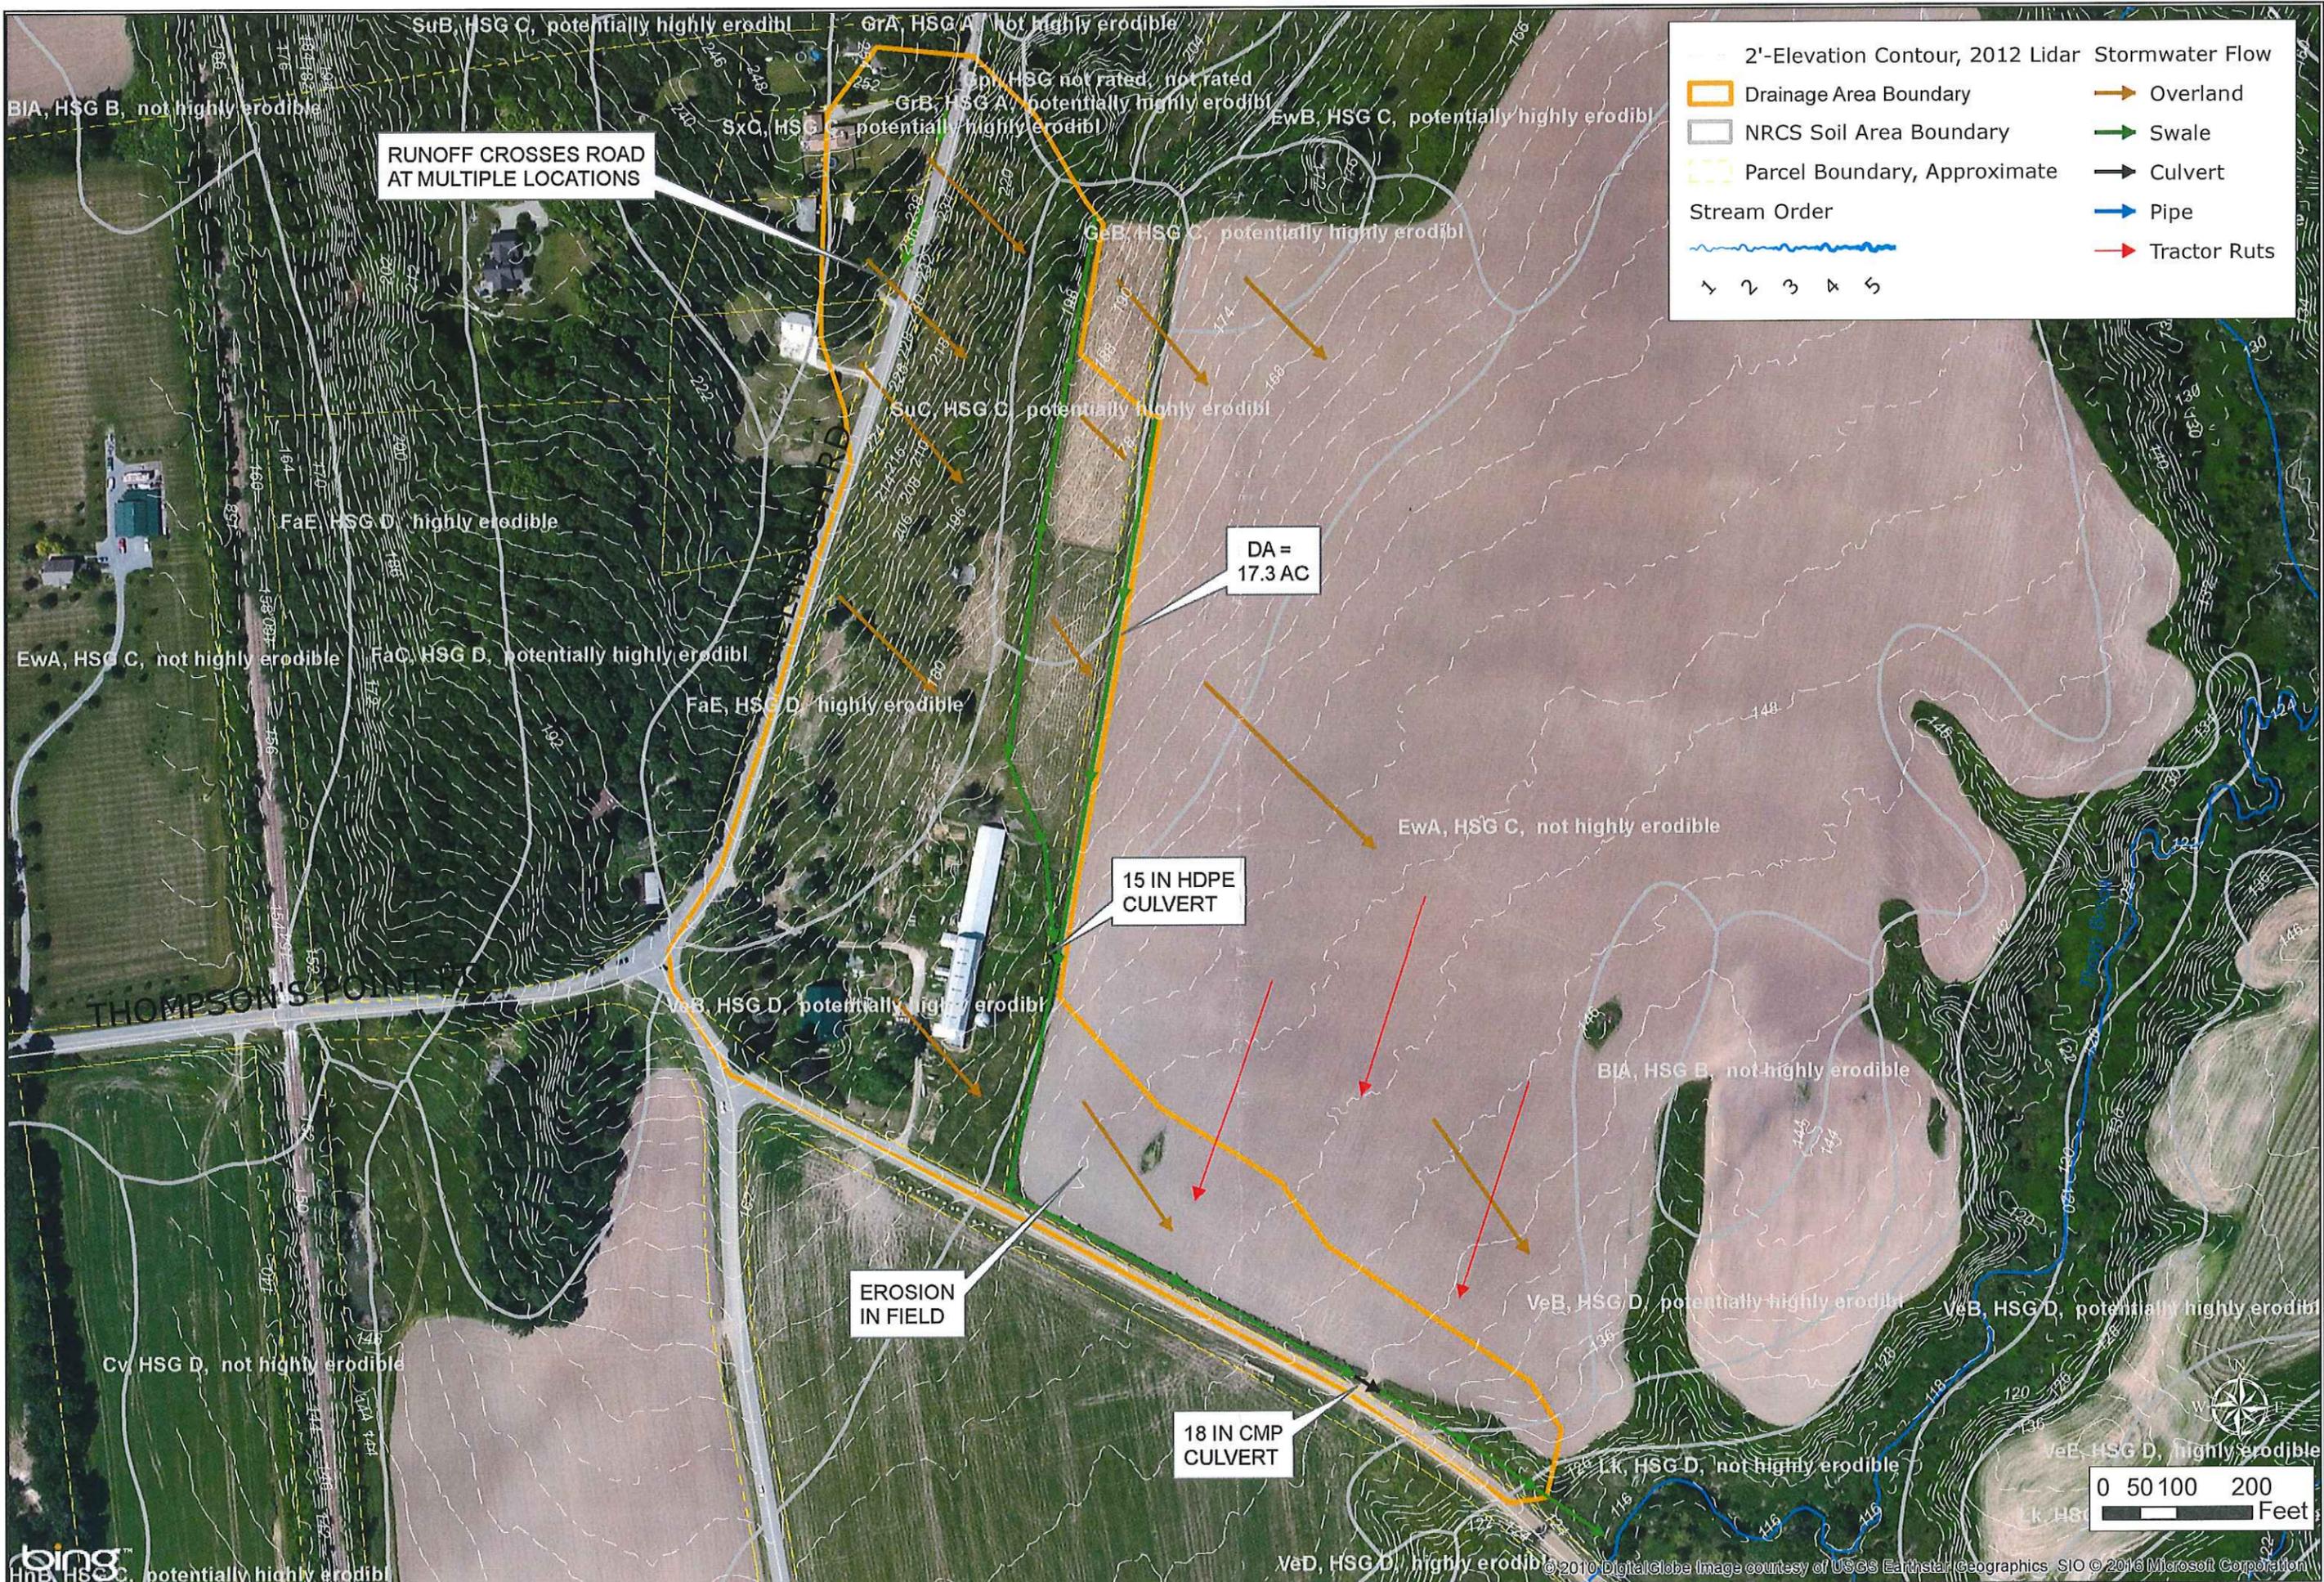
Stormwater Flow

The swale along the north side of East Thompson's Point Rd at the Mack farm field collects runoff from 17.3 acres including portions of East Thompson's Point and Greenbush Roads, residential properties, and portions of two farms. The ROW ditch is undersized and eroding and causes water to overtop and cause erosion in the adjacent field. The sediment laden water is directly discharged in to the stream, impacting Thorp Brook's stream morphology and water quality. +

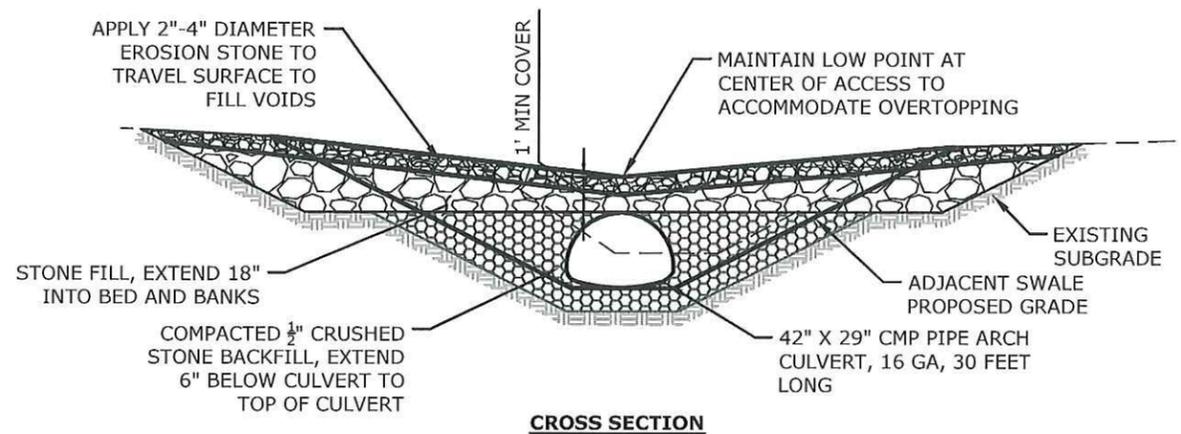
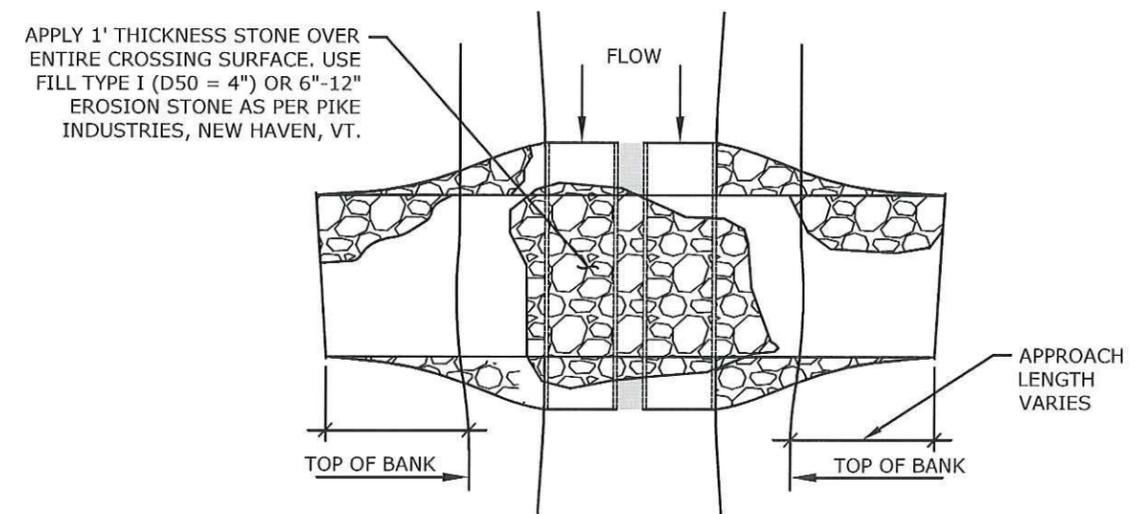
FIELD ACCESS CULVERT
NOT TO SCALE

CROSS SECTION

PLAN VIEW

REPLACE ACCESS WITH CMP 42" X 29" PIPE ARCH CULVERT AND RESURFACE ACCESS WITH STONE TO ACCOMODATE OVERTOPPING OF HIGH FLOWS (SEE DETAIL)

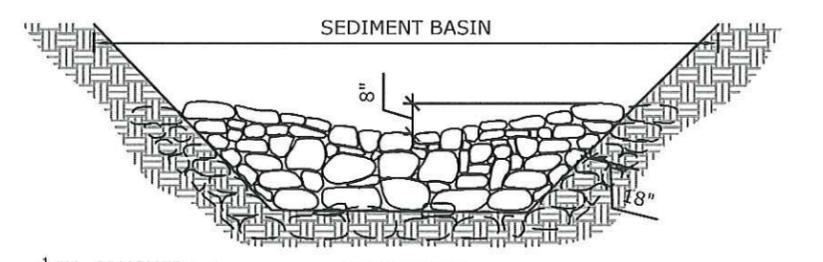
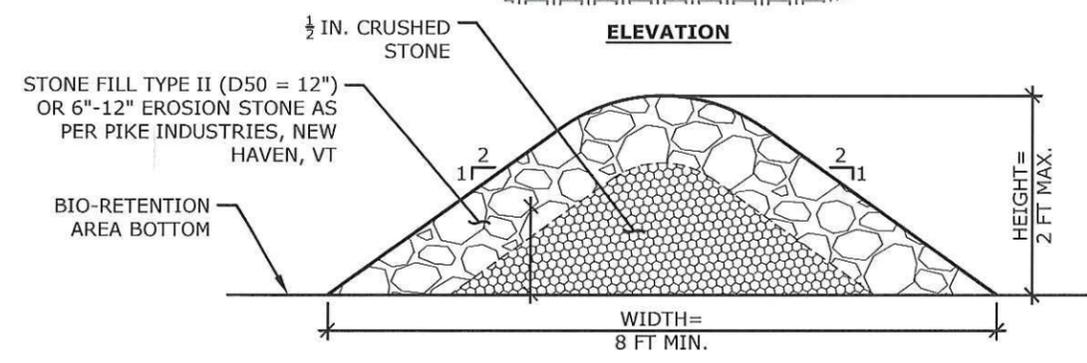
STONE FILTER BERM
NOT TO SCALE

ELEVATION

CROSS SECTION

NOTES:
EXTEND THE STONE A MINIMUM OF 18 INCHES INTO BANKS AND BOTTOM TO PREVENT CUTTING AROUND THE ENDS OR UNDER THE FILTER BERM.

BIO-RETENTION AREA WITH 3 STONE FILTER BERMS (SEE DETAIL)
FOOTPRINT ~ 2,300 SQUARE FEET
AVG. DEPTH ~ 1 FOOT
VOLUME ~ 2,300 CUBIC FEET

STONE FILTER BERMS FINAL LOCATIONS TO BE SET IN FIELD BY ENGINEER
