STATE OF VERMONT  
AGENCY OF TRANSPORTATION

Scoping Report

FOR  
Sharon IM 089-1(64)

Interstate Route 89, Bridges 17 N/S over the White River

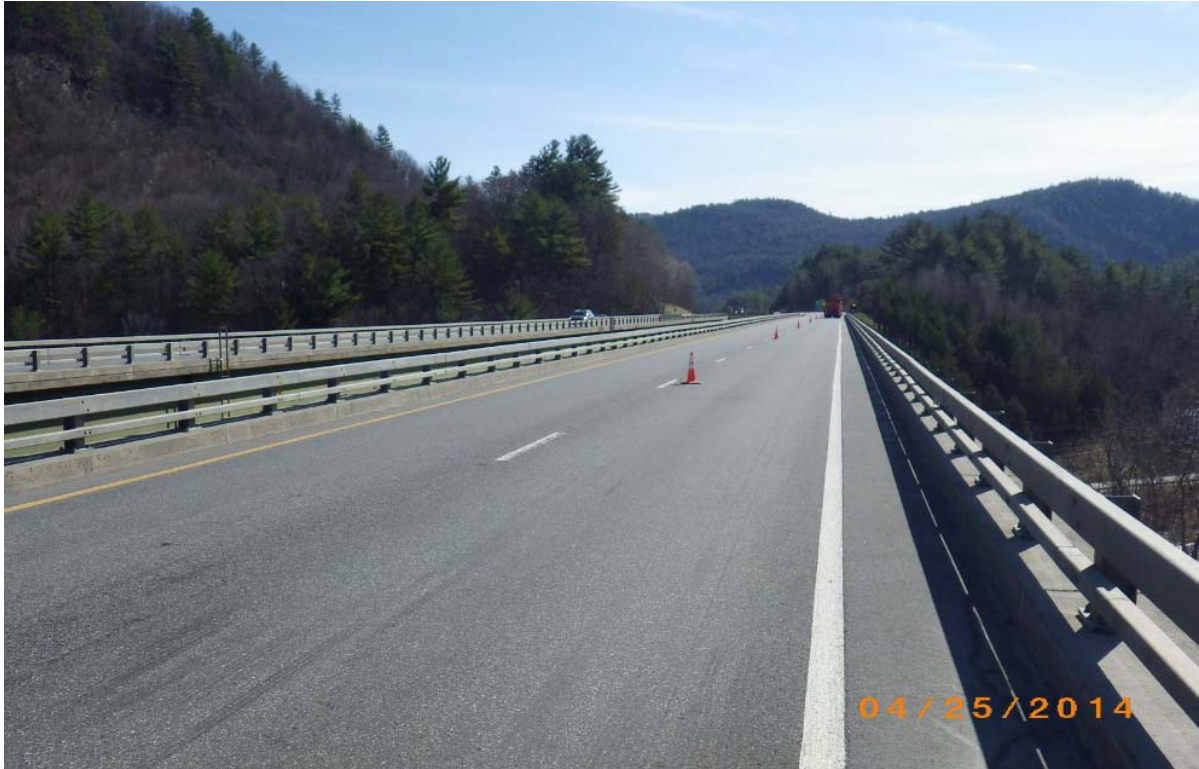
17S Facing South

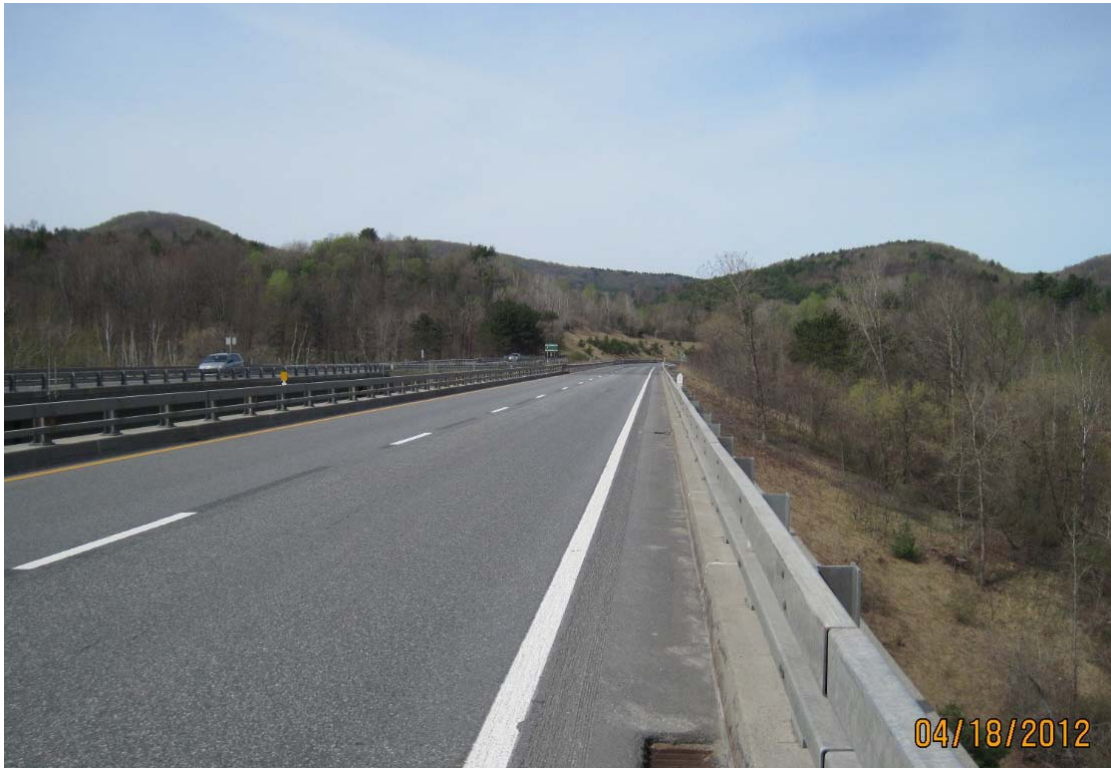
17N Facing North
