Scoping Study

Jamaica BO 1442(42) Depot Street Truss Town Highway 19 Bridge 32 over West River

Prepared for:
Vermont Agency of Transportation

May 2021

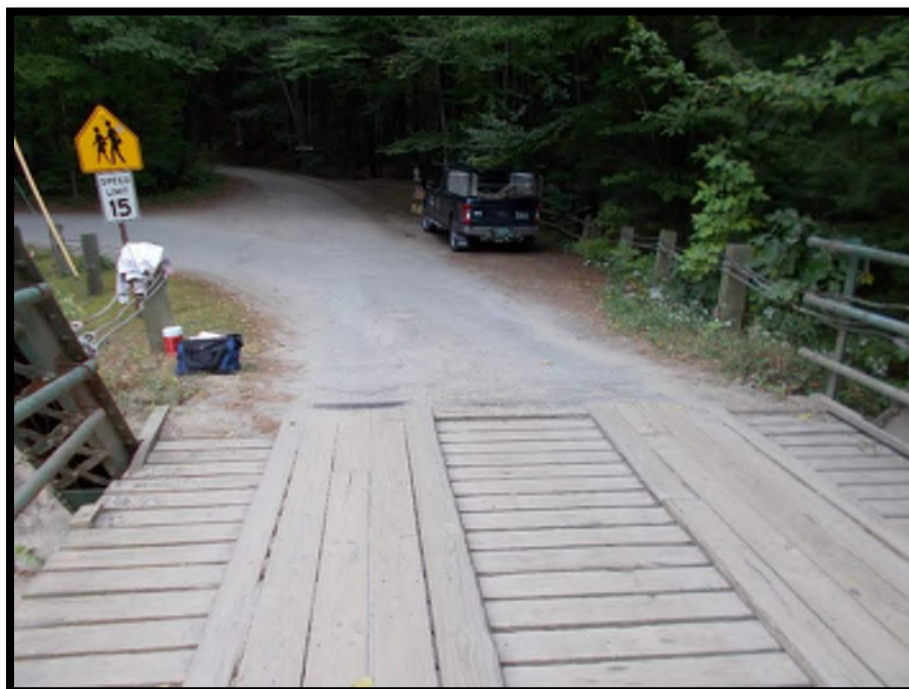
Photo 2: Looking East over Bridge 32 from Bridge Deck

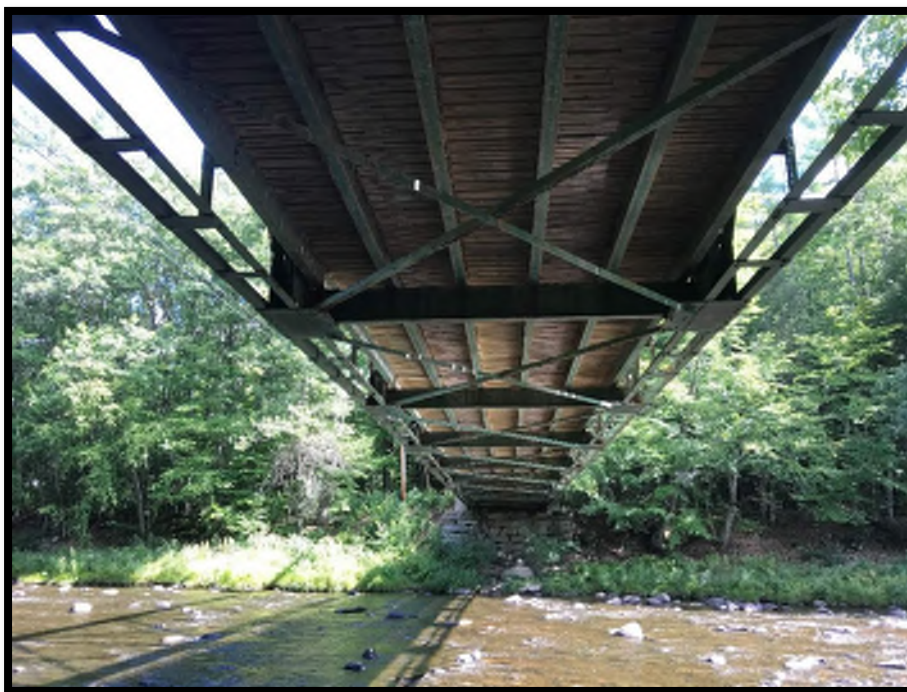
Photo 5: Looking East at Floor System from West Abutment

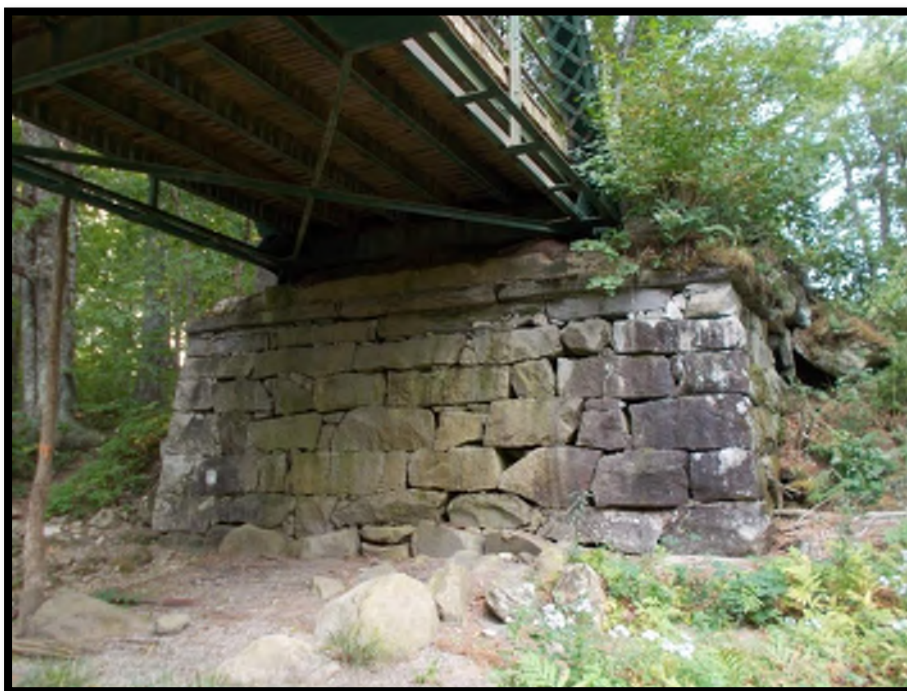
Photo 6: Face of West Abutment

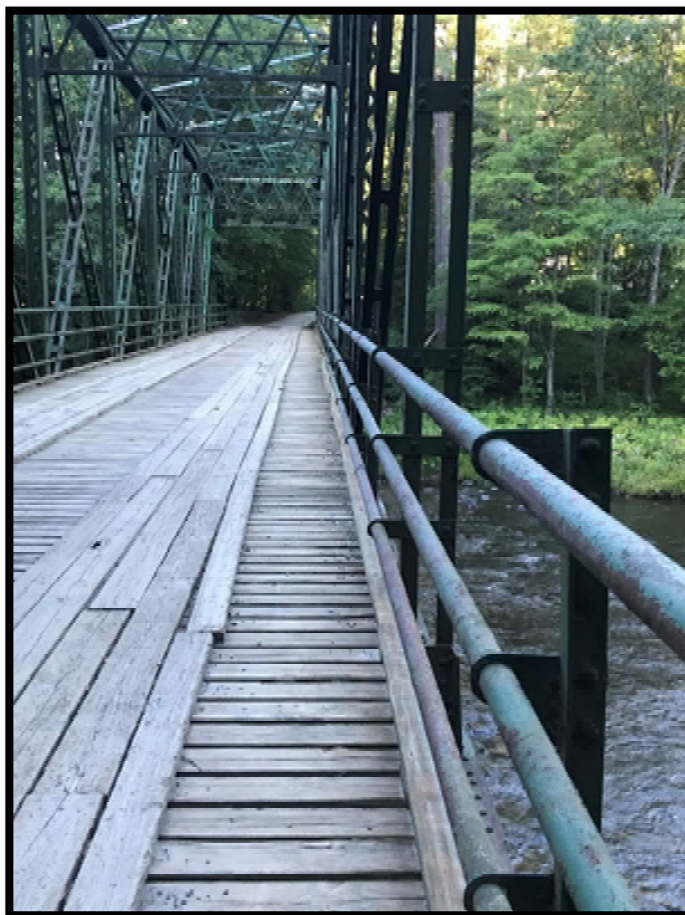
Photo 9: Looking West on Bridge 32

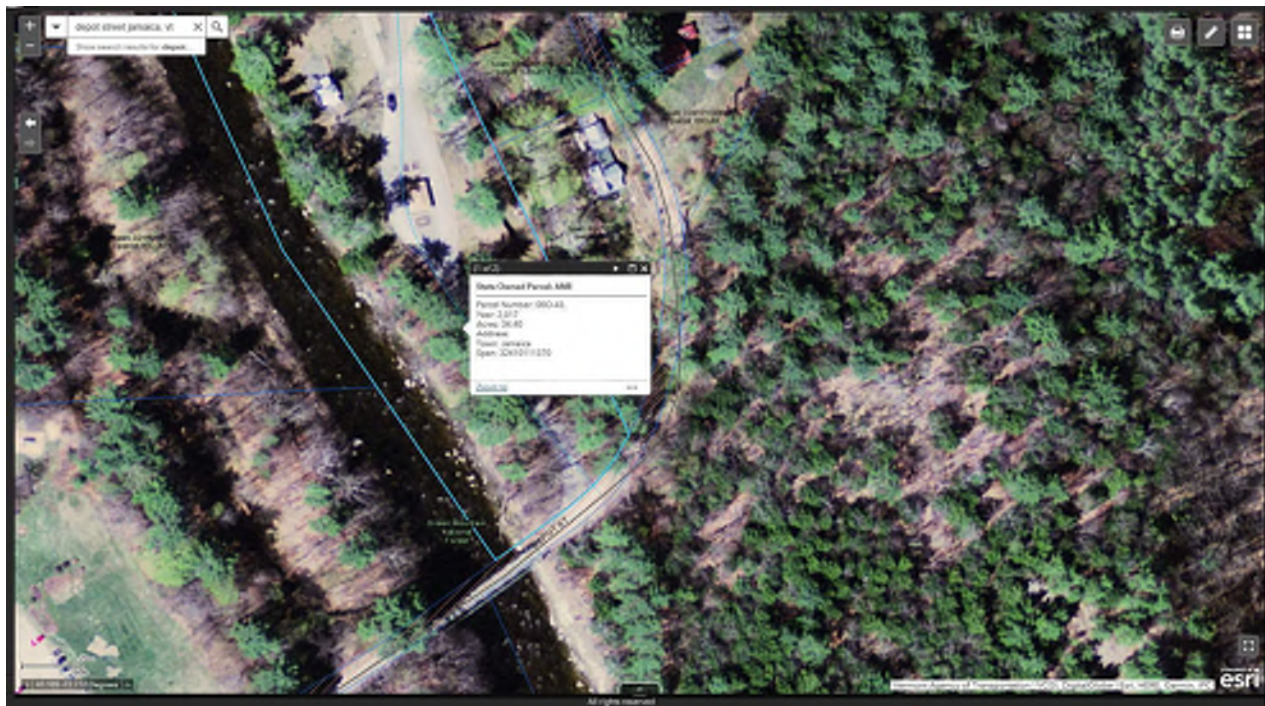
The Jamaica State Park and Green Mountain National Forest stand on both sides of Bridge No. 32 (*Figure 6*). If a future project at Bridge No. 32 requires temporary or permanent impacts to either of these publicly owned areas, Section 4(f) review will be required.

Figure 6. Section 4(f) properties near Bridge No. 32 at Jamaica State Park and Green Mountain National Forest.

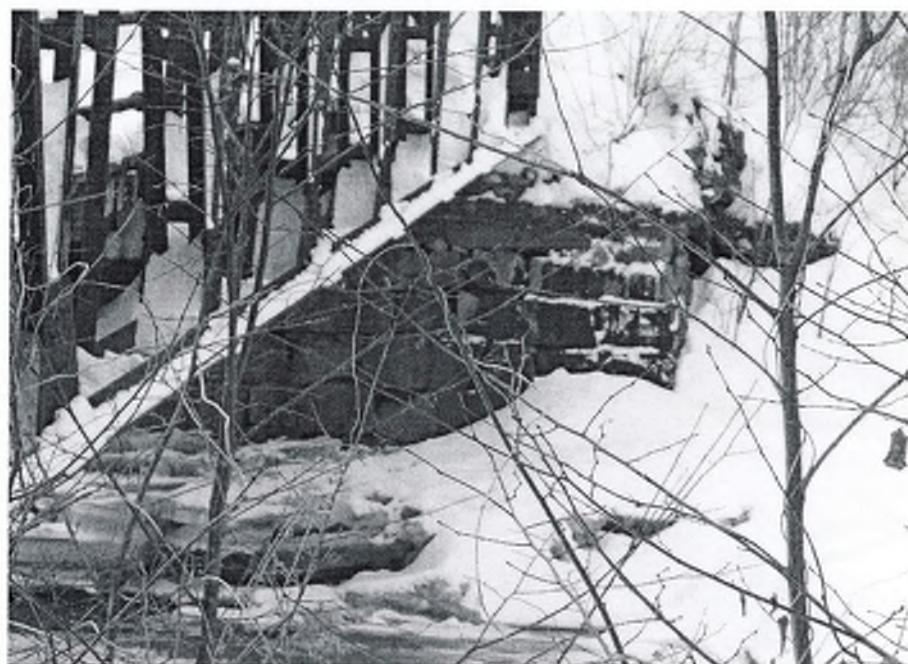
This is a more overall view

Also the abutment stones are loose

I have enclosed a PDF of the engineer's report dated 10/20/2017. This report does not seem to take into consideration the rust on both the top and bottom flanges of the two I-beams which are the stringers supporting the bridge span. As you can see in the photographs above, they seem to be extremely rusted, which, I would think, would weaken them severely. I believe the recommendation to paint the steel would only serve to hide the issues, and delay the repair or replacement. Also, sweeping sand off the bridge, as suggested by the engineer's report, would pollute the river and kill the fish. I have been assured by some people involved that, if the bridge fell in the river, its replacement would be assured. I think this is quite cynical.

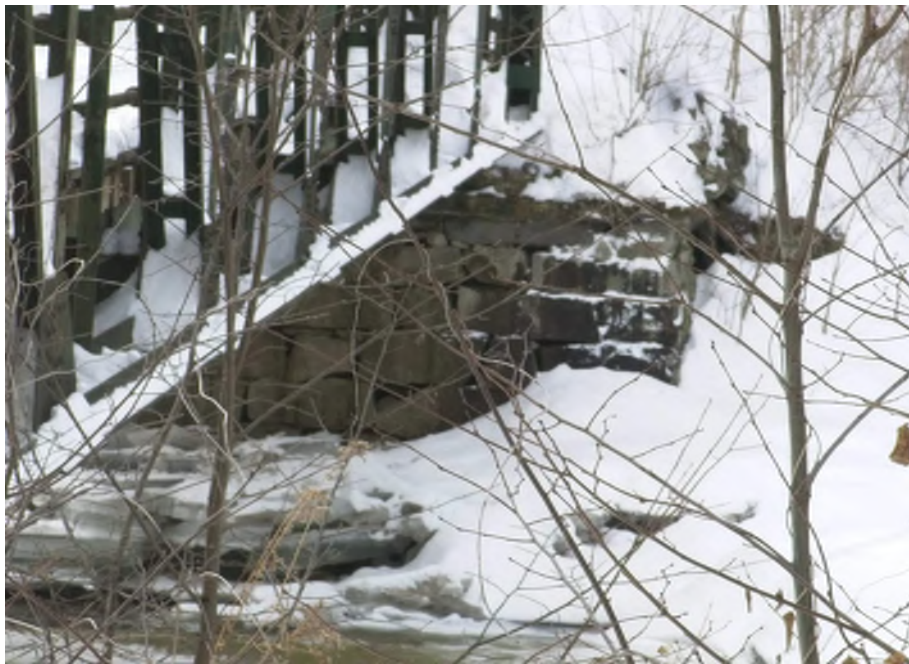
This is a more overall view

Also the abutments stones are loose
