STATE OF VERMONT  
AGENCY OF TRANSPORTATION

Scoping Report

FOR  
STATEWIDE NORTHWEST STP CULV(90):  
ESSEX VT15 BR #2

VT ROUTE 15, BRIDGE 2 OVER INDIAN BROOK

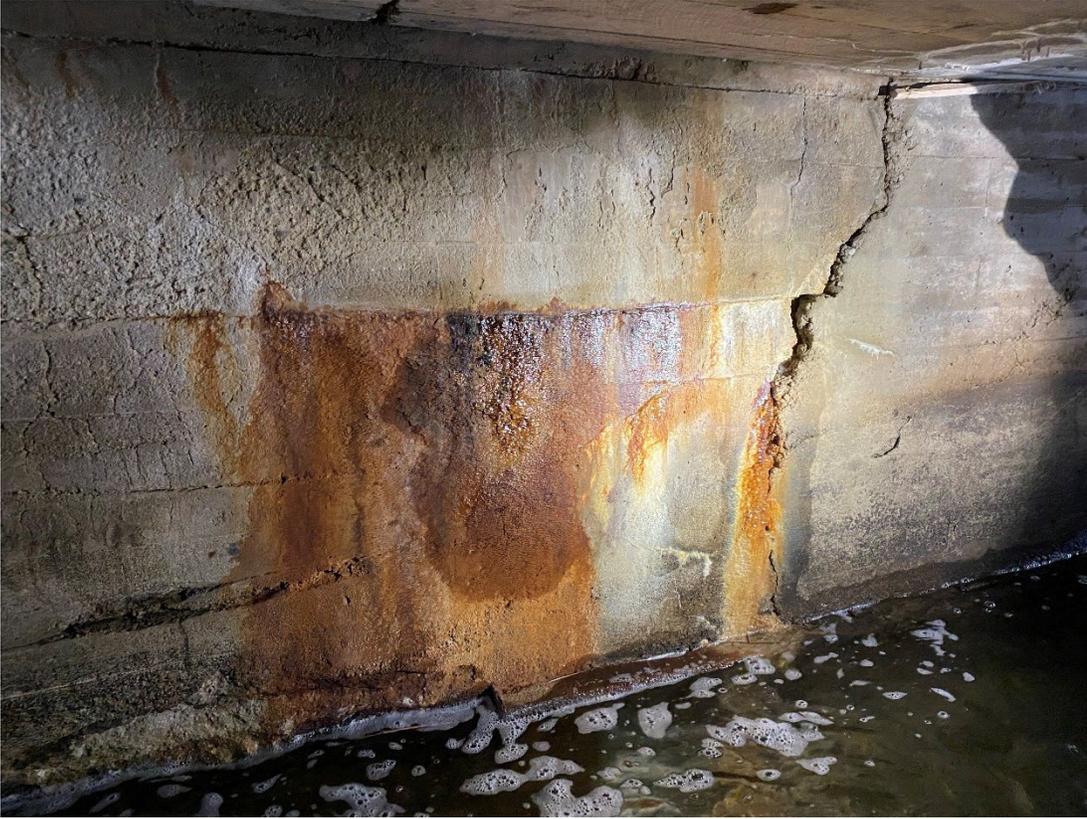
Eastern Box Wall - 1 (Inspection photo 2021)

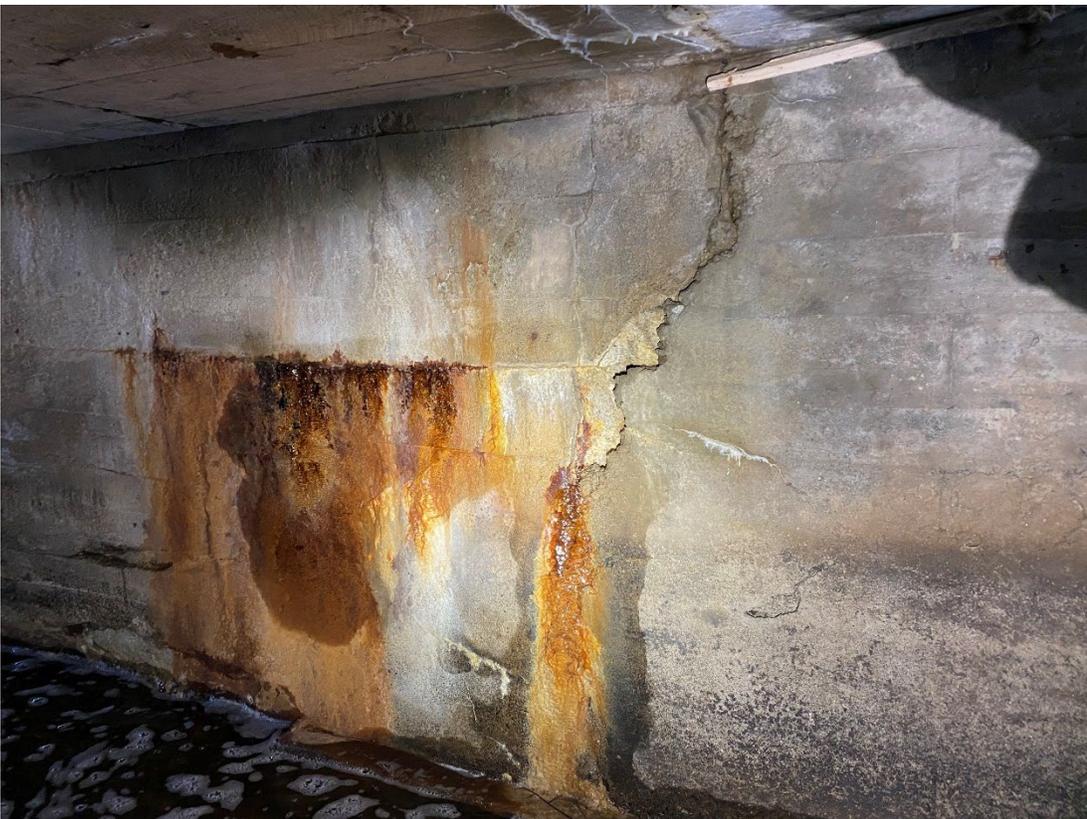
Eastern Box Wall - 2 (Inspection photo 2021)

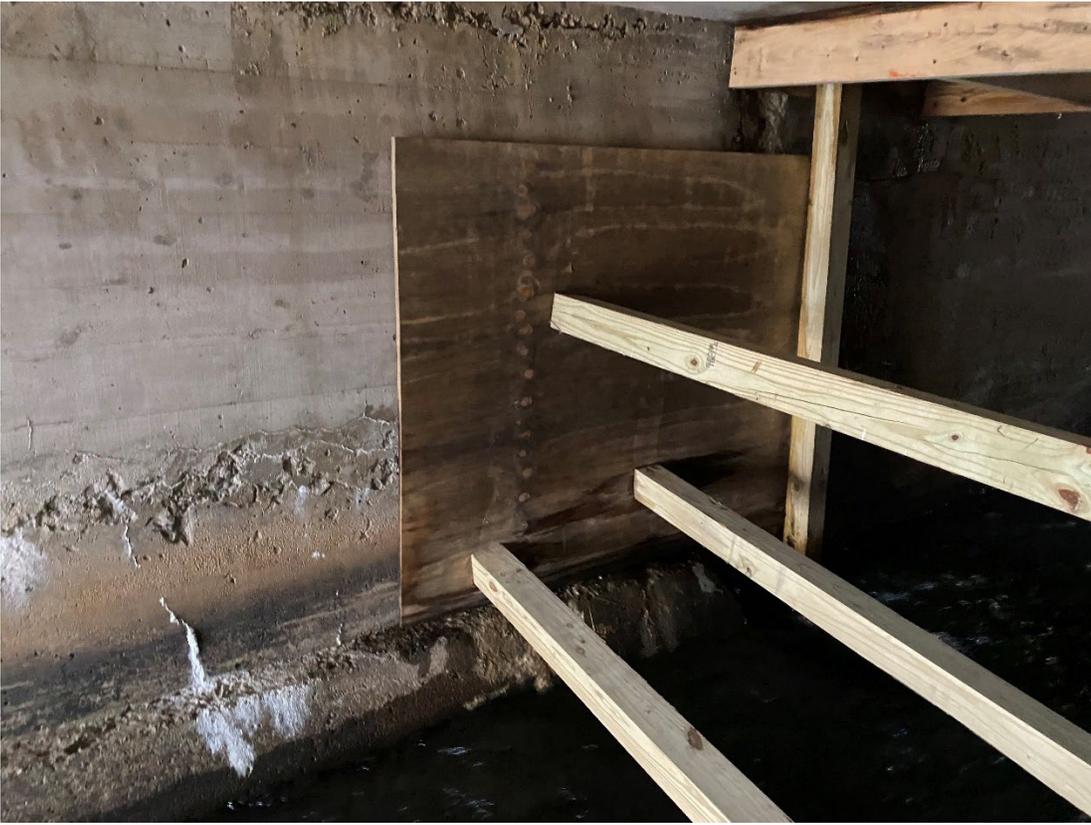
Eastern Box Wall Upstream (Inspection photo 2021)

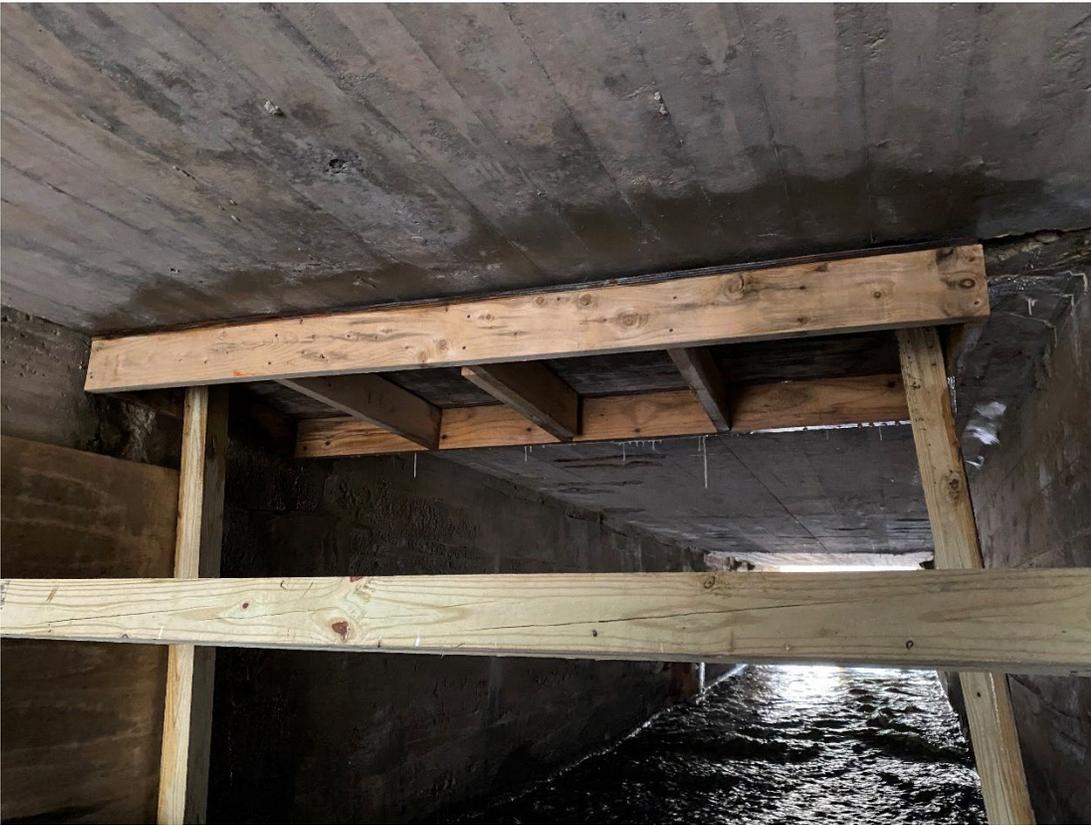
Timber Bunker (Inspection photo 2021)

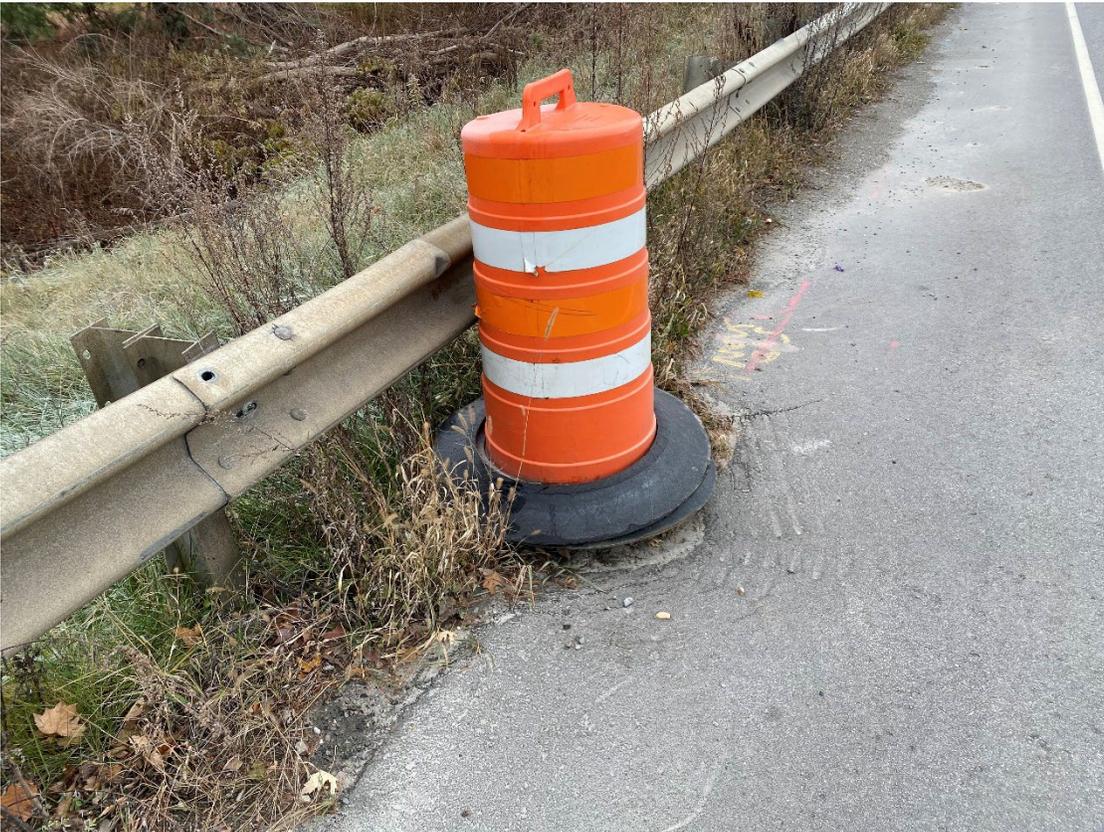
Depression along North Side with Barrel (Inspection photo 2021)

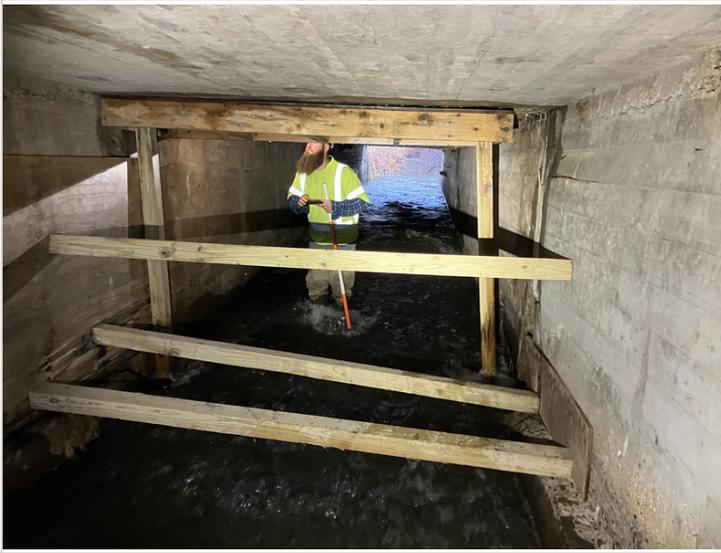
Timber Supports between Midspan and upstream End

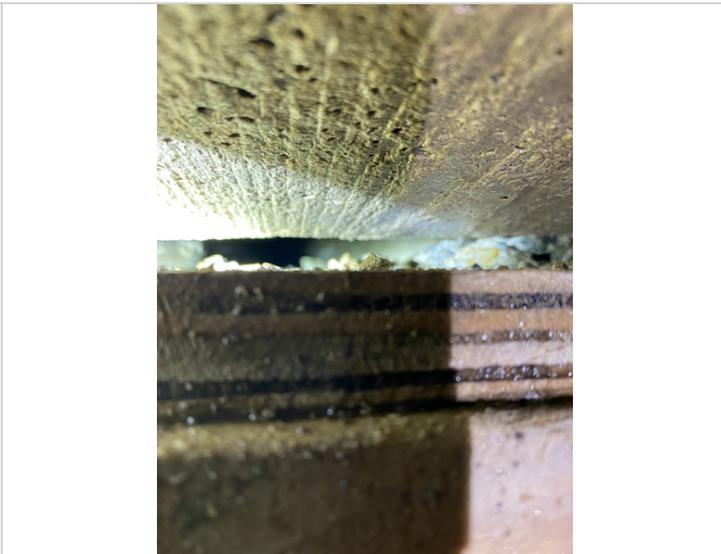
Full Depth Hole near Upstream End below  
Approach Rail

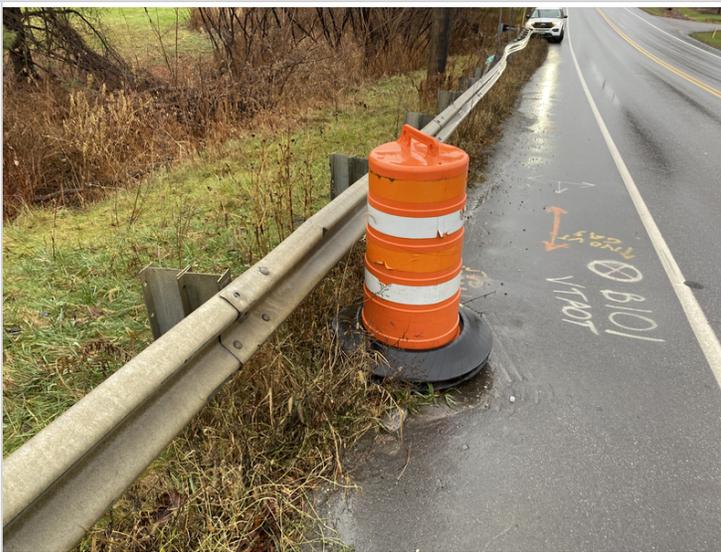
Traffic Barrel on Upstream Rail

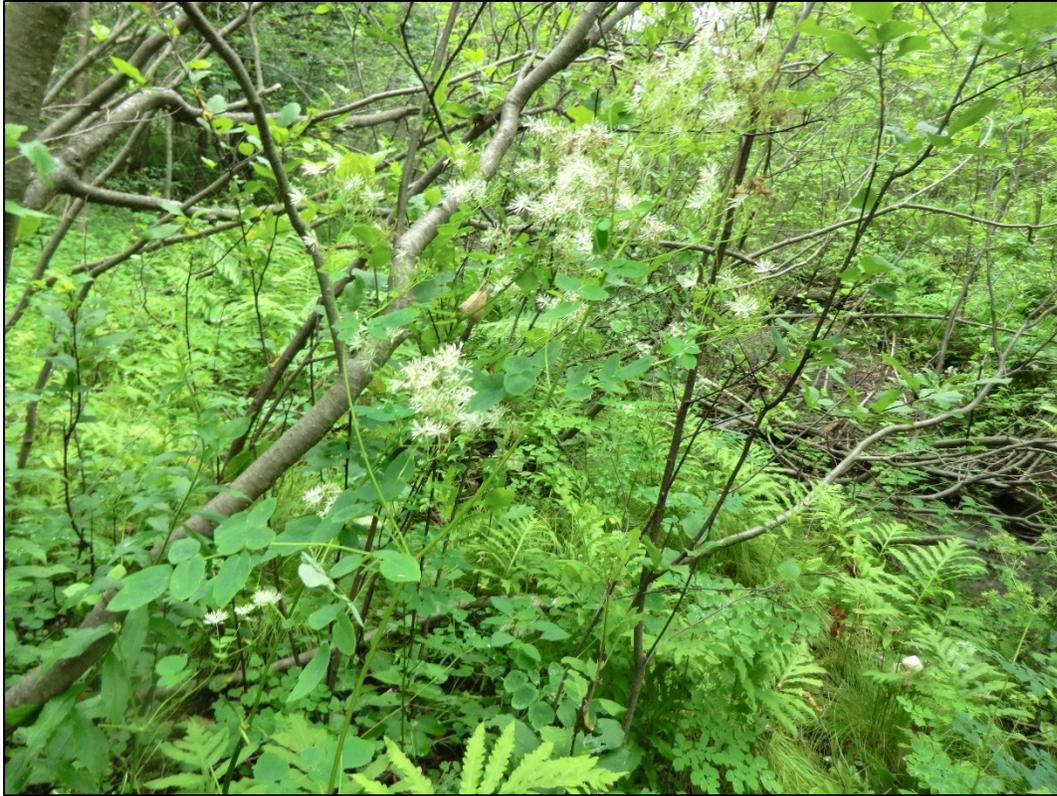
Wetland above the culvert is classified as Palustrine, dominantly Scrub-Shrub, broadleaved deciduous (PSS1C) and is seasonally flooded. This exhibited saturation and water-stained leaves as primary hydrology indicators and geomorphic position and FAC-neutral test as secondary indicators. Vegetation was dominated by American Elm, Box Elder, Speckled Alder, Sensitive Fern, and Tall Meadowrue (Figure 1).

**Figure 1.** VT Route 2A BR II Wetland above box culvert

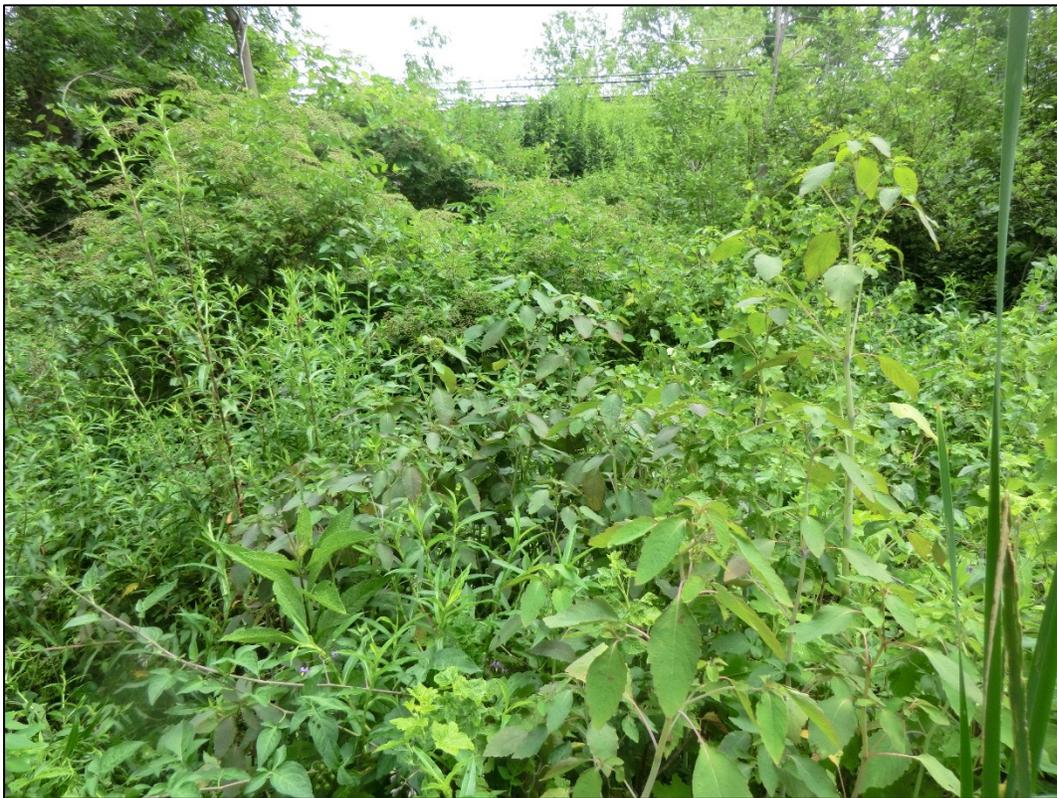
Wetland below the culvert is Palustrine, dominantly Scrub-Shrub, broadleaved deciduous, mixed with emergent, non-persistent and is seasonally flooded (PSS1/EM2C). Primary indicators of hydrology include: surface water, high water table, saturation, and water-stained leaves. Geomorphic position and FAC-neutral test are secondary hydrology indicators. The wetland below the culvert is dominated by herbaceous vegetation including: Sensitive Fern and Spotted Joe Pyeweed. Speckled Alder is present in the shrub layer (Figure 2).

**Figure 2.** VT Route 2A BR II Wetland below box culvert

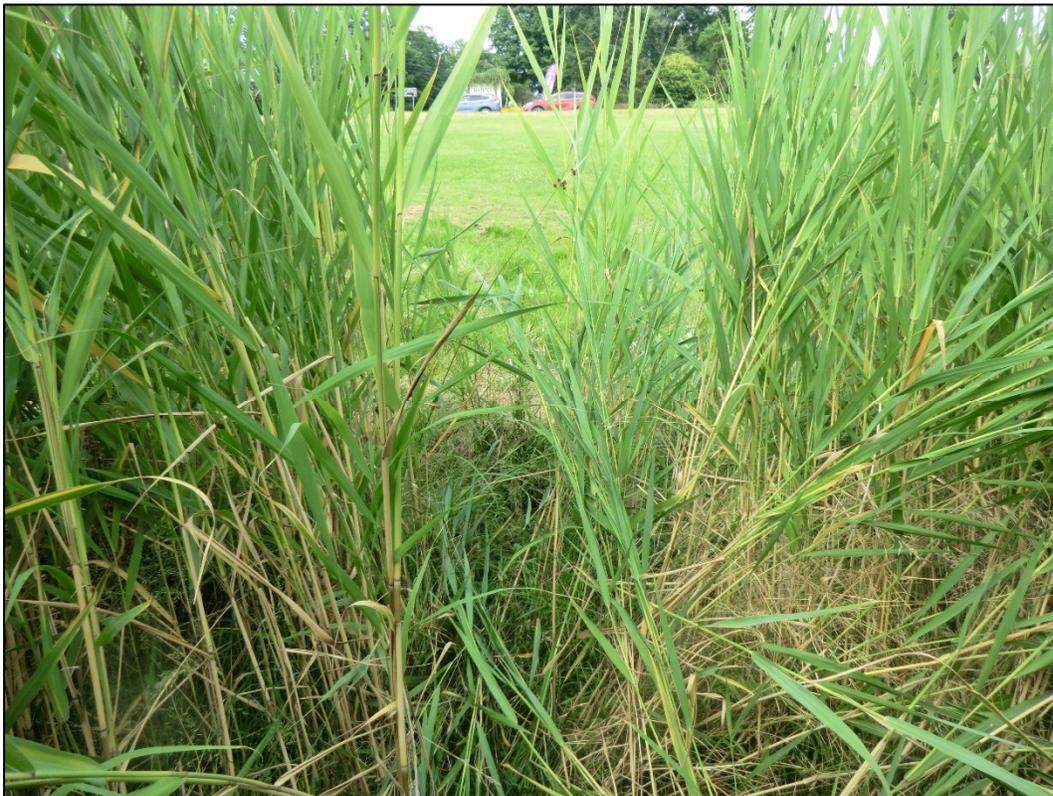
The area adjacent to Indian Brook below the culvert is dominated by Phragmites and wetland grasses, making the wetland a Palustrine, dominantly Emergent, persistent system that is seasonally flooded (PEMIC) as shown in Figure 3. Secondary wetland hydrology indicators include: drainage patterns, geomorphic position, and FAC-Neutral Test.

**Figure 3.** VT Route 2A BR 11 Wetland below box culvert

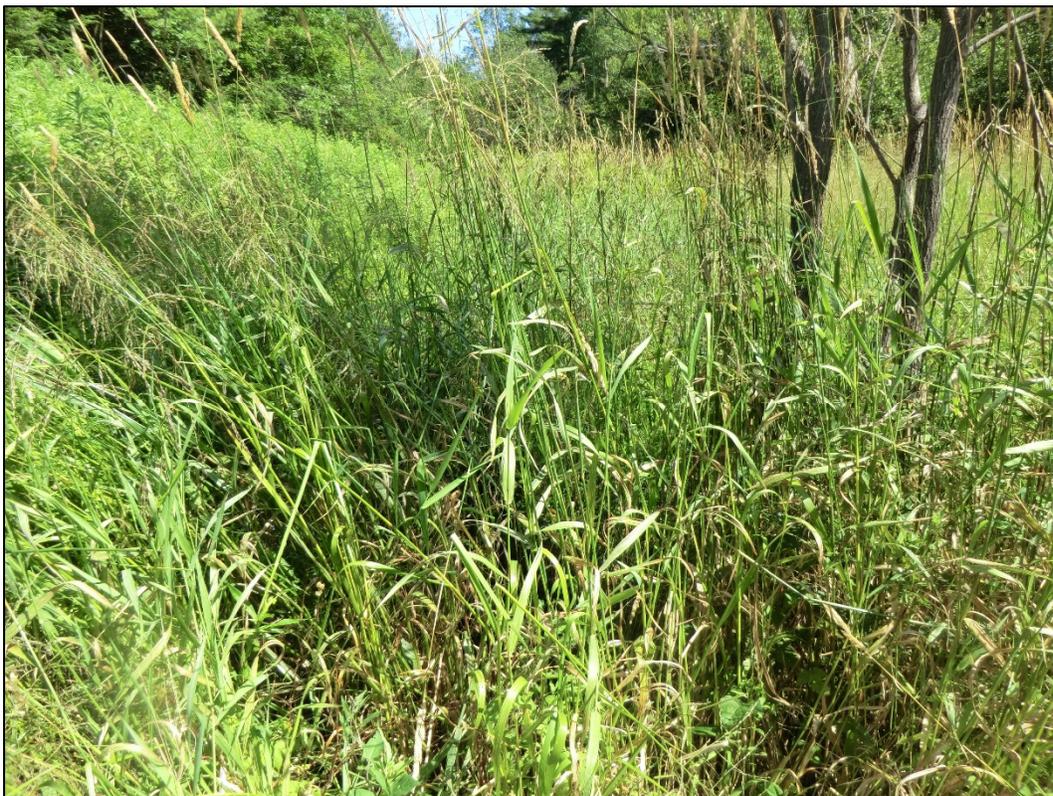
The wetland above the culvert inlet was dominated by Reed Canary Grass and an obligate wetland grass, *Glyceria striata* (Fowl Manna Grass) as shown in Figure 4. The wetland is Palustrine, dominantly Emergent, non-persistent wetland and is seasonally flooded (PEM2C). A small amount of *Salix bebbiana* (Bebb's Willow) was present in the upper layer of vegetation. Although the wetland area in the study area was less than 0.04 acres (page 3 of Appendix D), the wetland continues out of the study area to the north and appears to connect into a Class II wetland on the VSWI Class layer.

**Figure 4.** VT Route 289 BR 17 A wetland above culvert.

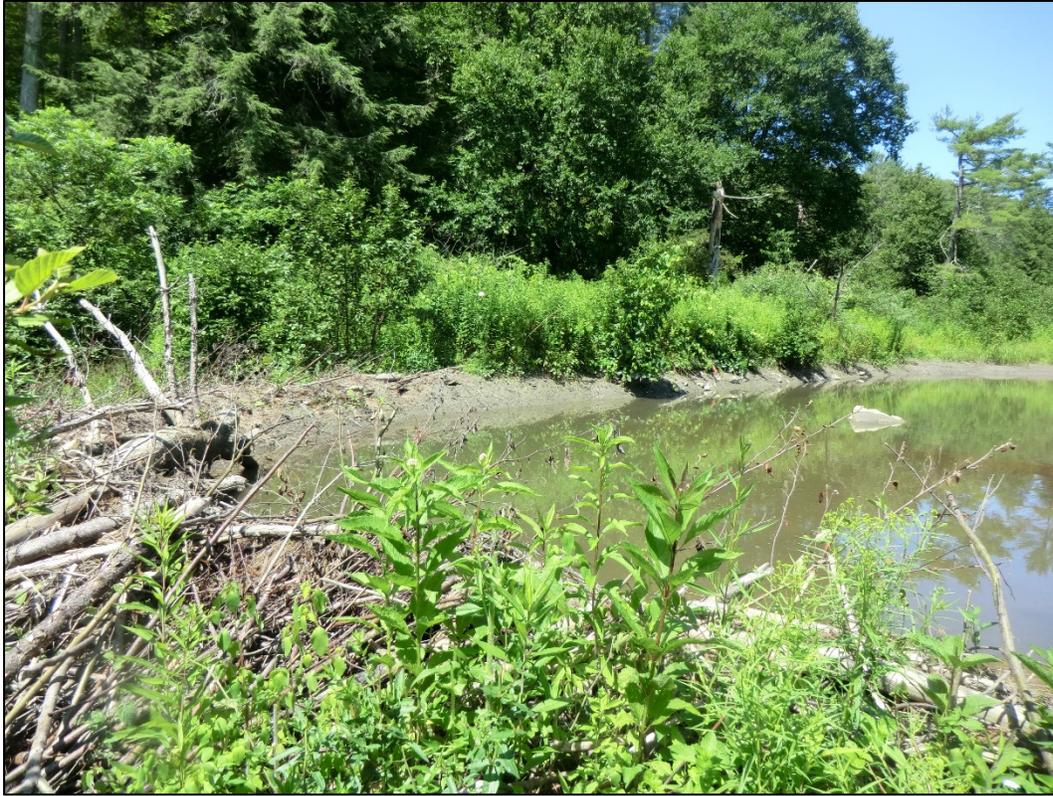
**Figure 5.** VT 289 BR 17A Beaver Influenced Wetland

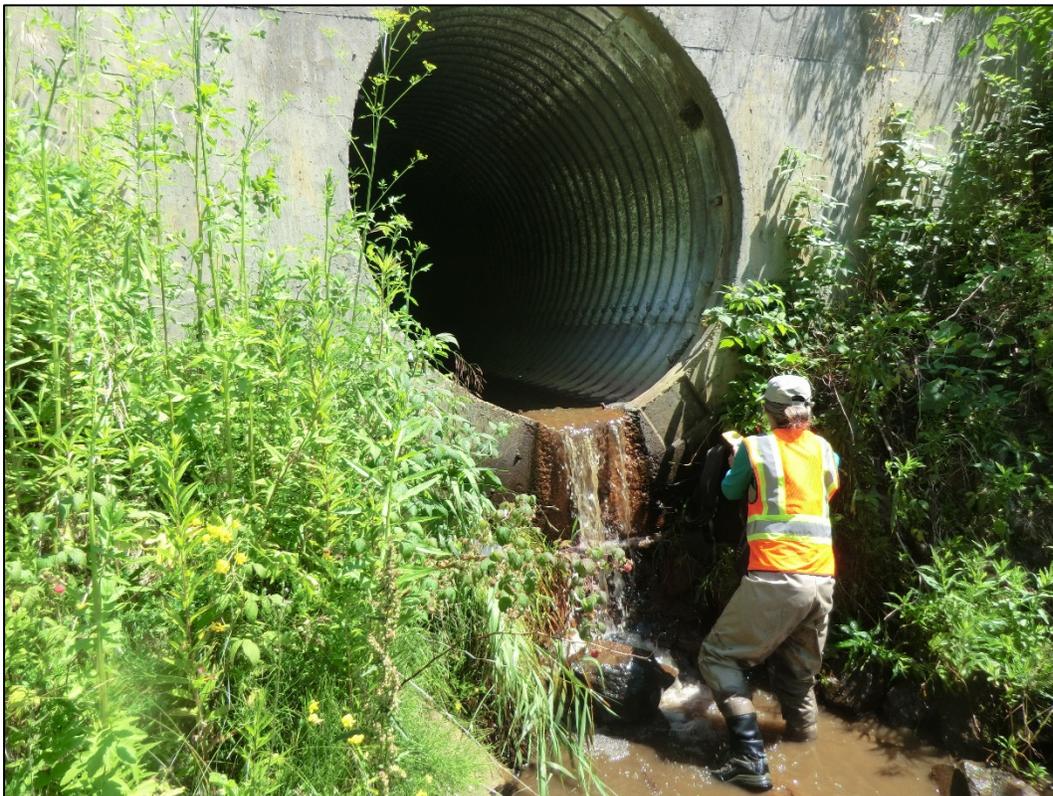
The Route 289 BR 17A culvert is greater than 500 feet in length and is a 7.1 ft high 6.6 ft high CMP. The outlet of the culvert is free fall (Figure 6) with a scour pool below the structure. At the time of the wetland delineation on July 15, 2022 there was very little water flowing through the structure; however, given the abnormally dry conditions at the time of the survey, it is likely the stream is perennial. Based on StreamStats, the drainage area at the culvert outlet of the unnamed Tributary to Alder Brook is 0.28 square miles.

Given the short distance from the outlet structure to Alder Brook (Figure 7) and the outlet drop of greater than a couple of feet, it would not be possible to retrofit the culvert for AOP. In addition, baffles would likely be needed throughout the 500-foot structure to address the velocity barrier.

**Figure 6.** VT Route 289 BR 17 A Culvert Outlet

Lee Simard, Fisheries Biologist, visited the Route 289 BR 17A site in late August 2022, and has made the recommendation that AOP will only be required if the structure were replaced.

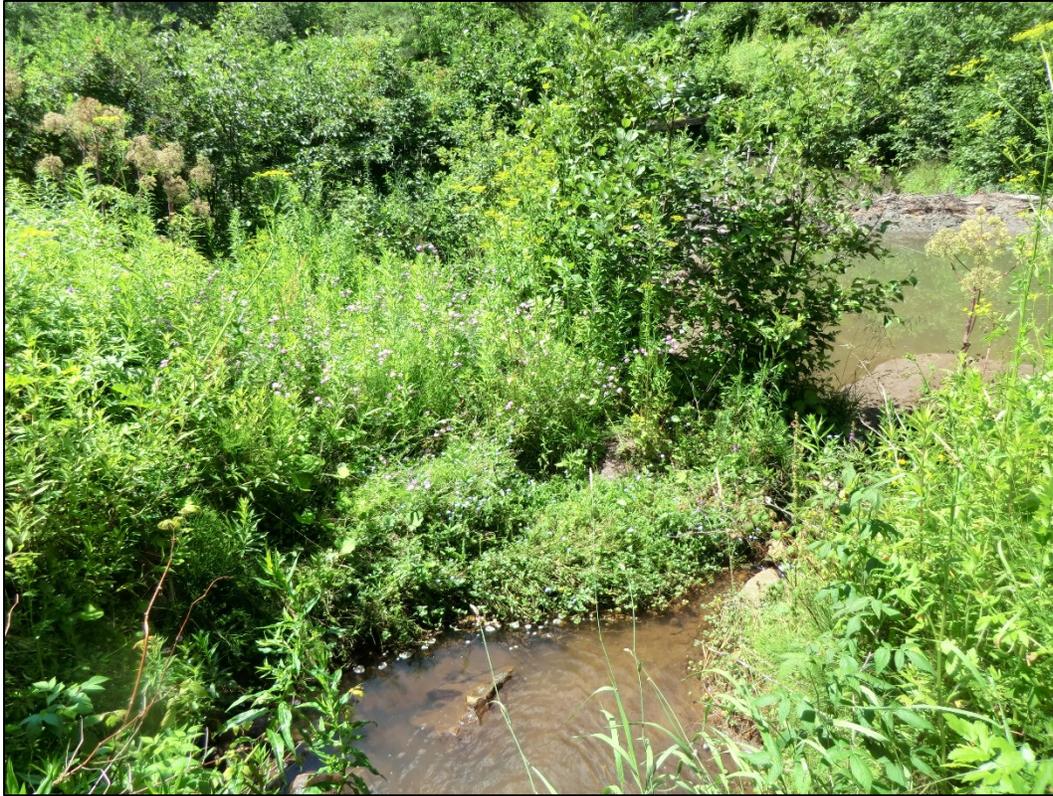
**Figure 7.** Unnamed Tributary to Alder Brook downstream of VT 289 Culvert
