STATE OF VERMONT  
AGENCY OF TRANSPORTATION

Scoping Report

FOR  
STATEWIDE NORTHWEST STP CULV(90):  
JERICHO VT15 BR #6A

VT ROUTE 15, BRIDGE 6A OVER UNNAMED BROOK

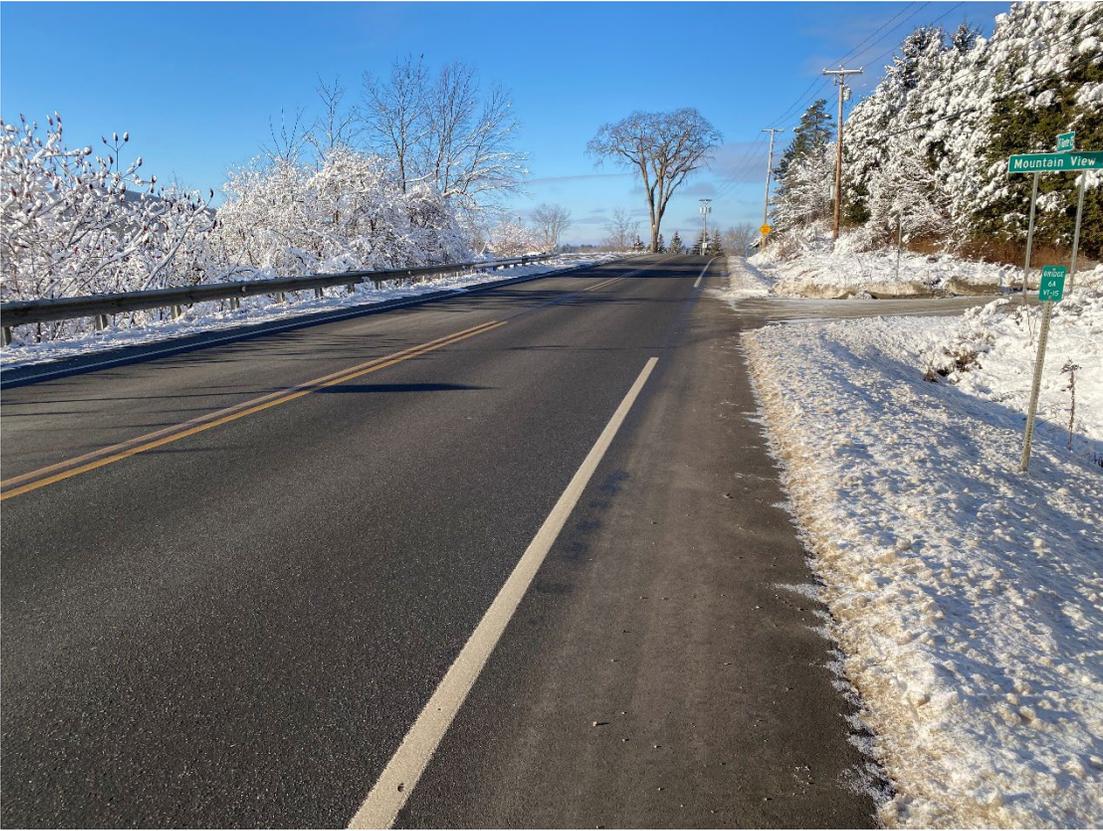
Eastern Approach (Inspection photo 2021)

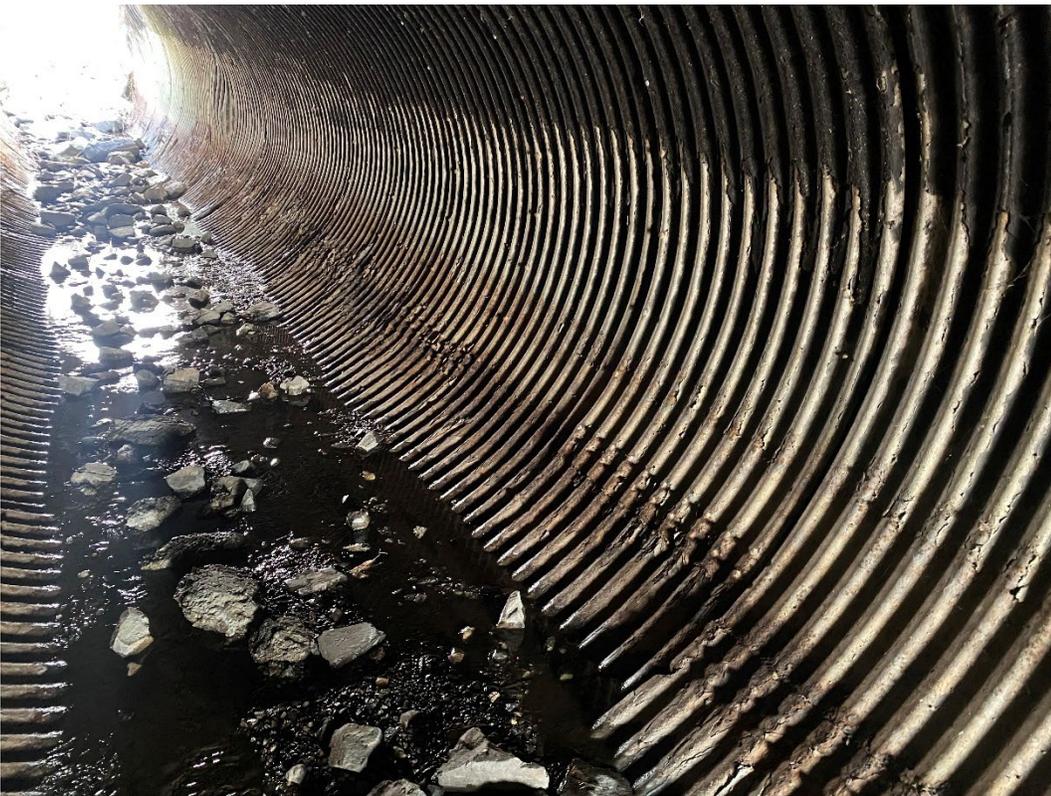
Eastern Wall (Inspection photo 2021)

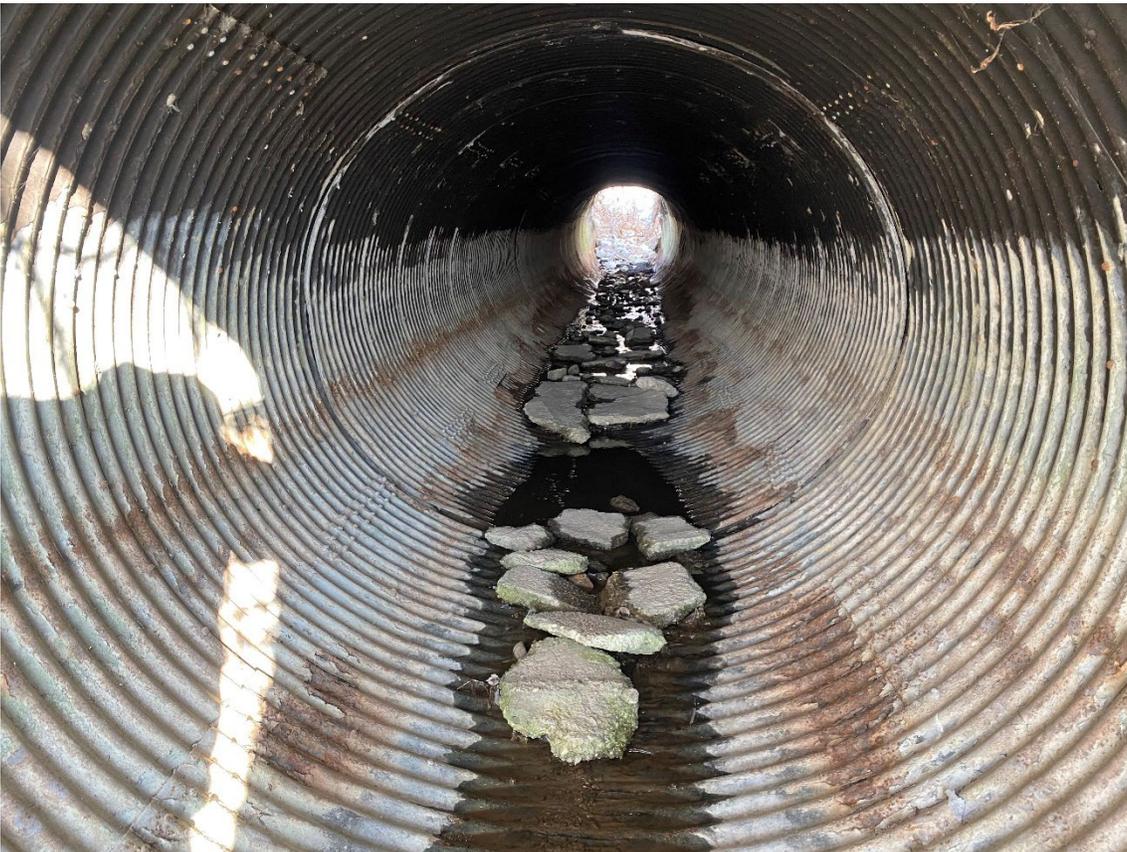
Culvert looking Upstream (Inspection photo 2021)

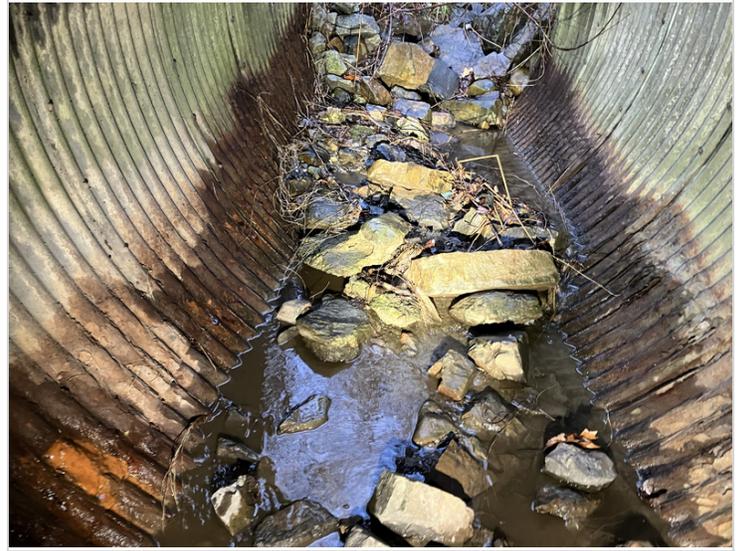
Rock buildup near Upstream End of Culvert

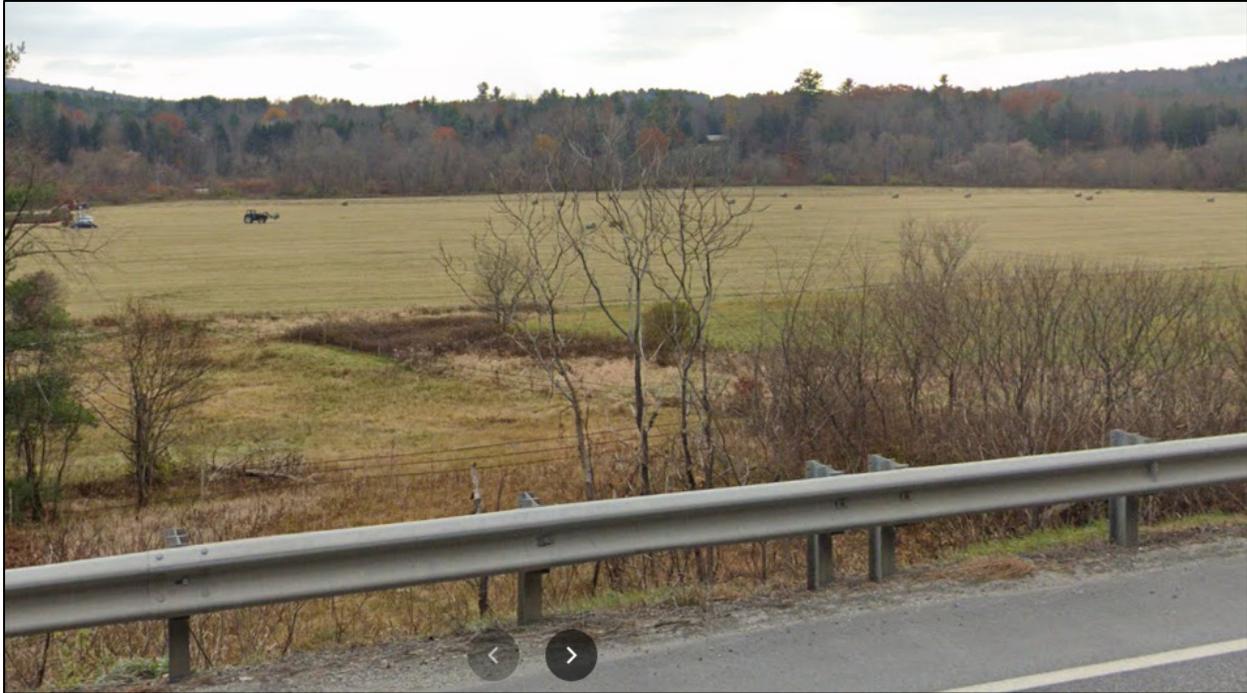
The resource evaluation of the Route 15 BR 6A site occurred outside of the growing season. Therefore, a wetland delineation could not be performed. Based on remote sensing, possible wetland habitat within the study area was identified. Google Streetview, Bing Streetview, imagery, hillshade, and LiDAR contours were used in combination to identify “possible wetlands”. Google Streetview was particularly useful for seeing the vegetated drainage, where the farmer had fenced off. Based on imagery and Streetview, it seems likely the wetland extends outside of this fenced area and is greater than 0.5 acres. A wetland greater than 0.5 acres is assigned a Class 2 wetland designation in Vermont. A map showing the possible extent of the wetland within the Route 15 BR 6A study area boundary is provided in a page 4 of Appendix D. The size of the possible wetland within the study area is approximately 0.05 acres. An open wetland boundary is included to indicate the wetland likely continues to the south.

**Figure 7.** Google Streetview showing a possible wetland downstream of the Route 15 6A culvert
