**STATE OF VERMONT
AGENCY OF TRANSPORTATION**

**Scoping Report
FOR
NORTON BF 0321(21)**

VT ROUTE 114, BRIDGE 41 OVER NUMBER FIVE BROOK

December 21, 2023

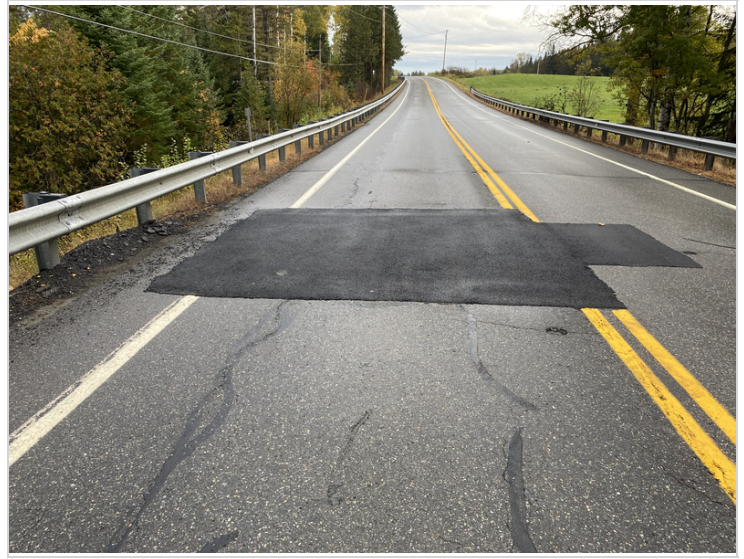
- c. Large perforations have formed along lower portions of the southern side of the culvert wall causing the pipe to deform/crush with piping occurring. The piping has caused settlement in the roadway with asphalt patching present over the structure mainly in the southern travel lane.

Asphalt Patch Over Downstream End

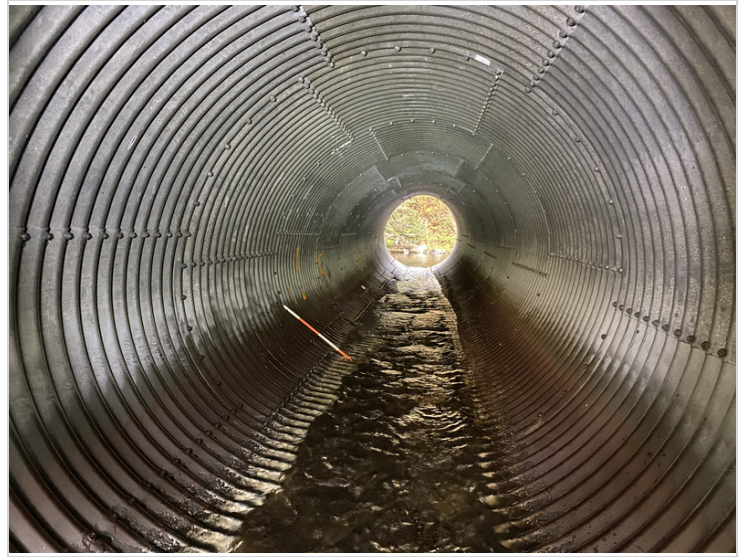
10/07/2022 Structure corrosion along the southern wall has progressed enough to allow for pipe deformation / crushing and is now in poor condition with a 12-month inspection cycle. Panels #3 through #6 along the southern side of pipe have large perforations causing the pipe to deform / crush with piping occurring. Large perforations allow sediment / backfill loss causing scattered piping (voids) to be present behind panels #3 through #7. Downstream half of panel #4 has less severe voiding along with small sections of panel #7. Voids start ~26'-0" from the upstream end along the southern side of pipe (Panel #7). Largest / heaviest piping / voids are present between panels #4 halfway up to the end of panel #6. Downstream end has a large scour pool on the downstream side with some slight erosion along the embankments with upper portions being undercut and having scattered boulders and good brush growth. (SMP)

Barrel from Upstream End with Southern Wall Deformation

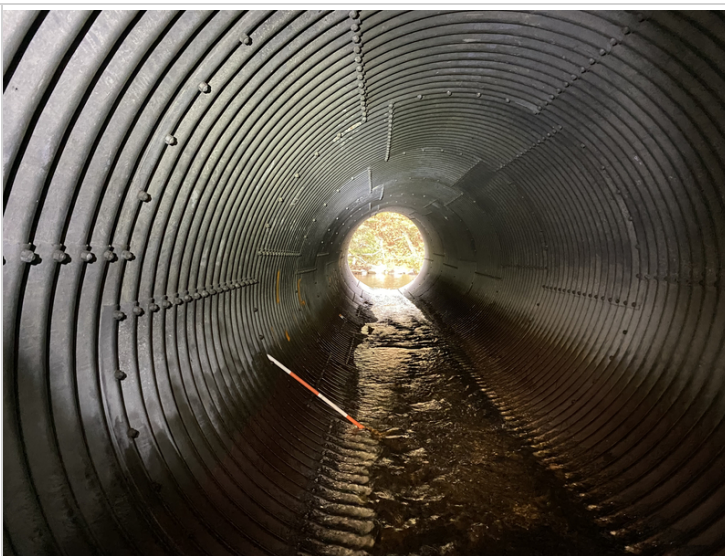
Barrel from Upstream End with Southern Wall Deformation

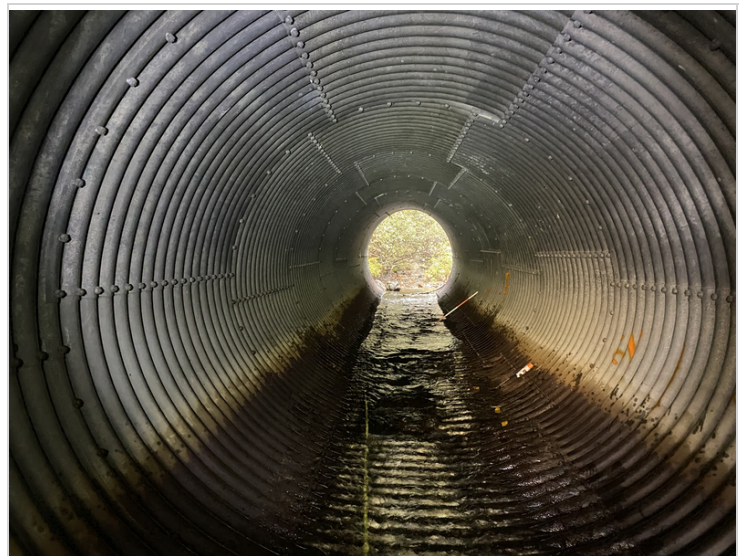
Barrel from Downstream End with Southern Wall Deformation

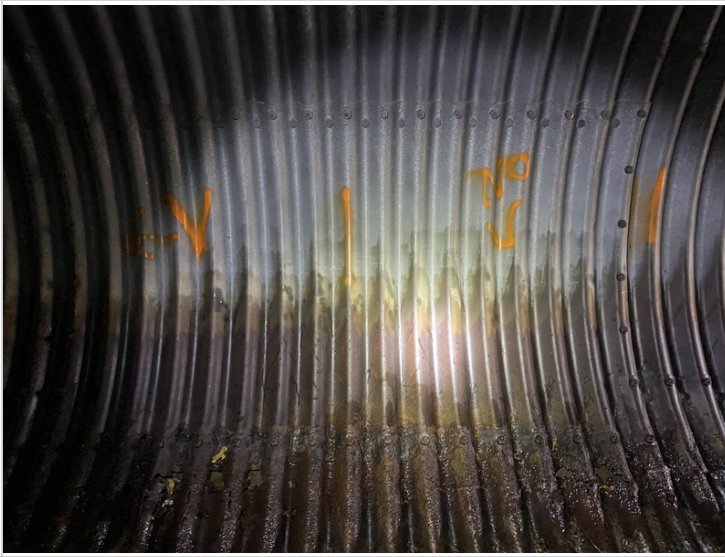
No Voids Present in Downstream Section of Panel #4 from Downstream End

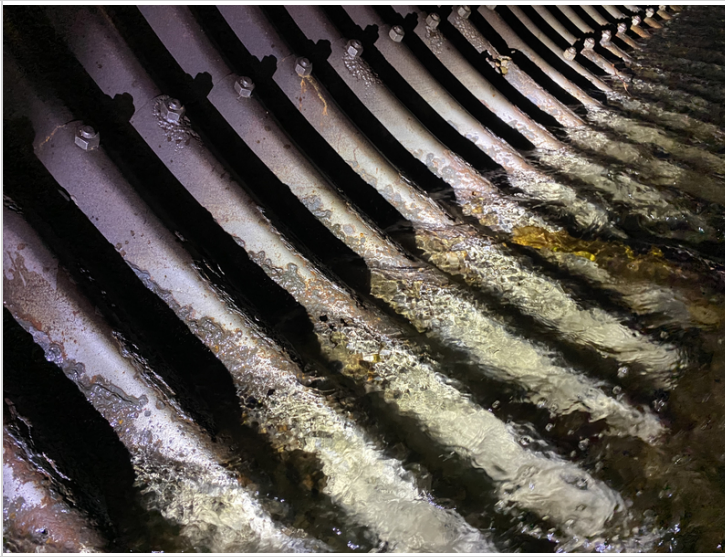
Southern Wall Perforations at Panel #7 from
Downstream End

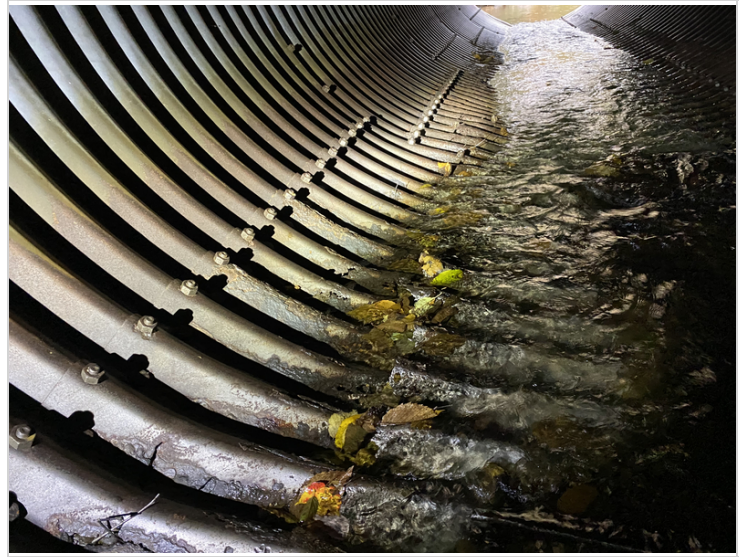
Perforations on Panel #5 from Downstream End
on Southern End

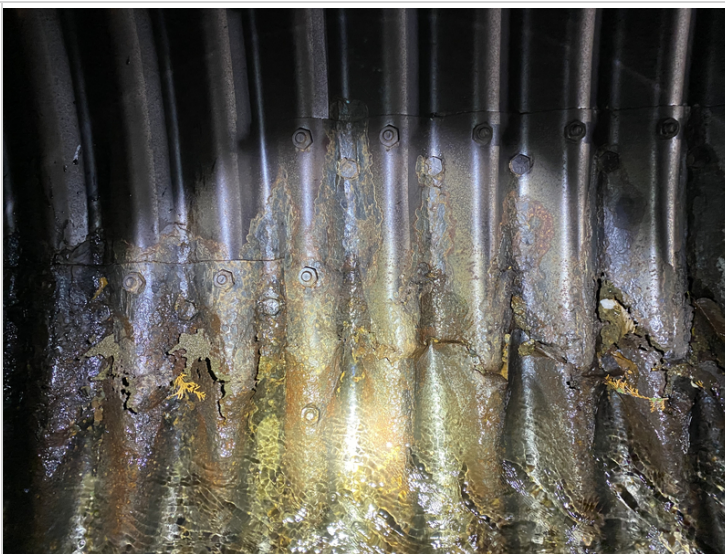
Perforations / Crushing on Southern Side of Panel #4 from the Downstream End

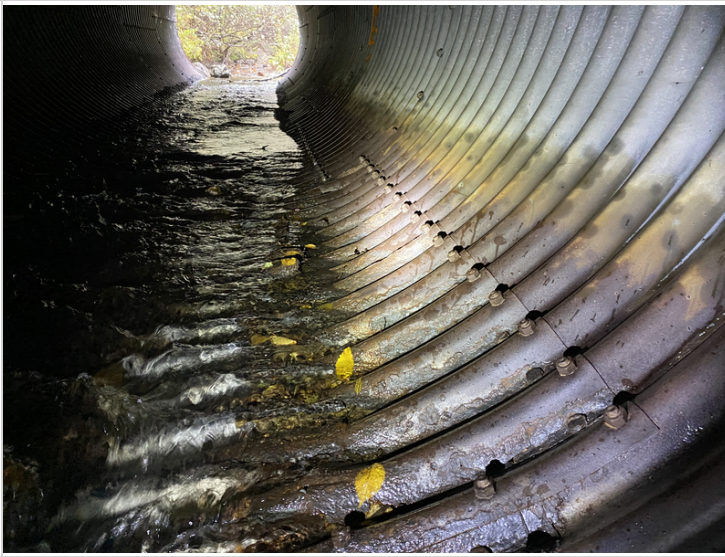
Panel #4 from Downstream End with Significant Bending on Downstream Portion and Large Perforations
