STATE OF VERMONT AGENCY OF TRANSPORTATION

Scoping Report

FOR FERRISBURGH BF 019-4(35)

US ROUTE 7, BRIDGE 139 OVER LEWIS CREEK

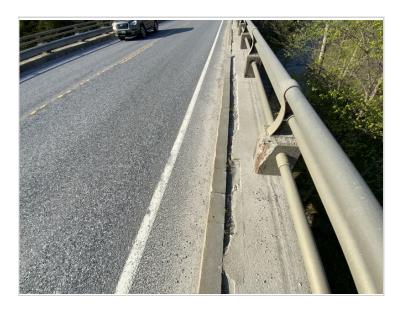
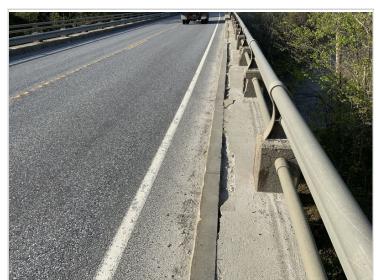
Downstream curb Downstream curb

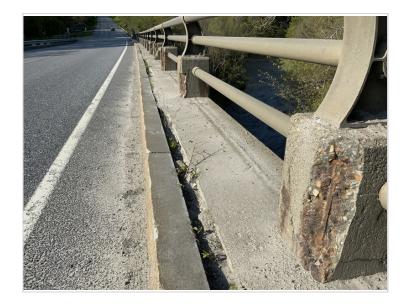
Guardrail pedestals

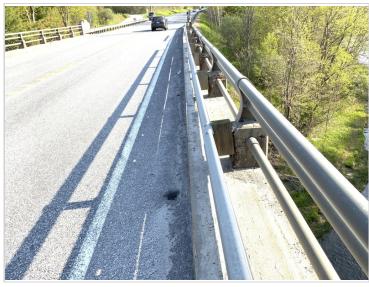
Guardrail pedestals

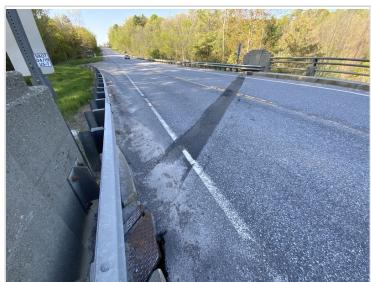
Abutment 1 joint

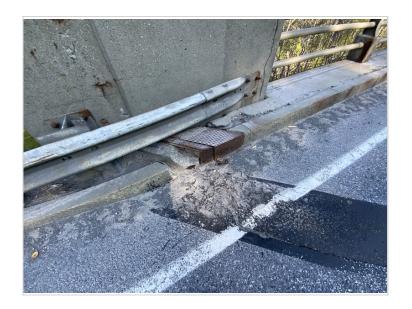
Abutment 1 downstream curb/joint end

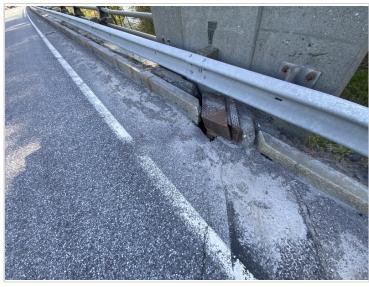
Abutment 1 upstream curb/joint end

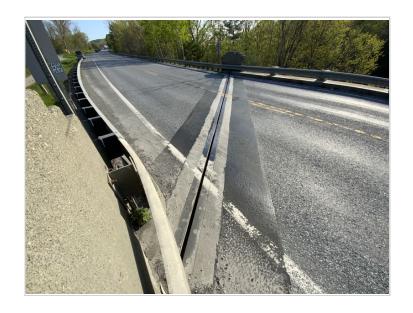
Abutment 2 joint

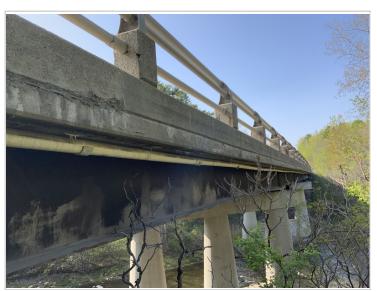
Downstream fascia

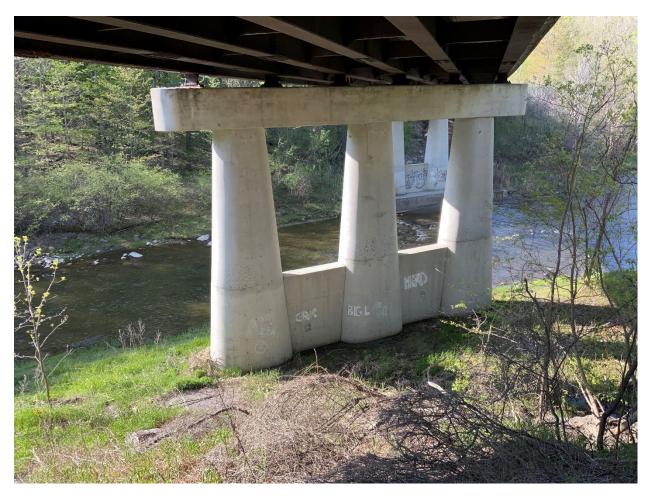
Appendix A 4: View of Pier 1.

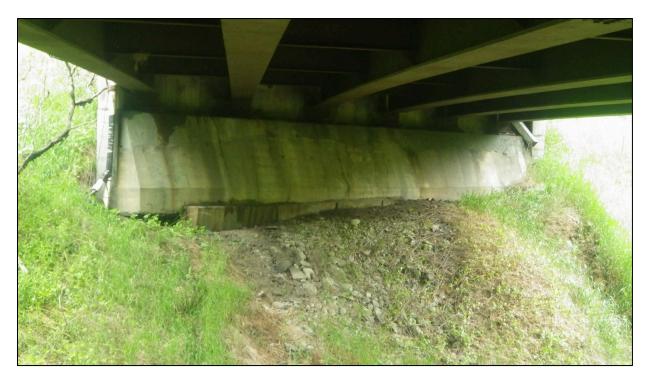
Appendix A 5: View of Abutment 2.

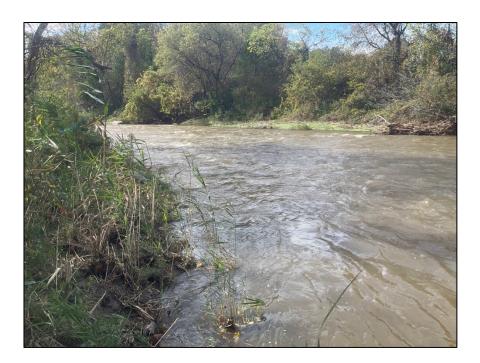
NO. 5 / 10.08.2023

Representative photo of the Lewis Creek, delineated by VHB as 2023-TOB-LC. Photo also shows the non-native invasive species common reed growing adjacent to Lewis Creek

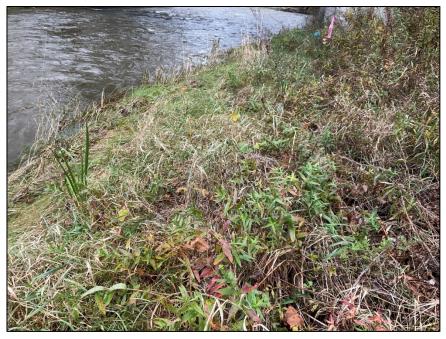
NO. 8 / 10.08.2023

Representative photo of the nonnative invasive species purple loosestrife growing as a clump near Lewis Creek
