STATE OF VERMONT AGENCY OF TRANSPORTATION

Scoping Report

Morristown BF 0239(4)

Town Highway 2 - FAS Route 0239, Bridge 8 over The Lamoille River

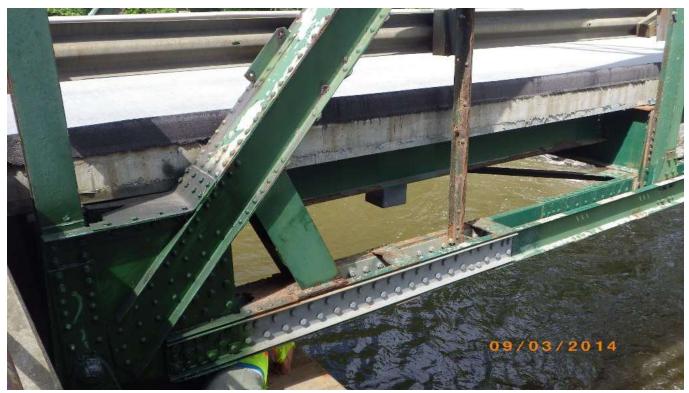
2014 sample

Stringer Rust

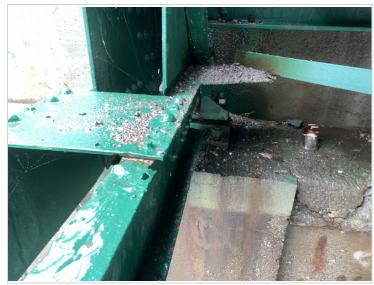
Bottom chord abutment 1 truss 2

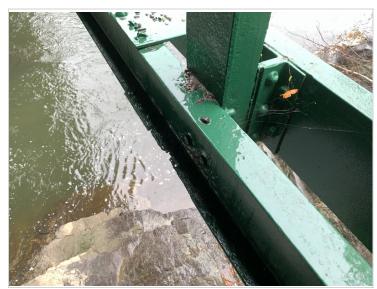
Bottom chord near rail post 1 truss 2

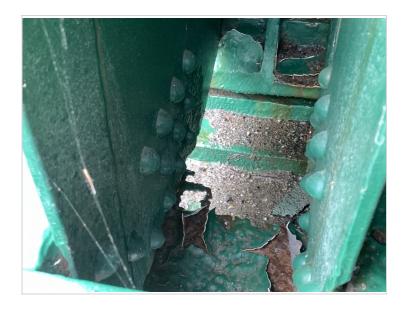
Heavy pitting in gusset plate 1 in truss 2 and perforations and section loss in stiffener plate

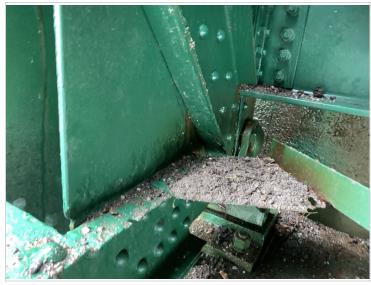
Diagonal 1 at interior gusset plate 1 of truss 2

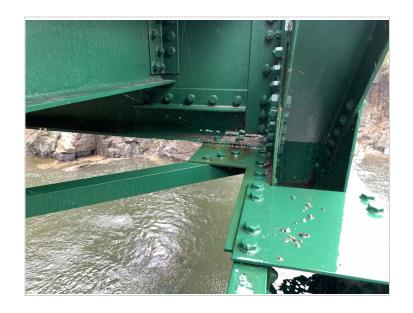
Floor beam 4 truss 1

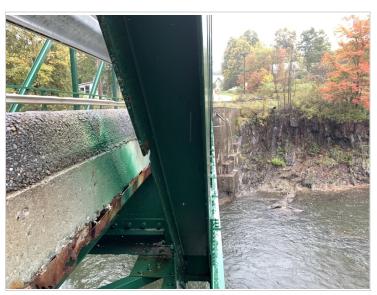
Diagonal 5 truss 1

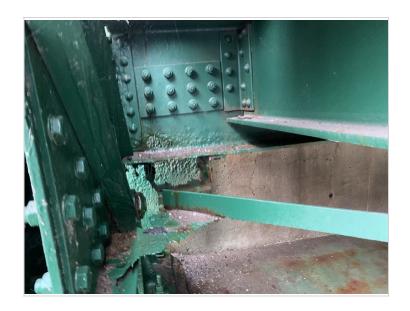
Floor beam 6 truss 1 side

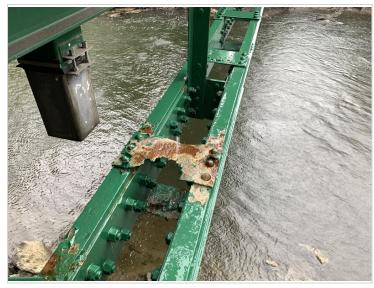
Bottom chord added steel plates and section loss truss 1 near abutment 2

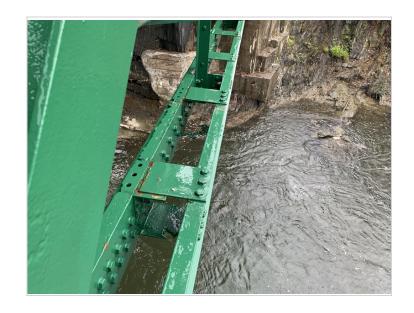
Bottom chord added steel plates and section loss truss 1 near abutment 2

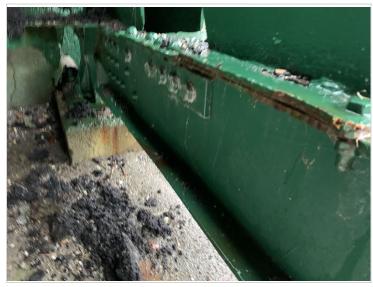
Interior bottom chord near abutment 2

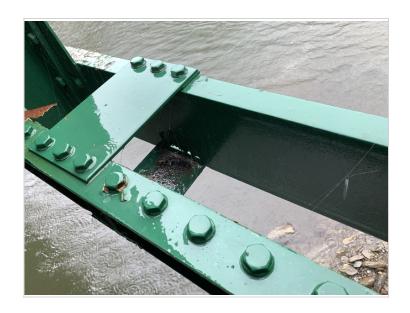
Perforations bottom chord between floor beam 4 and 5

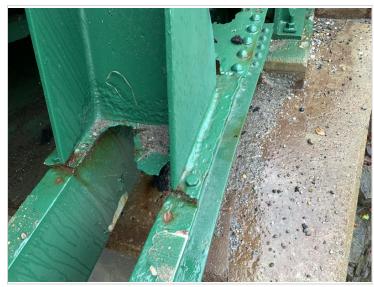
Section loss in exterior bottom chord at abutment 2

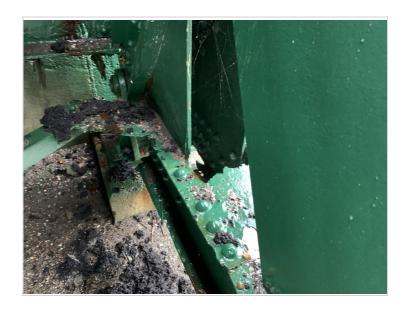
Section loss in interior bottom chord at abutment 2

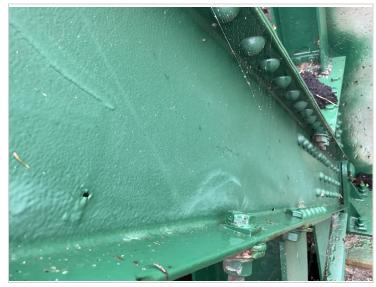
Diagonal 6 in truss 2 perforations

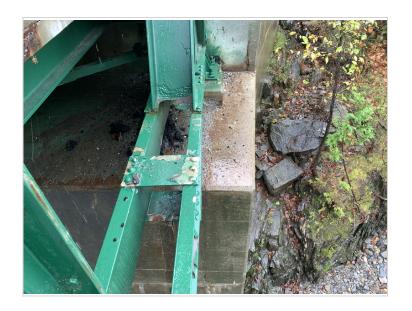
Distortion in bottom chord near abutment 2 truss 2

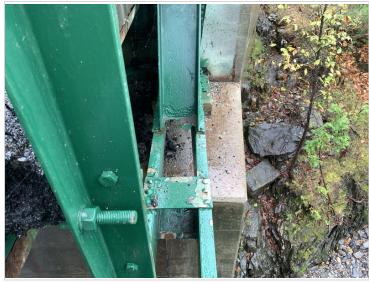
Distortion in bottom chord near abutment 2 truss 2

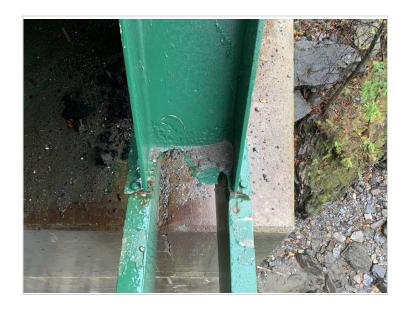
Distortion in bottom chord near abutment 2 truss 2

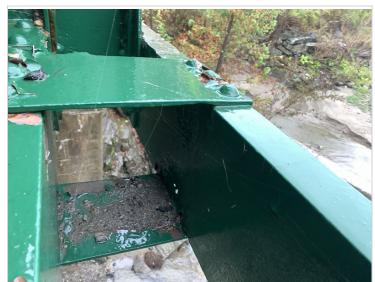
Perforation in exterior bottom chord near floor beam 5

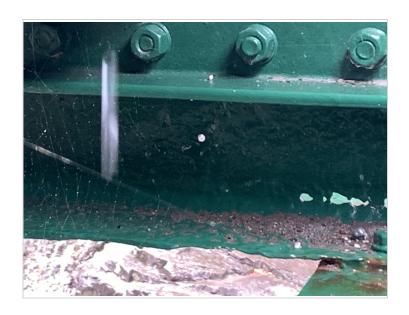
Holes in floor beam 4 truss 2

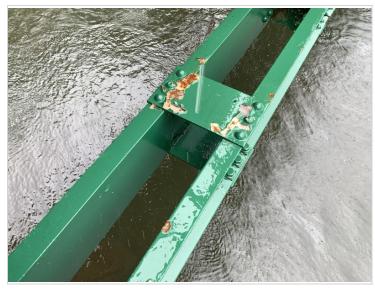
Hole in interior bottom chord of truss 2 between floor beam 4 and 5

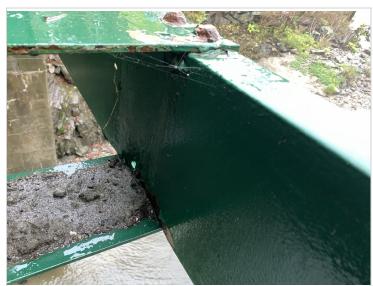
Hole in exterior bottom chord near floor beam 5

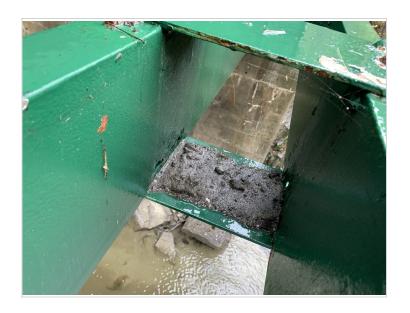
Hole in interior bottom chord near floor beam 5

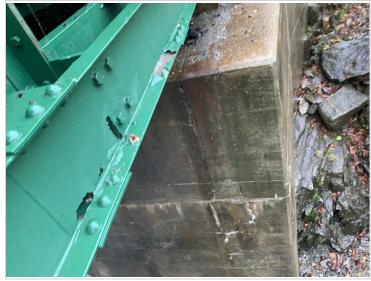
Holes in exterior bottom chord near rail post 6 truss 2

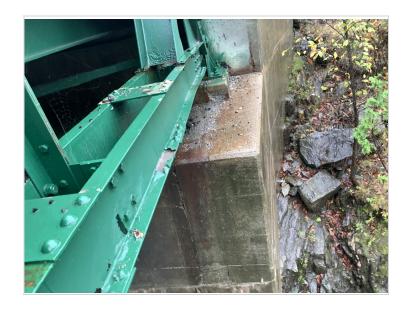
Distortion in bottom chord near abutment 2 truss 2

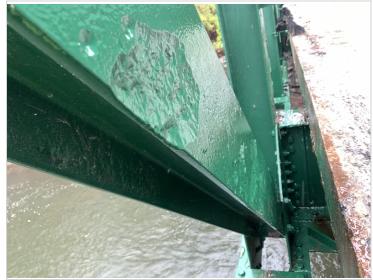
Previous pitting typical through out diagonals

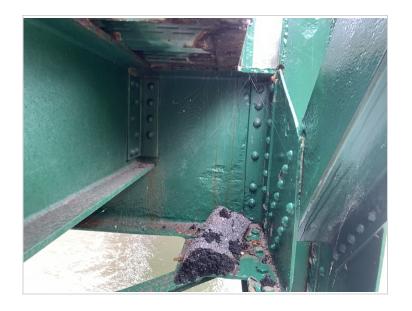
Section loss in diagonal truss 2

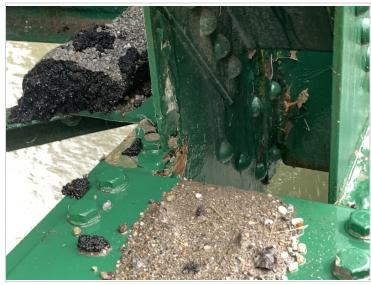
Interior gusset plate 2 hole truss 2

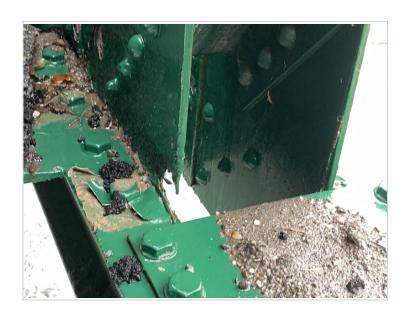
Interior gusset plate 2 hole truss 2

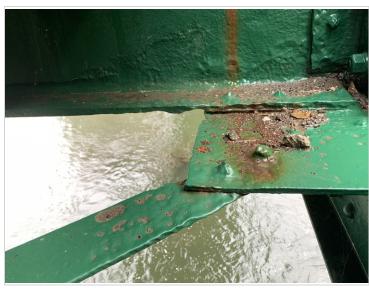
Section loss in floor beam 1 bottom flange

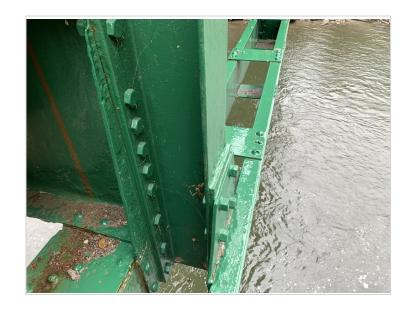
Previous pitting and section loss vertical 1 truss 2

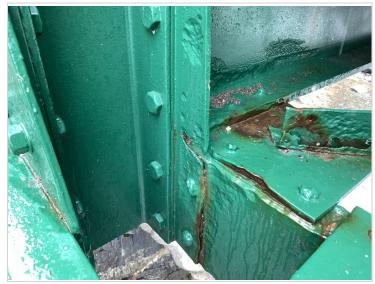
Perforation in flange of vertical 3 in truss 2

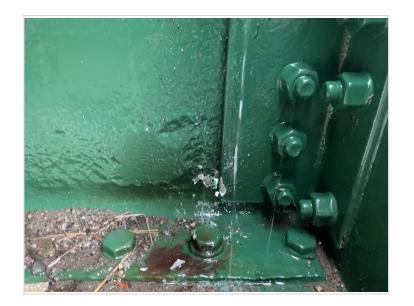
Floor beam 3 hole truss 2

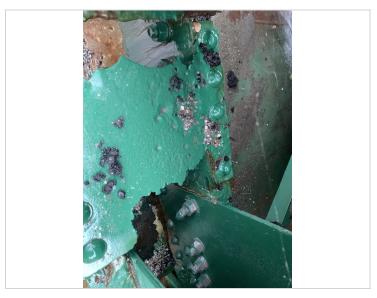
Hole in bottom chord with stiffener in place at abutment 2 gusset plate 7

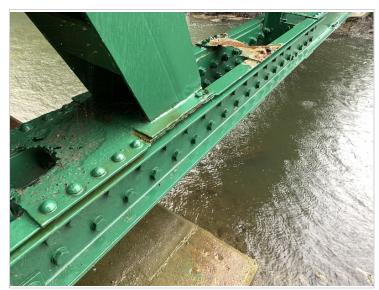
Bottom chord section loss near abutment 2 upstream end

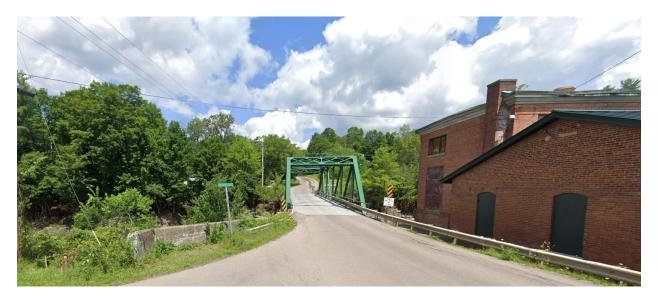
Figure 2: Utilities across the roadway and building on South side of the bridge via Google Maps

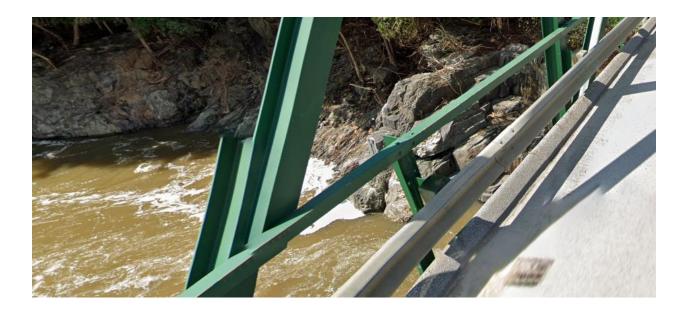
Figure 5: Bedrock outcrop visible on the west side of the bridge via Google Maps

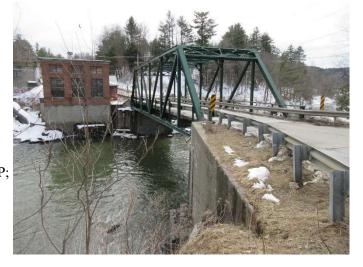
This single-span riveted Pratt through truss bridge is 121 feet long with a 21.5-foot-wide concrete cast-in-place deck with metal railings. The superstructure is composed of four panels joined by solid end posts and crossed portal bracing with lattice undersides. The upper bracing consists of two solid I-beam king posts. The deck is paved with concrete curbs on both sides and supported by longitudinal rolled I-beams and anchored by concrete abutments. According to the Morristown State Register nomination form (Brack 1990), the 1928 bridge, fabricated by the American Bridge Company, replaced an earlier wood covered bridge destroyed in the 1927 flood. The 1928 bridge was reconstructed in 2012; however, its characteristic trusses and chords remain, and alterations appear to be limited to repainting and wood posts reinforcing the guardrails. The bridge therefore retains its integrity of design, materials, and workmanship. The bridge retains its integrity of location as it has not been relocated.

The bridge is in poor condition, rated as "fracture critical." The deck, approaches, and abutments are in generally good condition but show cracking and moisture staining, and the chords and verticals show signs of serious deterioration. The rail posts, bottom chords and connection plates, diagonals and connection plates, and floor beams suffer from heavy section loss. Perforations are present in rail posts, bottom chords, gusset plates, floor beams, rail posts, and verticals. Heavy pitting is found in the second downstream vertical. Efflorescence covers most of the concrete curbs. Furthermore, a large section of the upstream curb near the north abutment is missing.

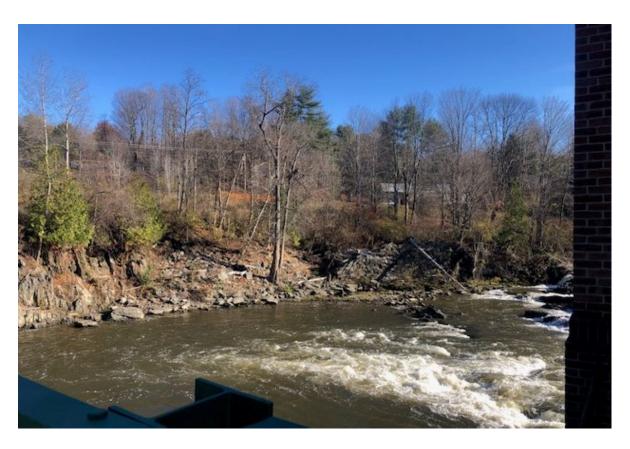
Mill remains further along the river NE of the bridge. Possible woolen mill remains.

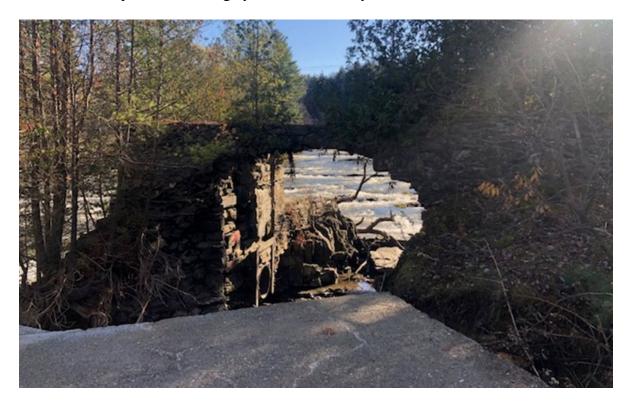
Structural remains located in back of (immediately south and east) the hydroelectric building. These are stone and do not appear to be related to the current structure. These may be associated with a mill structure that post-dates the Beers or may be connected to the mill structures across the river.
