STATE OF VERMONT AGENCY OF TRANSPORTATION

Scoping Report

FOR Rutland City BF 3000(24)

TOWN HIGHWAY 8 (RIVER ST), BRIDGE 27 OVER VERMONT RAILWAY (VTR) -General Merritt A. Edson Memorial Bridge-

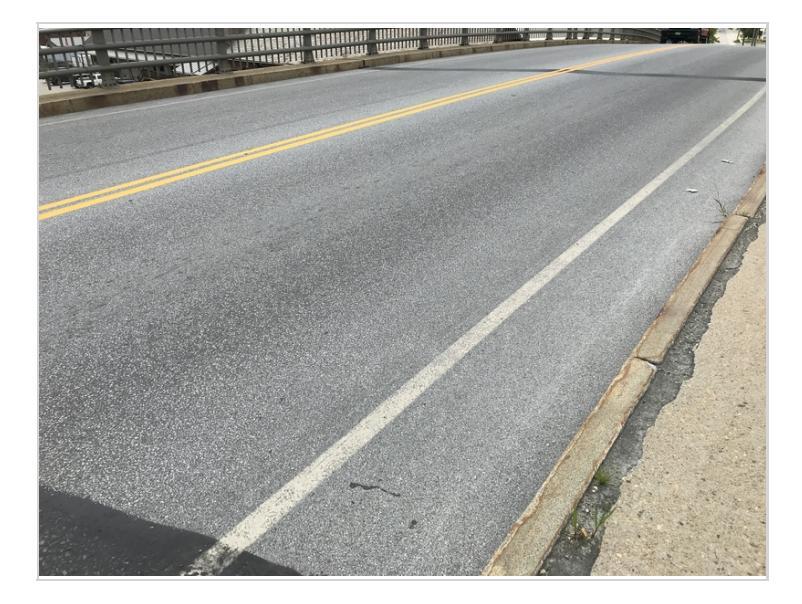
Deck East span

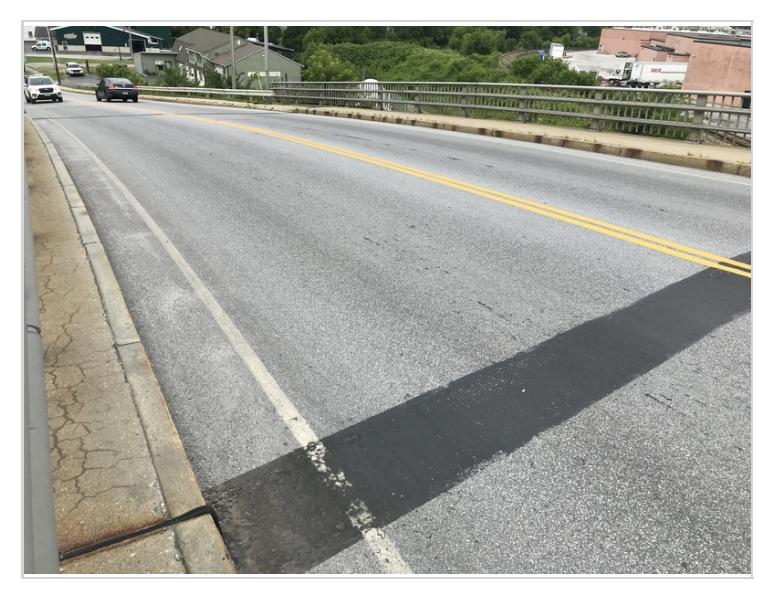
Deck West span

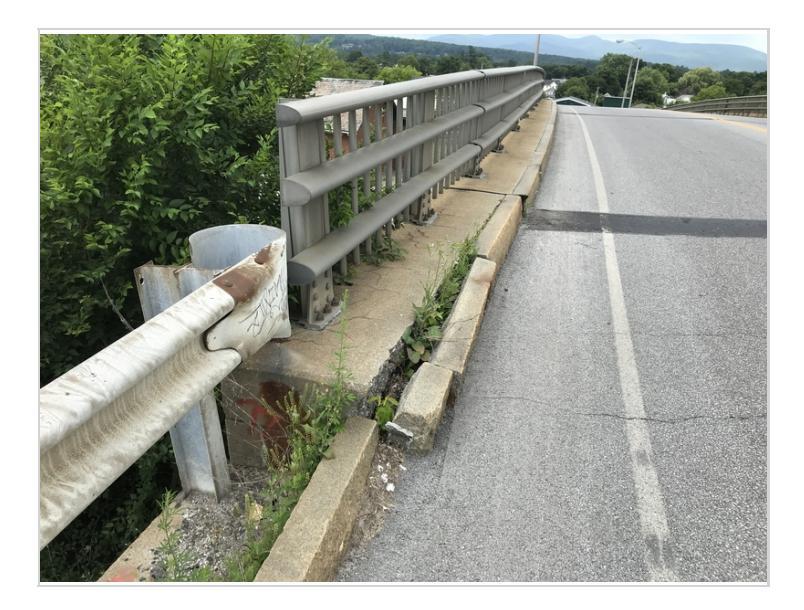
South curb East end

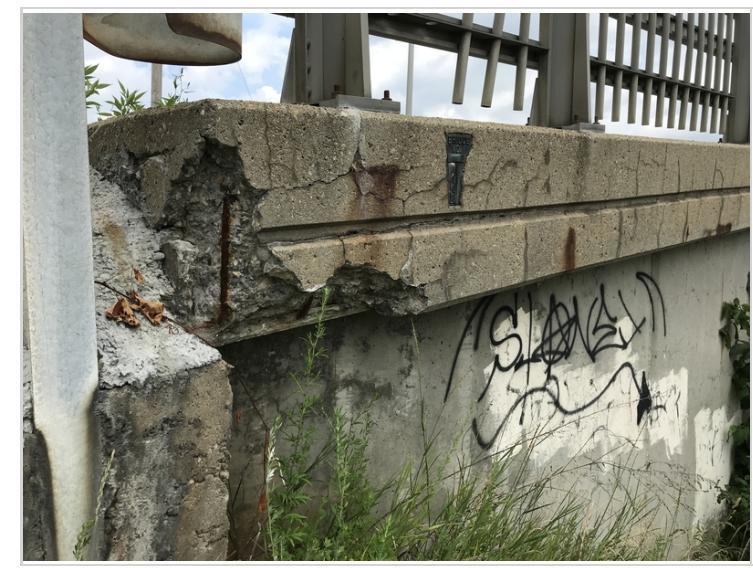
SW end approach curb/fascia

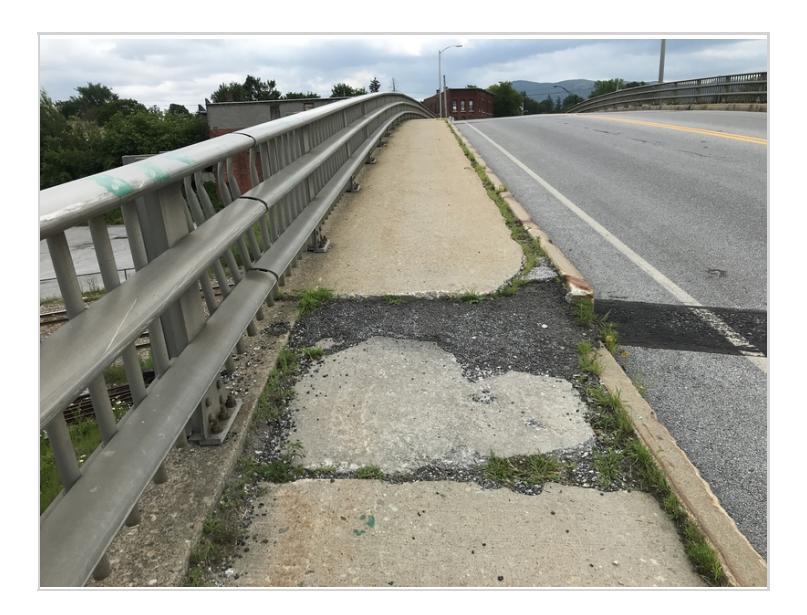
Sidewalk from West abutment

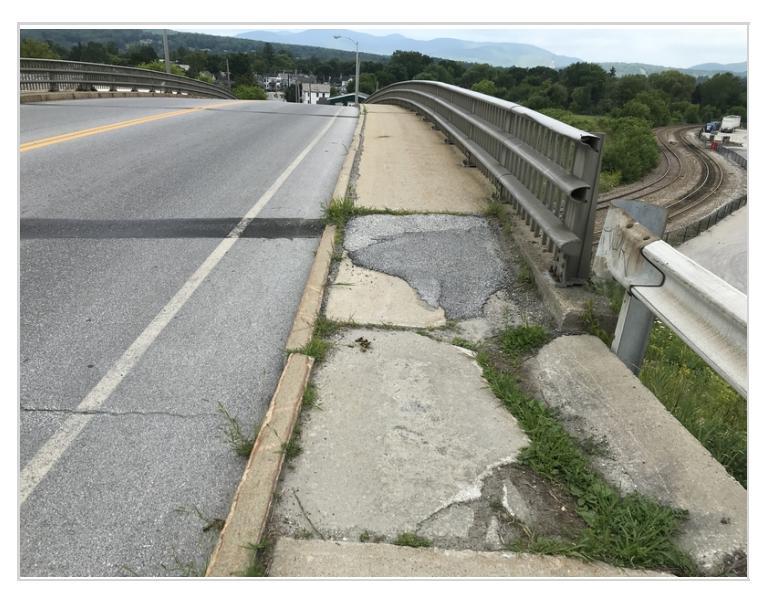
Sidewalk from East end

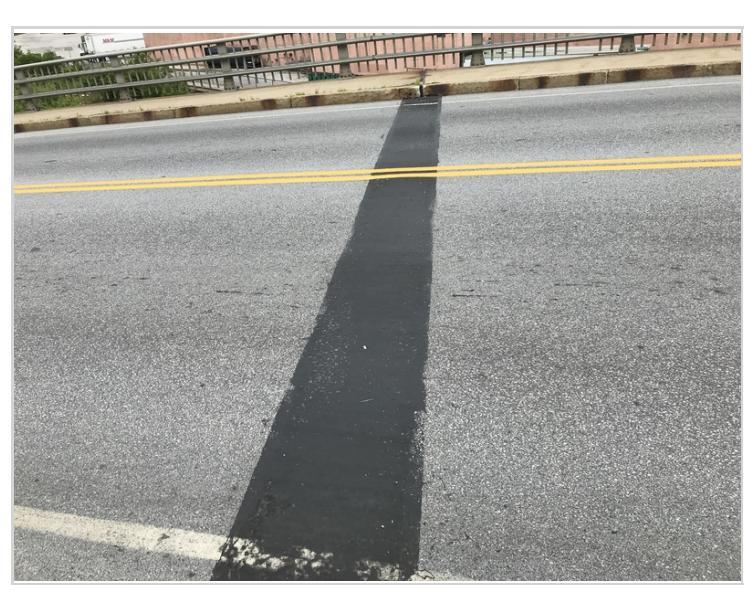
Joint East pier

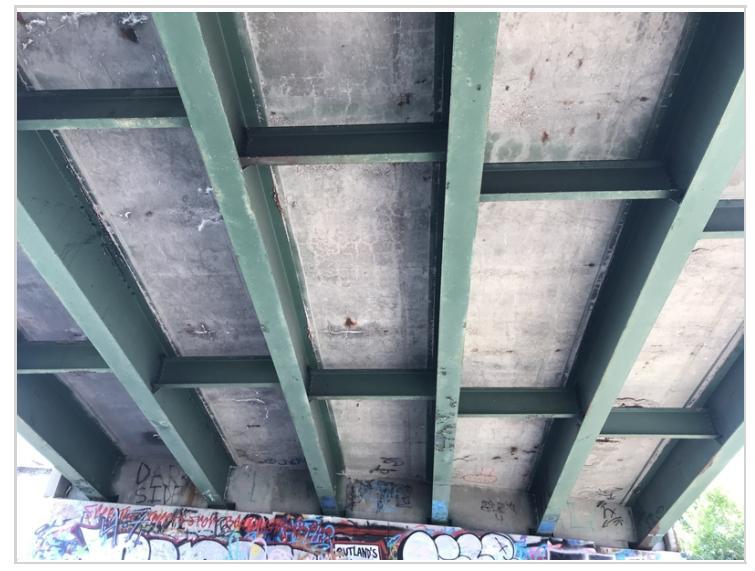
South end East pier joint

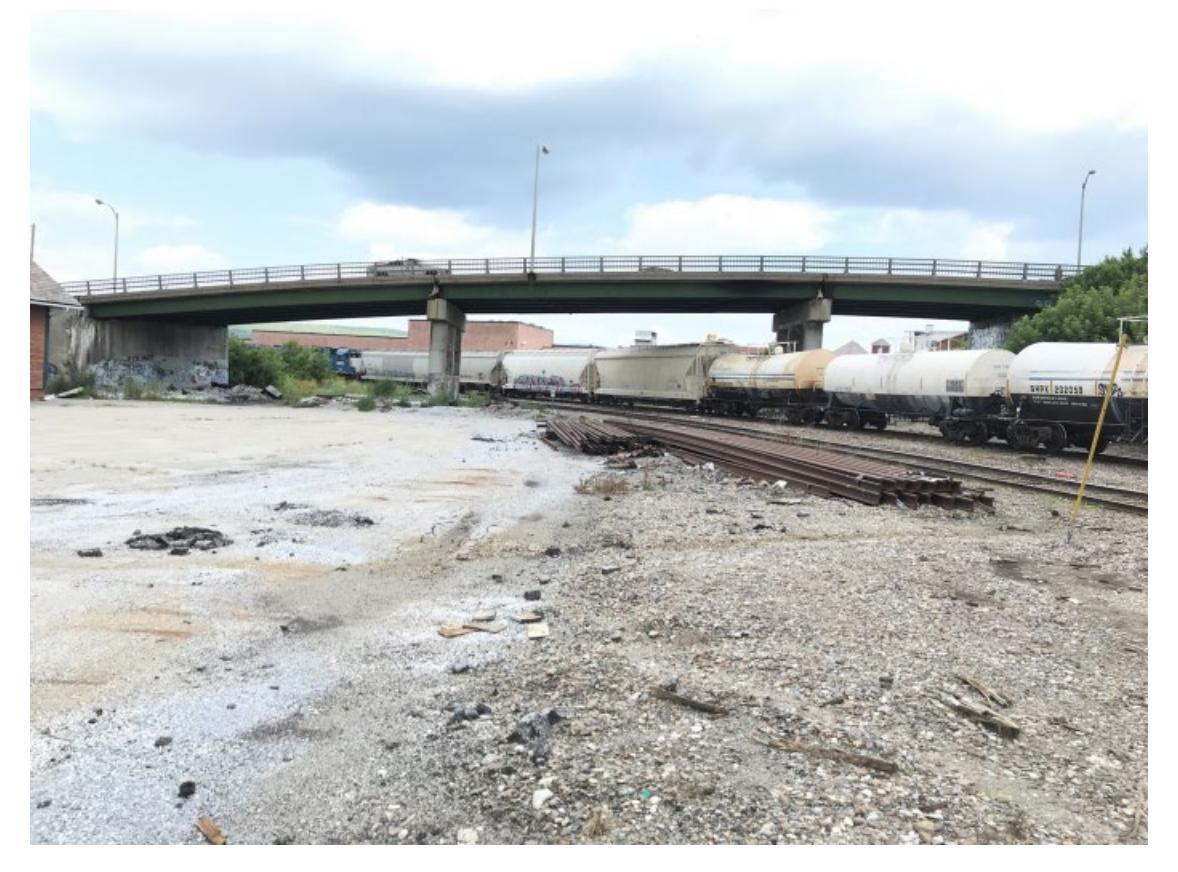
Figure A1: Overall View. Rutland City, Bridge #27, River Street. Photo from 07/21/2022 inspection.

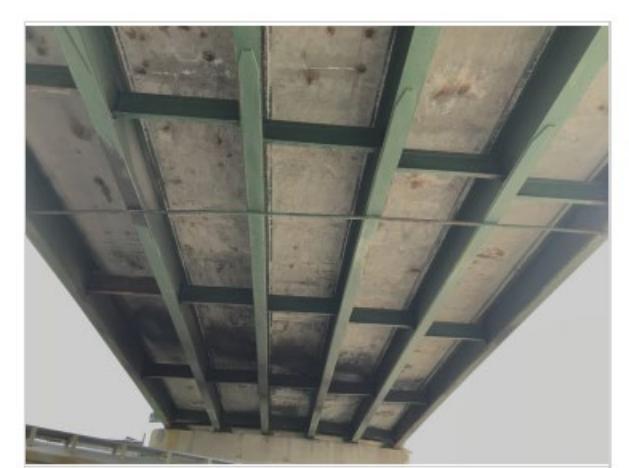
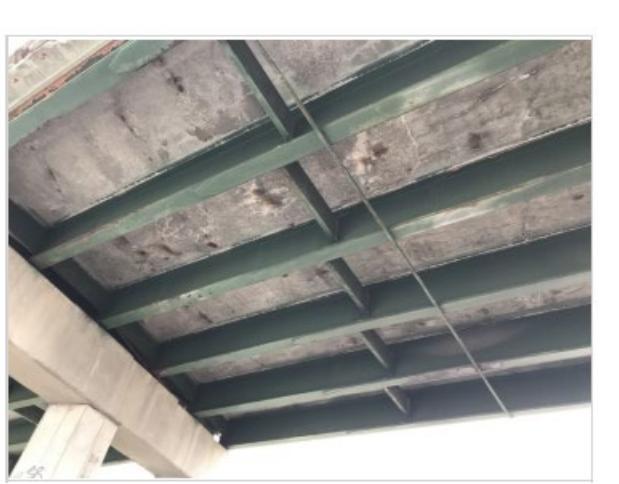
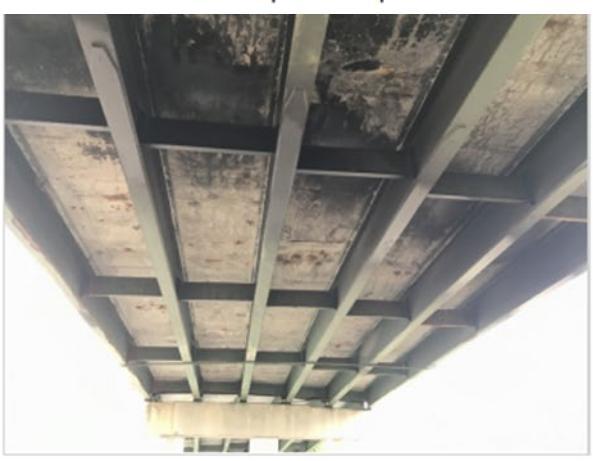
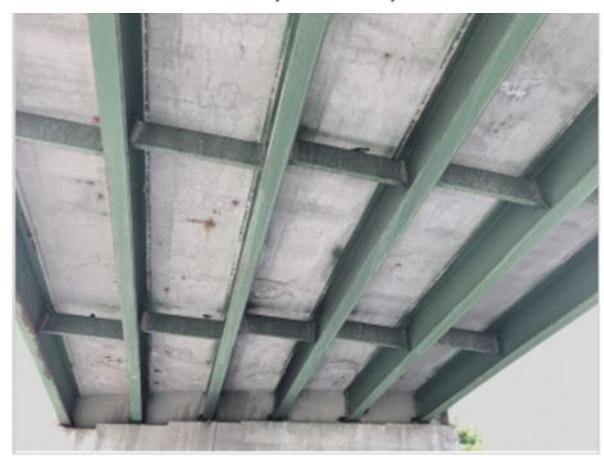
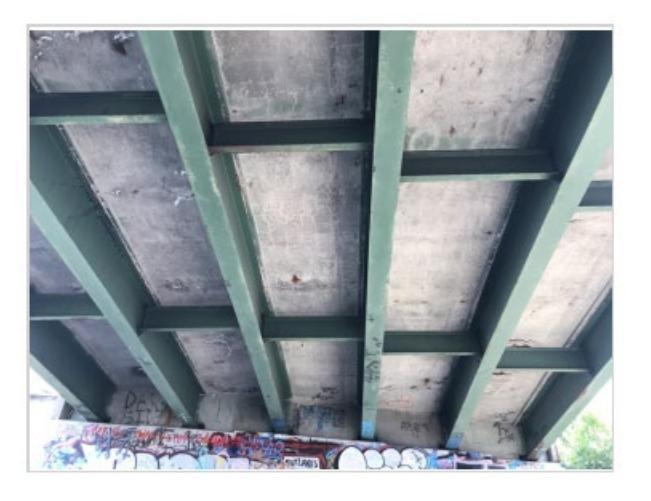
Figure A2: Condition photos of deck. Rutland City, Bridge #27, River Street. Photo from 07/21/2022 inspection.
