STATE OF VERMONT AGENCY OF TRANSPORTATION

Scoping Report

Swanton BF 036-1(16) VT ROUTE 78, BRIDGE 6 OVER MISSISQUOI RIVER

March 10, 2025 Revised May 30, 2025

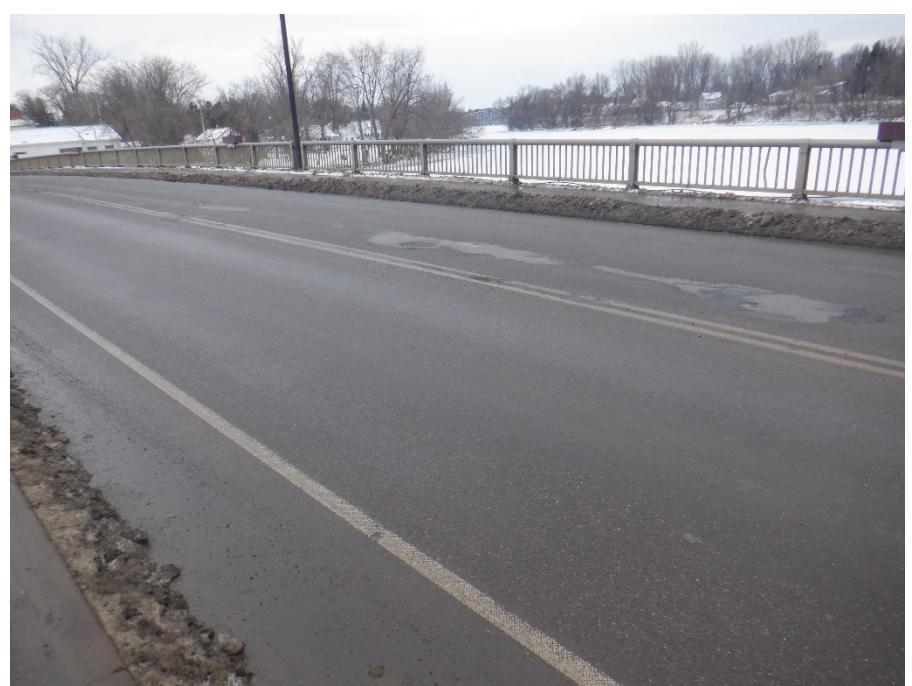
Photo 1: Bridge 6 – Typical Top of Deck, Looking Southeast

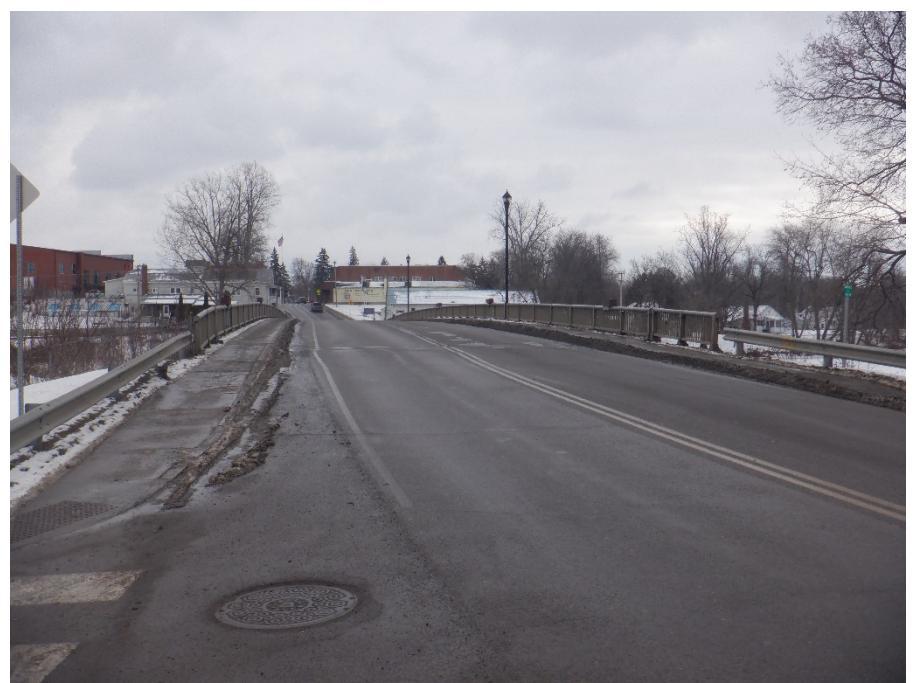
Photo 2: Bridge 6 – Bridge from West Approach, Looking East

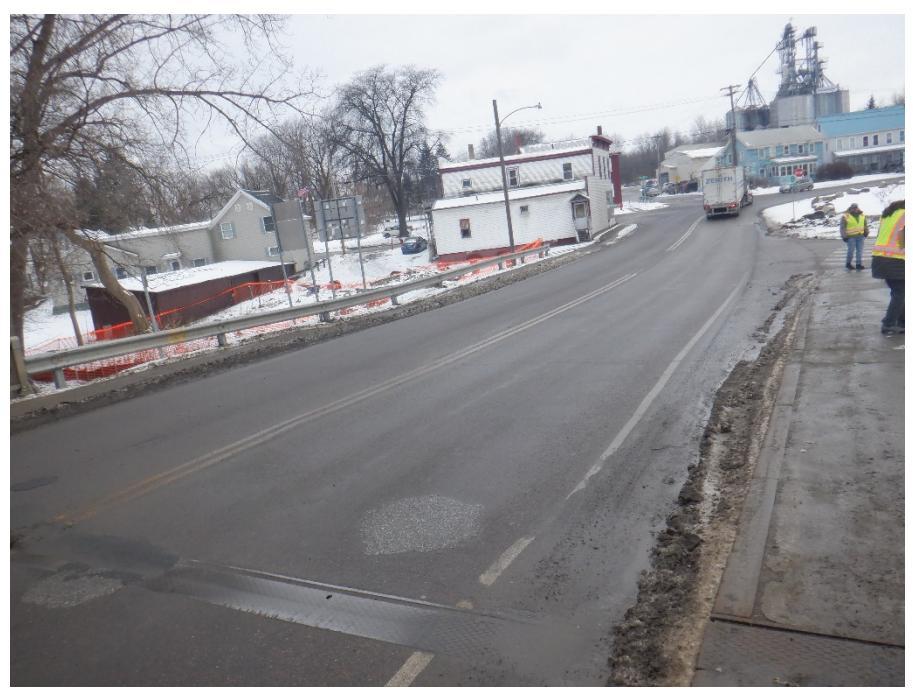
Photo 3: Bridge 6 – West Approach from Bridge, Looking West

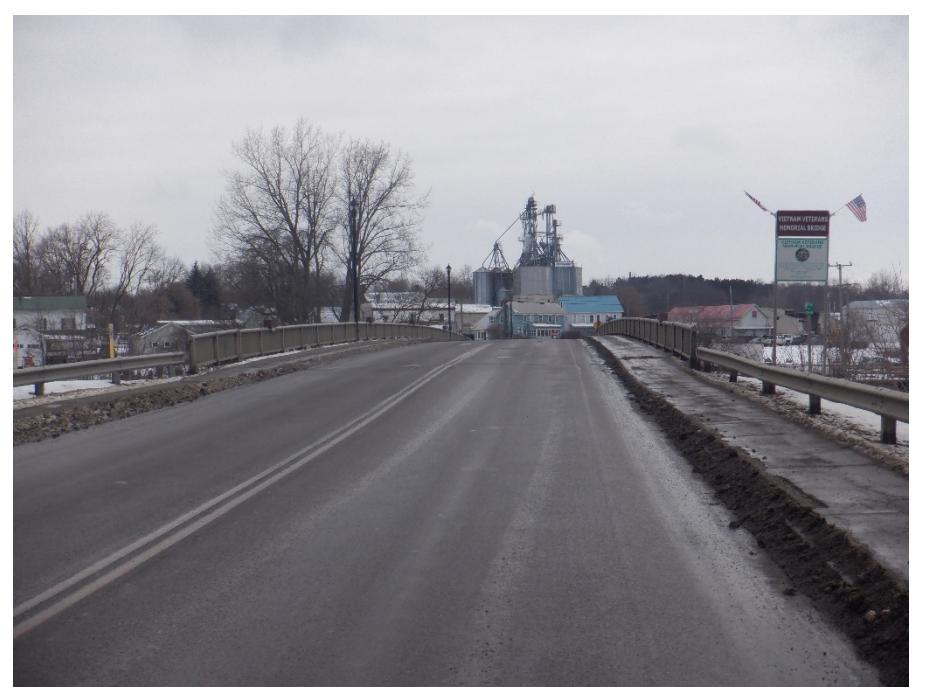
Photo 4: Bridge 6 – Bridge from East Approach, Looking West

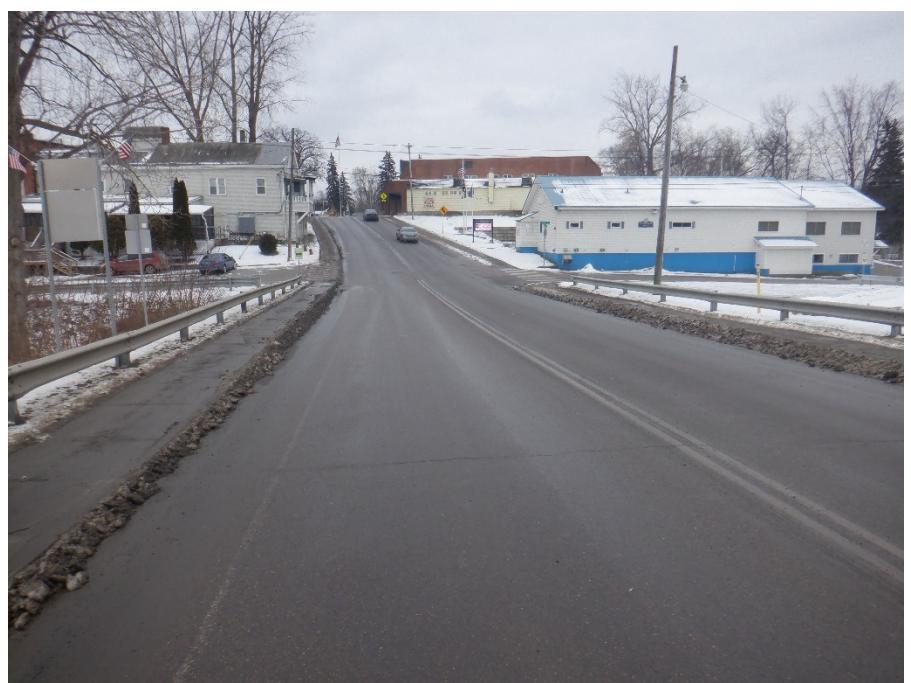
Photo 5: Bridge 6 – East Approach from Bridge, Looking East

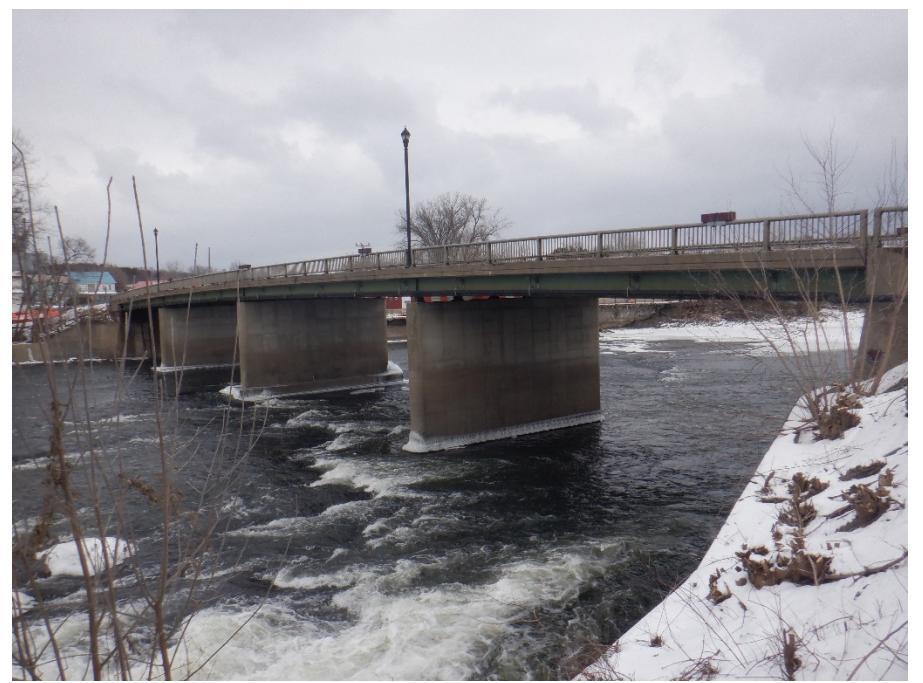
Photo 6: Bridge 6 – South Elevation, Looking North

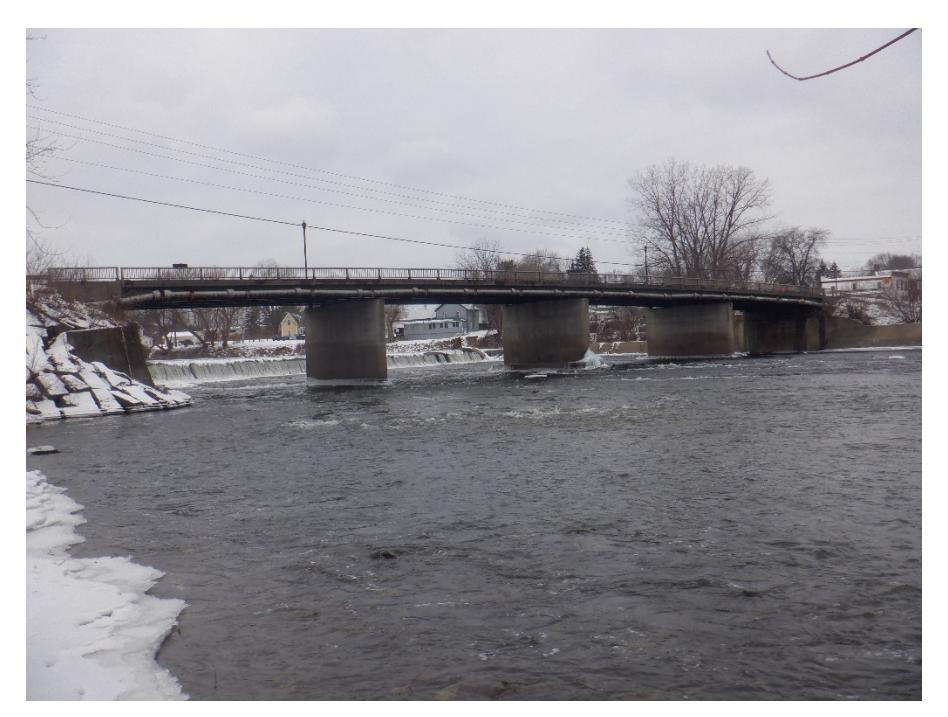
Photo 7: Bridge 6 – North Elevation, Looking South

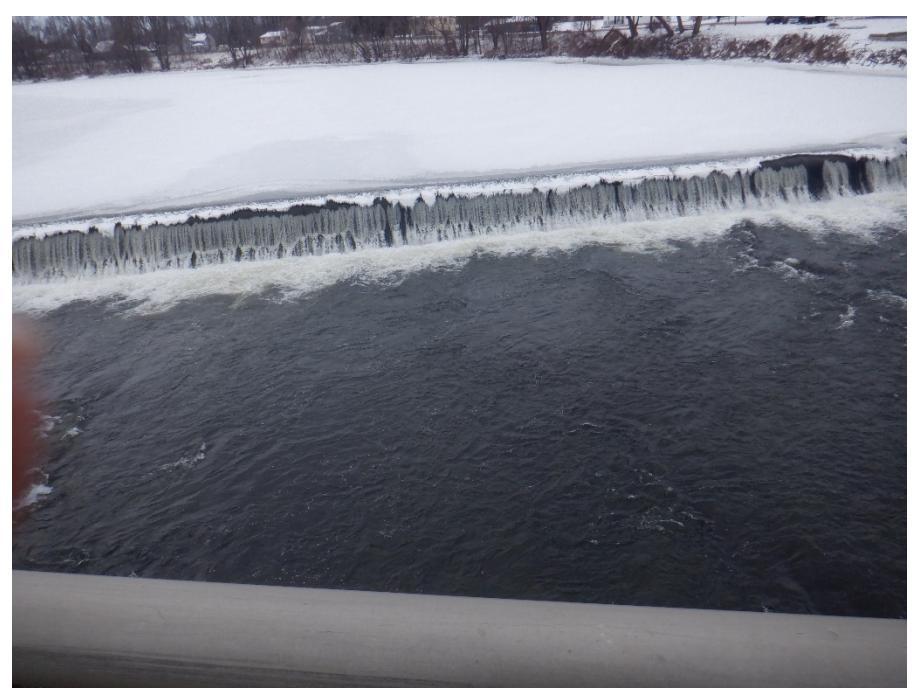
Photo 8: Bridge 6 – Looking Upstream (South)

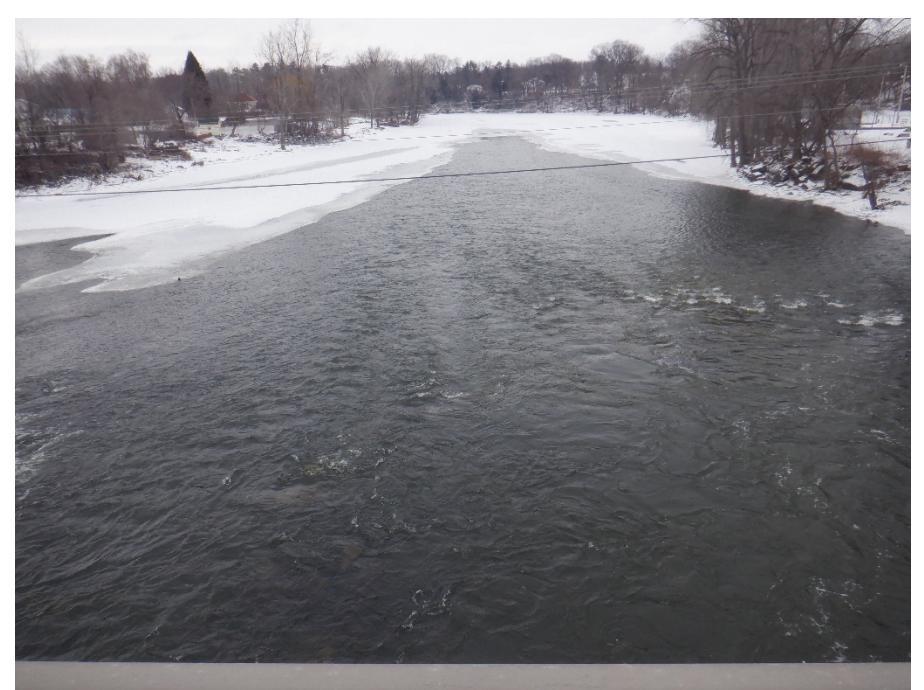
Photo 9: Bridge 8 - Looking Downstream (North)

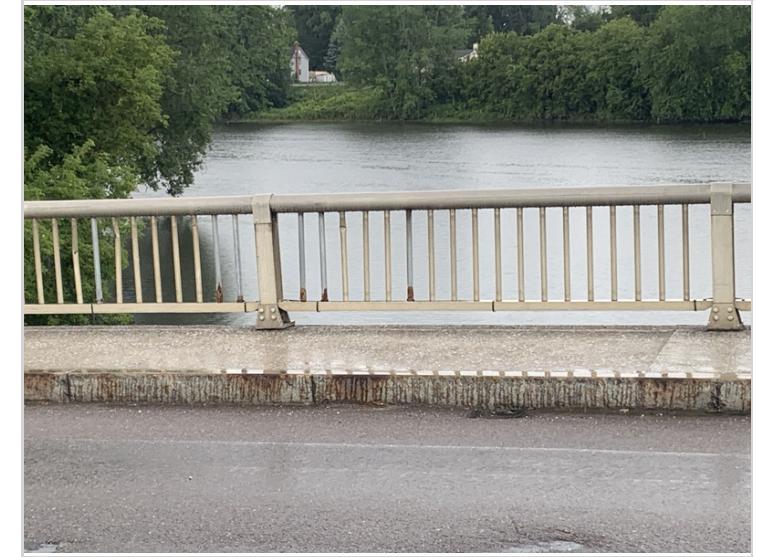
Upstream near abutment 2 rail spindles

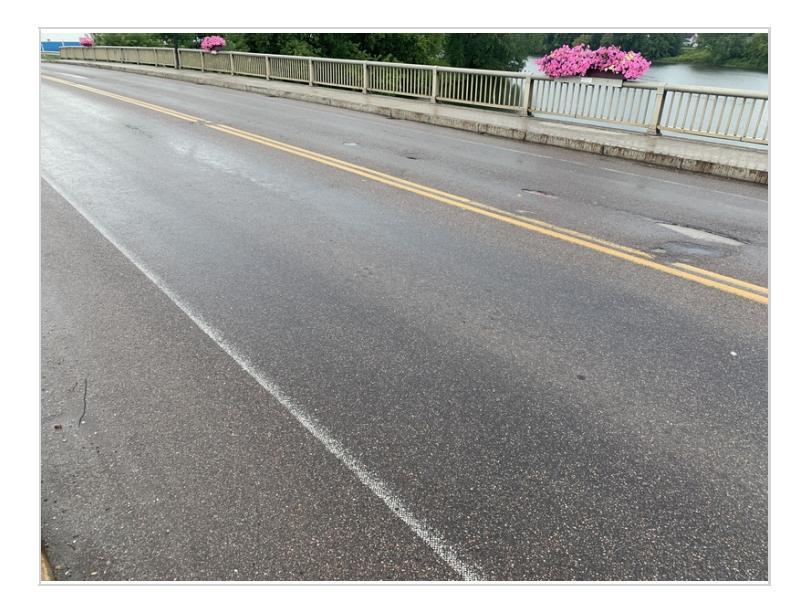
Missing bolt in the rail hoop

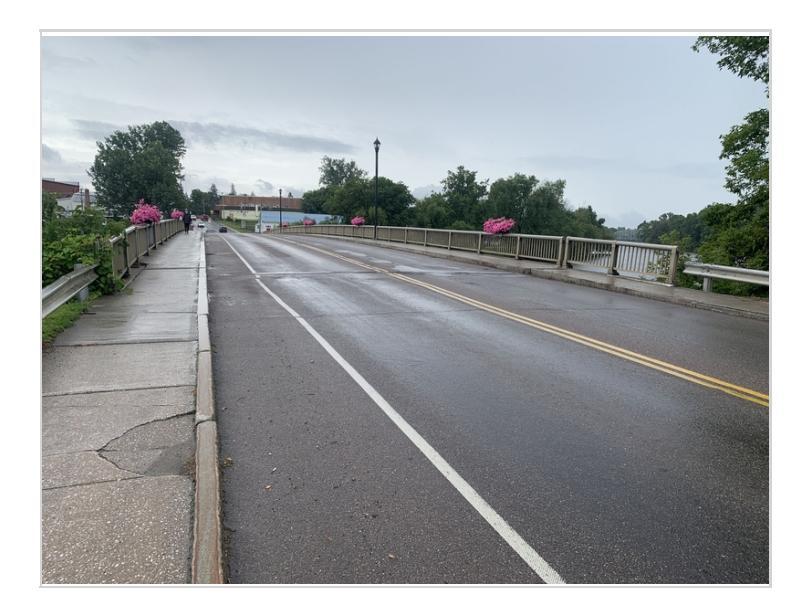
Potholes in wearing surface

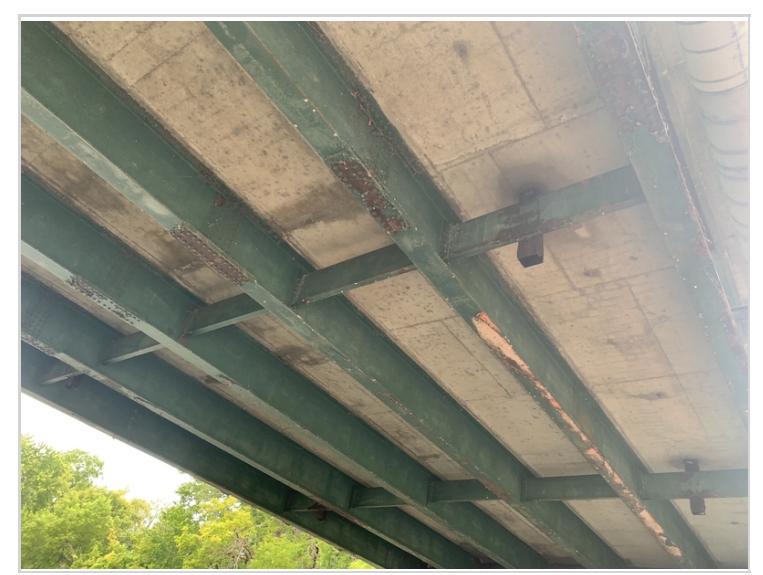
Exposed deck

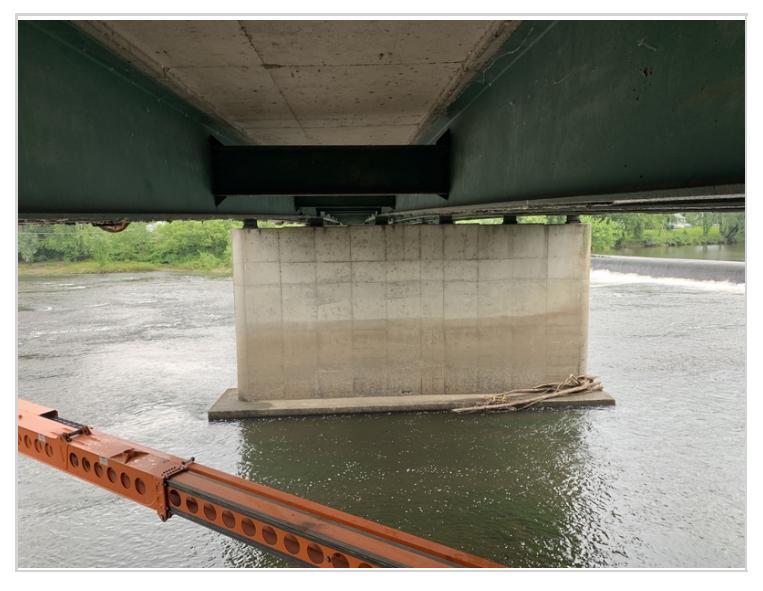
Pier 1 span 1

- 7. Pier 1 has undermining noted in the latest inspection report.

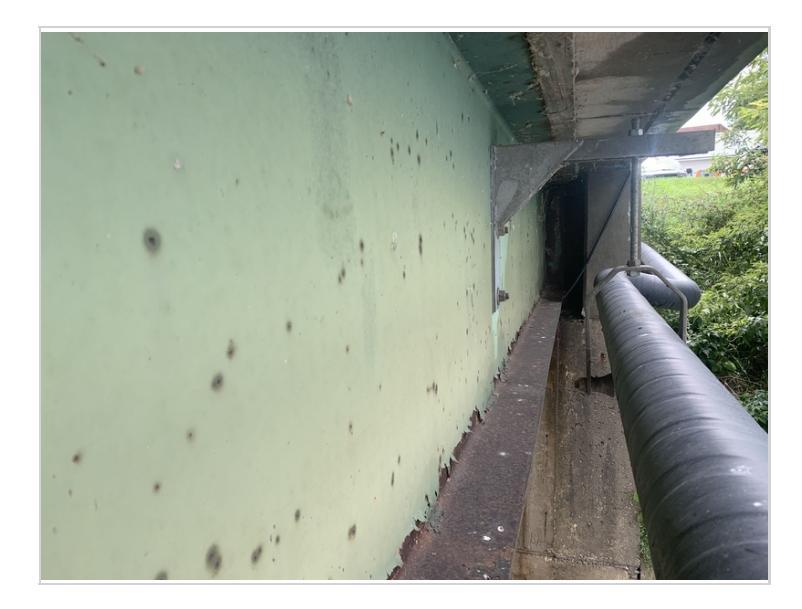
Section loss beam 1

Heavy rust scale beam 1

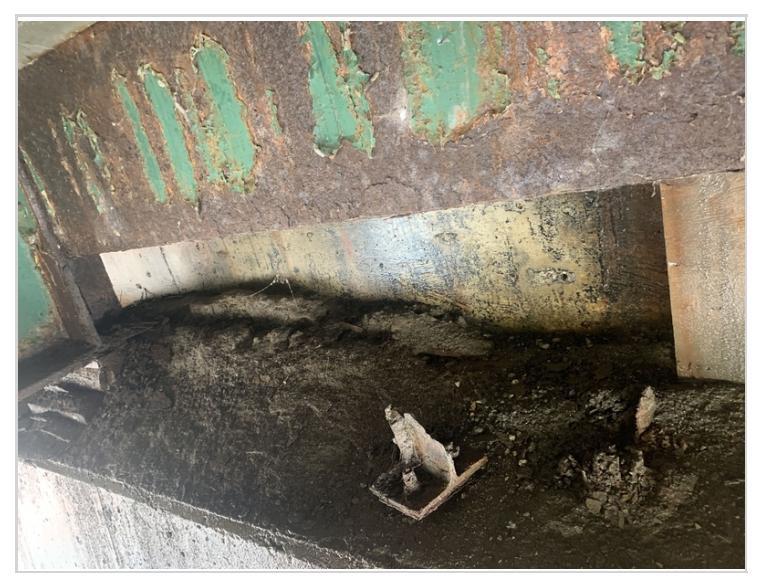
Debris on abutment 2 seat

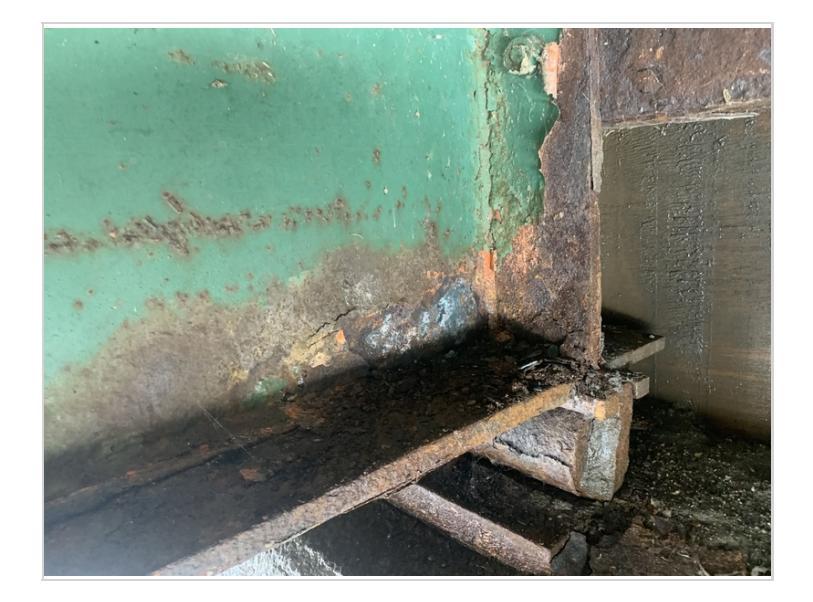
Section loss beam ends abutment 1

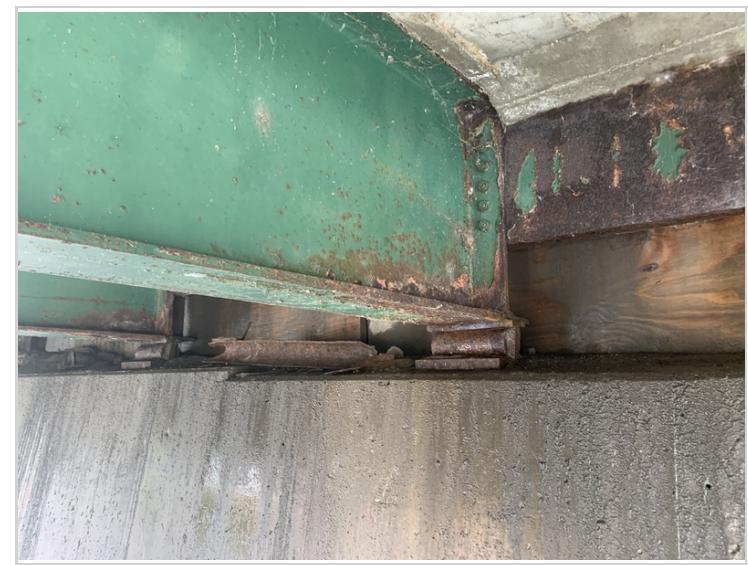
Wood blocking along back wall from bay 3 to upstream end

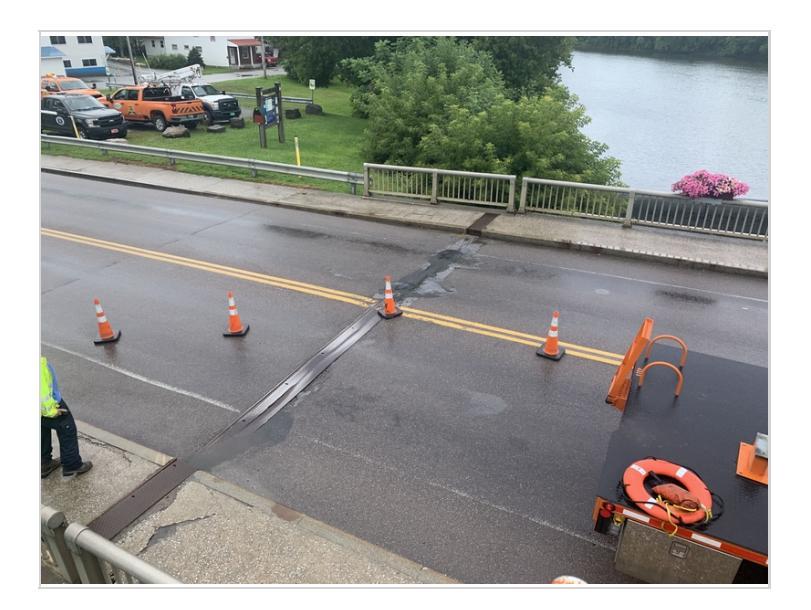
joint abutment 1 patching

8/8/23 joints have failed over half of the bridge and have wood temporary supports installed to fix holes that have developed. Sliding steel plate joints are present over both abutments having failed and wide cracking with bending over the other half. the steel plates will continue to fail on the other lane. The joints need a more permeant repair as the wood and existing steel plate will fail again. Troughs have areas of heavy section loss and have failed in multiple locations. Joints allow heavy leakage to structure below and have built up ~12" of debris and sediment along abutment bridge seats. Joint are in need of major rehab or full replacement over both abutments.

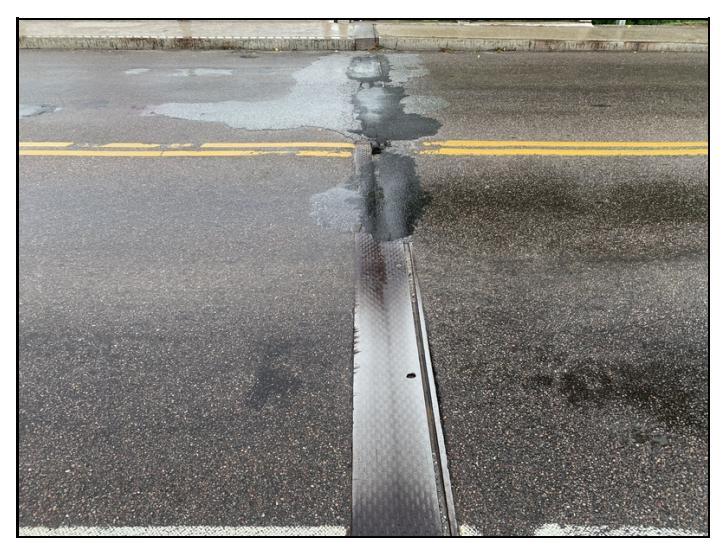
Abutment 2 joint

Joints have had some temporary repair work done to plug holes that have developed in the roadway.

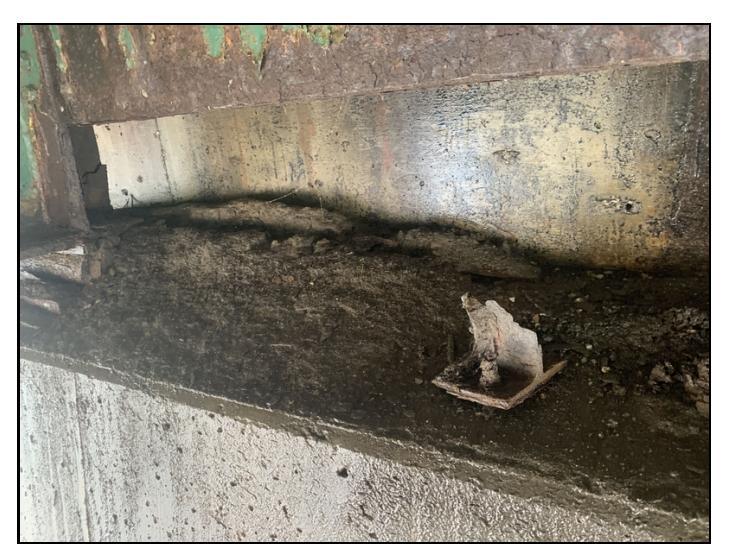
Wood used to support joint abutment 1

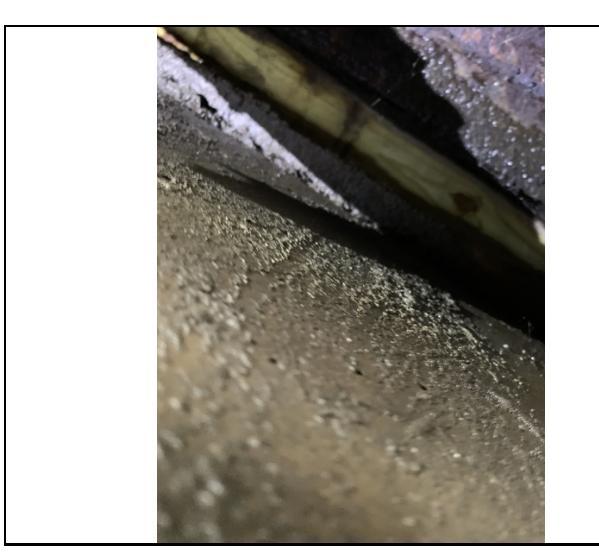
drain trough failed from corrosion

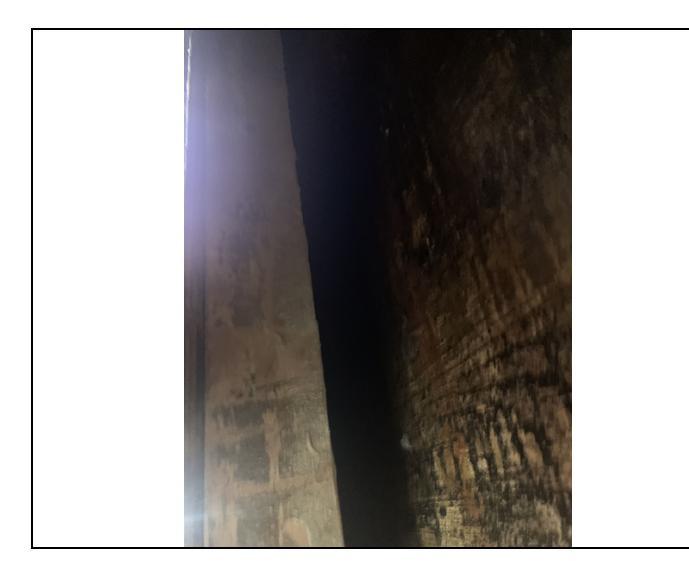
Joint trough abutment 1

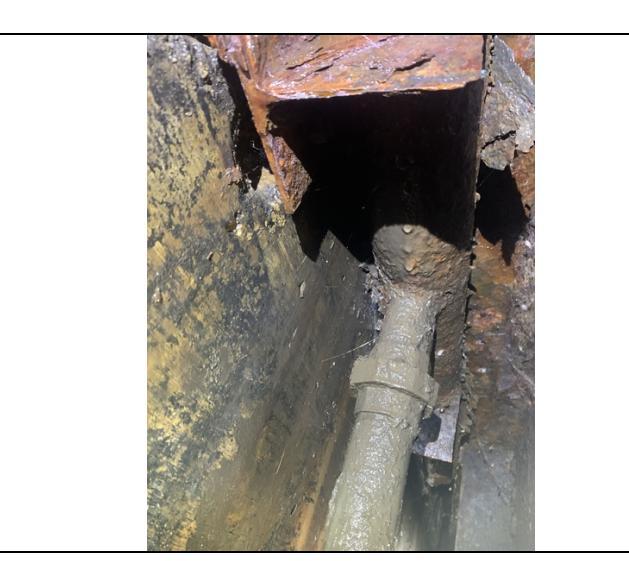
plywood temporary form work abutment 1

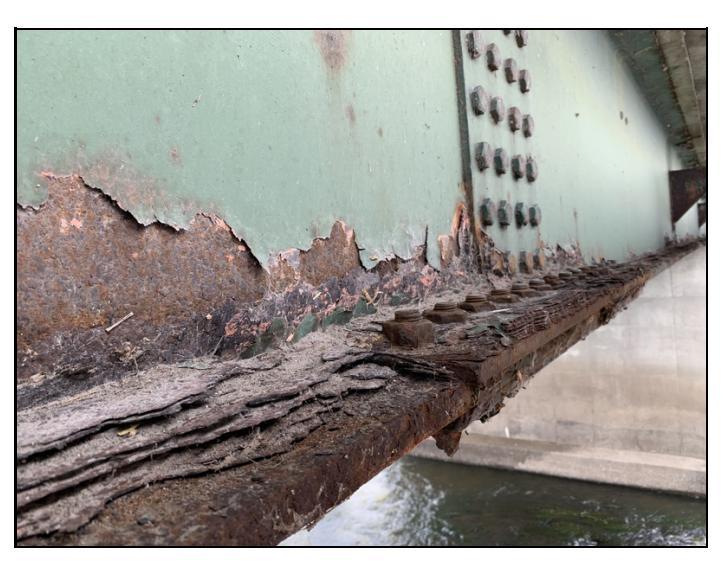
Failed Joints over both abutments have allowed continuous leakage to structure below which has progressed steel corrosion that has minor to to moderate rust scaling and is in need of cleaning and painting. Beam #1 throughout also has built up rust scaling along the outer lower flange and should be cleaned and painted to prevent further corrosion.

End diaphragm's abutment 1

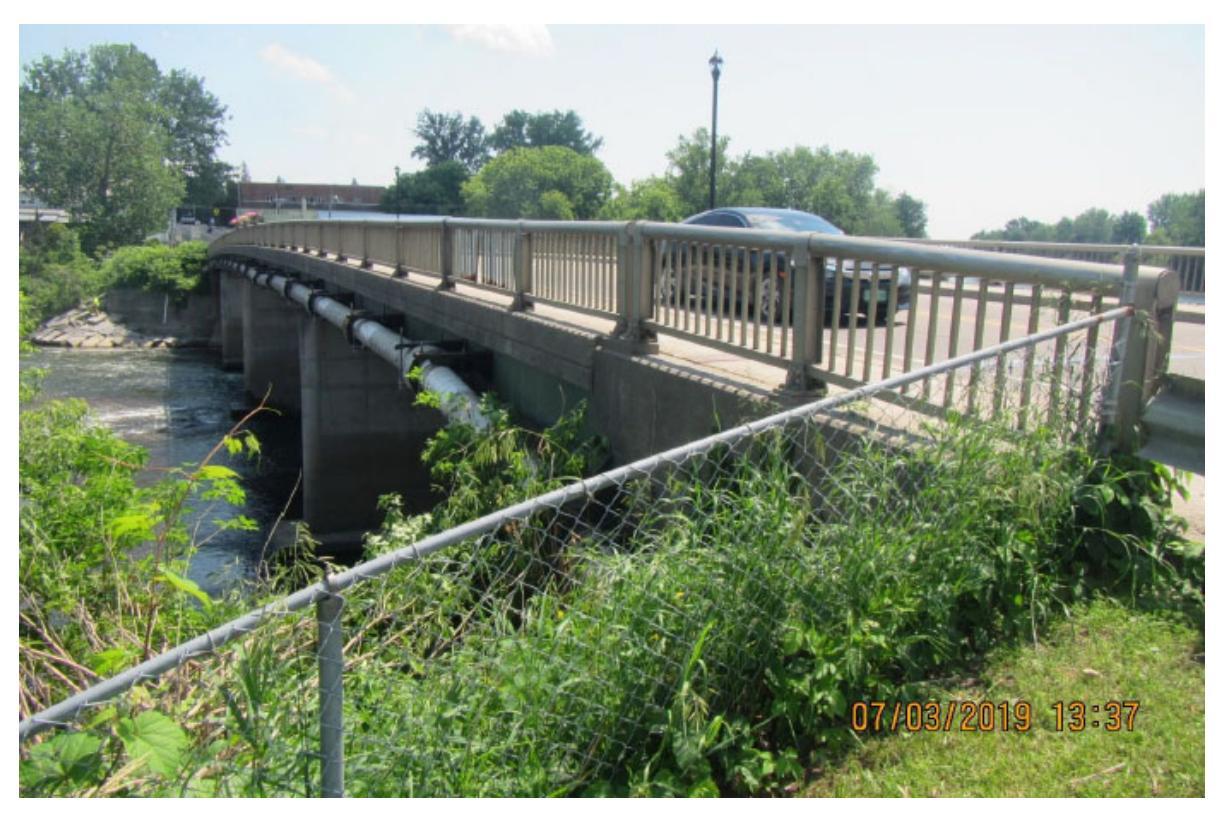
Figure 1. Facing south at northern end of bridge. Note utility alongside bridge for full length, and light pole on bridge.

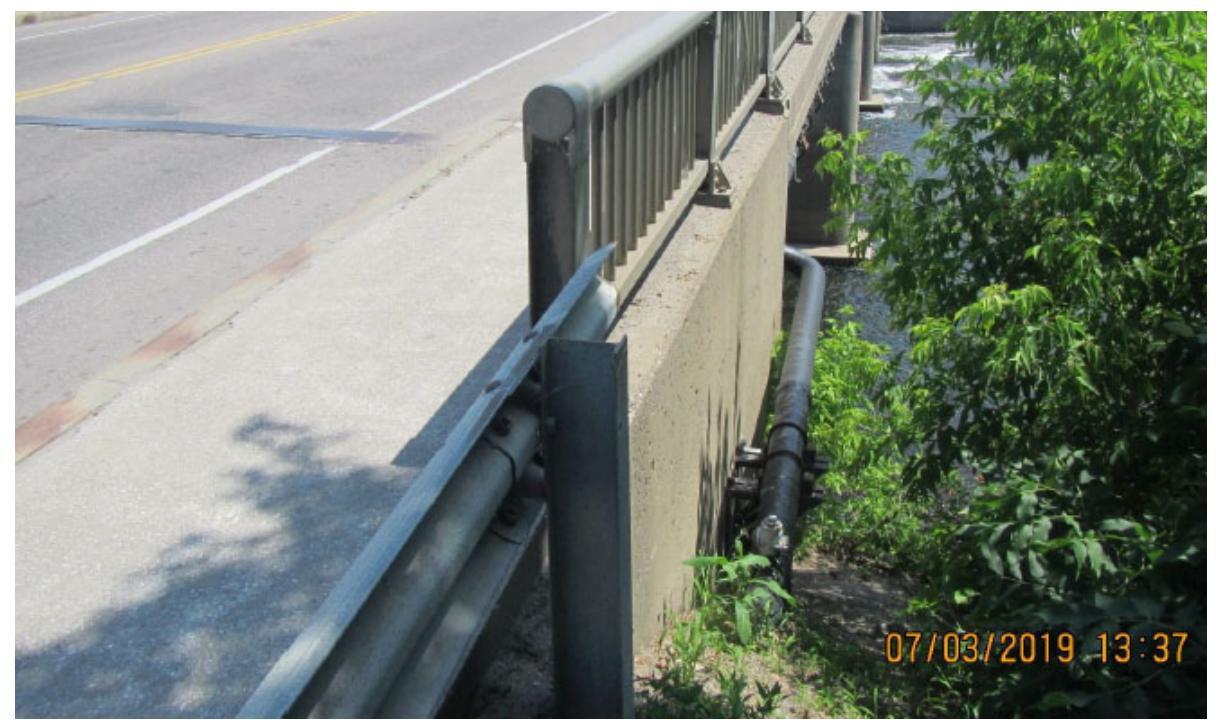
Figure 2. Facing south at northern end of bridge. Note utility alongside bridge and under abutment.

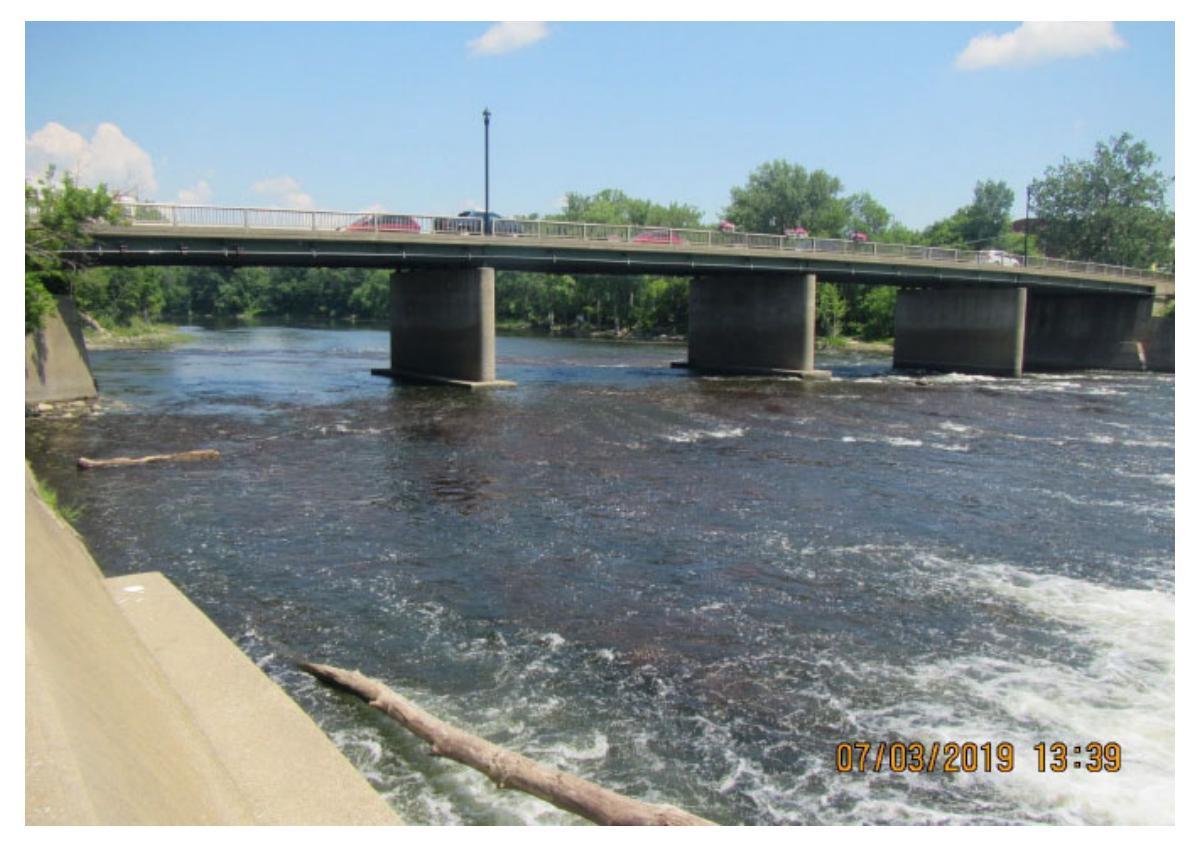
Figure 3. Facing upstream at structure, note pier locations and utilities

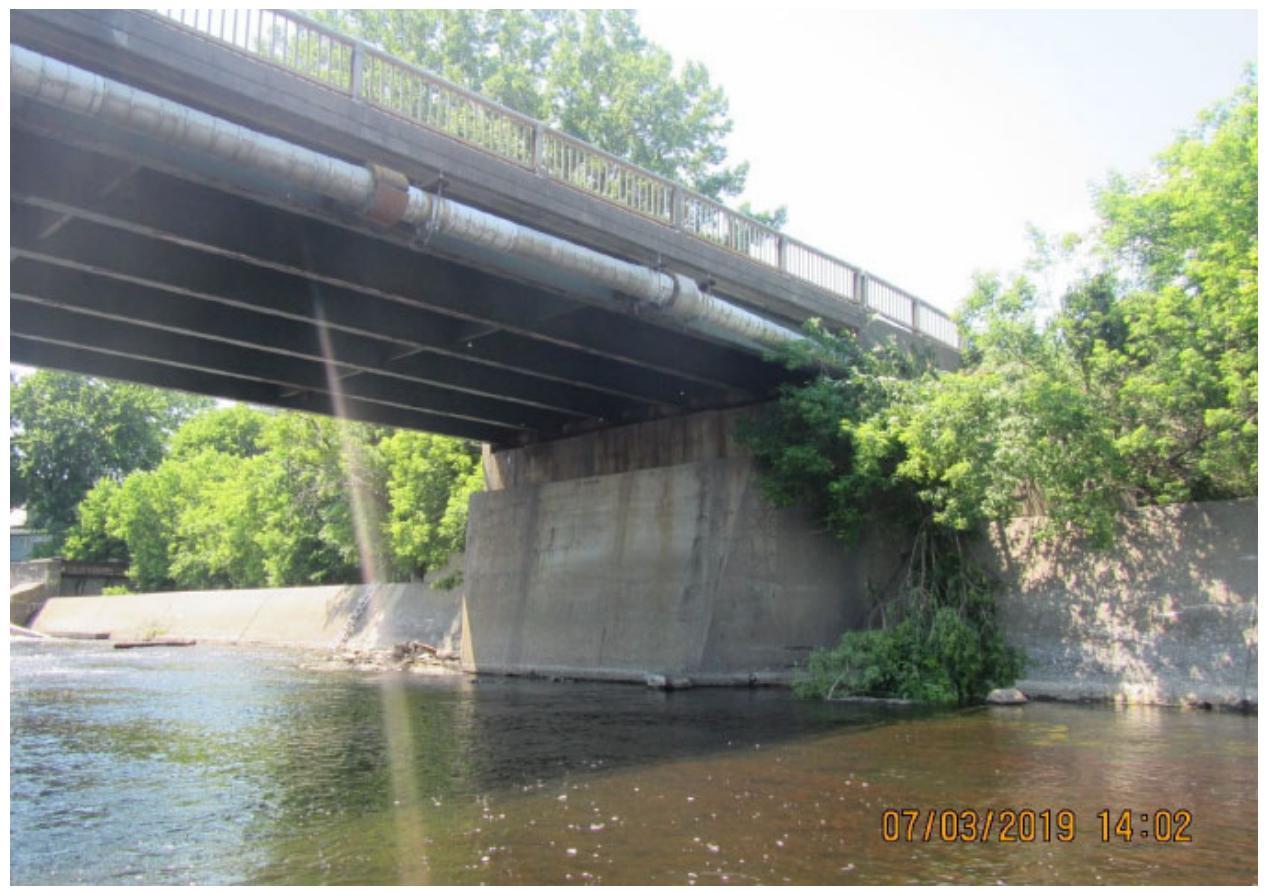
Figure 5. Facing northern abutment. Note utility on bridge and retaining walls adjacent to abutment.
