STATE OF VERMONT  
AGENCY OF TRANSPORTATION

**Scoping Report**

**Swanton BF 036-1(16)**  
**VT ROUTE 78, BRIDGE 6 OVER MISSISQUOI RIVER**

March 10, 2025  
Revised May 30, 2025  
Final August 15, 2025

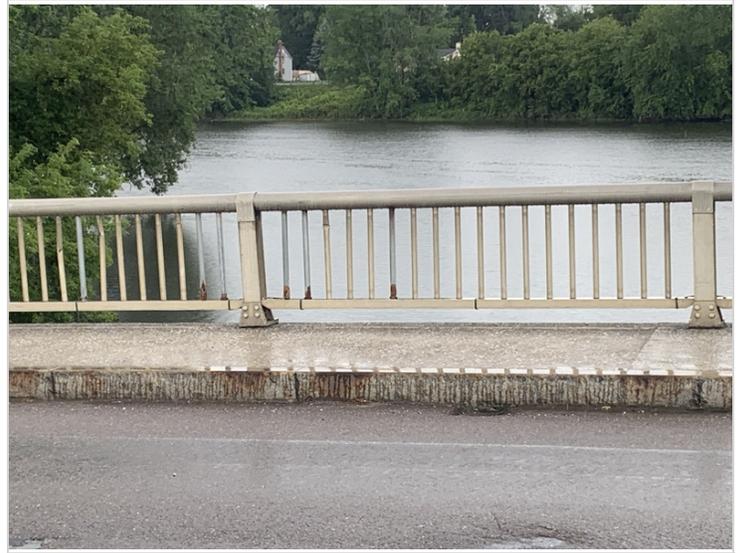
Upstream near abutment 2 rail spindles

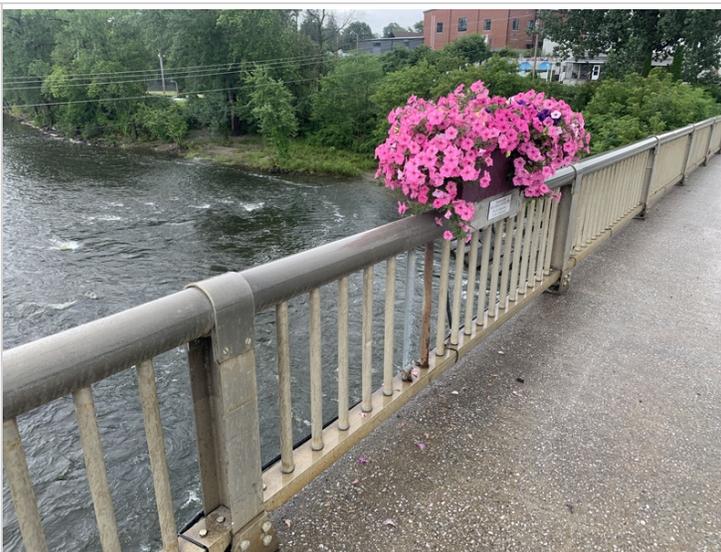
Downstream near pier 1 rail spindles

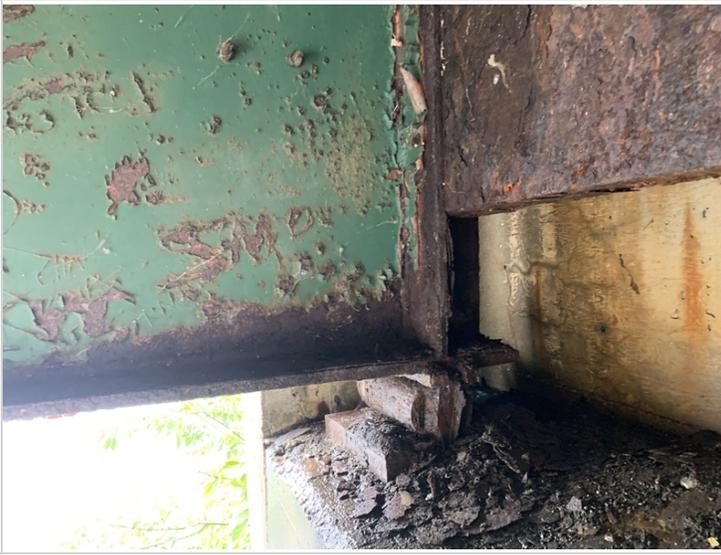
Beam 6 bearing

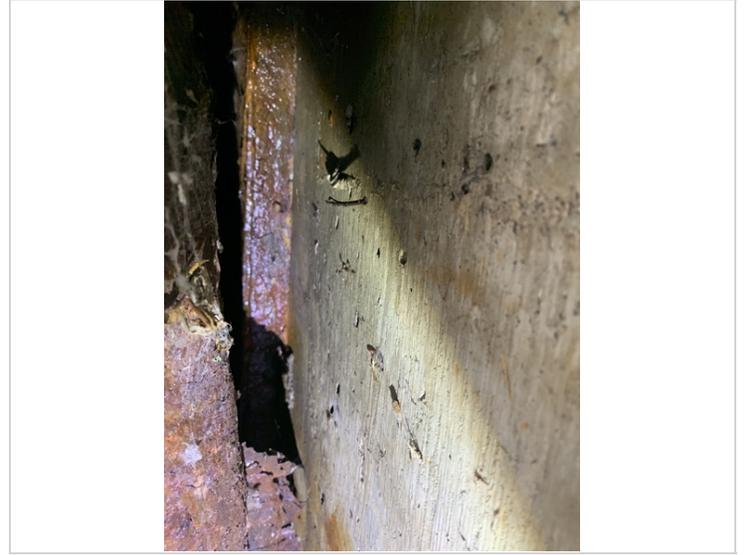
Abutment 1 joint

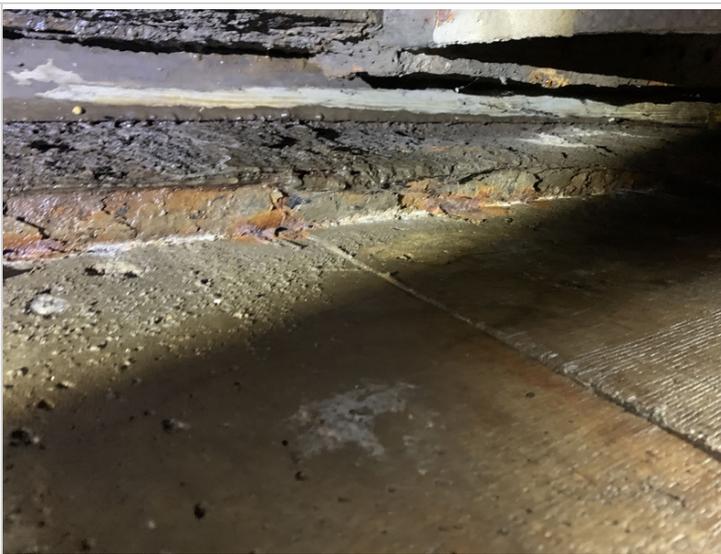
Abutment 1 joint

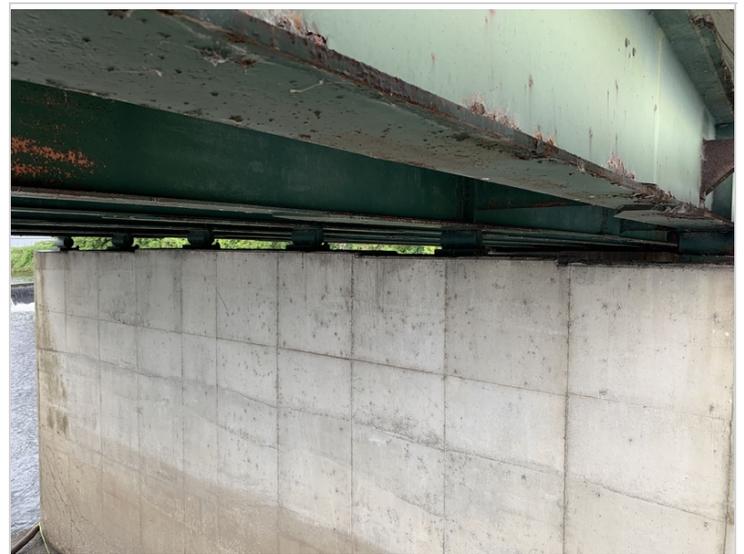
Pier 1 bearings

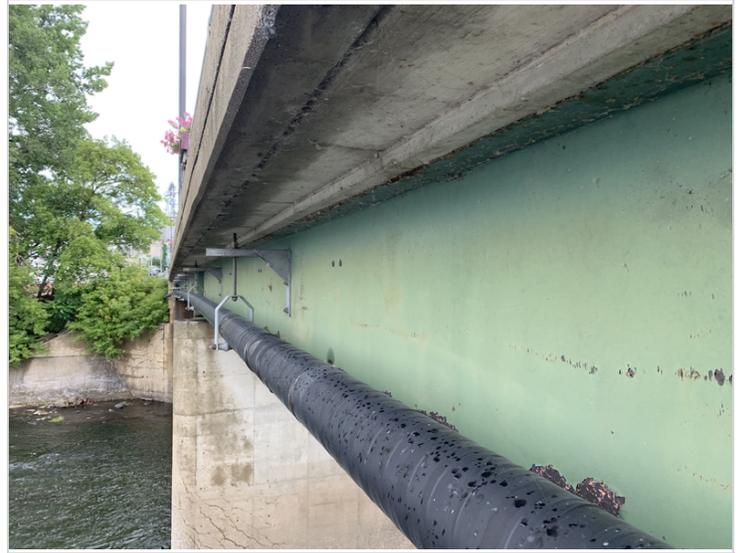
Beam 6 looking west

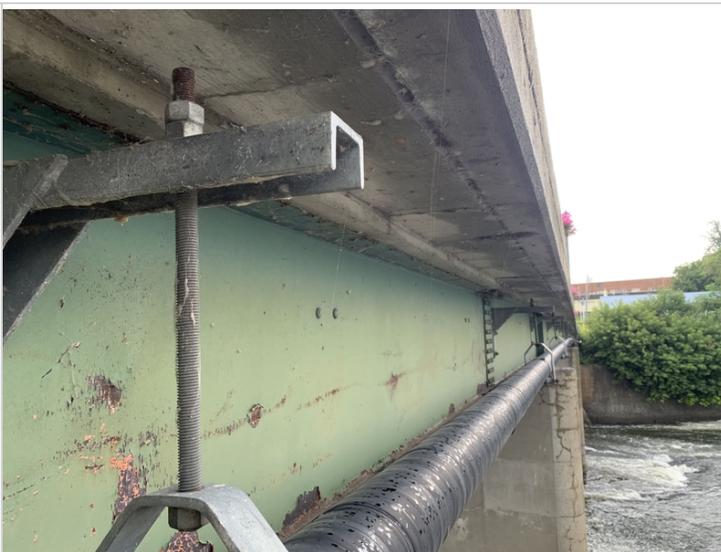
Beam 6 looking east

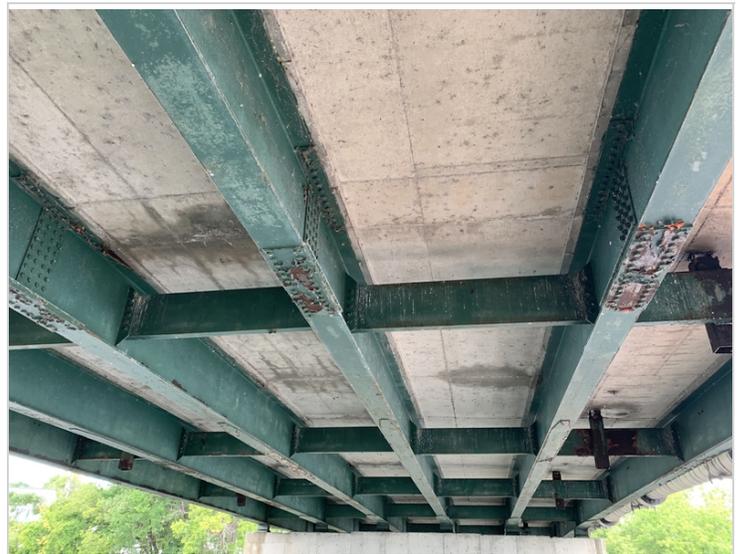
Span 2 deck

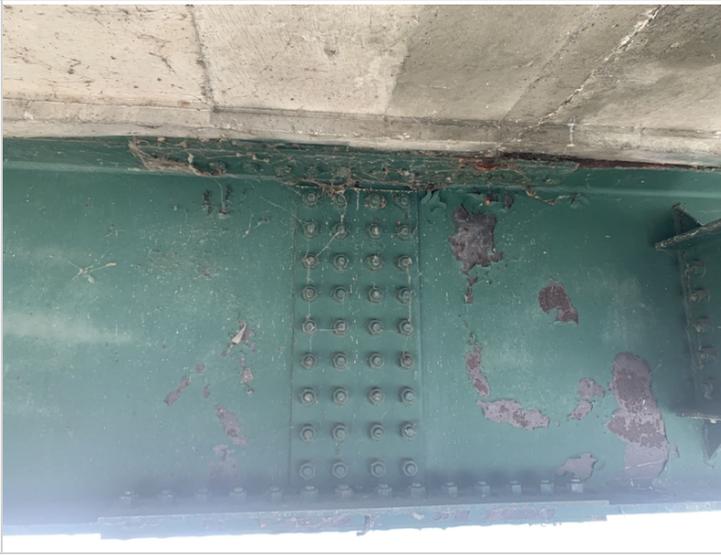
Beam 4 splice plate span 2

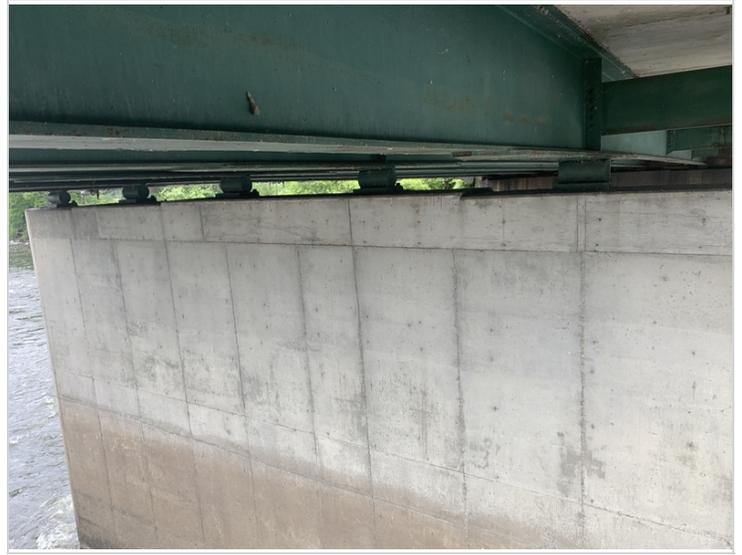
Pier 3 bearings

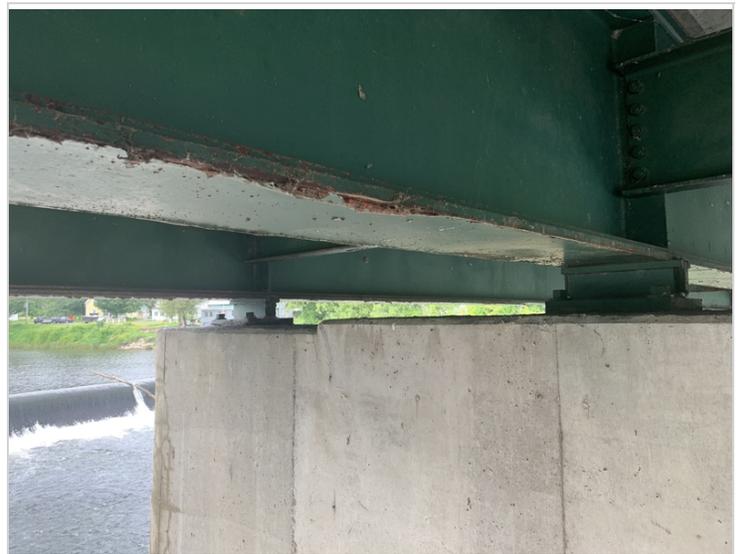
Pier 2 fixed bearings beams 5,6

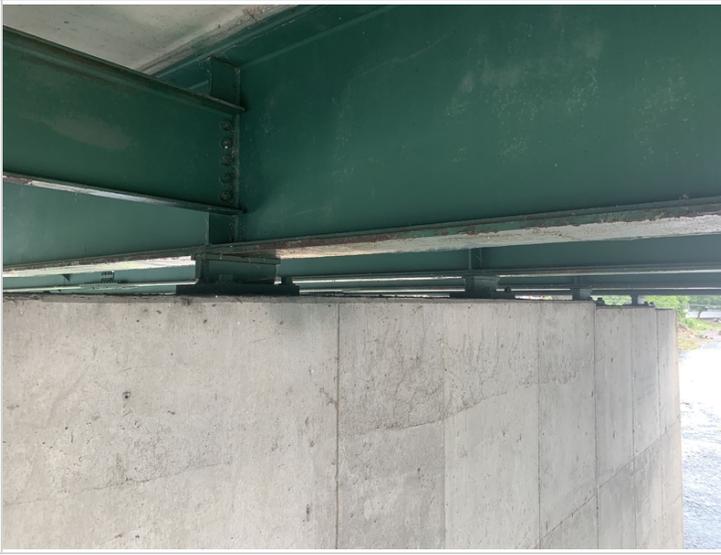
Pier 2 fixed bearings beams 1-4

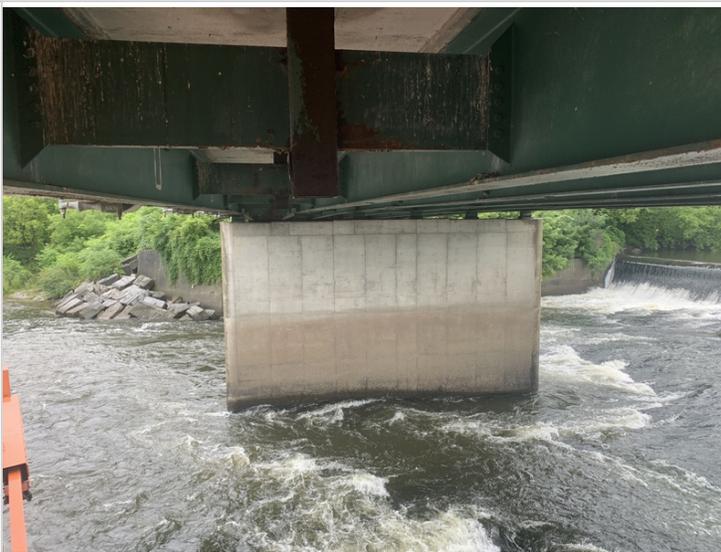
Pier 3 span 3

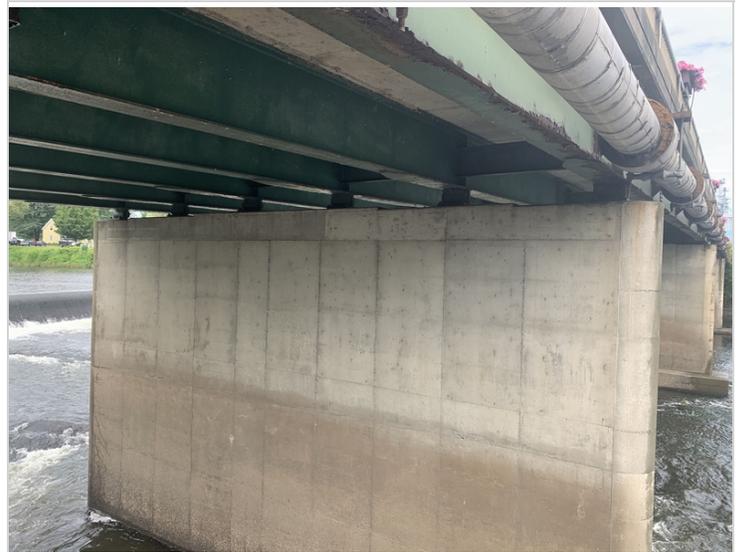
Pier 3 span 4

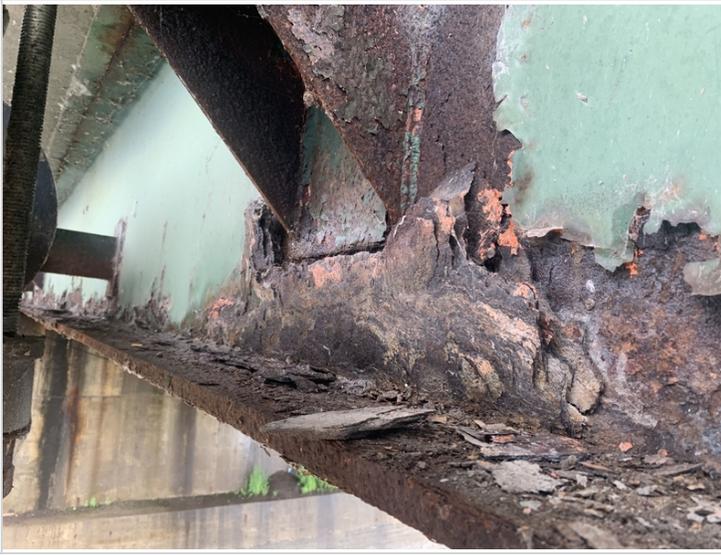
Beam 1 span 1

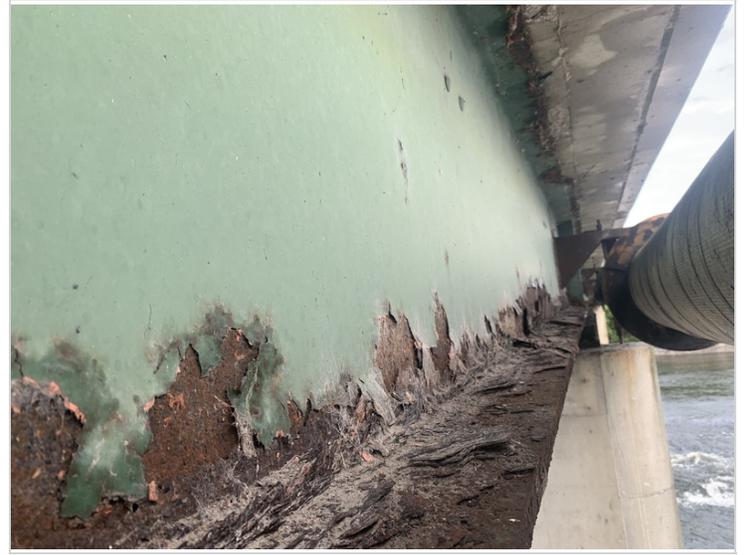
Beam 1

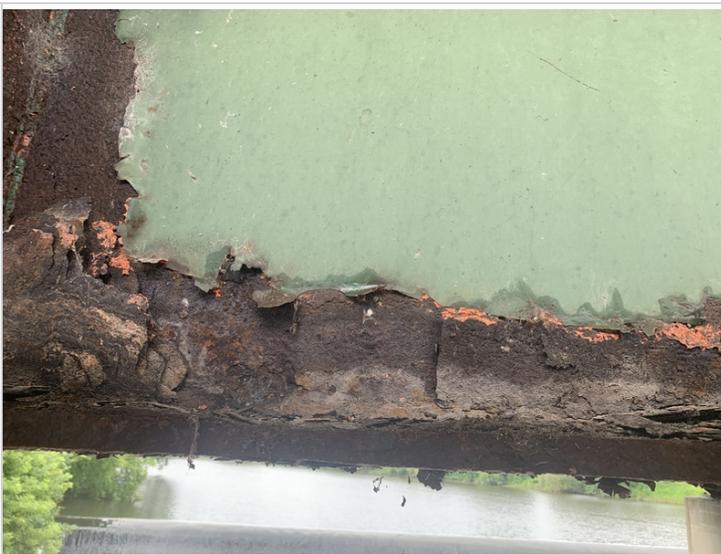
Section loss beam 1

Failed Joints over both abutments have allowed continuous leakage to structure below which has progressed steel corrosion that has minor to moderate rust scaling and is in need of cleaning and painting. Beam #1 throughout also has built up rust scaling along the outer lower flange and should be cleaned and painted to prevent further corrosion.

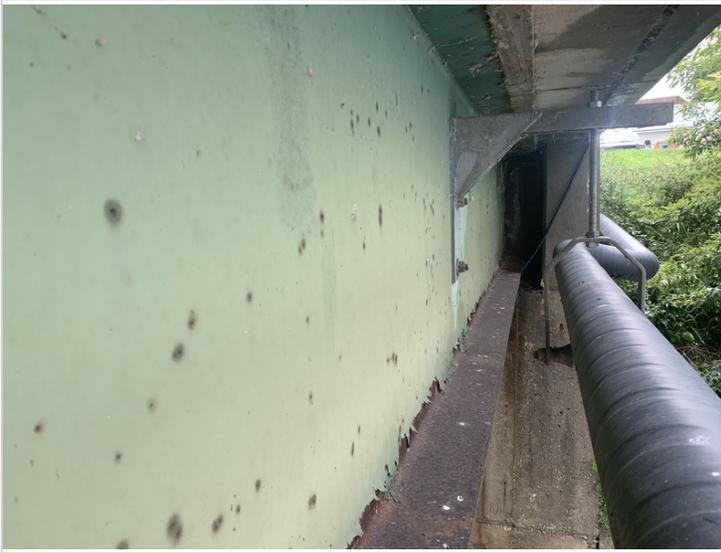
Beam 6 span 4

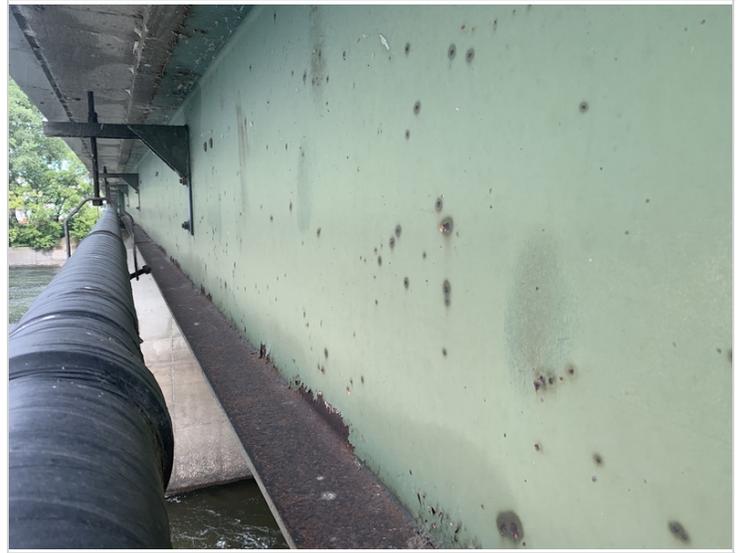
Beam 6 looking west

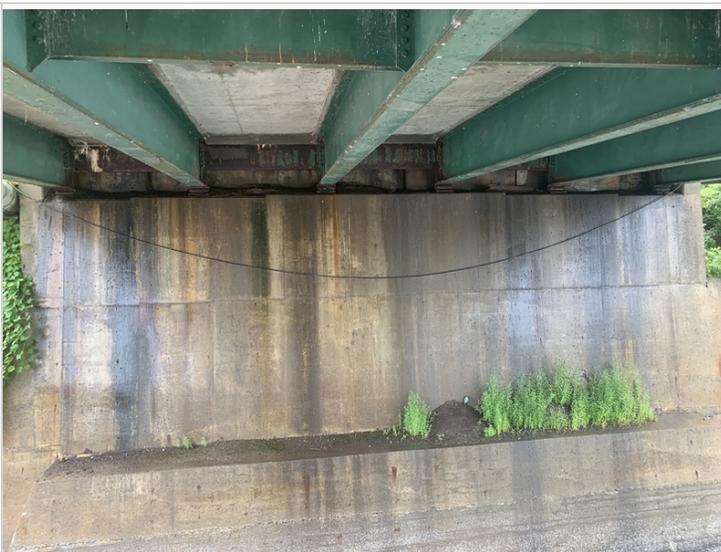
Abutment 2

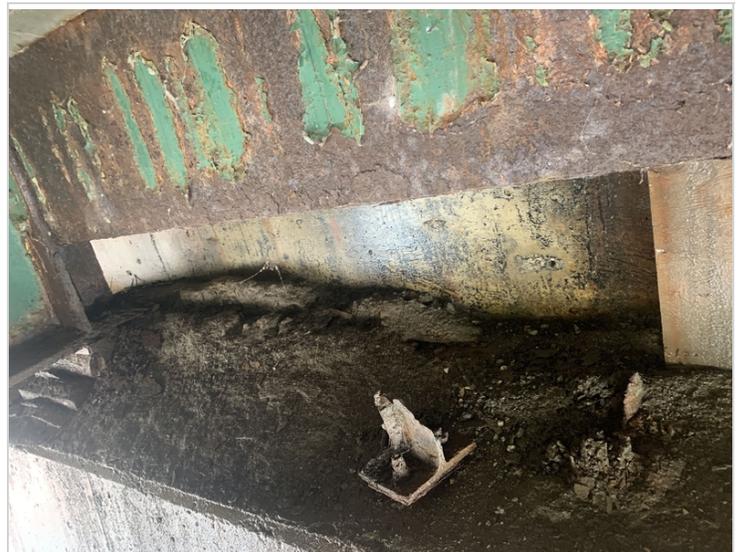
Debris on abutment 2 seat

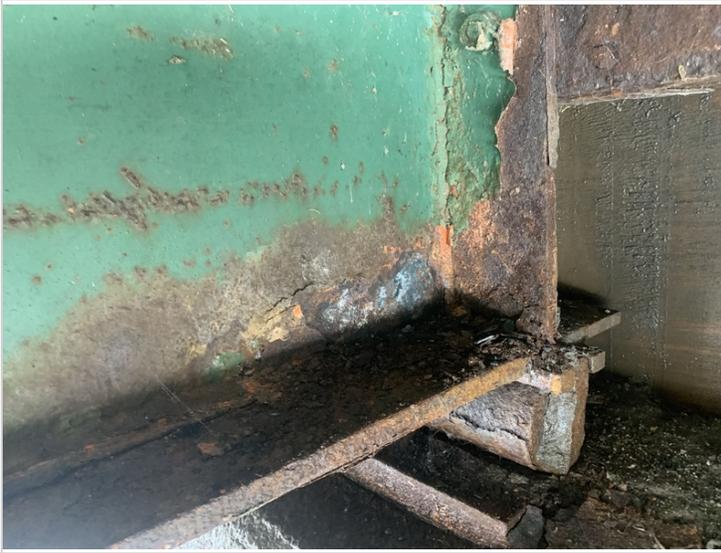
Section loss beam ends abutment 1

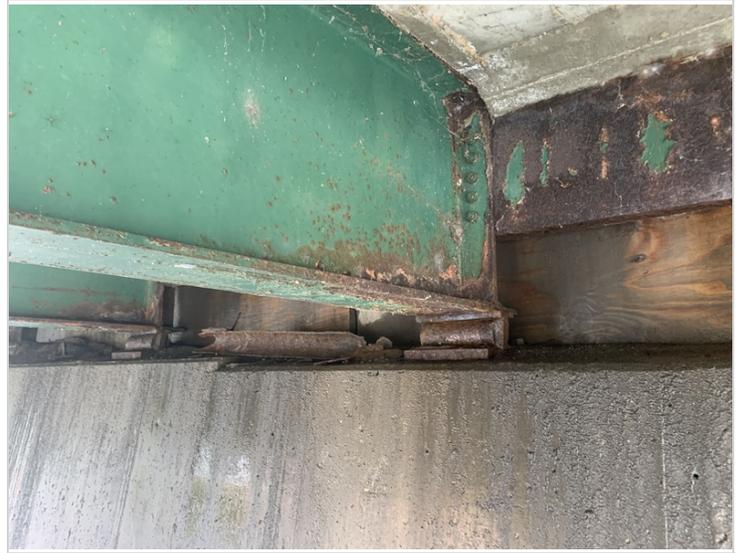
Wood blocking along back wall from bay 3 to upstream end

Joints have had some temporary repair work done to plug holes that have developed in the roadway.

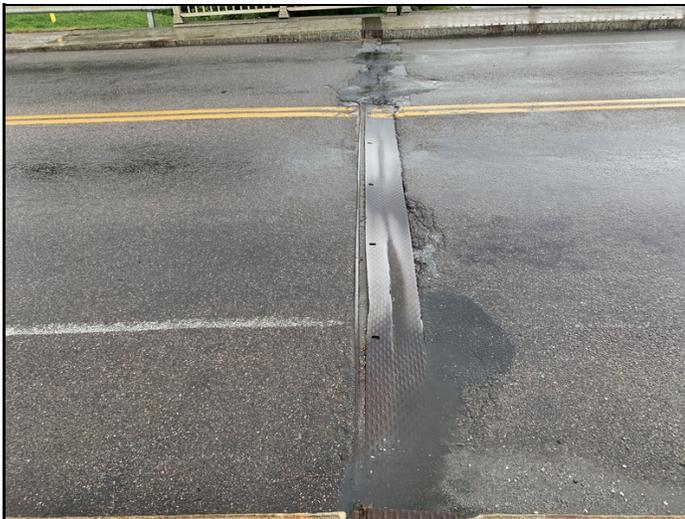
8/8/23 joints have failed over half of the bridge and have wood temporary supports installed to fix holes that have developed. Sliding steel plate joints are present over both abutments having failed and wide cracking with bending over the other half. The steel plates will continue to fail on the other lane. The joints need a more permeant repair as the wood and existing steel plate will fail again. Troughs have areas of heavy section loss and have failed in multiple locations. Joints allow heavy leakage to structure below and have built up ~12" of debris and sediment along abutment bridge seats. Joint are in need of major rehab or full replacement over both abutments.

Abutment 2 joint

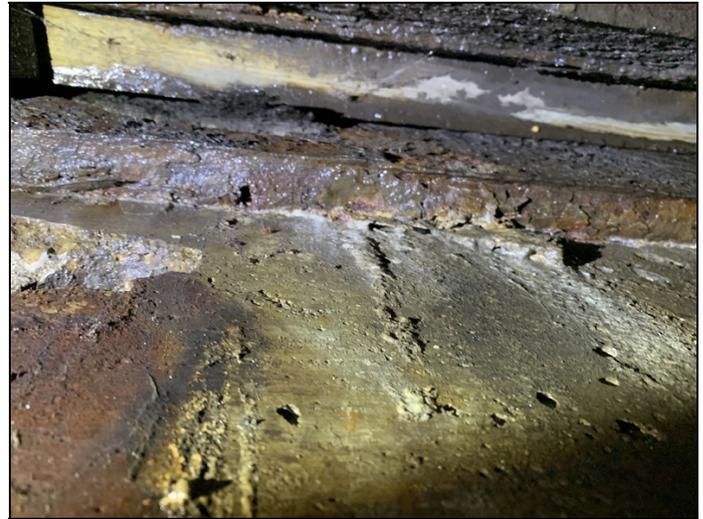
Wood used to support joint abutment 1

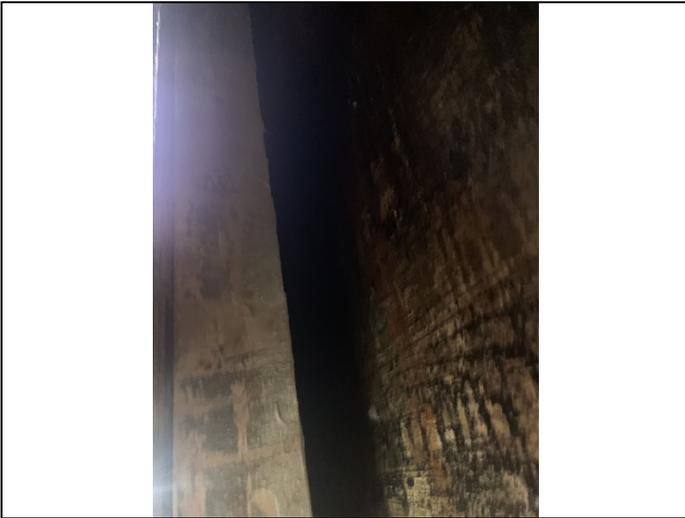
plywood temporary form work abutment 1

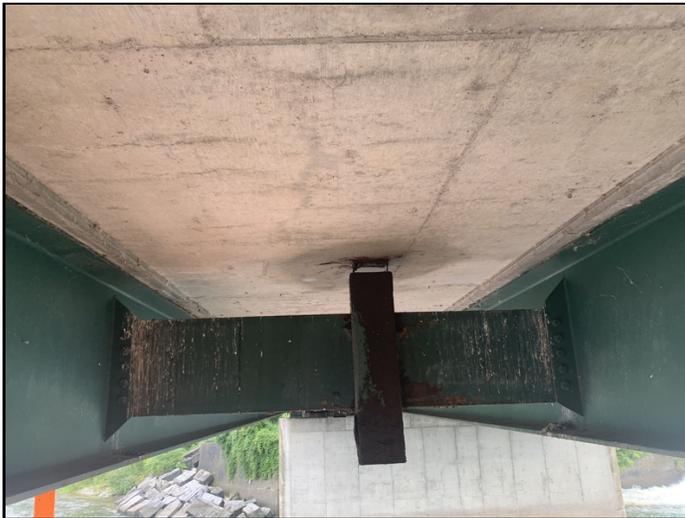
Deck drains along both the upstream and downstream sides have been previously repaired however have full perimeter perforations present at the deck soffit and continue to allow leakage to structure below and should be replaced.

Typically drain

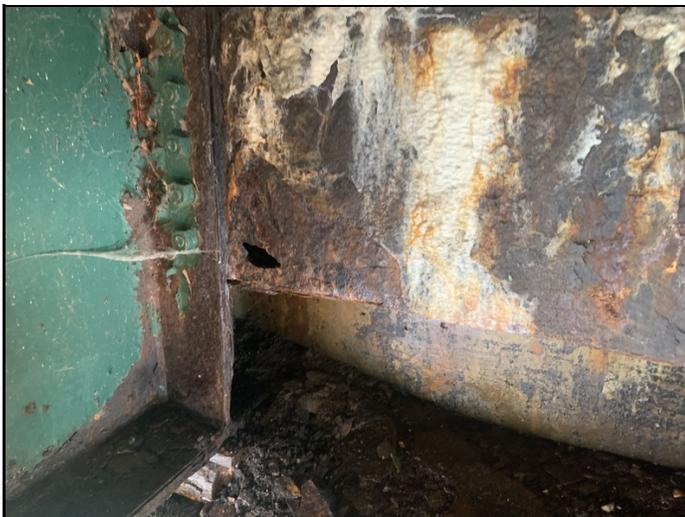
hole in the diaphragm

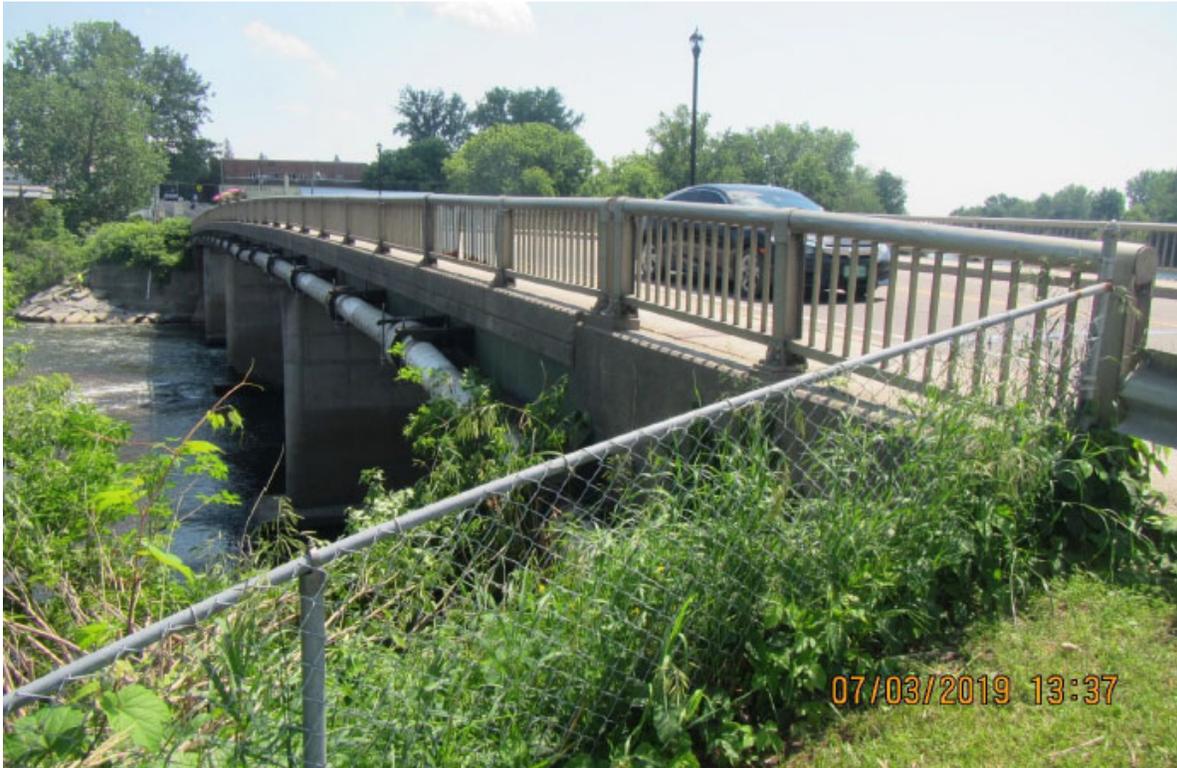
Figure 1. Facing south at northern end of bridge. Note utility alongside bridge for full length, and light pole on bridge.

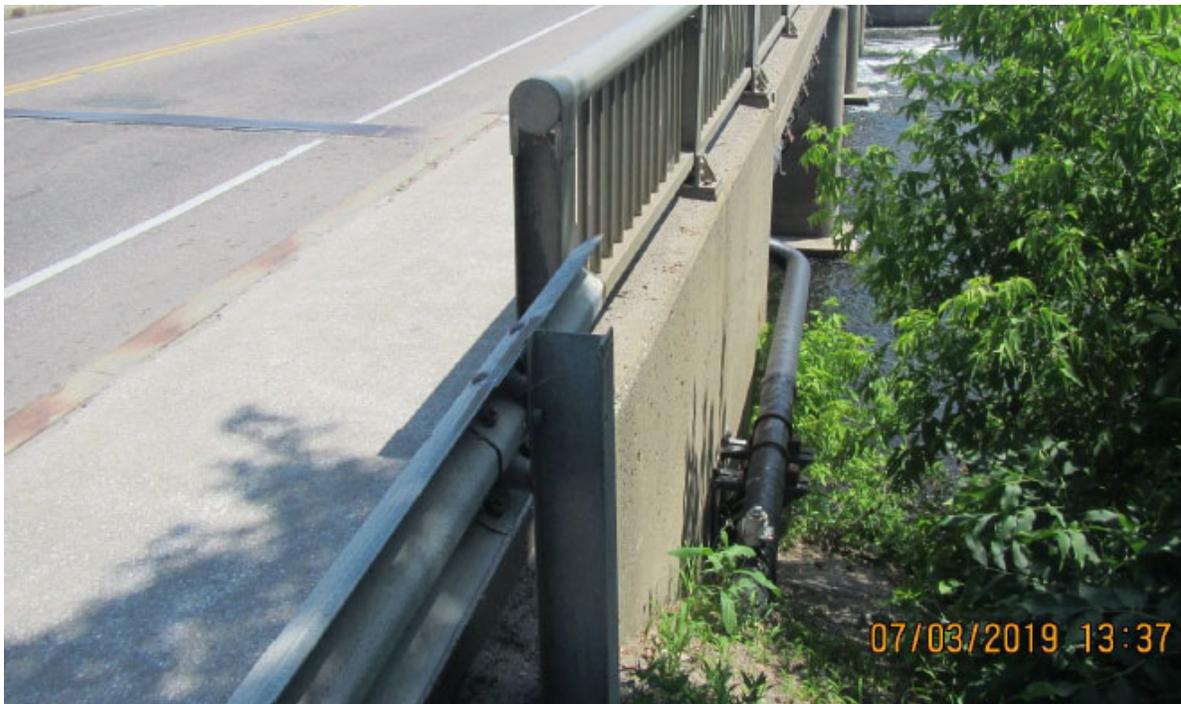
Figure 2. Facing south at northern end of bridge. Note utility alongside bridge and under abutment.

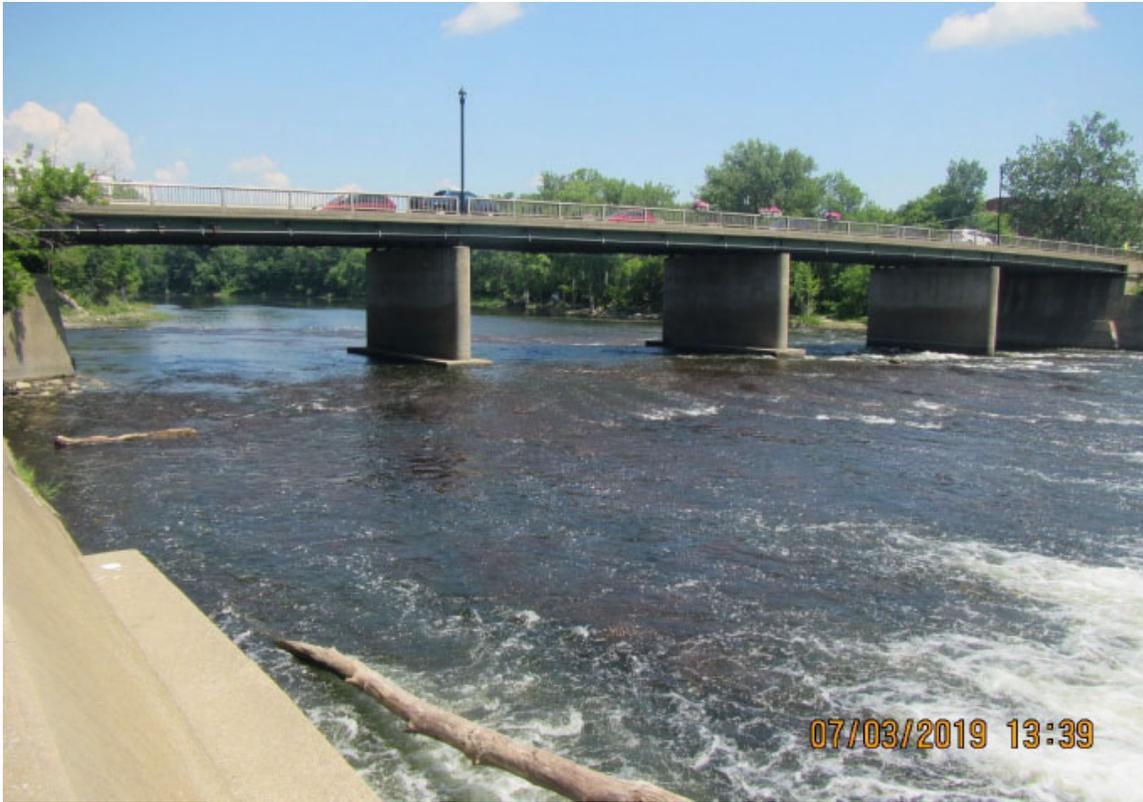
Figure 3. Facing upstream at structure, note pier locations and utilities

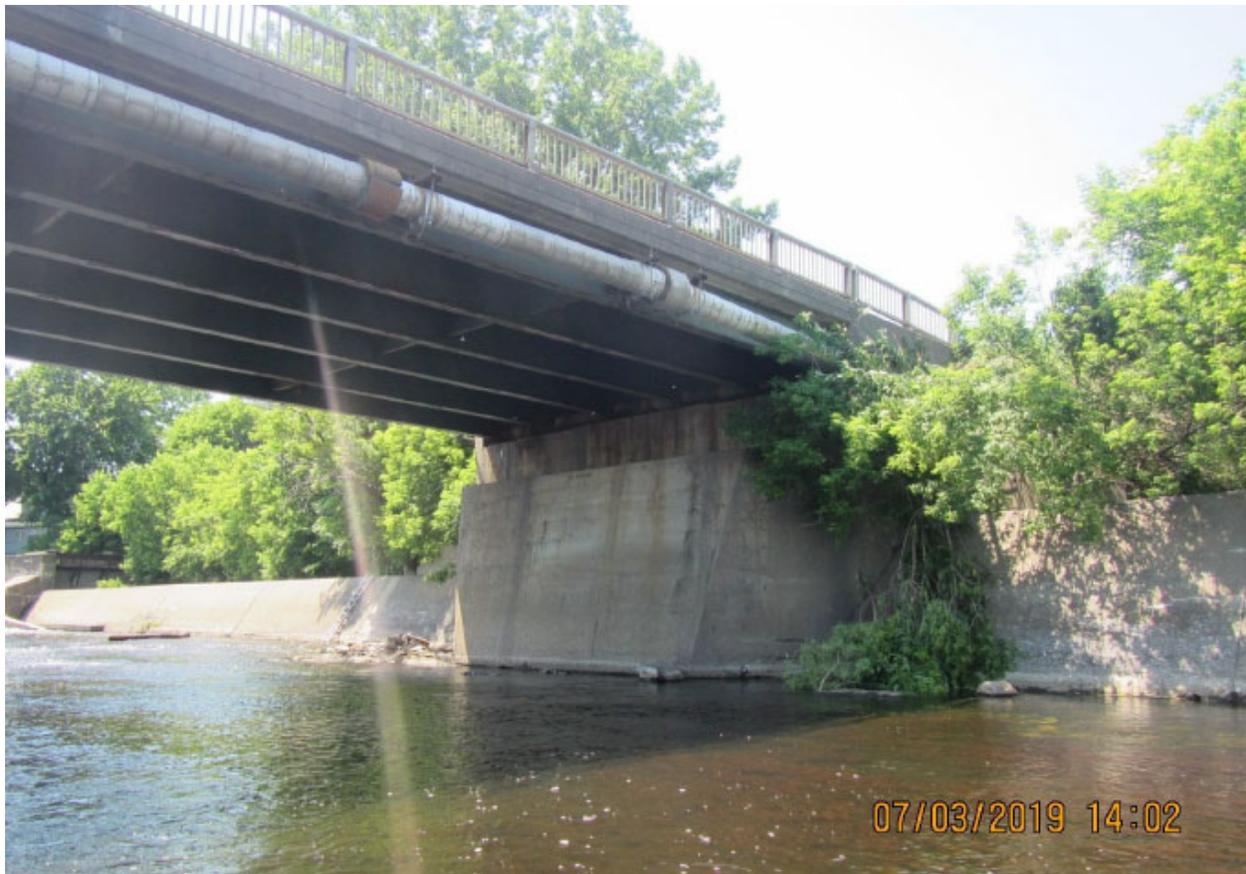
Figure 5. Facing northern abutment. Note utility on bridge and retaining walls adjacent to abutment.
