Local Concerns Meeting

Upper Cox Brook Covered Bridge

Lower Cox Brook Covered Bridge

Northfield Falls Covered Bridge

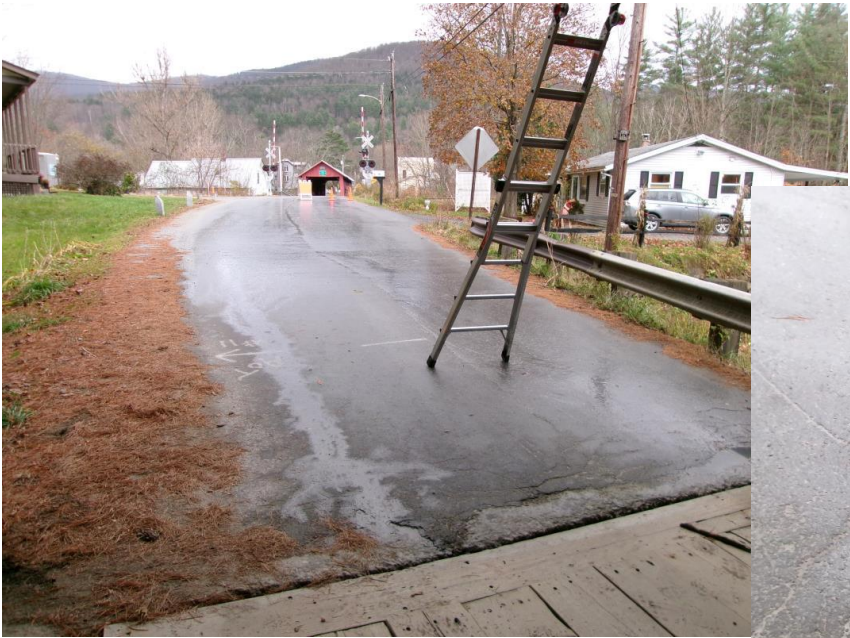
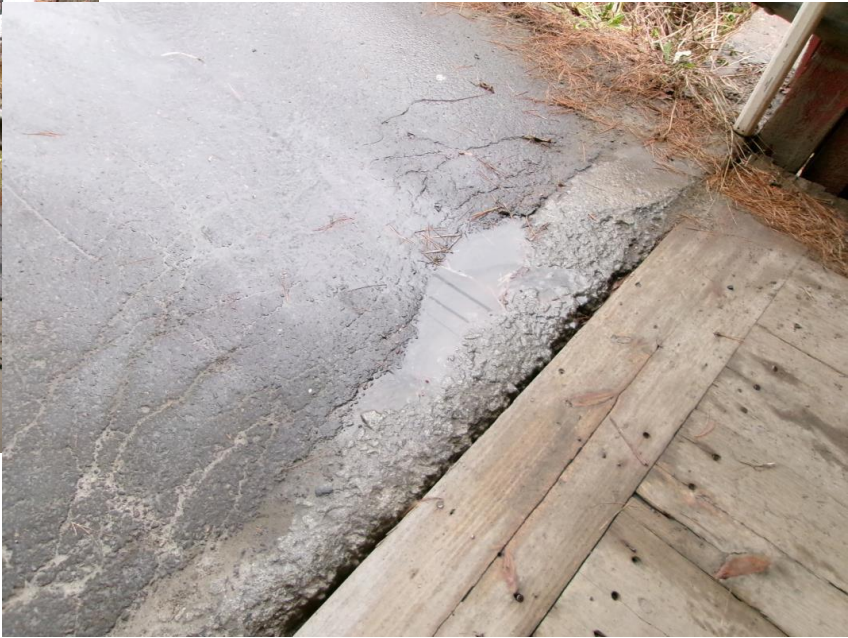
Approaches

- Drainage Issues
- Ponding

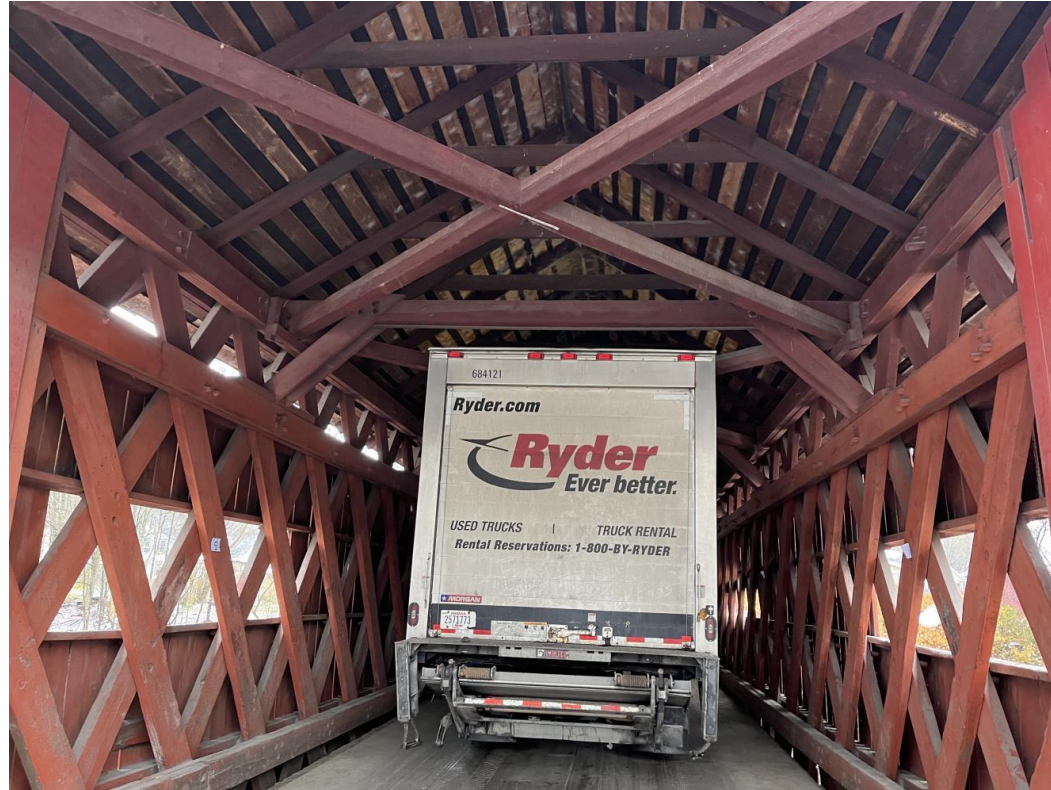
Access

- Oversized Vehicles
