Draft Scoping Report Upper Cox Brook Covered Bridge Town Highway 3 Bridge 10 over Cox Brook

Northfield BO CVBR(7)

January 24, 2026

Prepared for:
Vermont Agency of Transportation

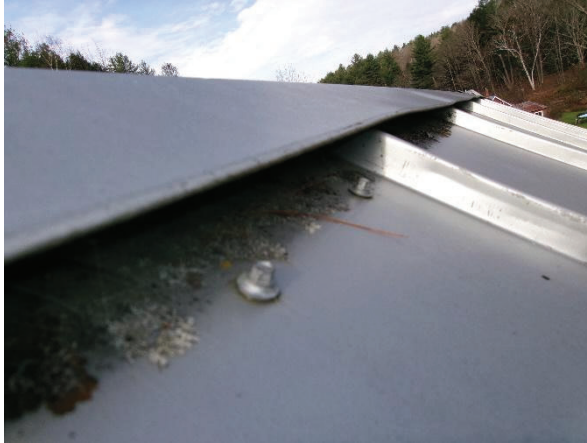
Roof Ridge Cap

- The metal roof ridge cap is attached to the roof boards with nails and screws and is not mechanically field-seamed or watertight. There is some moss growth under the roof ridge cap.
- The roof boards and rafters exhibit through splits, breaks, rot and insect damage. Rafters sit on a 3"x7" rafter support beam.
- The siding boards exhibit areas of faded paint. The siding is in good condition; however, removal and replacement will likely be required to provide access for the extensive superstructure member replacements.

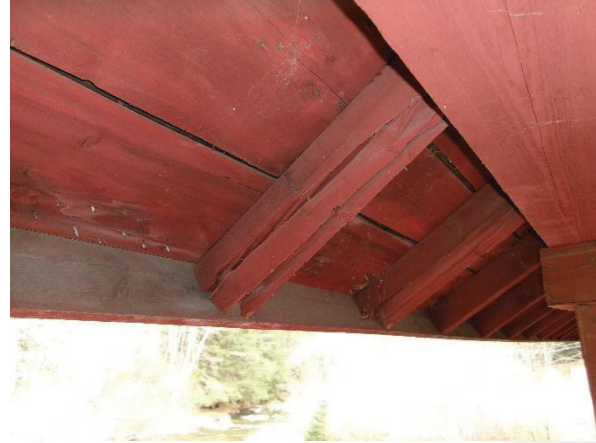
Splits and Breaks in Roof Boards and Rafters

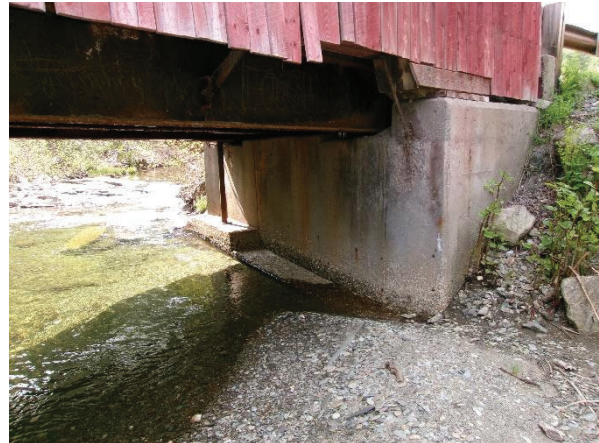
North Abutment

- Both abutments exhibit some areas of concrete spalling, delamination, exposed rebar, efflorescence staining, and vertical, horizontal, and map cracking.
- At the spalled areas the concrete was observed to contain rebar.

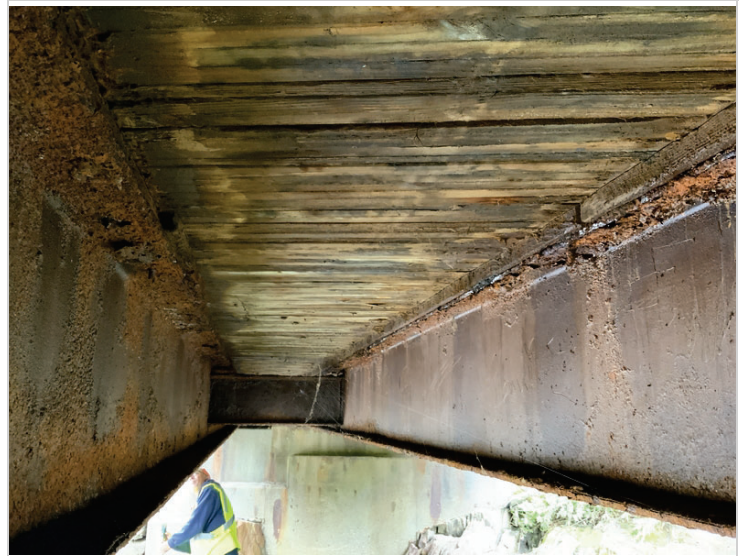
Deck

Heavy saturation throughout with mildew staining and fuzzy mold. The boards are starting to split and check apart from decaying wood in the surrounding areas of the beams.

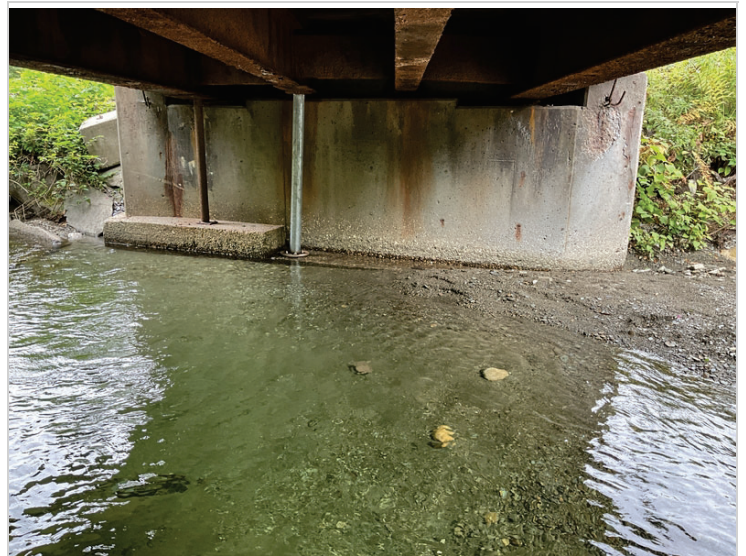
Abutment 1 has scattered shrinkage cracks throughout with small areas of rust stains. Abutment 2 small surface spall in the downstream end and fine vertical shrinkage crack in the upstream end with minor rust staining

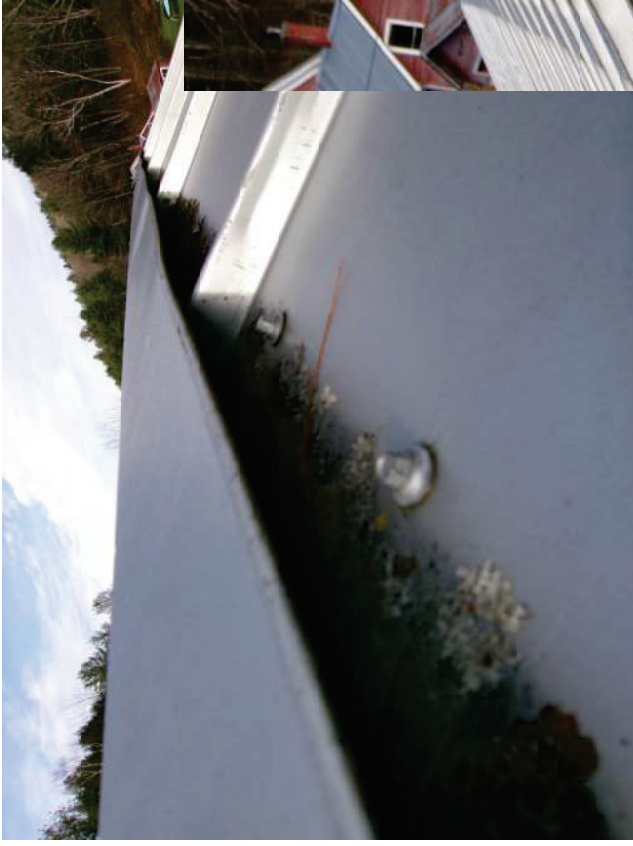
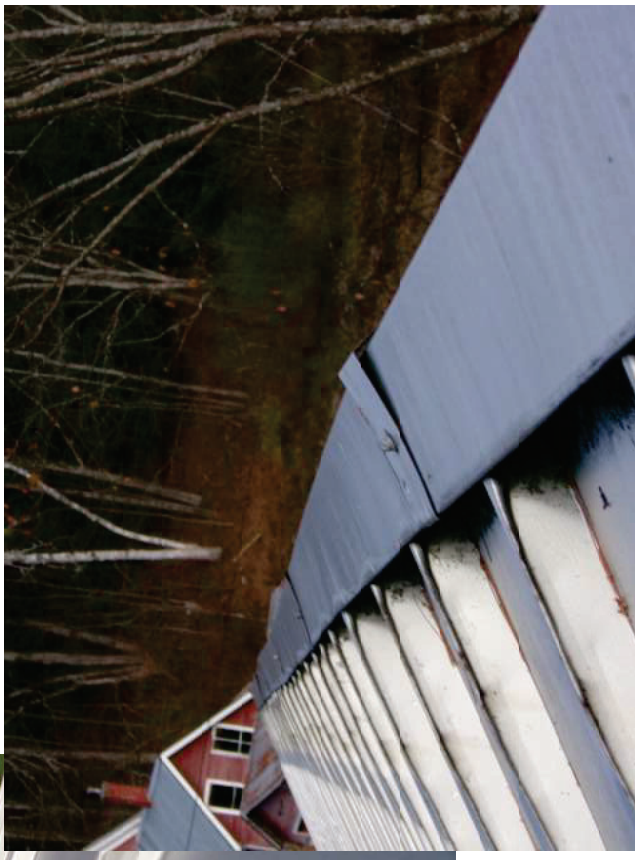
Metal Roof

- Leaks
- Screw Attachment

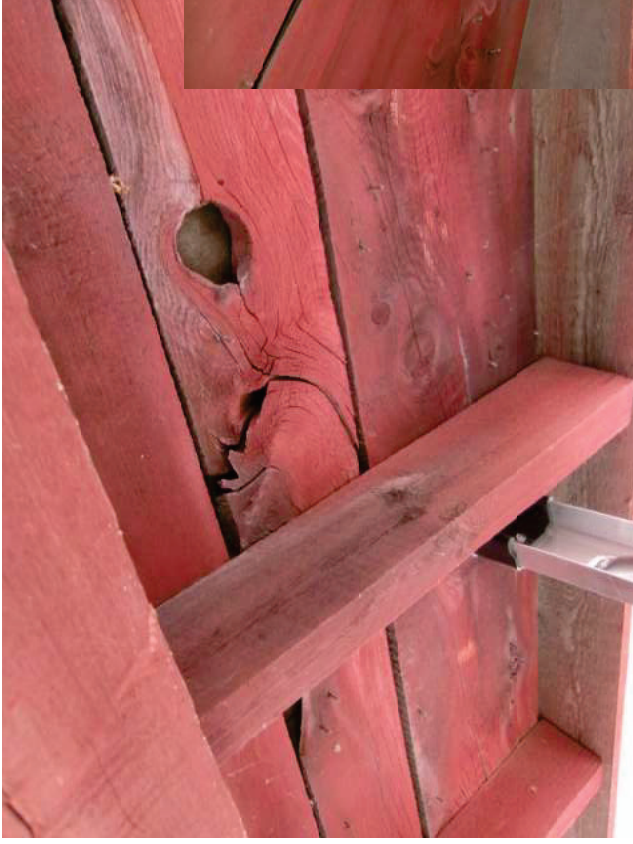
Roofboards and Rafters

- Splits
- Breaks
- Rot

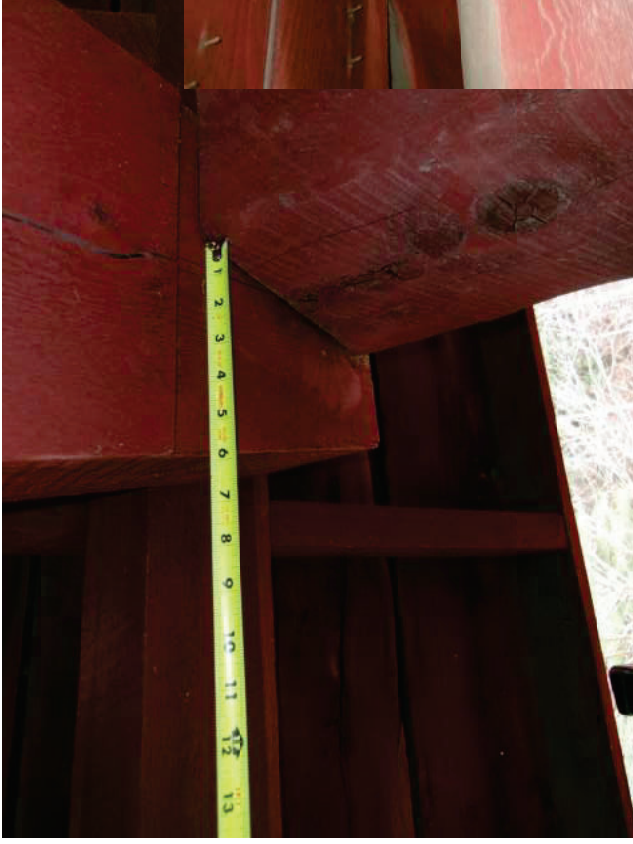
Upper Bracing Members

- Splits
- Breaks
- Rot
- Impact Damage

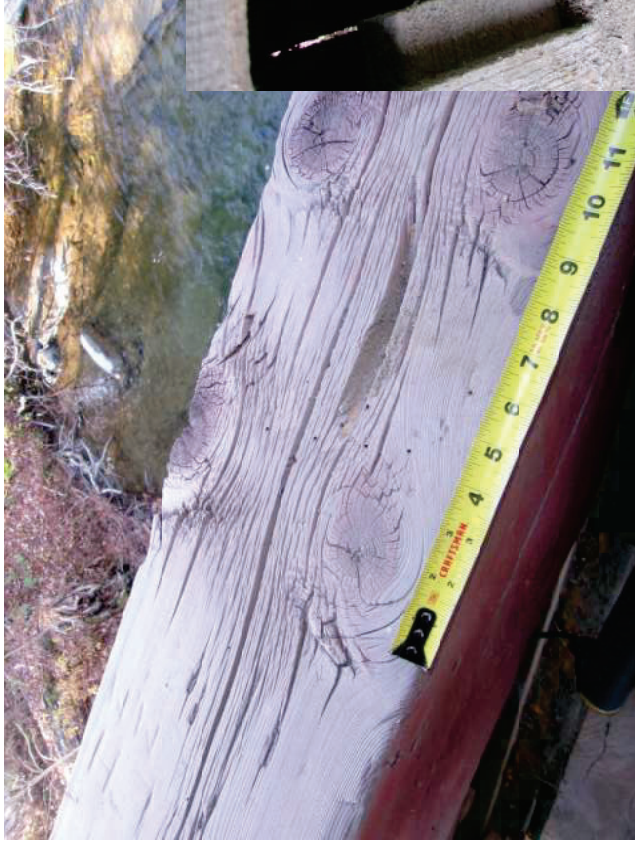
Truss Members

- Splits
- Breaks
- Rot
- Weathering
- High Moisture Content

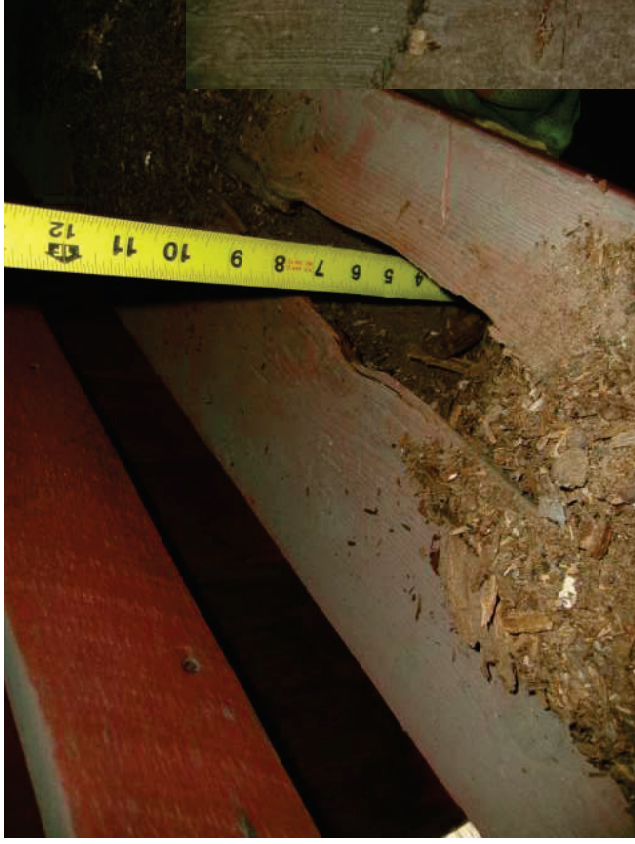
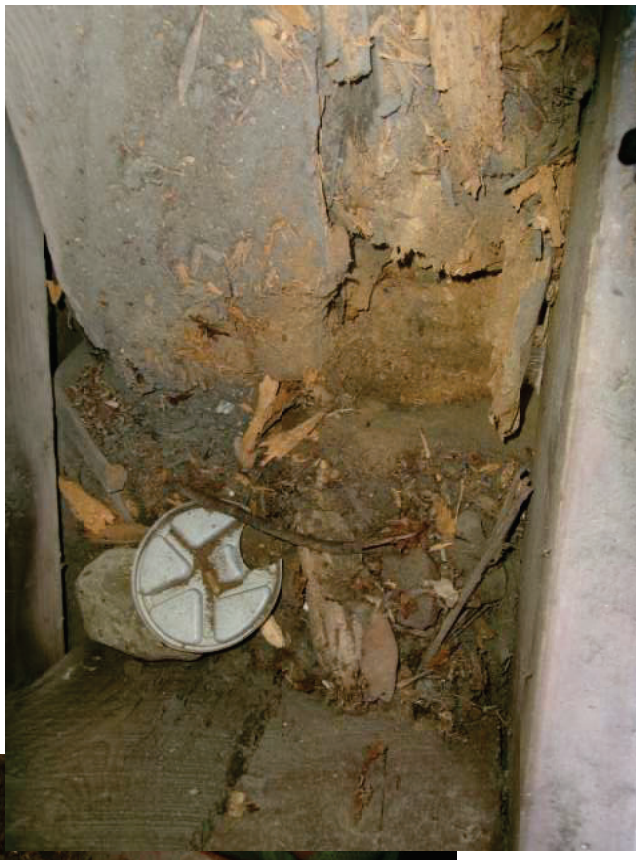
Truss Members (Continued)

- Splits
- Breaks
- Rot
- Weathering
- High Moisture Content

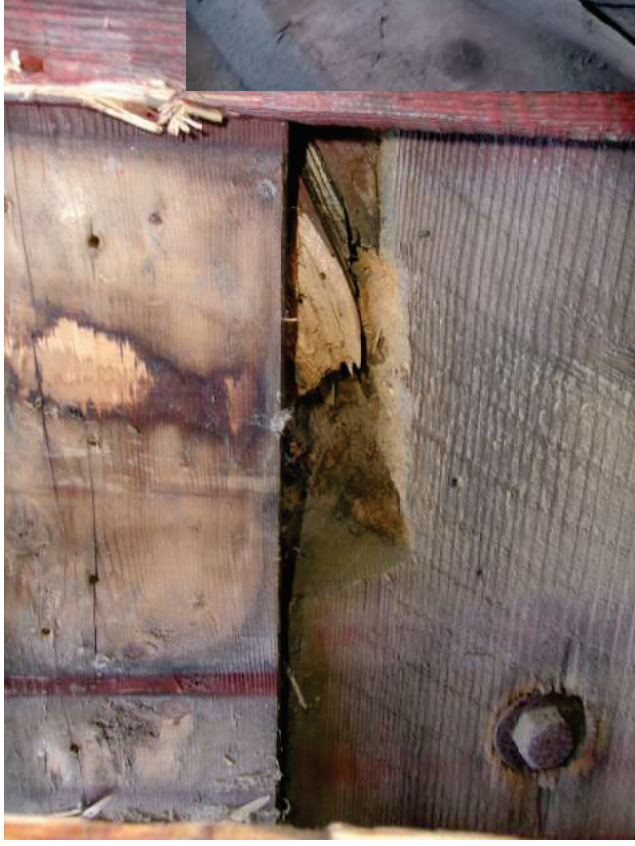
Truss Members (Continued)

- Splits
- Breaks
- Rot
- Weathering
- High Moisture Content

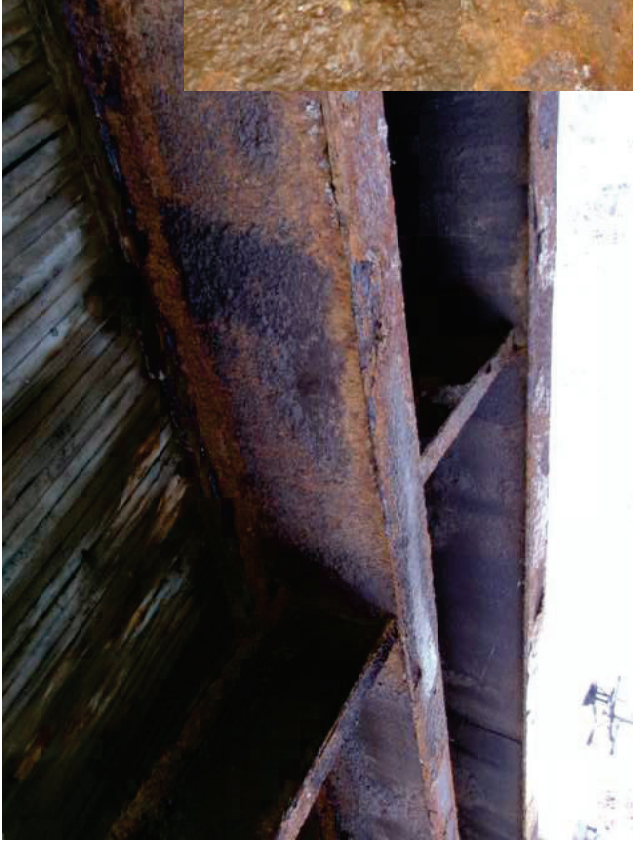
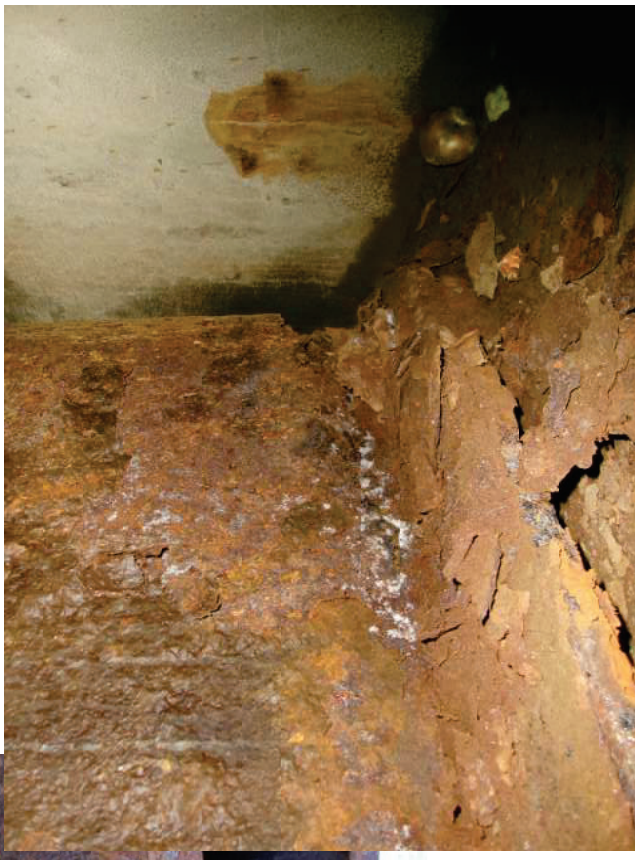
Steel Beams

- Rust Holes
- Advanced Corrosion

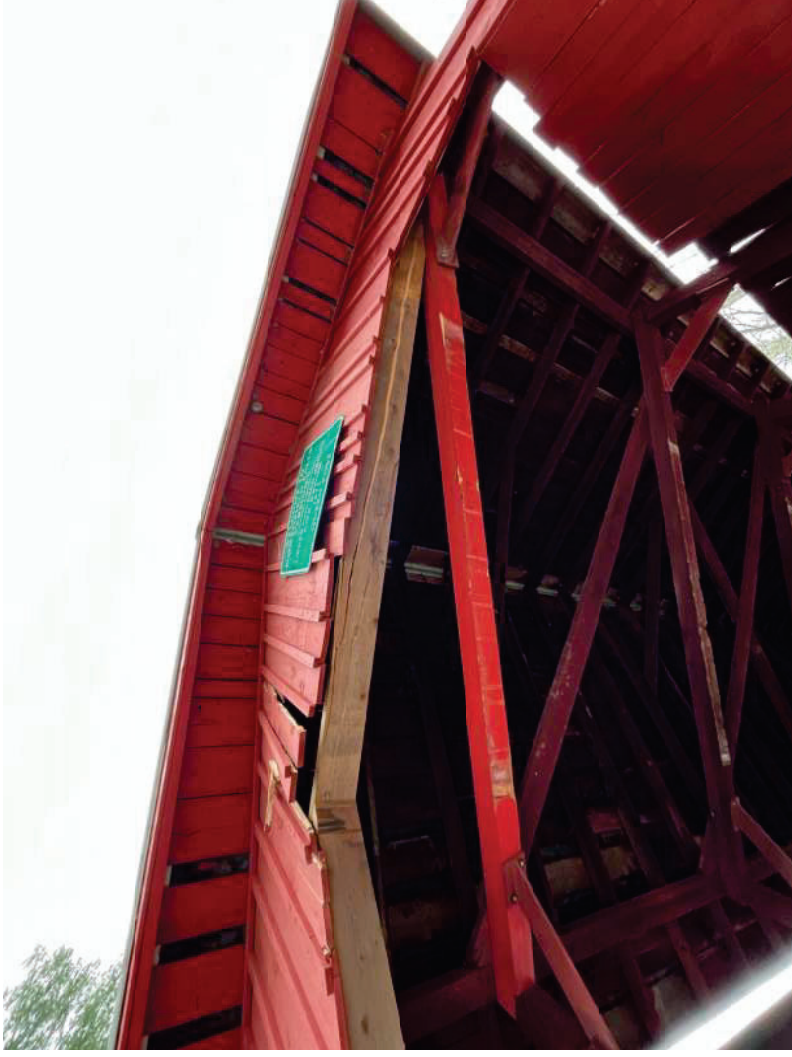
Portals

- Breaks
- Impact Damage

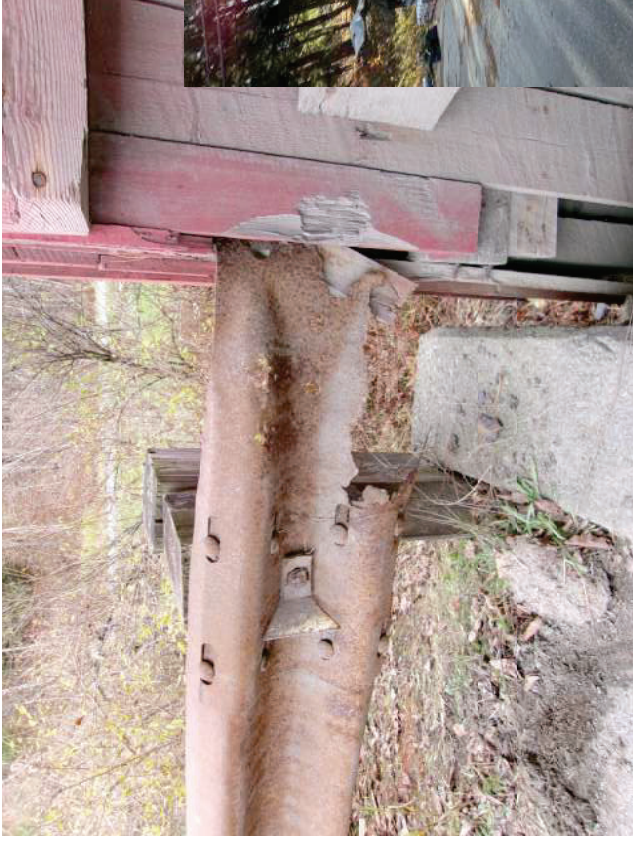
Approach Railing

- Extensive Corrosion
- Rust Holes
- Rotted Wood Posts
- Impact Damage

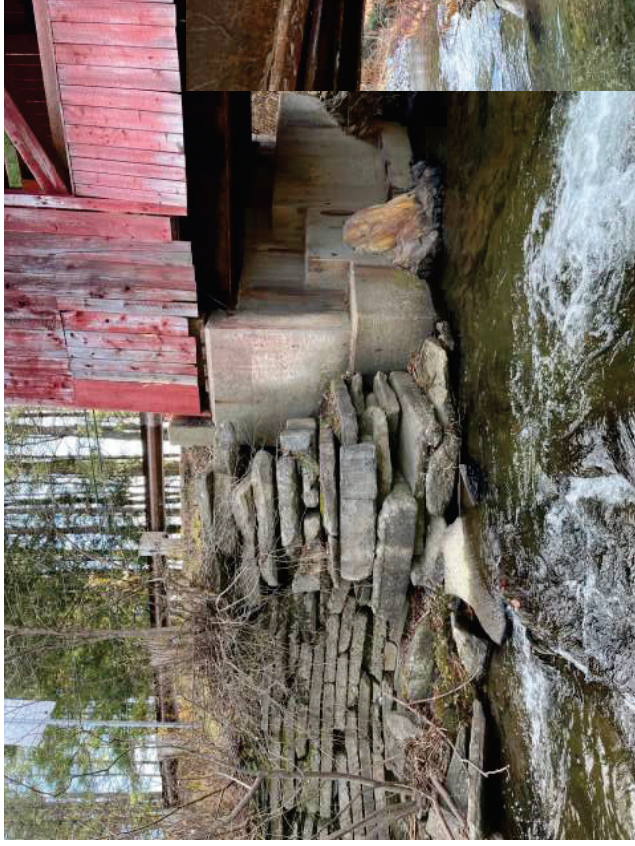
Abutments

- Voids
- Spalling
- Exposed Rebar

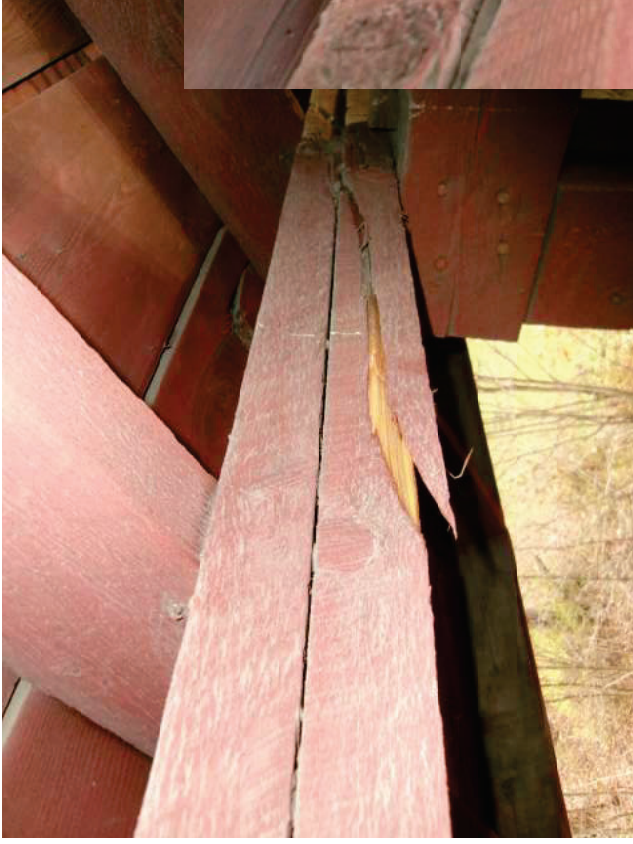
- Splits
- Breaks
- Rot
- Insect Damage

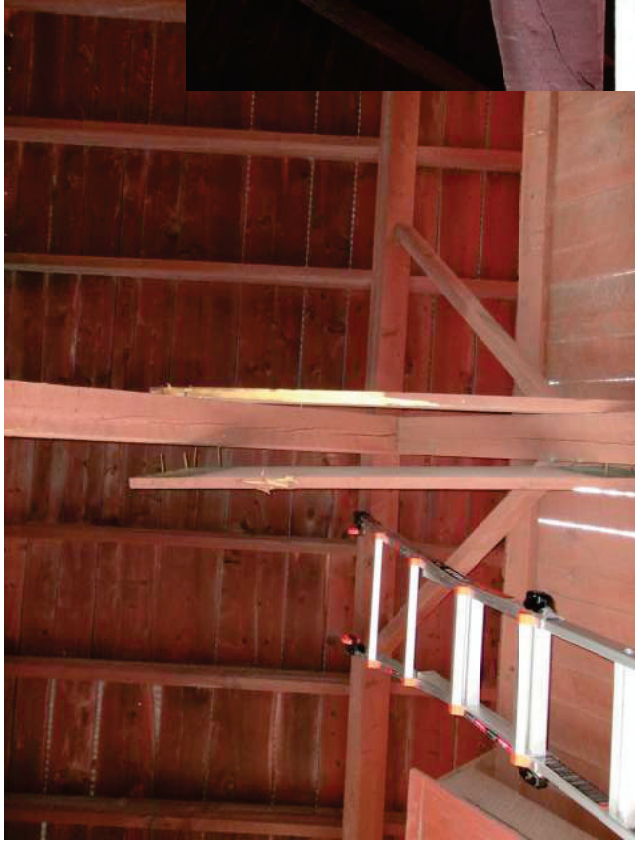
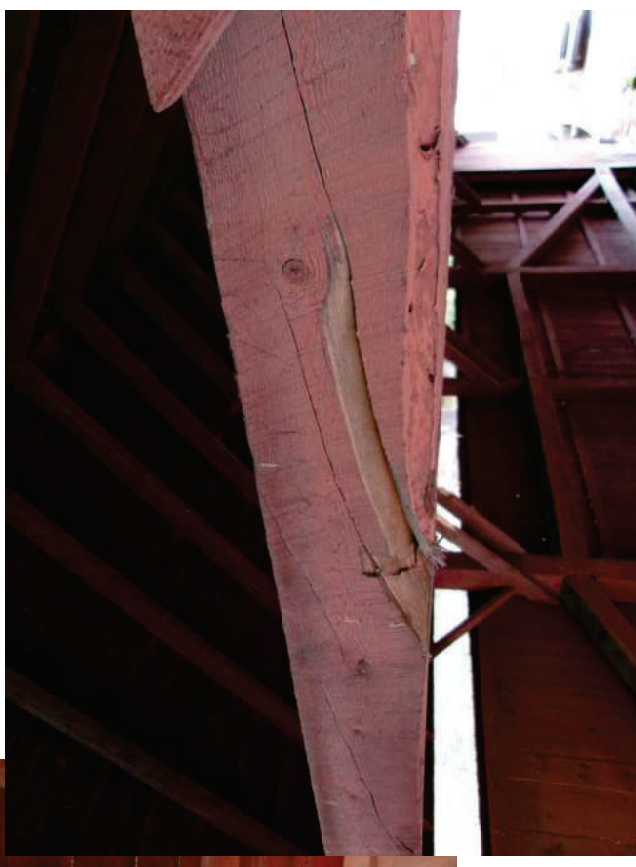
Upper Bracing Members

- Splits
- Breaks
- Rot
- Impact Damage

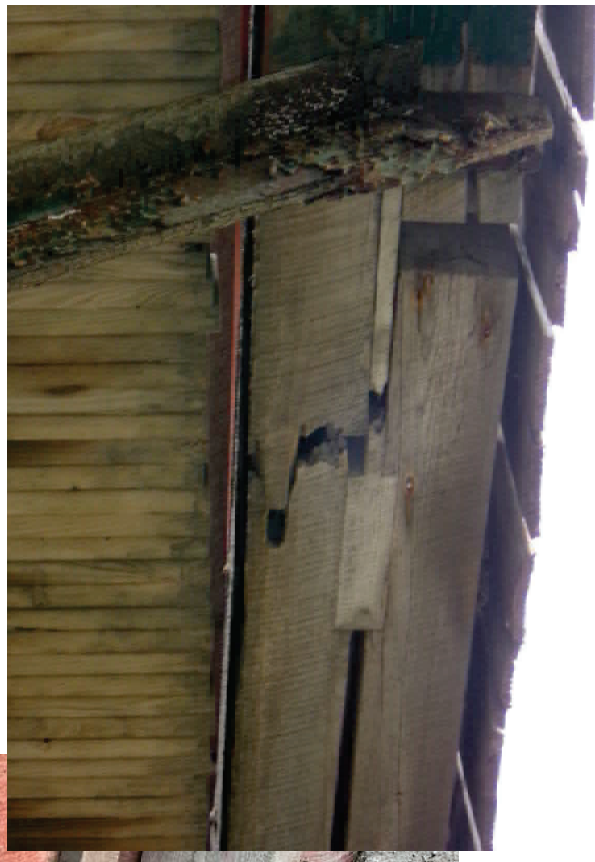
Truss Members

- Splits
- Breaks
- Rot
- High Moisture Content

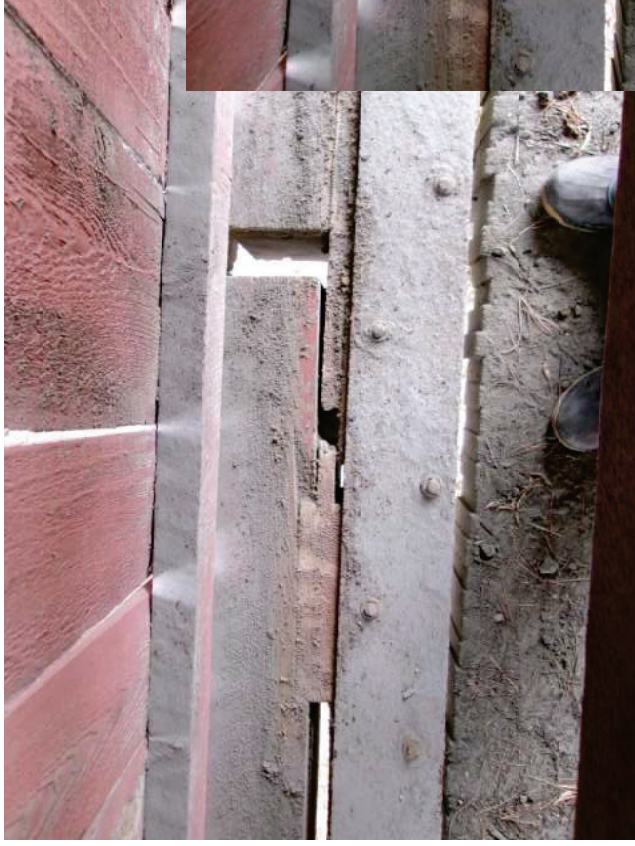
Truss Members (Continued)

- Splits
- Breaks
- Rot
- High Moisture Content

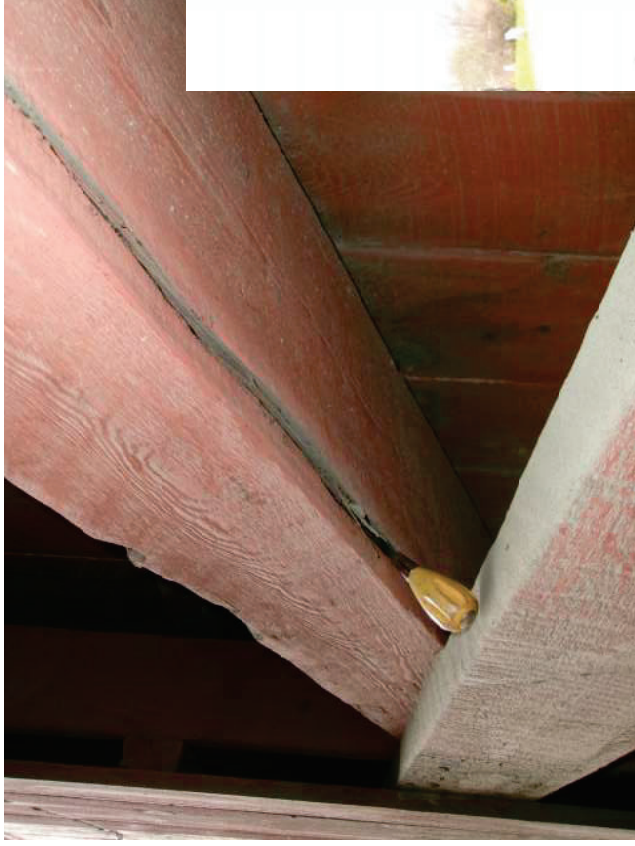
Truss Members (Continued)

- Splits
- Breaks
- Rot
- High Moisture Content

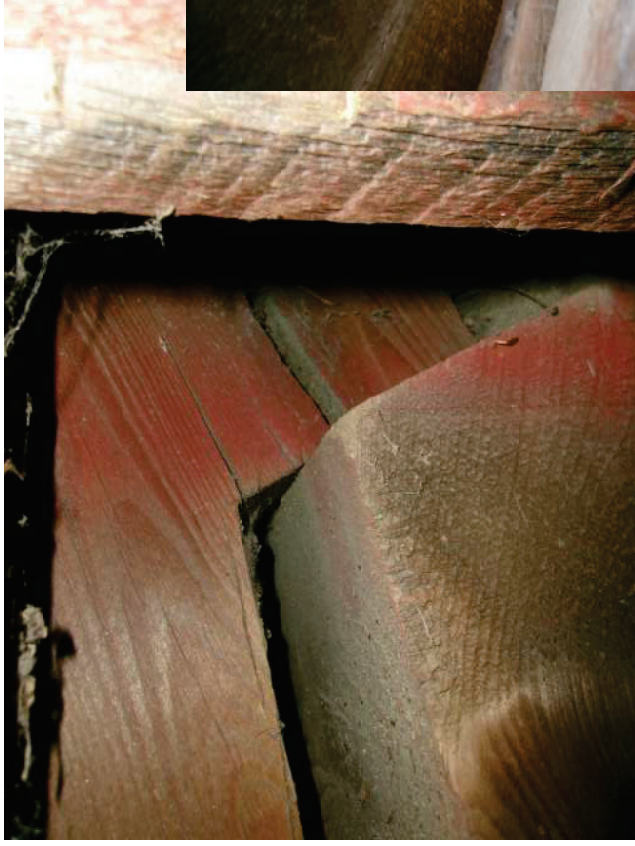
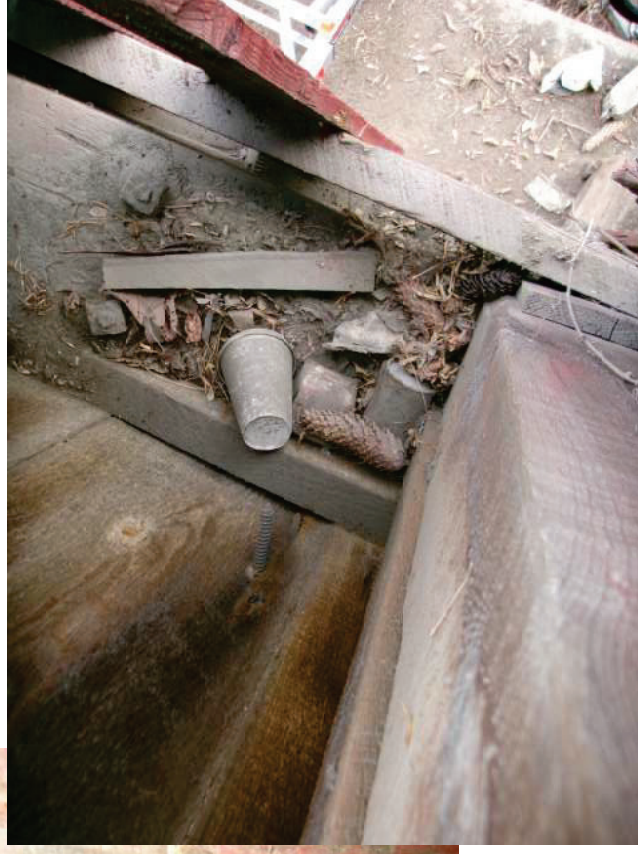
Truss Members (Continued)

- Splits
- Breaks
- Rot
- High Moisture Content

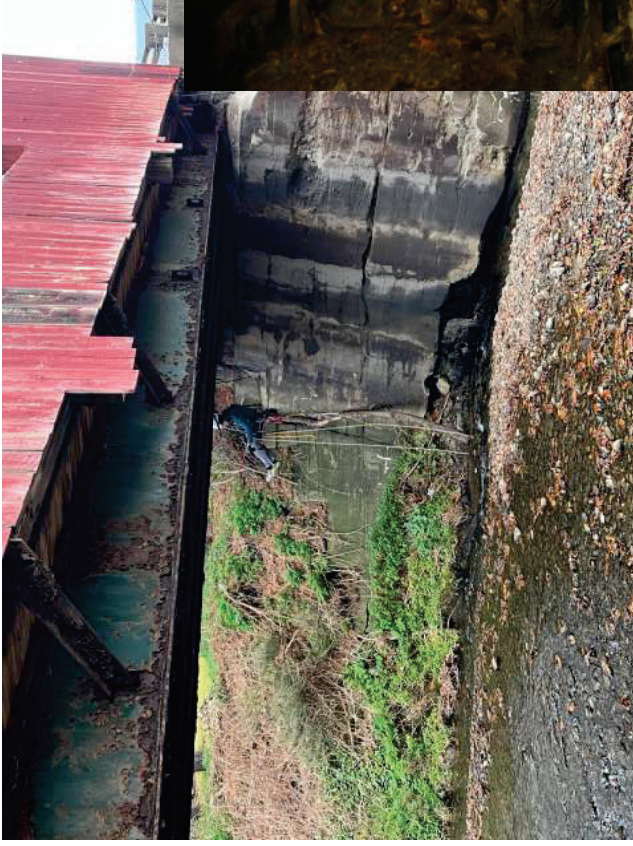
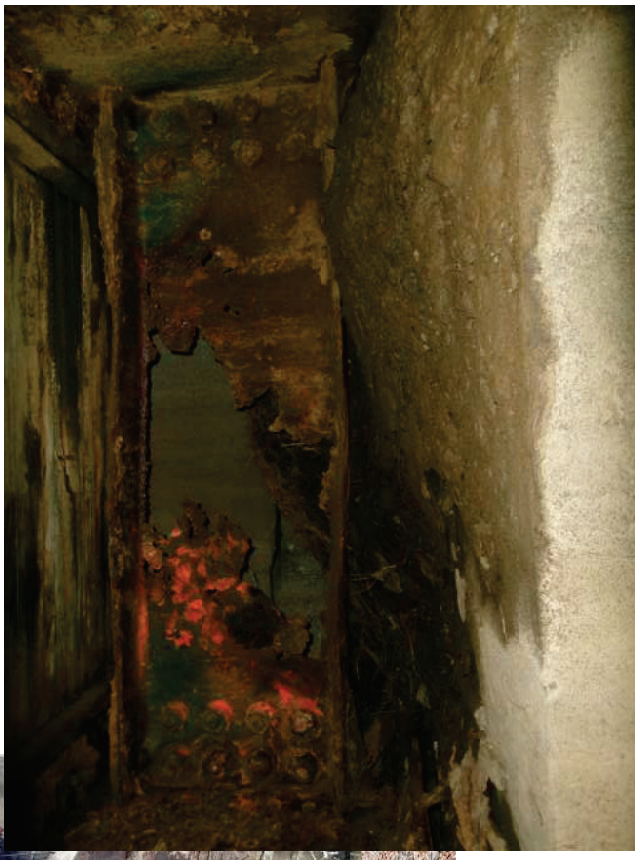
Steel Beams

- Rust Holes
- Advanced Corrosion

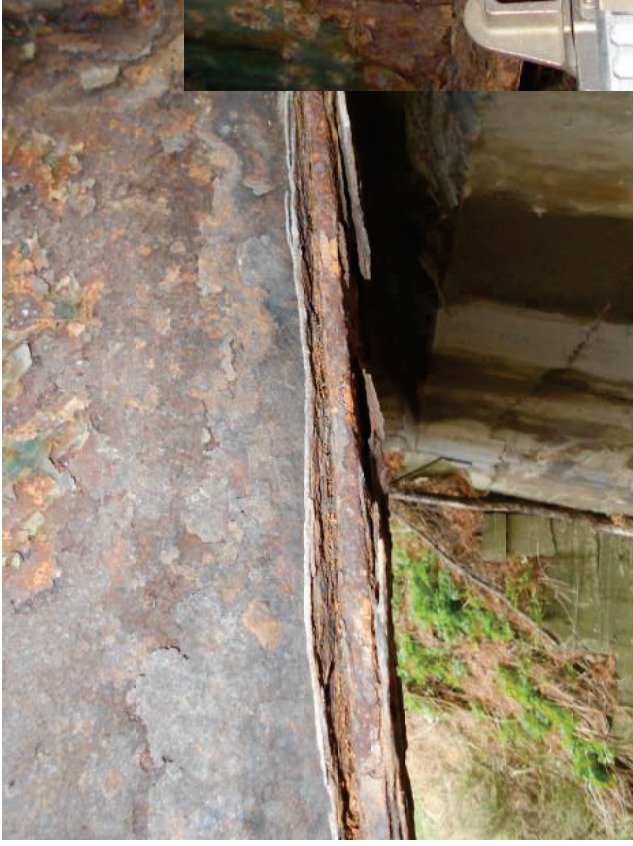
Steel Beams (Continued)

- Rust Holes
- Advanced Corrosion

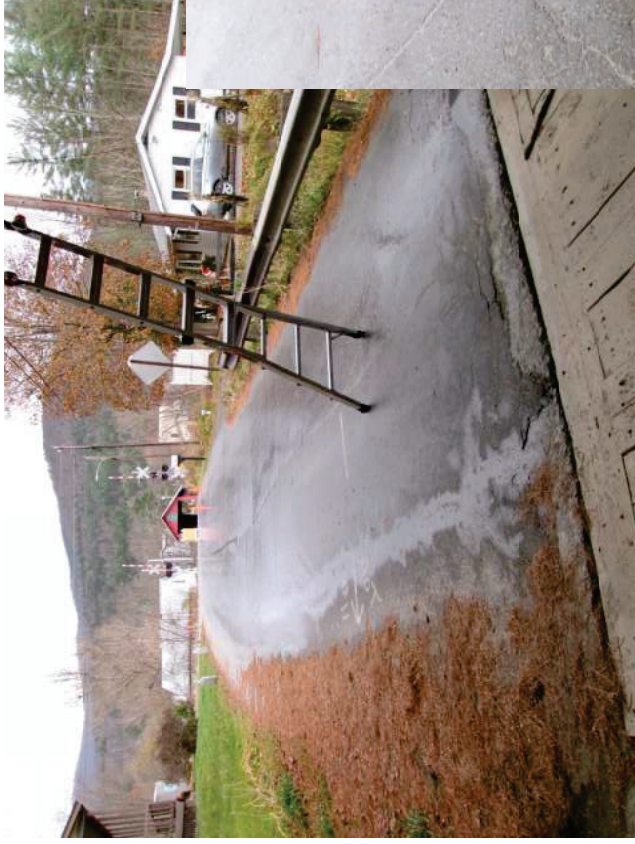
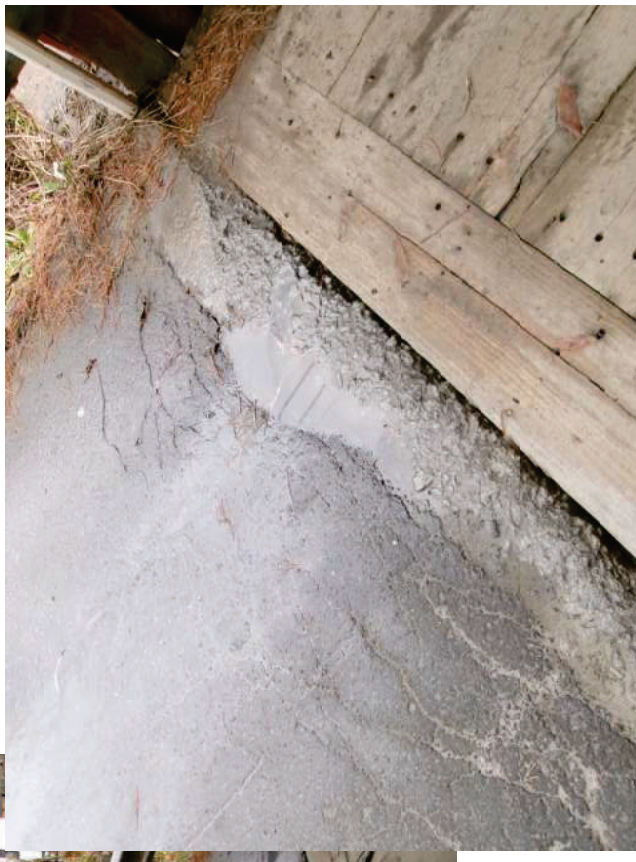
Approaches

- Drainage Issues
- Ponding

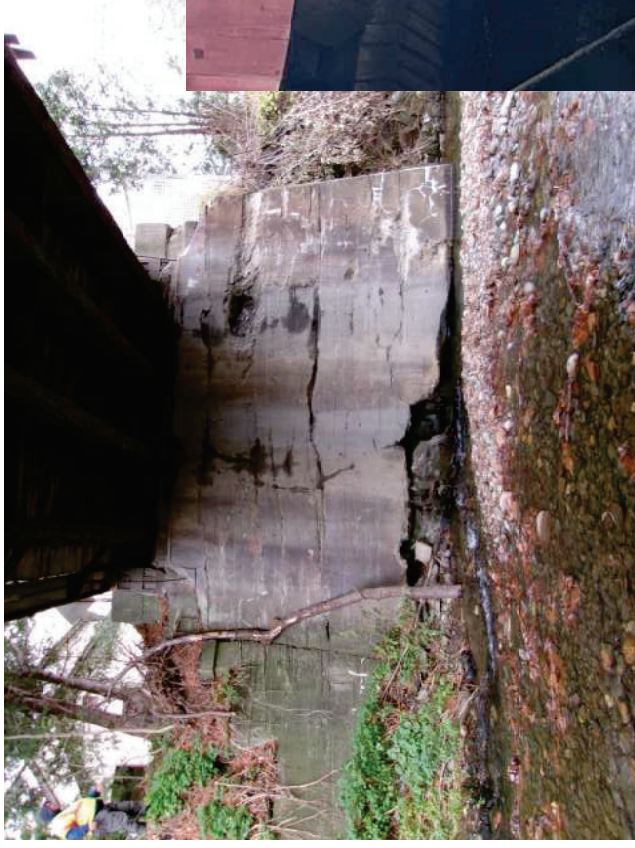
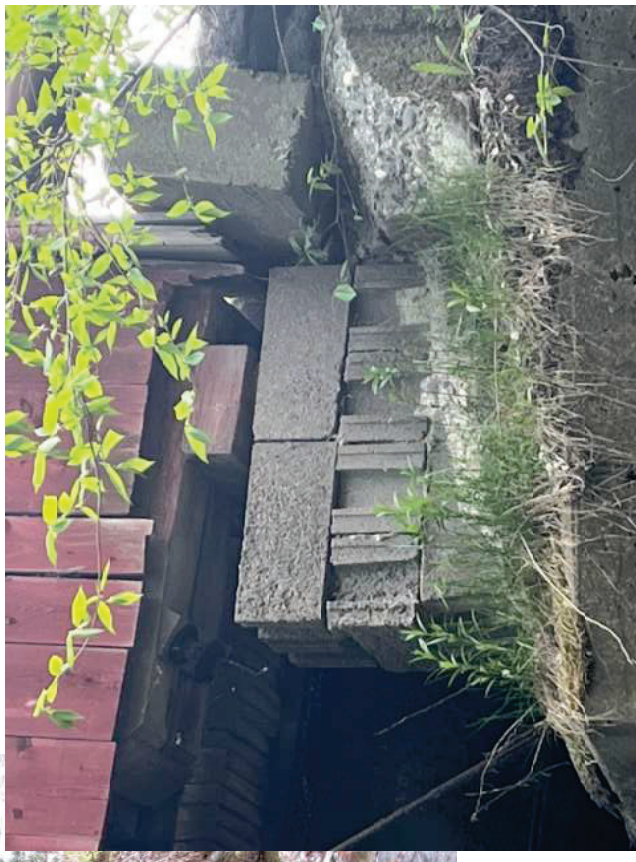
Abutments

- Voids
- Spalling
- Exposed Rebar

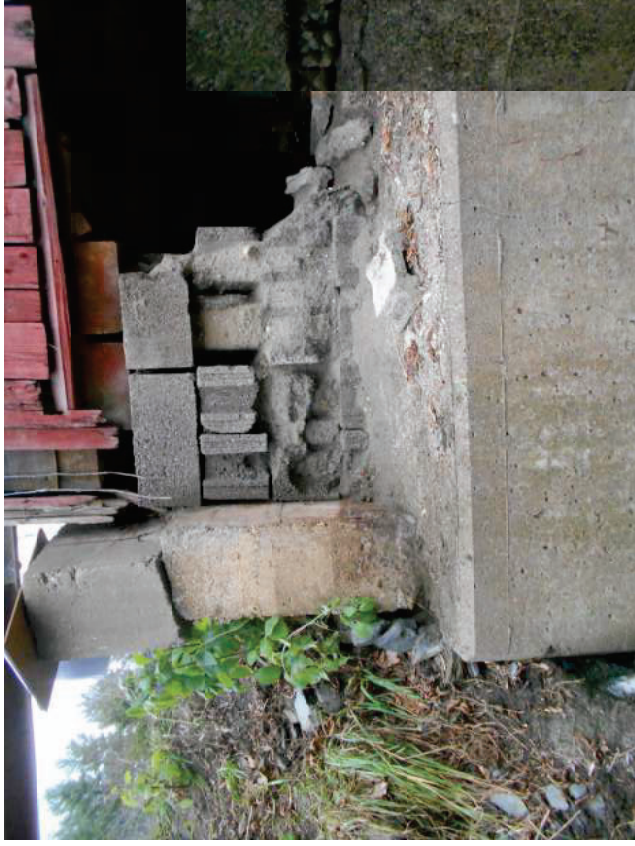
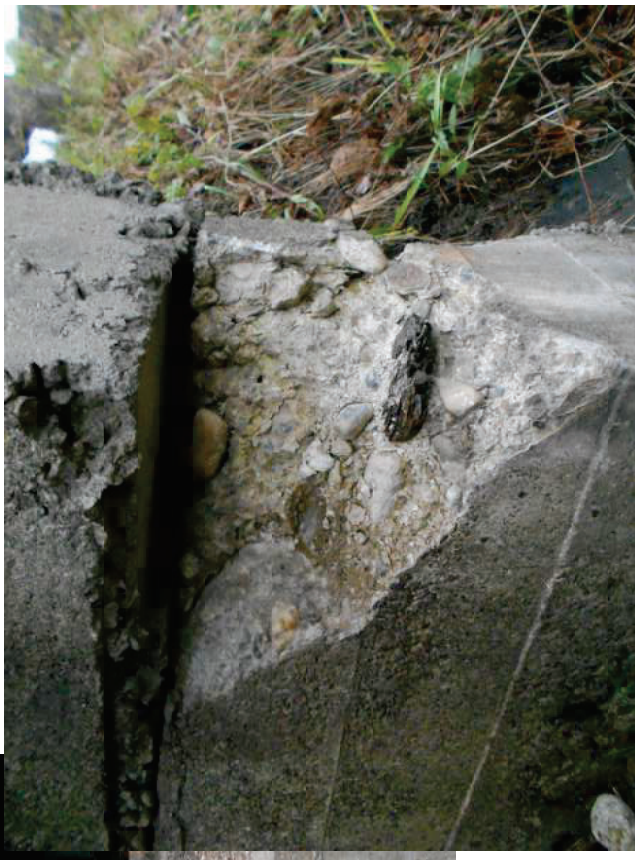
Abutments

- Voids
- Spalling
- Exposed Rebar
- CMU Truss Bearings

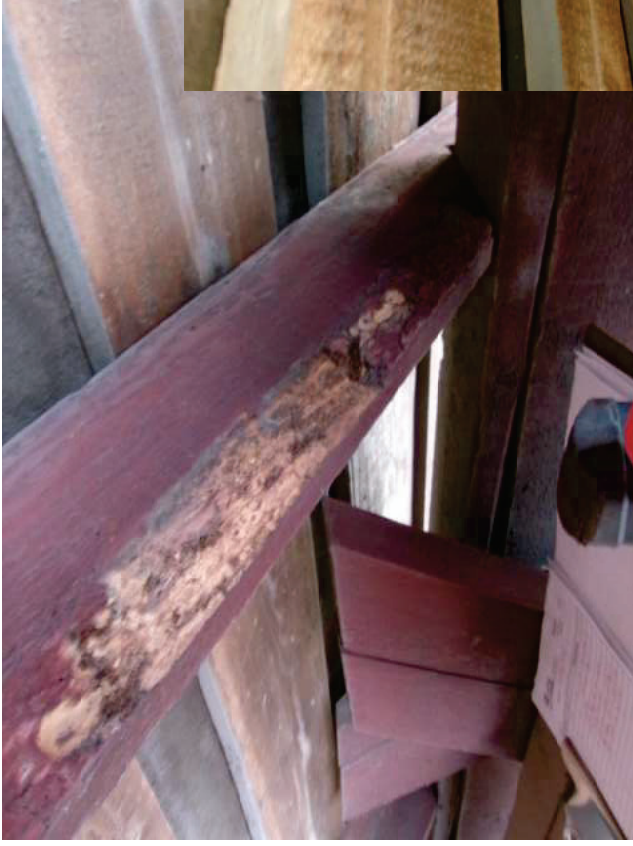
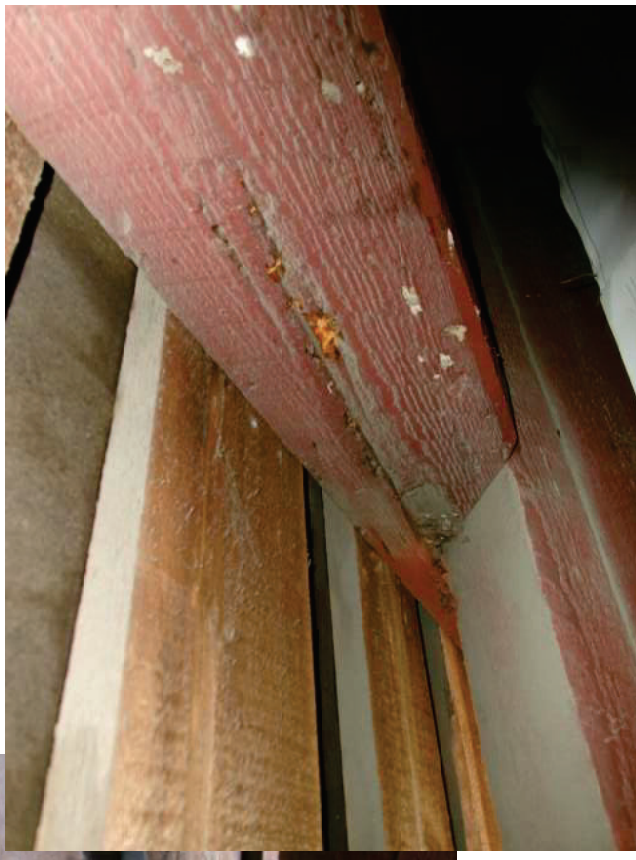
- Splits
- Breaks
- Rot
- Insect Damage

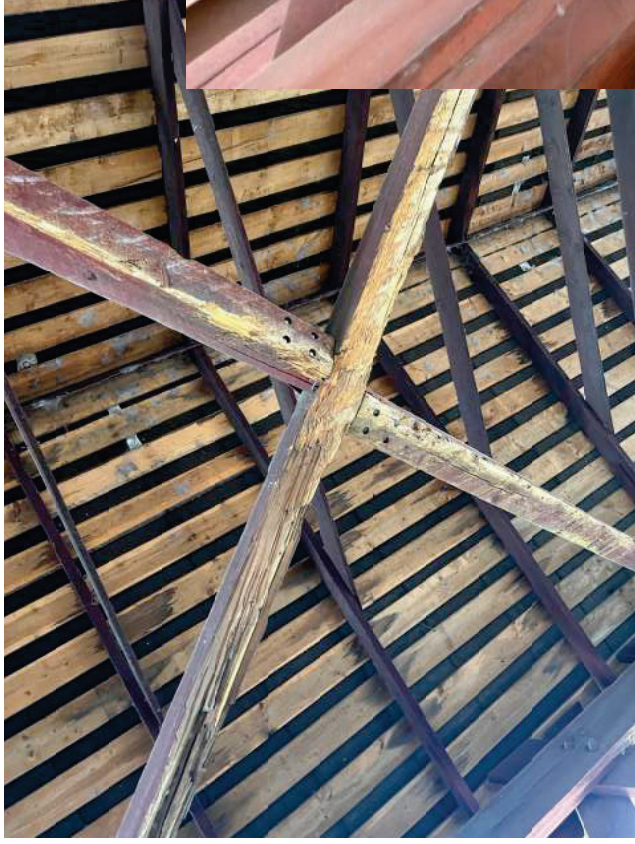
Upper Bracing Members

- Splits
- Breaks
- Rot
- Impact Damage

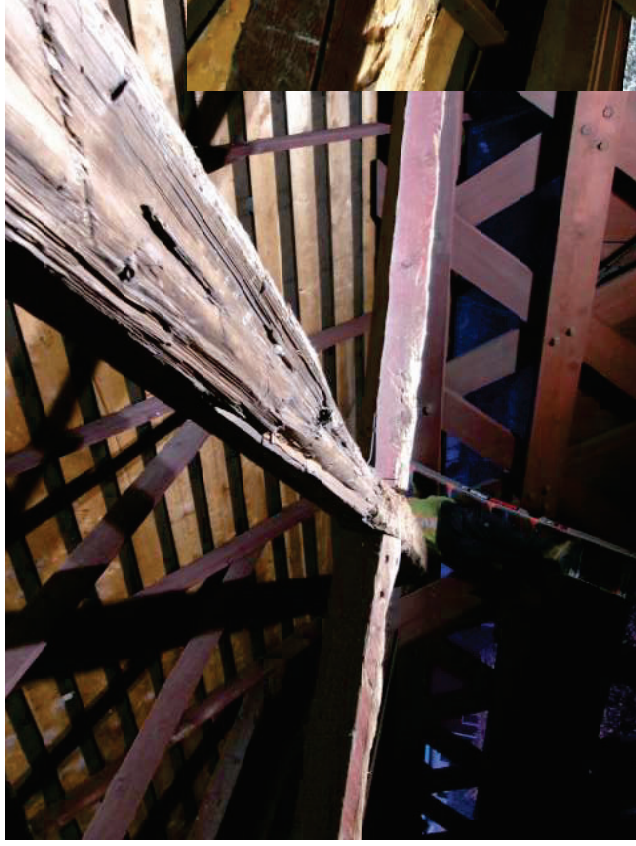
Upper Bracing Members (Continued)

- Splits
- Breaks
- Rot
- Impact Damage

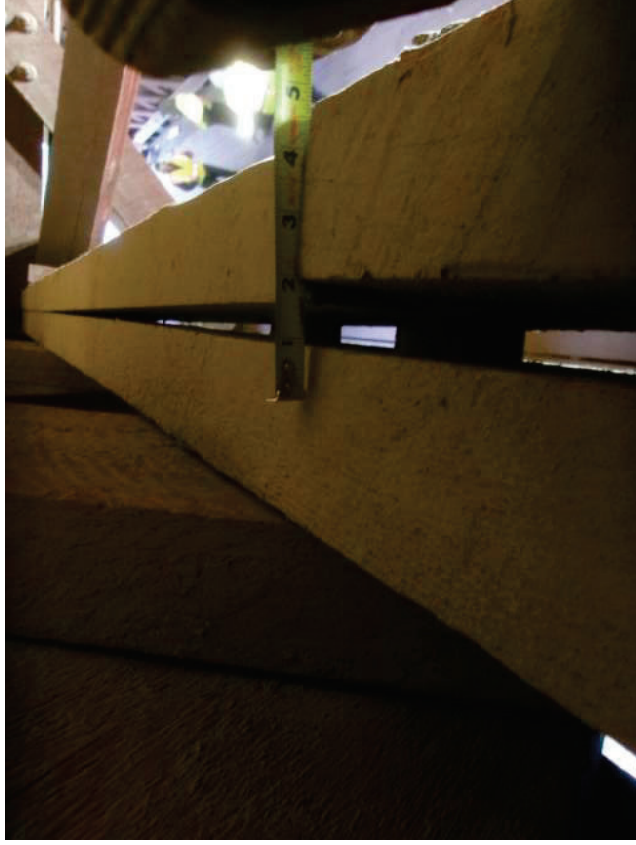
Truss Members

- Splits
- Breaks
- Rot
- Misalignment
- High Moisture Content

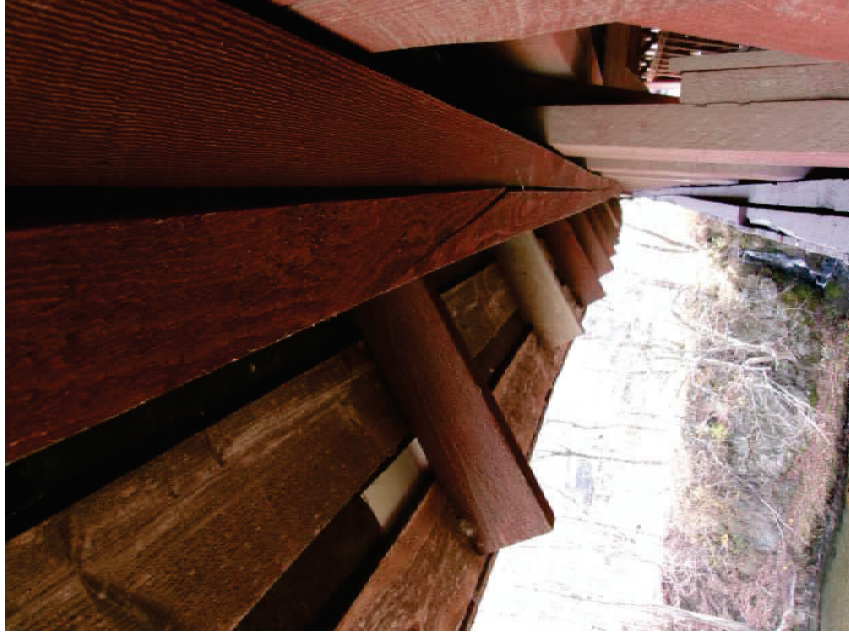
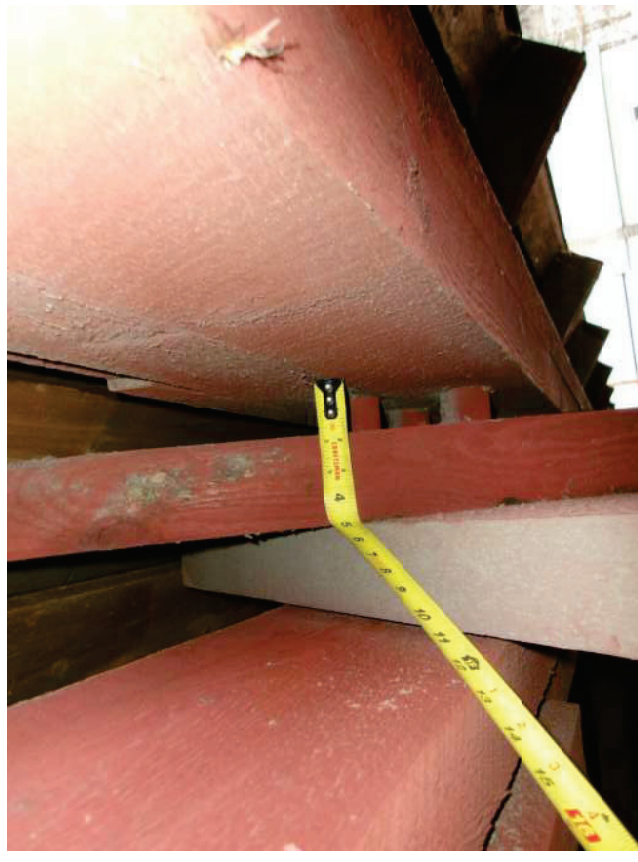
Truss Members (Continued)

- Splits
- Breaks
- Rot
- Misalignment
- High Moisture Content

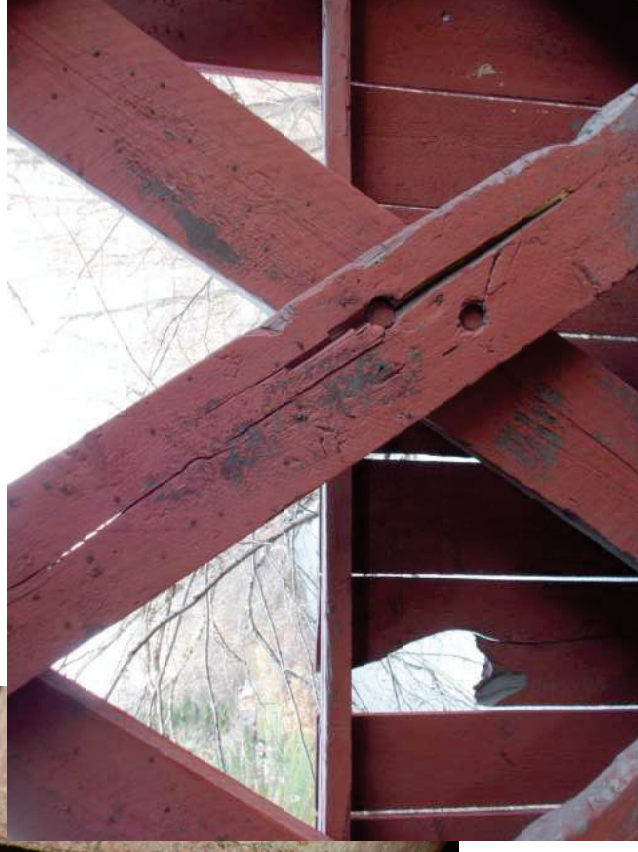
Truss Members (Continued)

- Splits
- Breaks
- Rot
- Misalignment
- High Moisture Content
