Draft Scoping Report Upper Cox Brook Covered Bridge Town Highway 3 Bridge 10 over Cox Brook

Northfield BO CVBR(7)

January 24, 2026

Prepared for:
Vermont Agency of Transportation

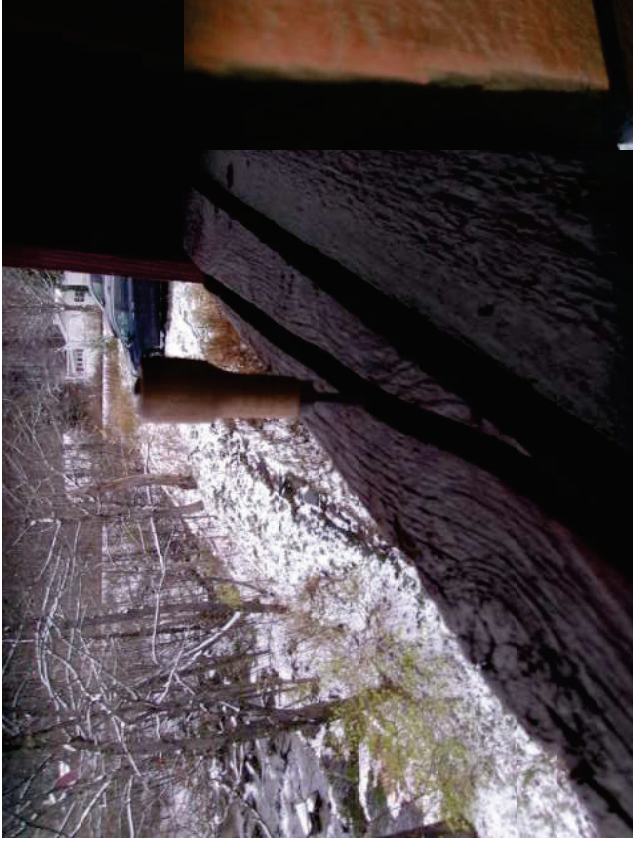
Truss Members (Continued)

- Splits
- Breaks
- Rot
- Misalignment
- High Moisture Content

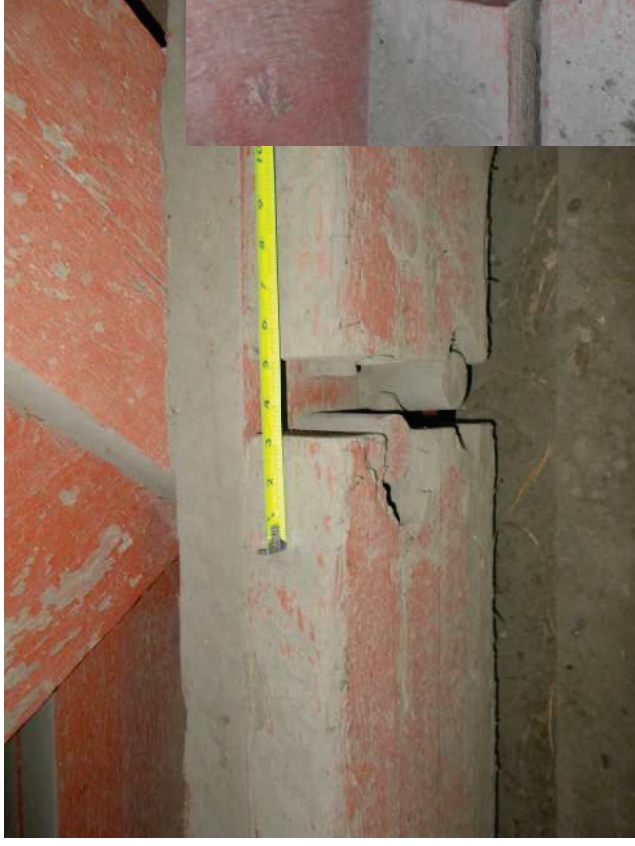
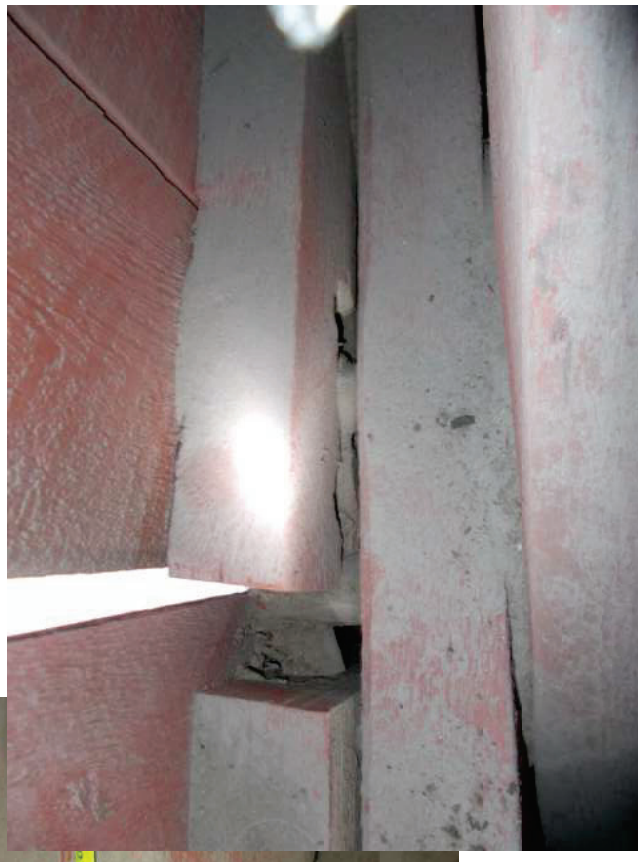
Truss Members (Continued)

- Splits
- Breaks
- Rot
- Misalignment
- High Moisture Content

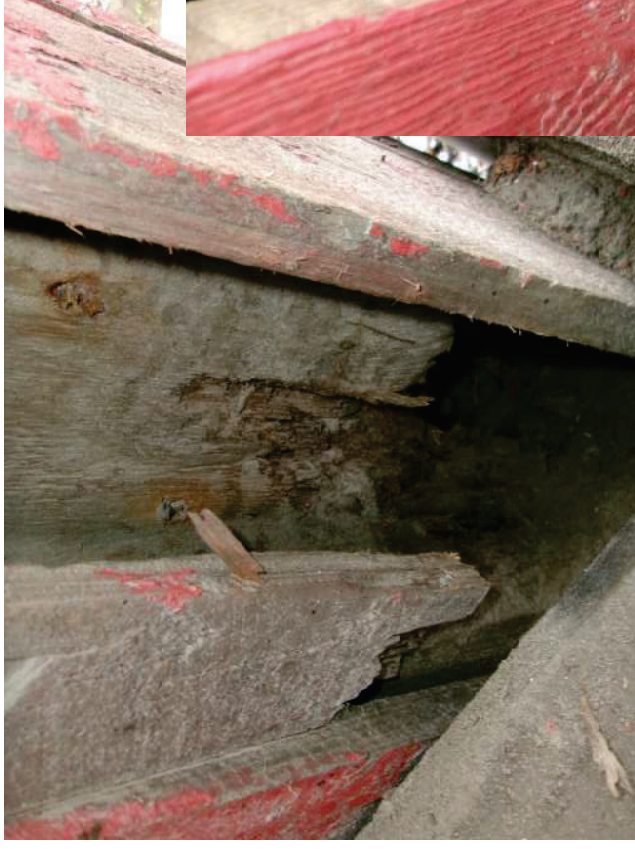
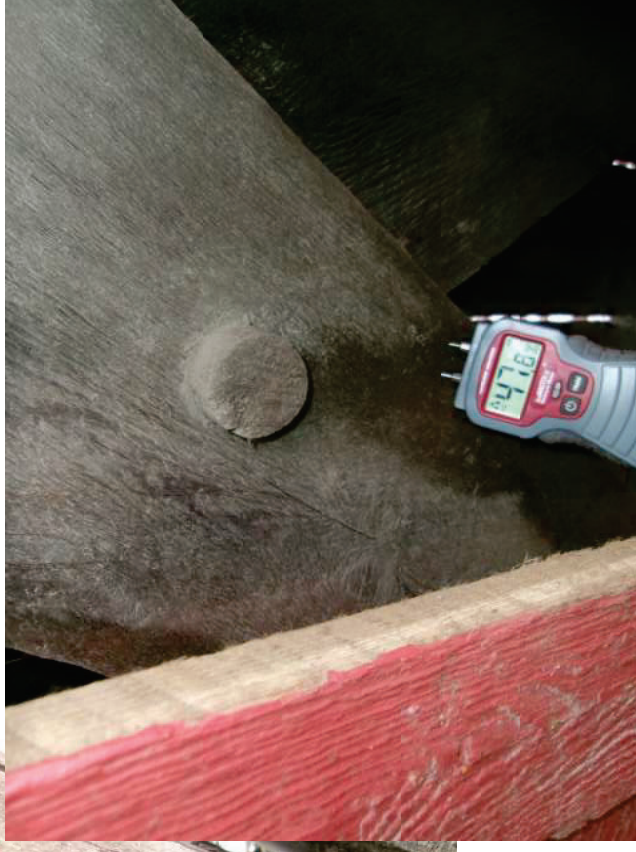
Truss Members (Continued)

- Splits
- Breaks
- Rot
- Misalignment
- High Moisture Content

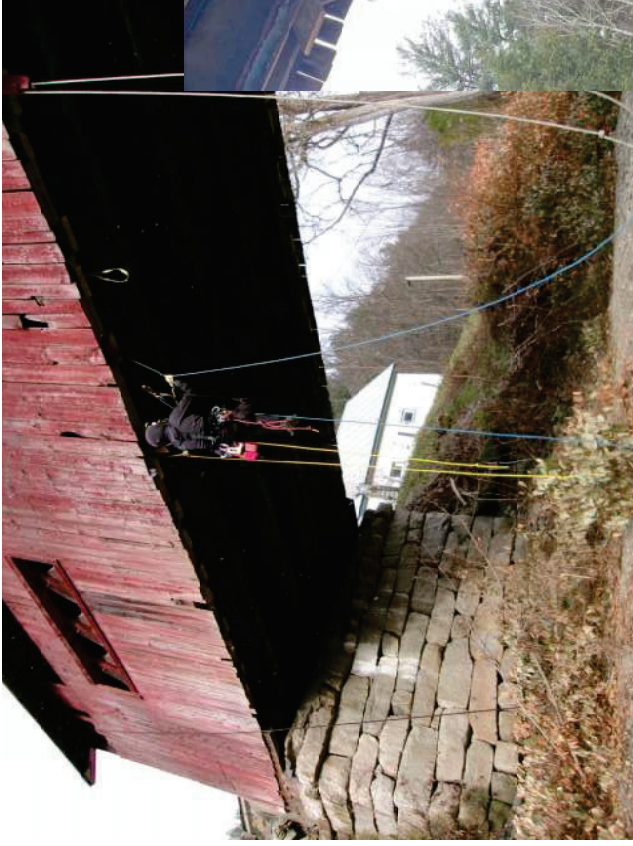
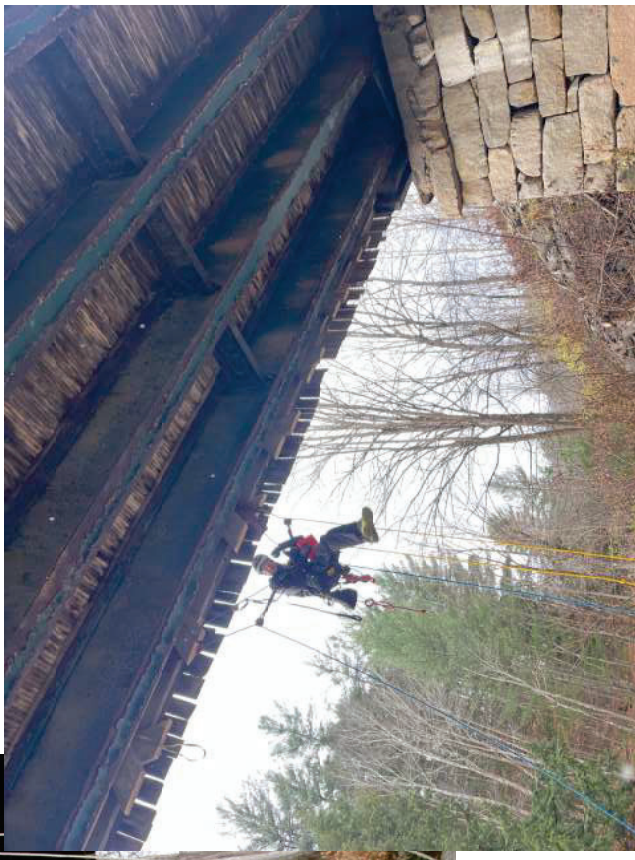
Steel Beams

- Rusting
- Advanced Corrosion

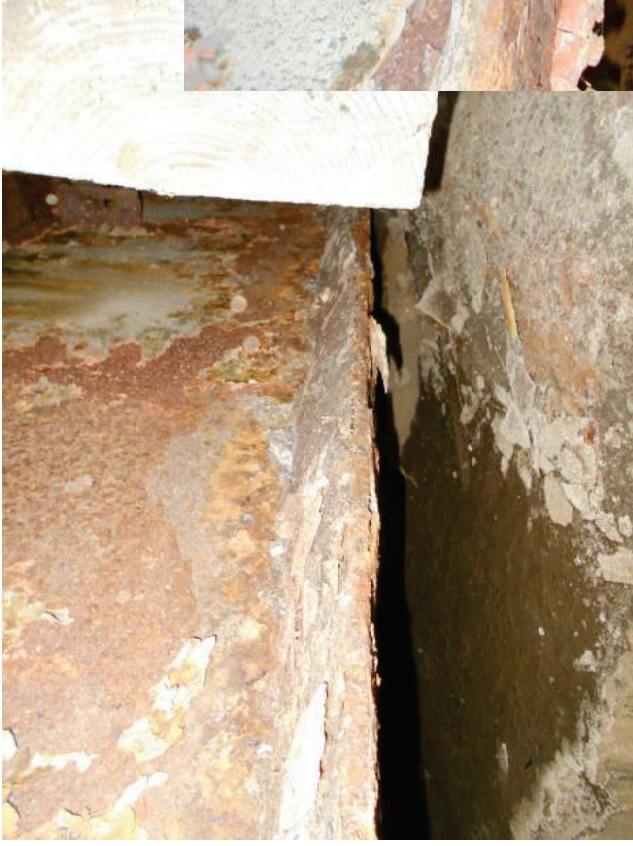
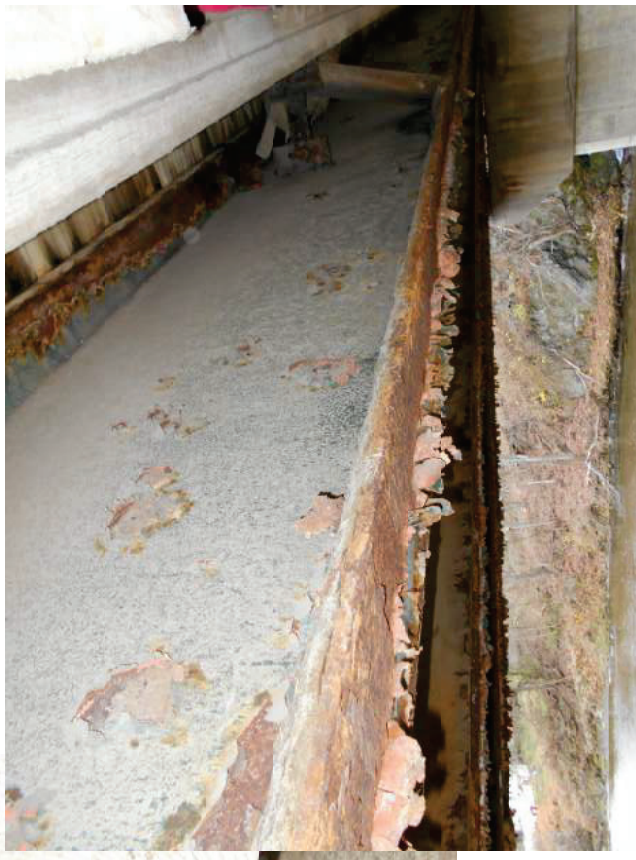
Steel Beams (Continued)

- Rusting
- Advanced Corrosion

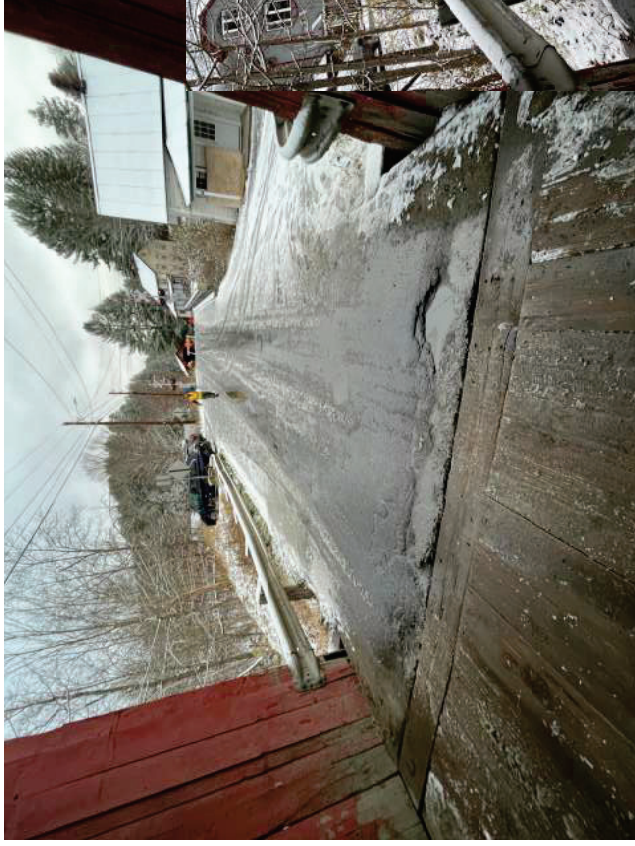
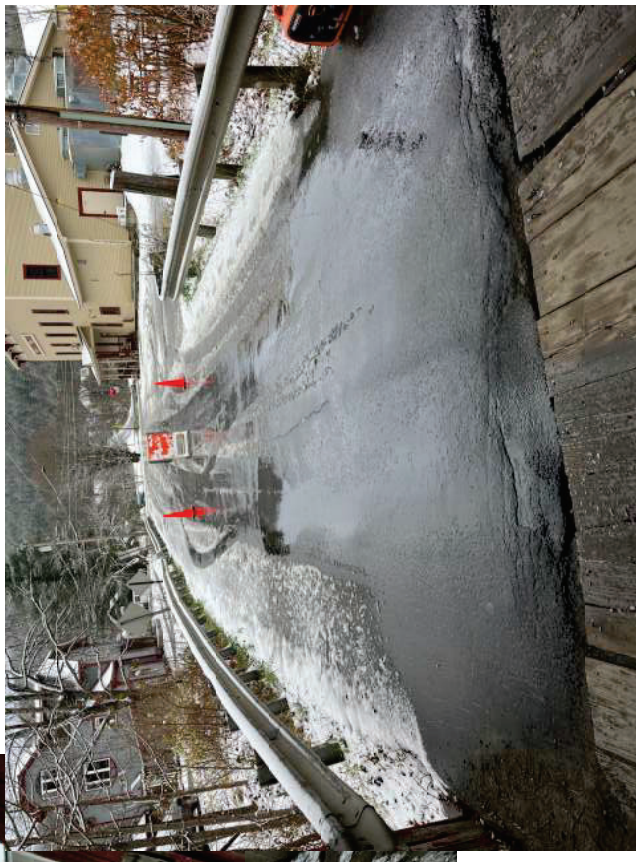
Approaches

- Drainage Issues
- Ponding

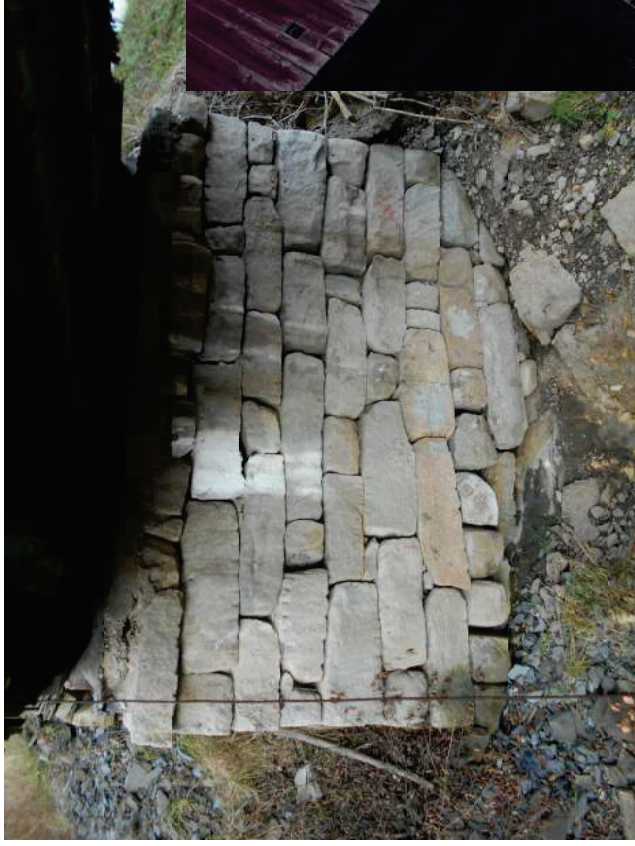
Substructure

- Voids
- Spalling
- Exposed Rebar

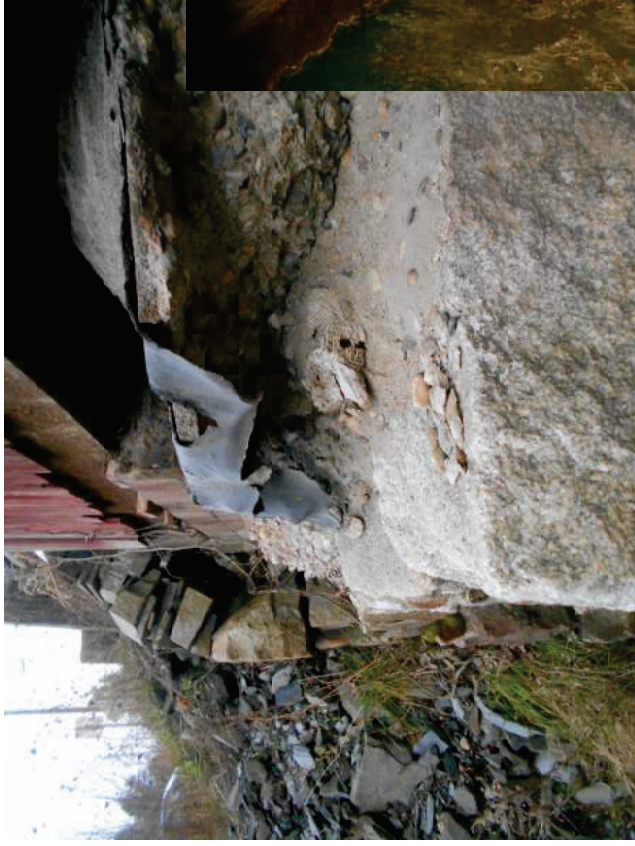
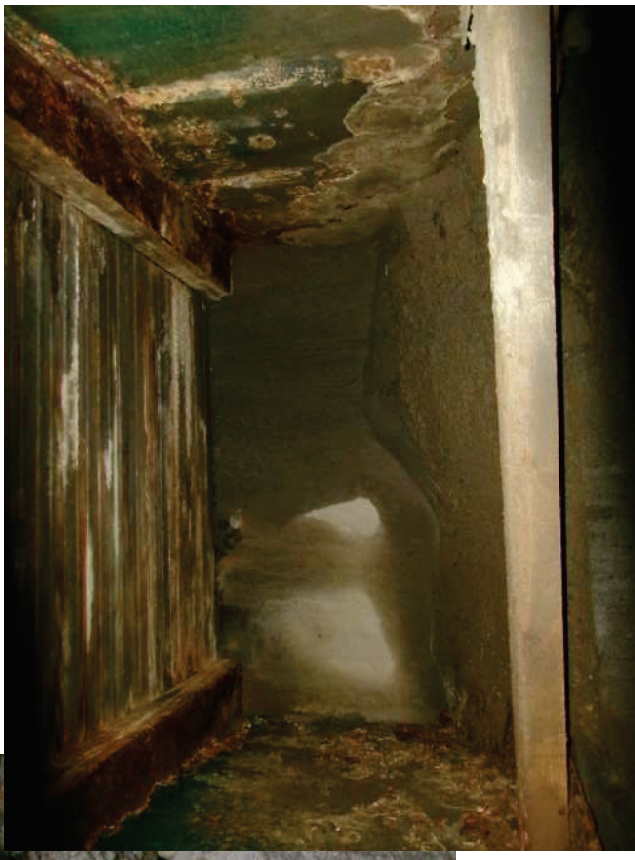
Substructure

- Voids
- Spalling
- Exposed Rebar

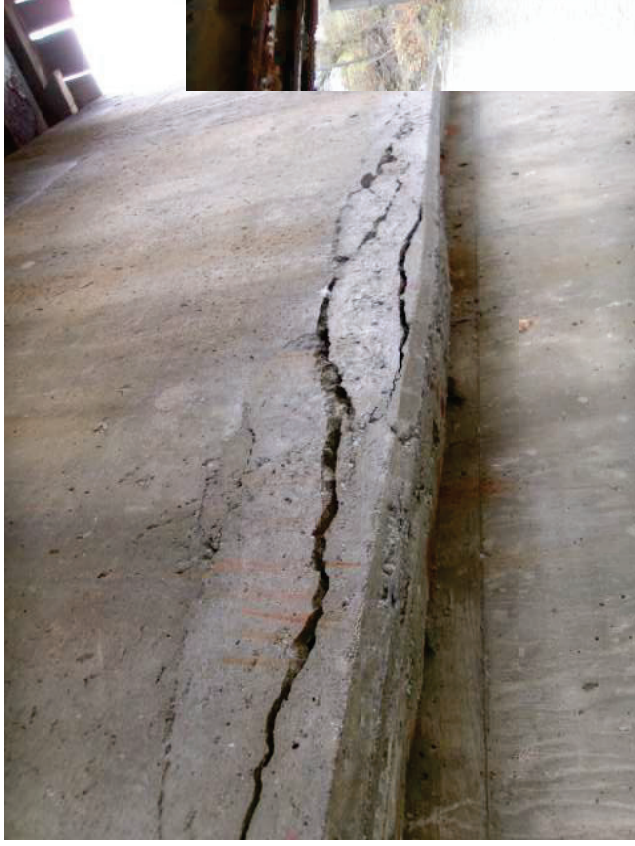
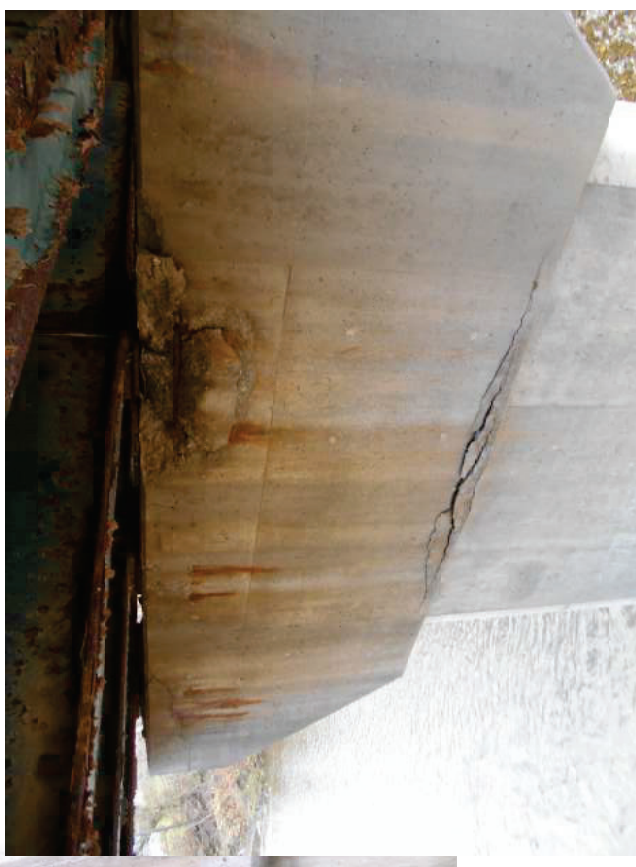
Substructure

- Voids
- Spalling
- Exposed Rebar

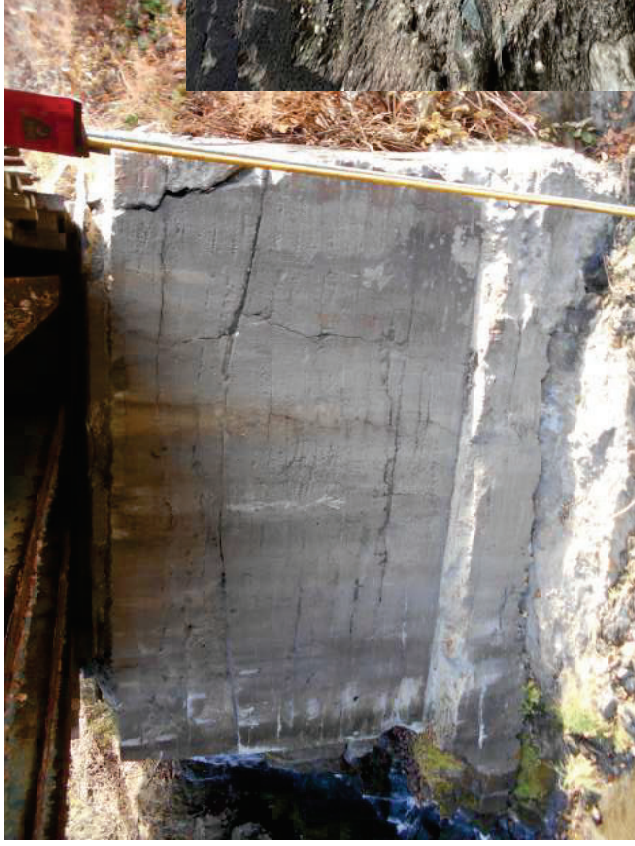
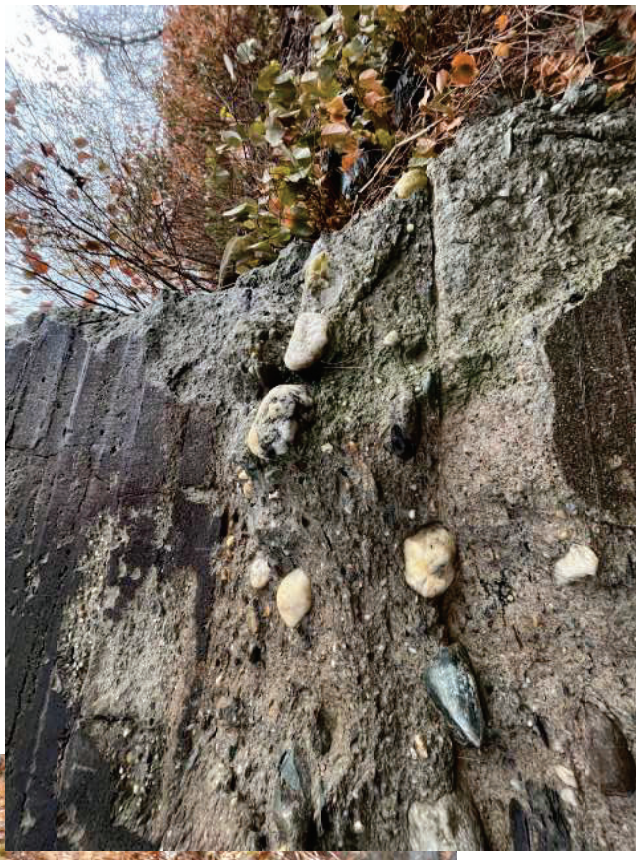
Substructure

- Voids
- Spalling
- Exposed Rebar
- CMU Truss Bearings

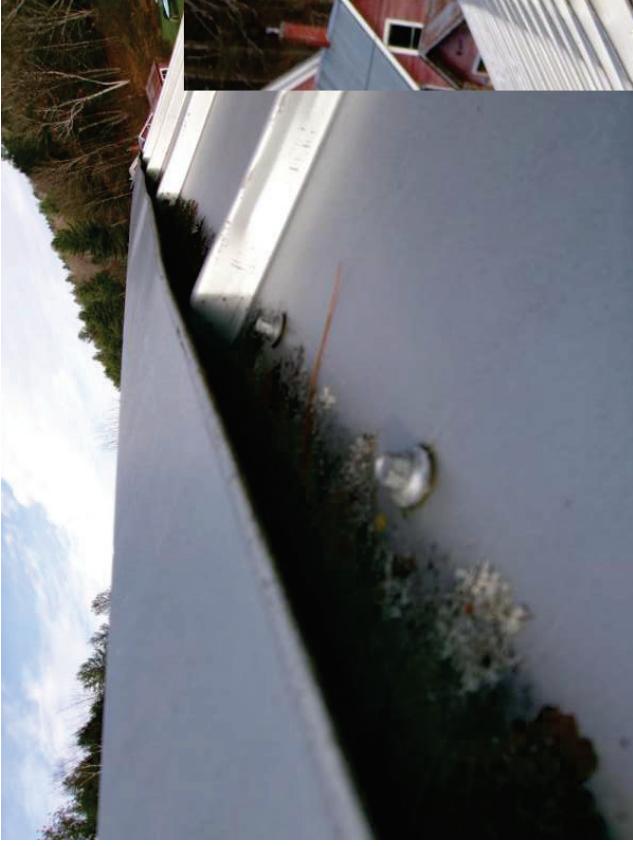
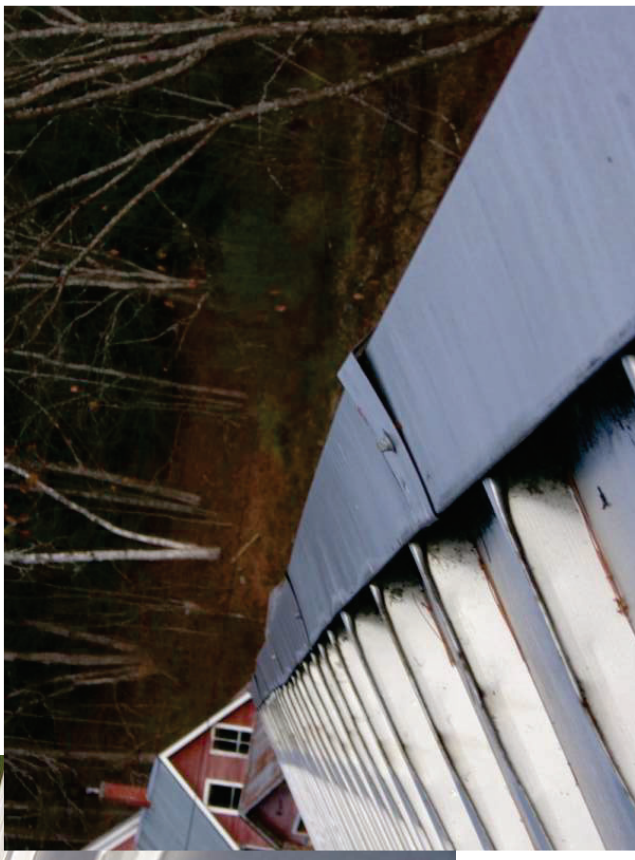
- Leaks
- Screw Attachment

- Existing
 - Standing Seam Metal Roof
 - 2"x6" Rafters, Eastern Spruce
 - 1" Thick Roof Boards, Eastern Spruce
- Recommended Work
 - New Standing Seam Metal Roof (PTN 2)
 - Replacement all Existing Roof Boards (PTN 2)
 - 8 Rafters (14%) to be Replaced due to Condition (PTN 2)

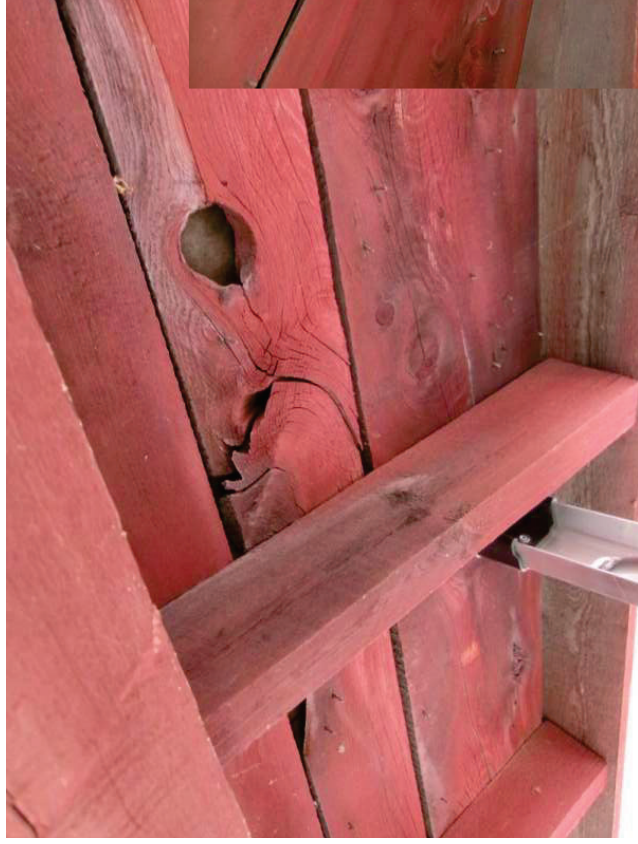
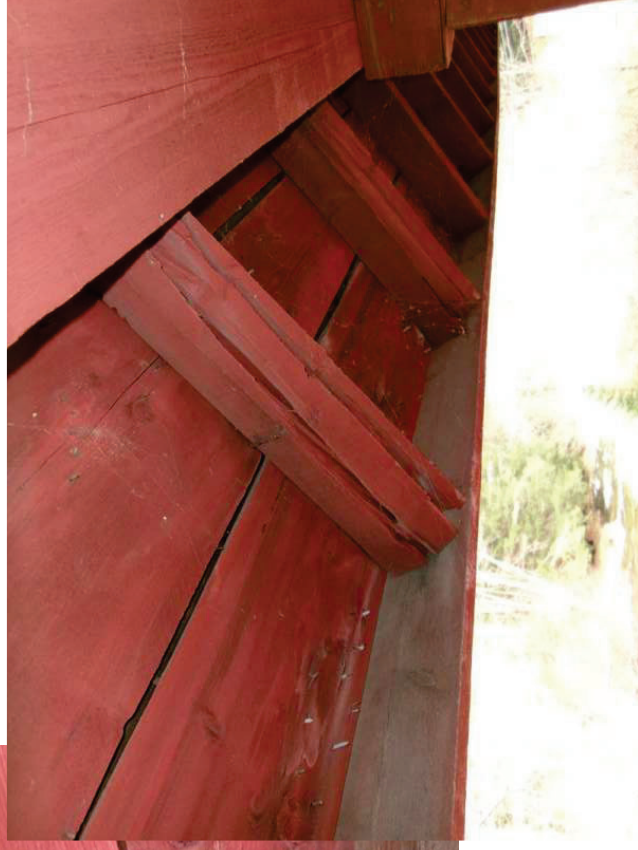
Roofboards & Rafters

- Splits
- Breaks
- Rot

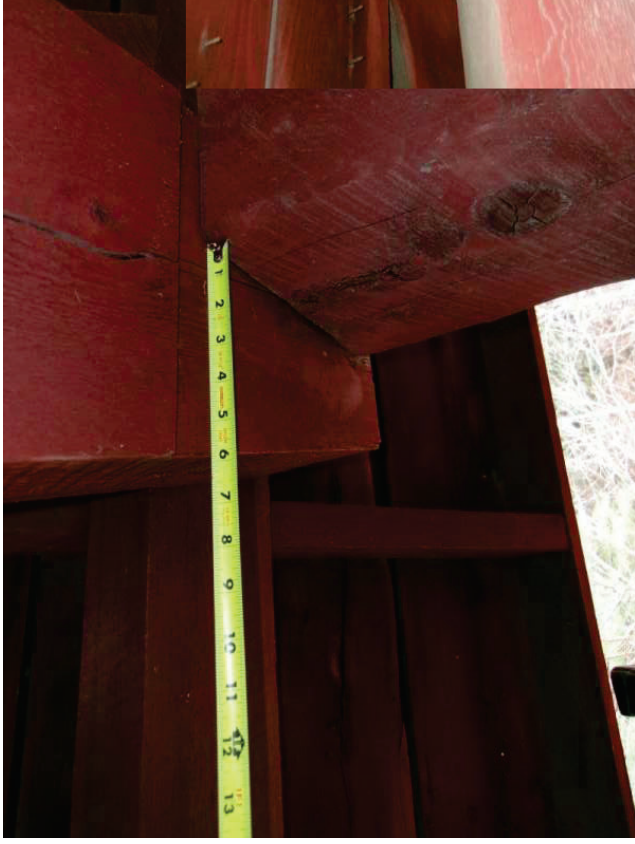
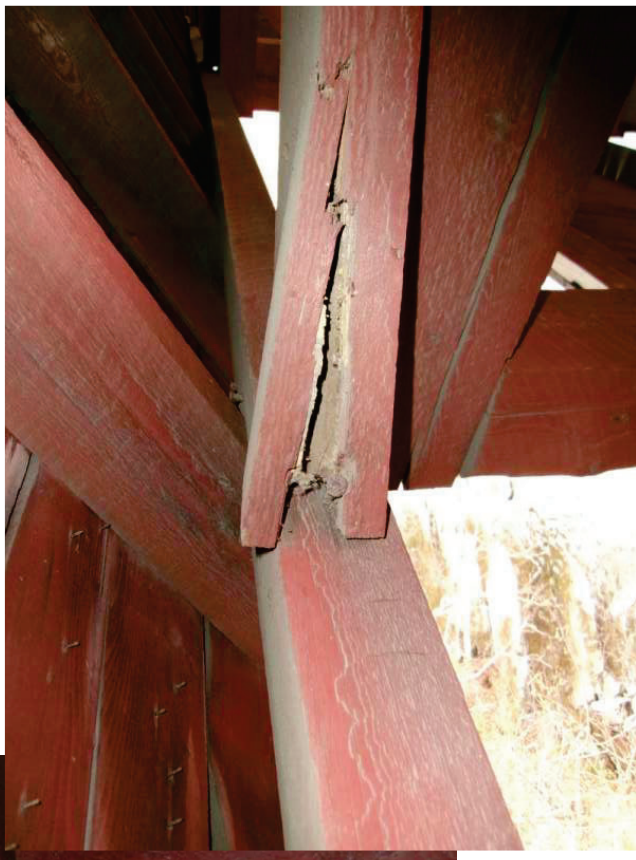
Upper Bracing Members

- Splits
- Breaks
- Rot
- Impact Damage

- Existing
 - 6"x6" Crossbeams, Eastern Spruce
 - 2"x8" Diagonal Braces, Eastern Spruce
 - Steel Knee Braces
- Recommended Work
 - Replacement of all Upper Bracing (PTN 2)
 - 2 Cross Beams (22%) to be Replaced due to Condition (PTN 2)
 - Redo Steel Knee Braces?

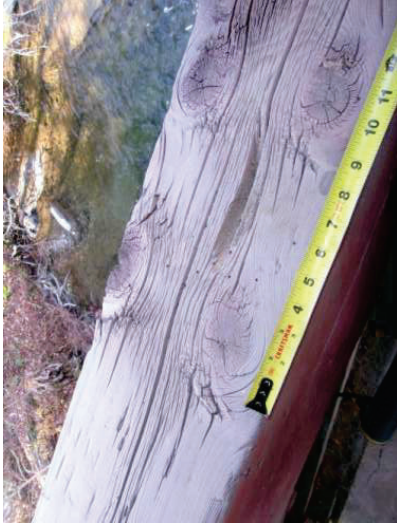
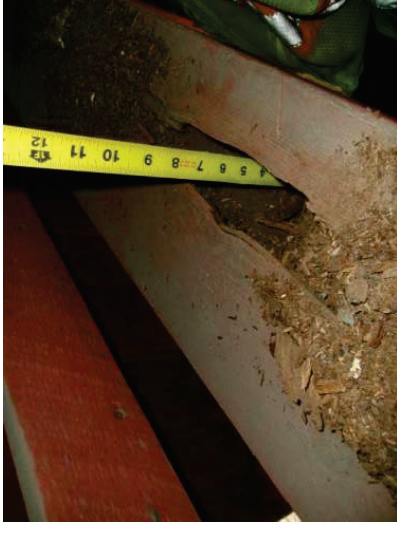
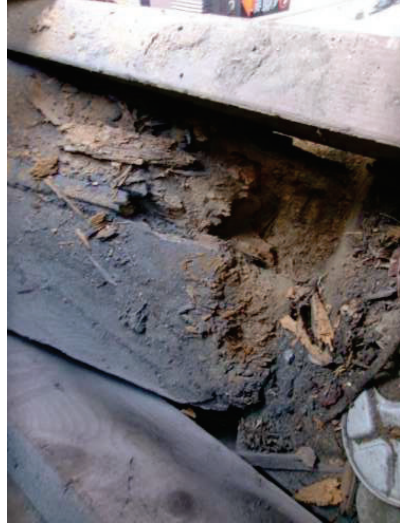
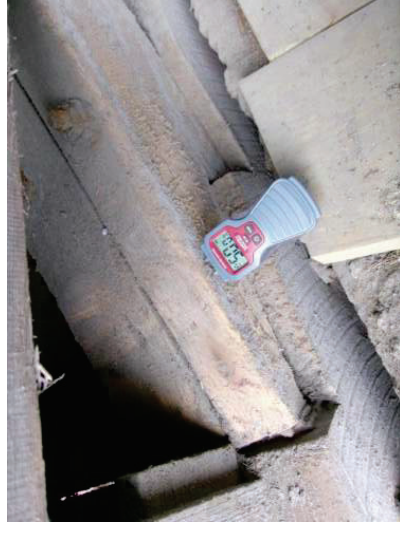
Truss Members

- Splits
- Breaks
- Rot
- Weathering
- High Moisture Content

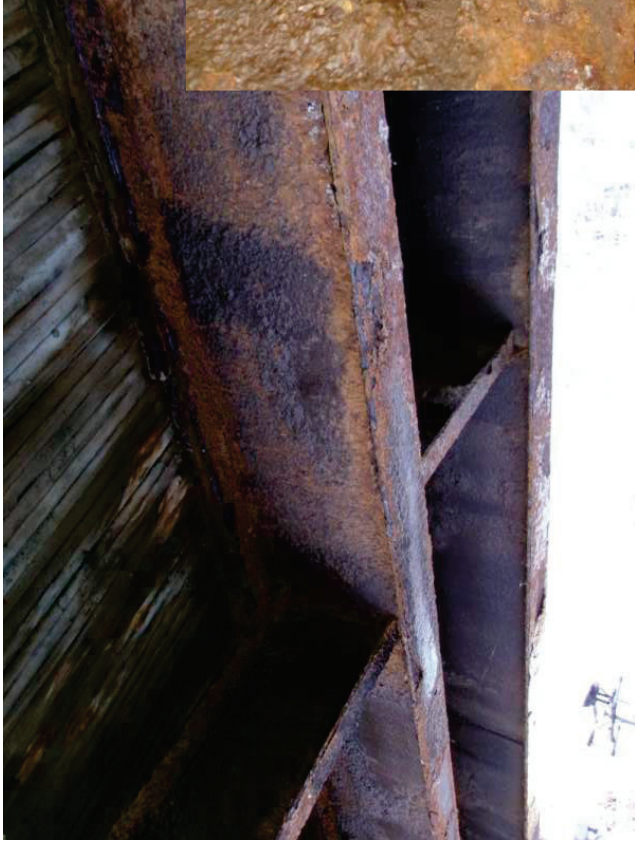
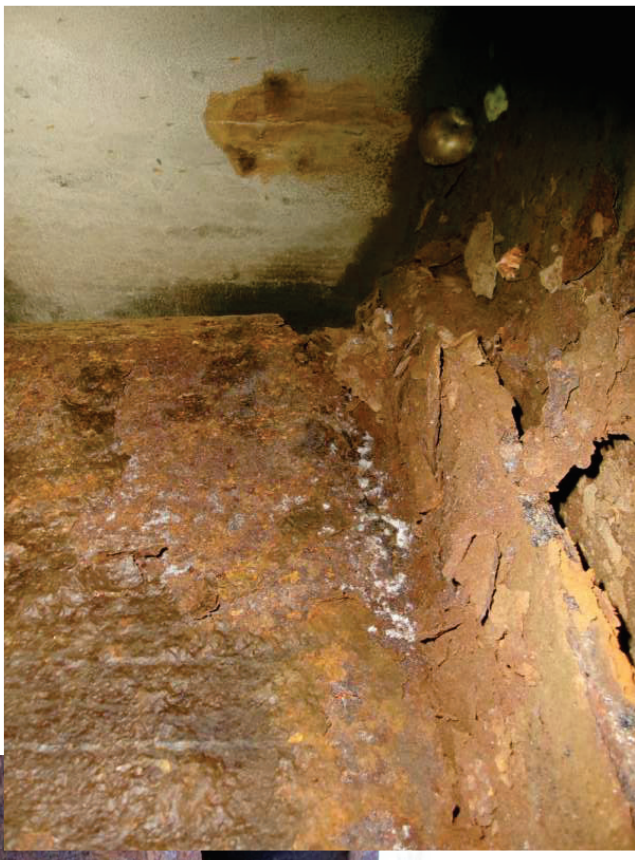
- Rust Holes
- Advanced Corrosion

- Existing:
 - 24WF100 and 21WF62 Steel Beams
 - C15x33.9 Steel Diaphragms
 - 2"x6" Nail Laminated Deck, Southern Yellow Pine
 - 1 ½" Thick Runner Boards, Eastern Pine
- Recommended Work
 - Replace Steel Stringers with new Steel Stringers (PTN 2)
 - Replace Deck with Nail Laminated (PTN 2), or Glulam Deck (PTN 4)
 - Replace Runner Boards with Full Width 1 ½" Thick Runners, White Oak (PTN 2)

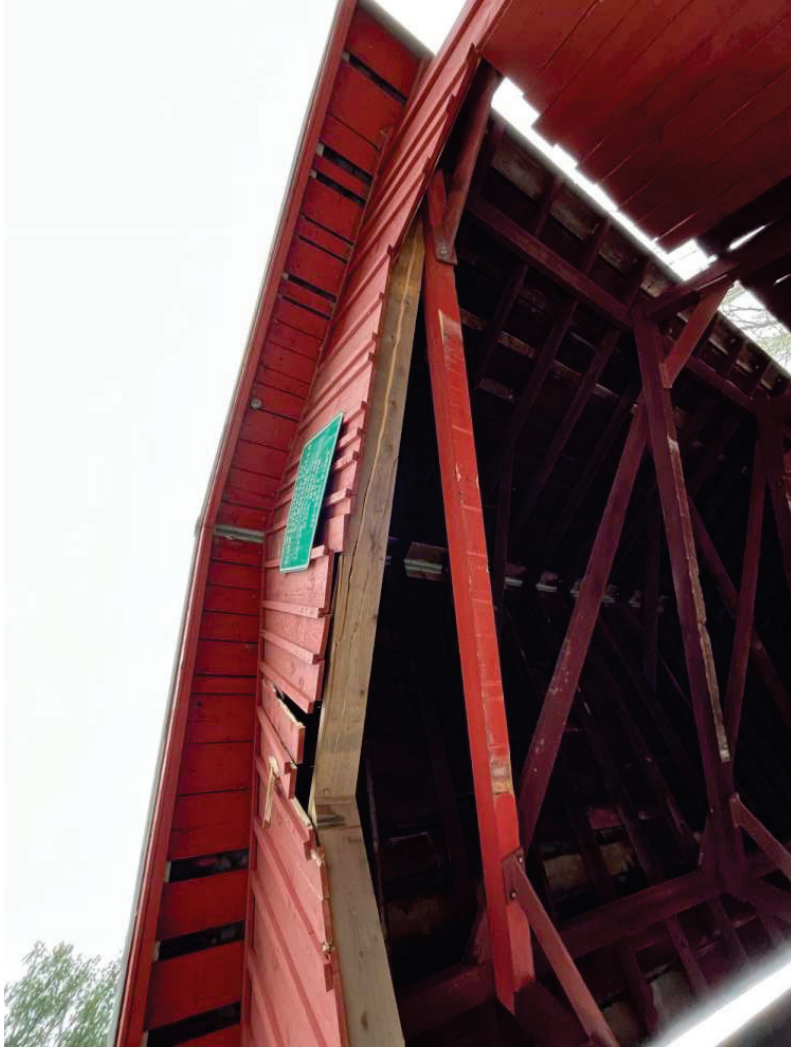
Portals

- Breaks
- Impact Damage

- Existing
 - 1" Thick Boards
- Recommended Work
 - Replacement of all Existing Siding Boards (Eastern White Pine) (PTN 2)

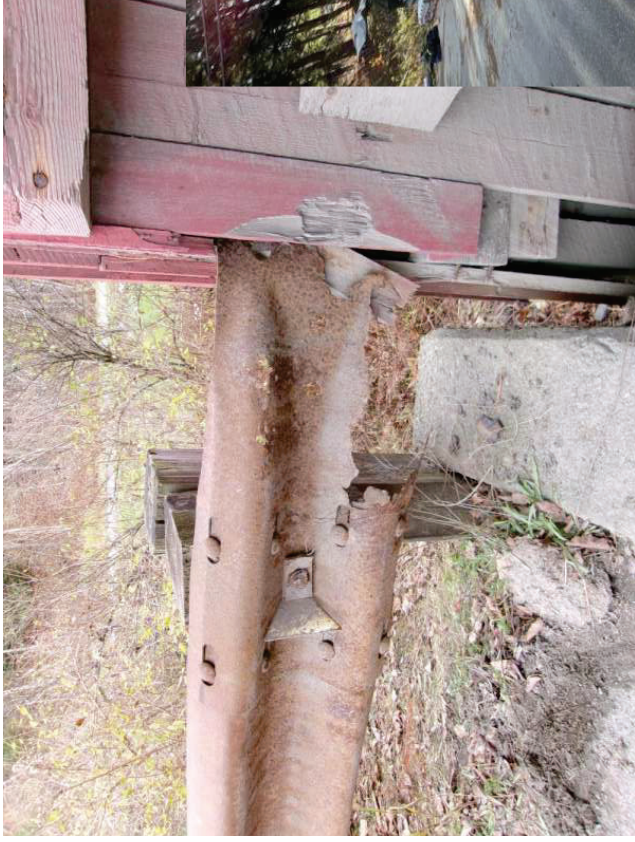
Approach Railing

- Extensive Corrosion
- Rust Holes
- Rotted Wood Posts
- Impact Damage

- Superstructure Replacements/Repairs PTN 1 - 4
- Substructure Repairs PTN 1
- Current Live Load Rating = 10 Tons
- Proposed Live Load Rating = 20 Tons
- Approach Work
 - Approximate 200' of Roadway Reconstruction
 - New Signage
 - New Steel Backed Timber Guardrail

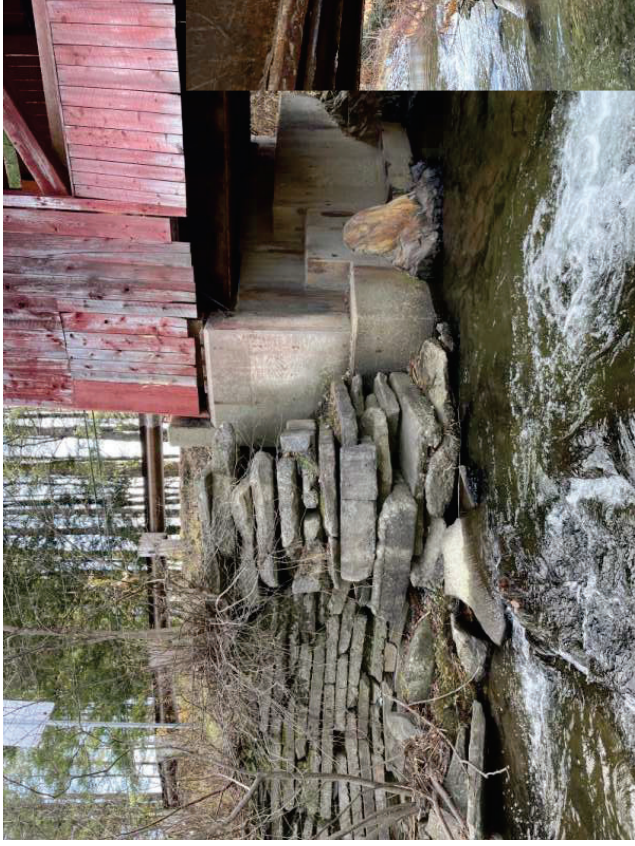
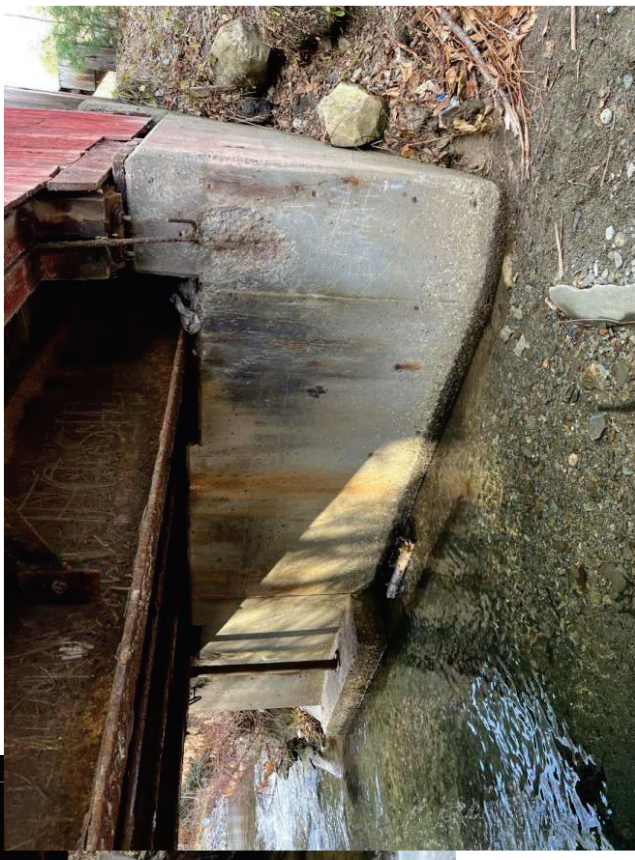
Abutments

- Voids
- Spalling
- Exposed Rebar

- Bridge Seat Elevation Modification (PTN 1)
- Concrete Repair / Crack Sealing (PTN 1)
- Stain And Seal Concrete (PTN 1)

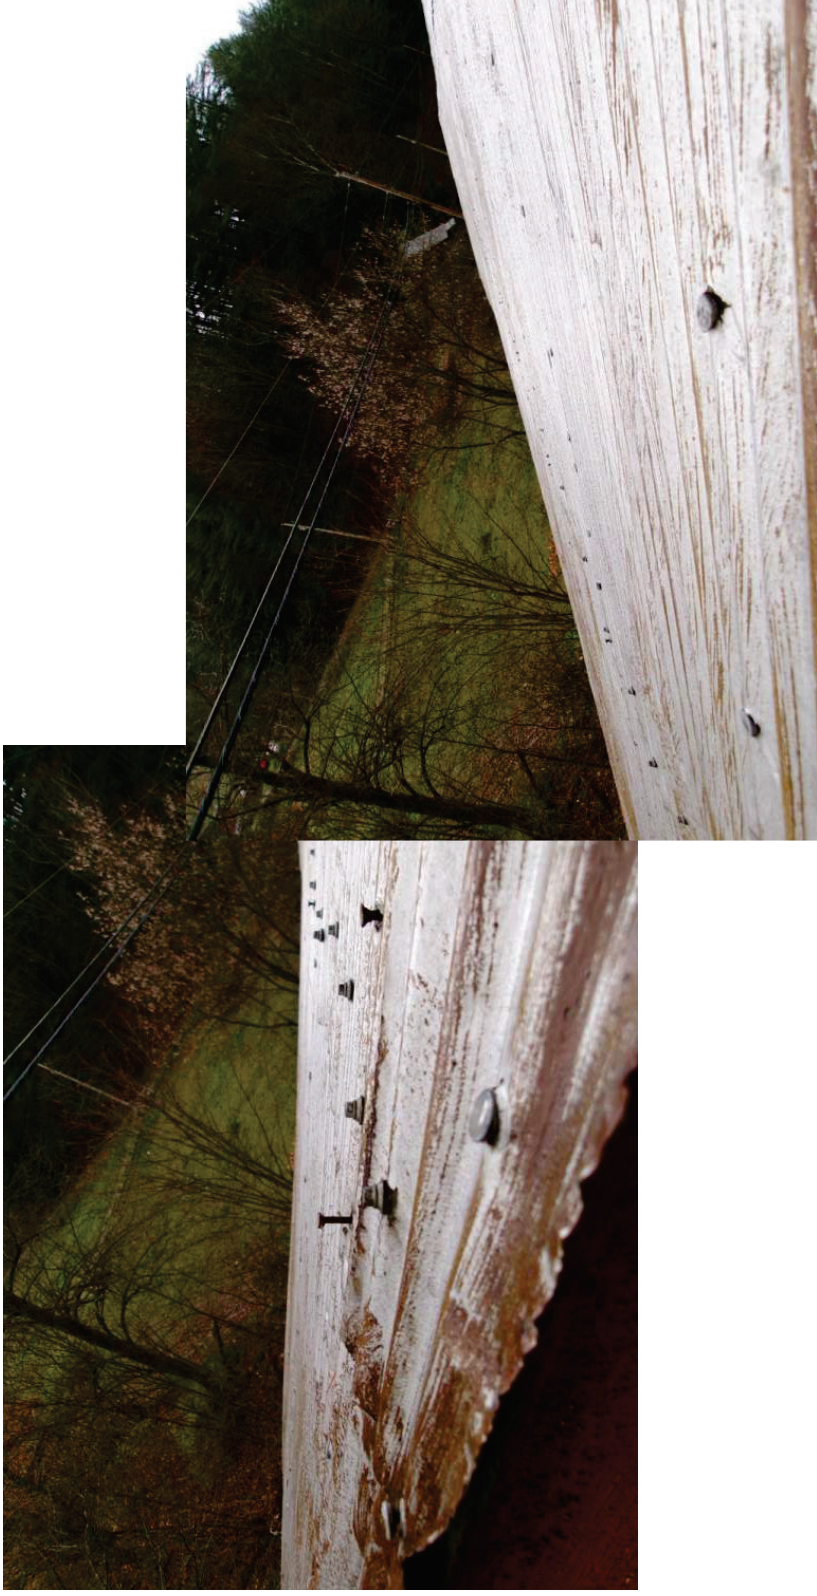
- Rusting
- Leaks
- Nail Attachment

- Existing
 - Standing Seam Metal Roof
 - 2"x6" Rafters, Eastern Spruce
 - 1"x8" Roof Boards, Eastern Spruce
 - 6"x6" Rafter Support Beam, Eastern Spruce
- Recommended Work
 - New Standing Seam Metal Roof (PTN 2)
 - Replacement all Existing Roof Boards (PTN 2)
 - 5 Rafters (8%) to be Replaced due to Condition (PTN 2)
 - 1 Rafter Support Beam (8%) to be Replaced due to Condition (PTN 2)

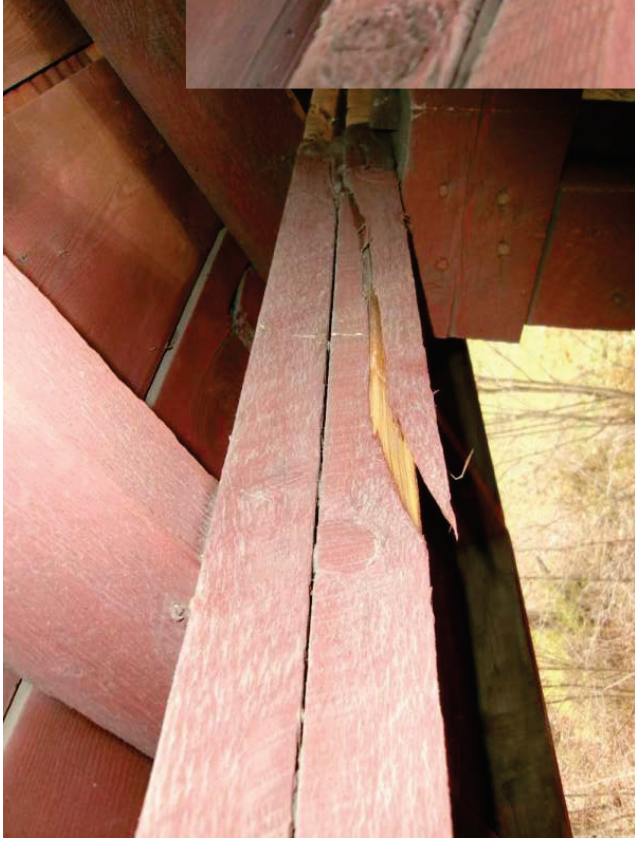
Roofboards, Rafters & Rafter Support Beam

- Splits
- Breaks
- Rot
- Insect Damage

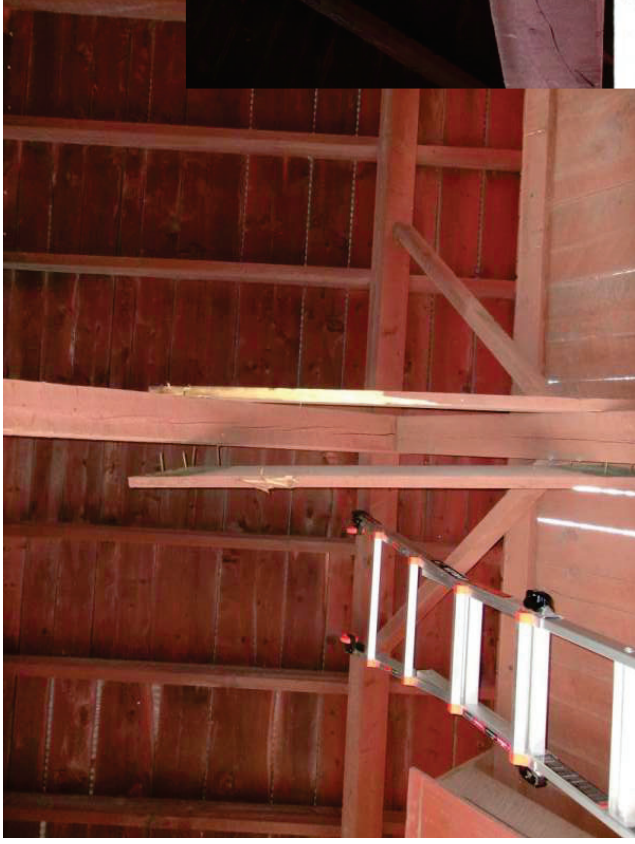
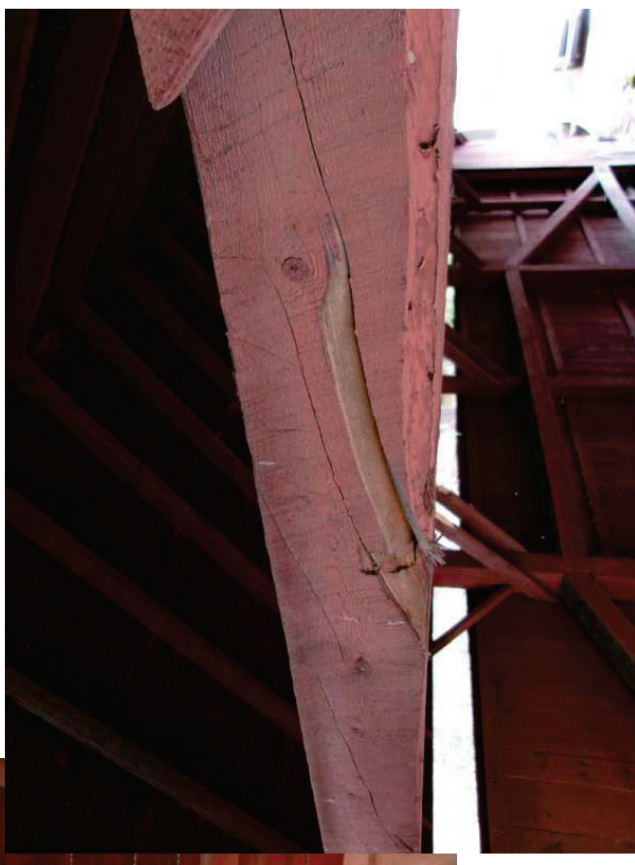
Upper Bracing Members

- Splits
- Breaks
- Rot
- Impact Damage

- Replacement of all Upper Bracing (PTN 2)
- 2 Crossbeams (29%) to be **Replaced** due to Condition (PTN 2)
- 7 Knee Braces (29%) to be **Replaced** due to Condition (PTN 2)
- Strengthen all Knee Braces (PTN 3)

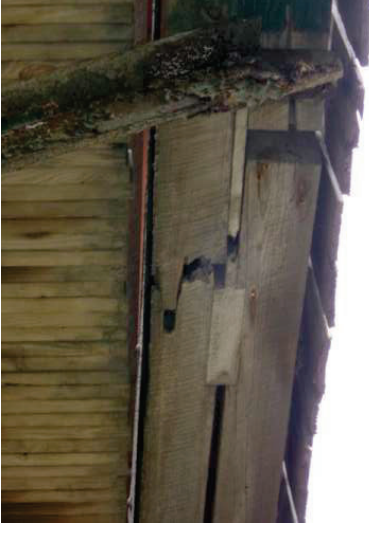
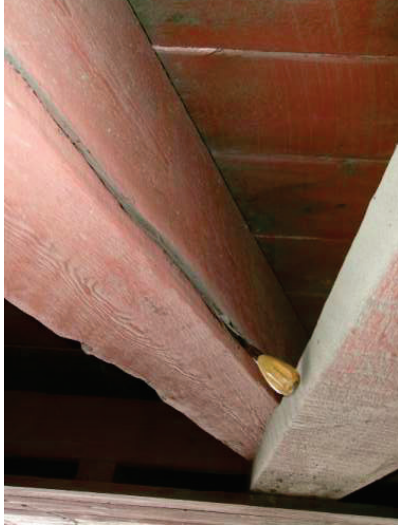
Truss Members

- Splits
- Breaks
- Rot
- High Moisture Content

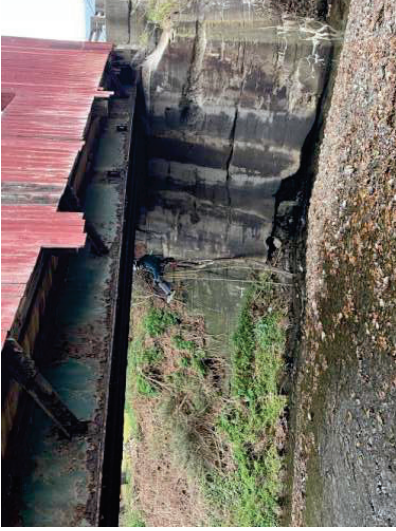
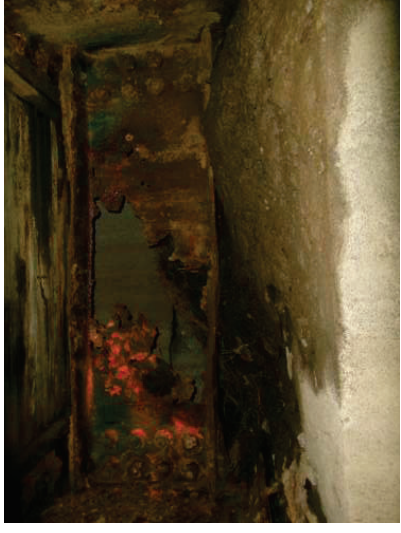
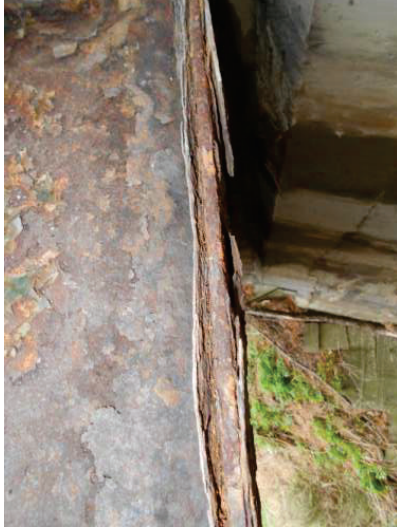
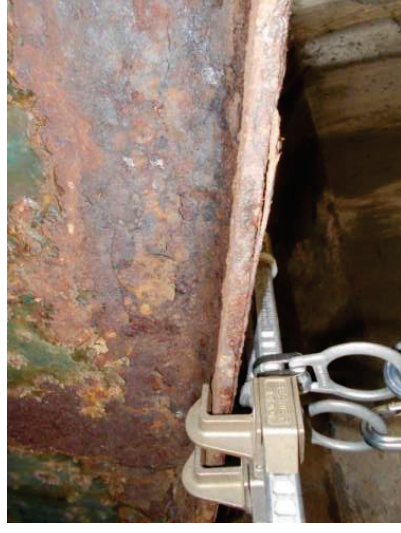
- Rust Holes
- Advanced Corrosion

- Existing:
 - 24WF84 Steel Beams
 - C15x33.9 Steel Diaphragms
 - 2"x6" Nail Laminated Deck, Southern Yellow Pine
 - 1 5/8" Thick Runner Boards, Eastern Spruce
- Recommended Work
 - Replace Steel Stringers with new Steel Stringers (PTN 2)
 - Replace Deck with Nail Laminated (PTN 2), or Glulam Deck (PTN 4)
 - Replace Runner Boards with Full Width 1 1/2" Thick Runners, White Oak (PTN 2)
