Draft Scoping Report Upper Cox Brook Covered Bridge Town Highway 3 Bridge 10 over Cox Brook

Northfield BO CVBR(7)

January 24, 2026

Prepared for:
Vermont Agency of Transportation

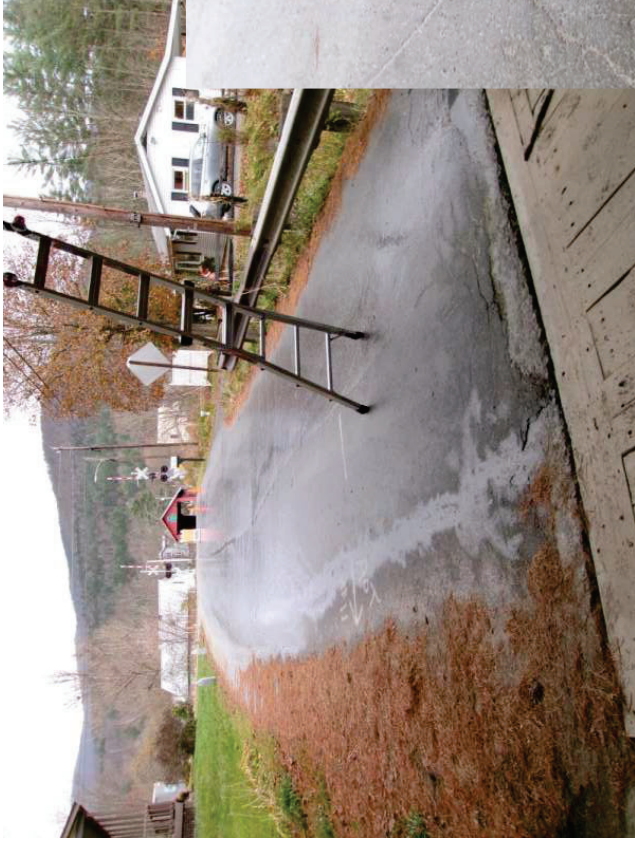
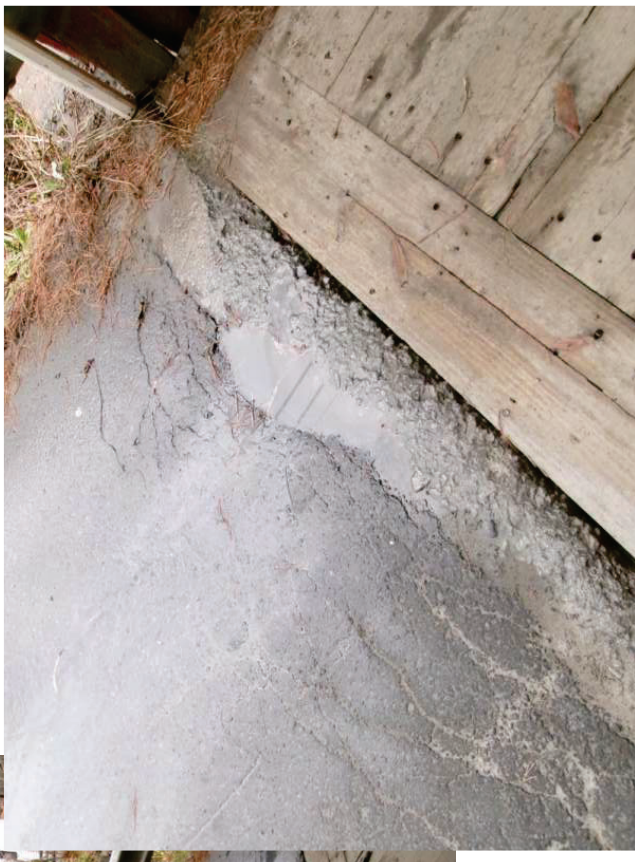
Approaches

- Drainage Issues
- Ponding

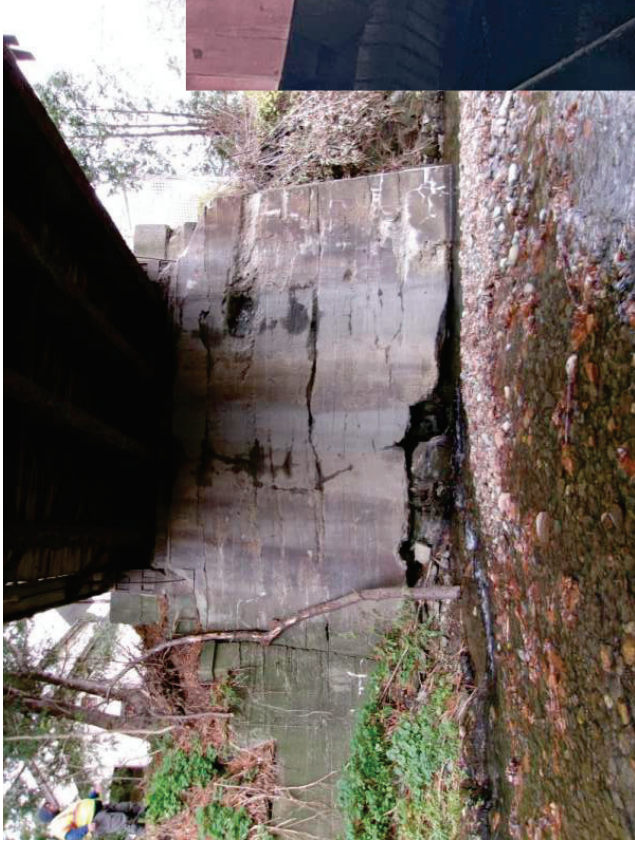
Abutments

- Voids
- Spalling
- Exposed Rebar
- CMU Truss Bearings

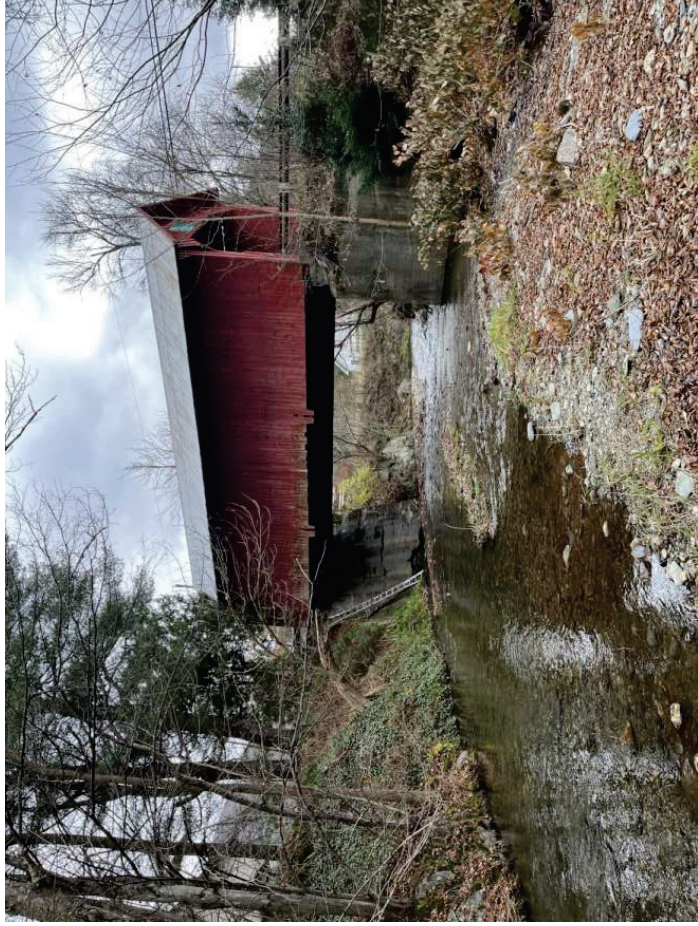
Recommended Work: Fascia & Portal Siding

- Existing
 - 1" Thick Boards
- Recommended Work
 - Replacement of all Existing Siding Boards (Eastern White Pine) (PTN 2)

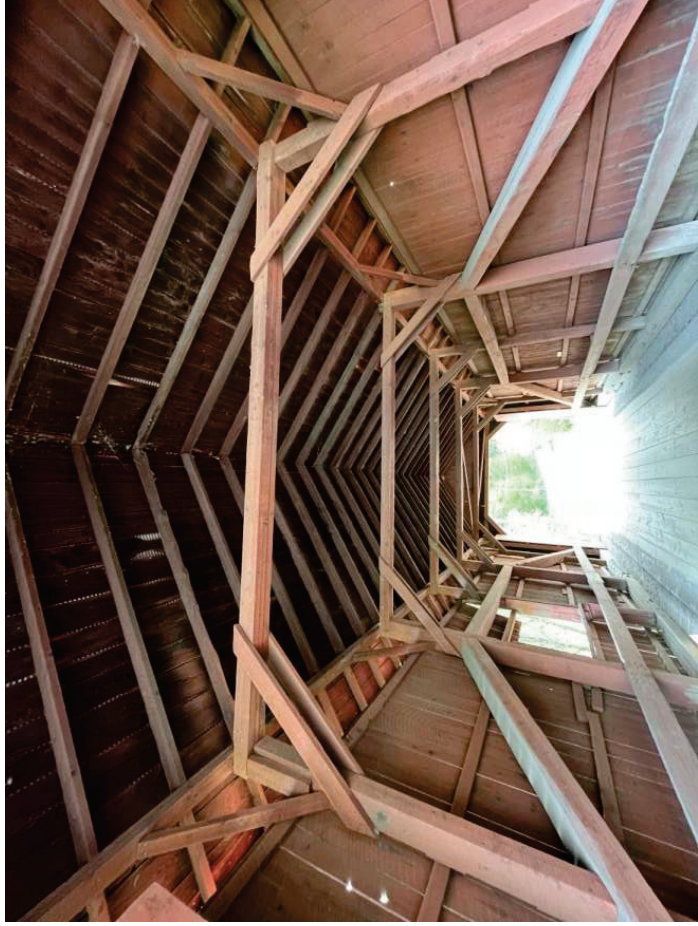
Recommended Work: Lat. Bracing Members

- Existing
 - 6"x6" Crossbeams, Eastern Spruce
 - 2"x8" Diagonal Braces, Eastern Spruce (North Portal Only)
 - 2"x6" Knee Braces, Hemlock

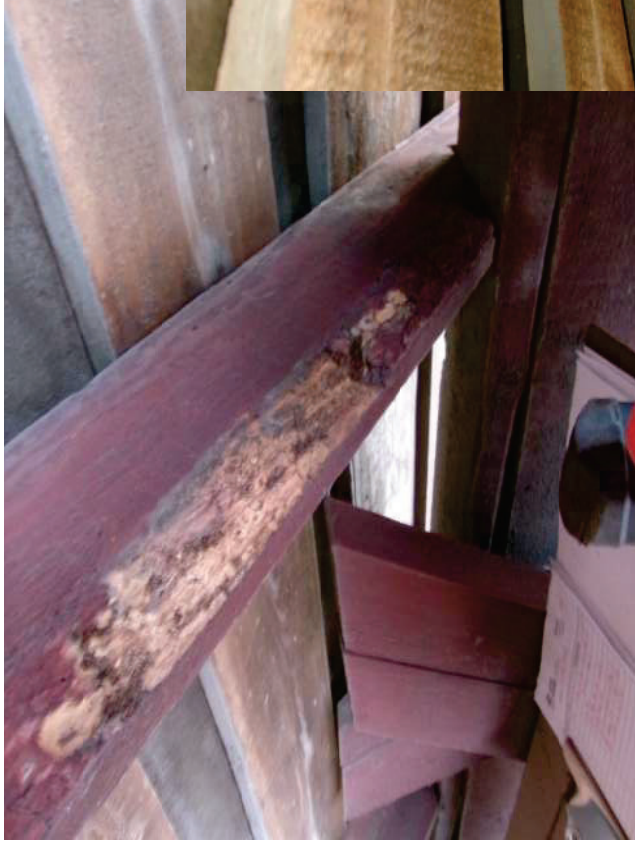
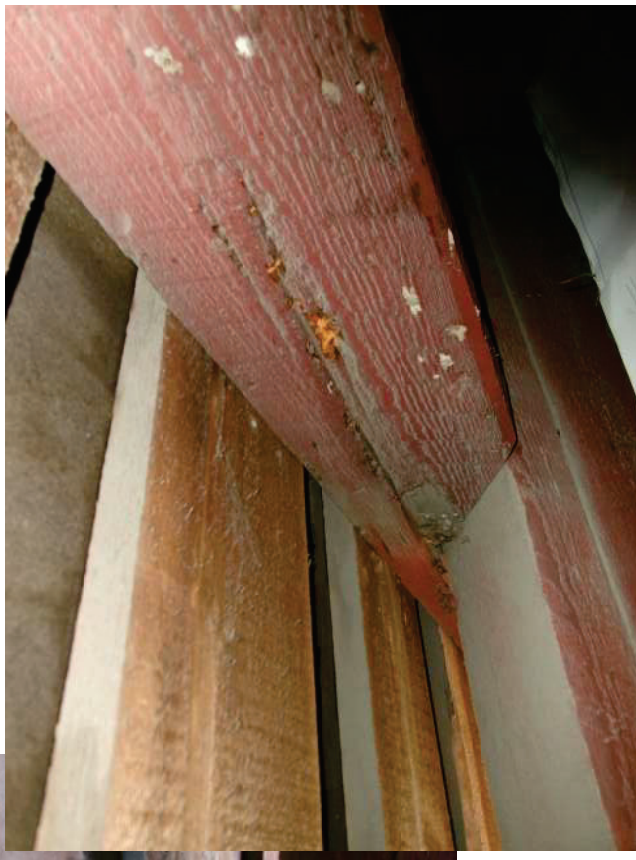
- Splits
- Breaks
- Rot
- Insect Damage

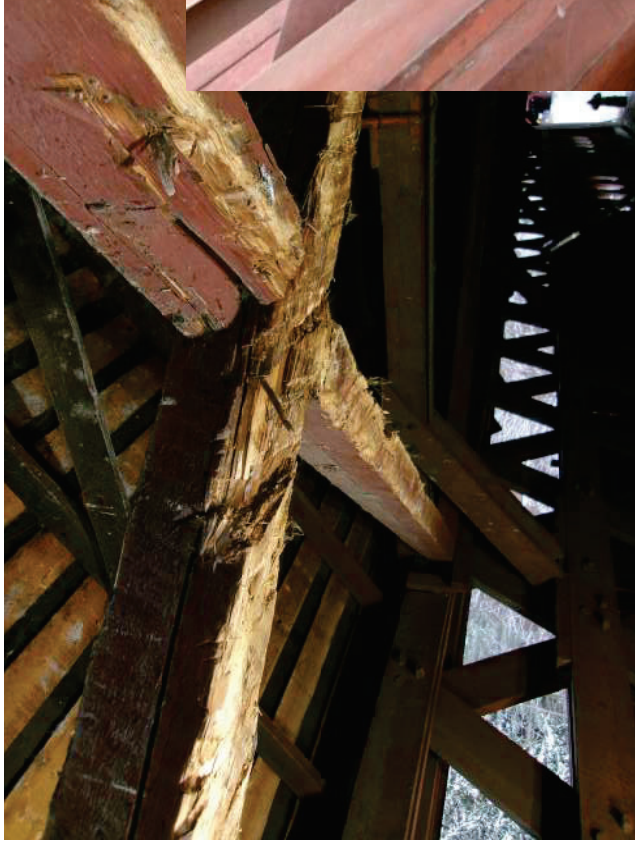
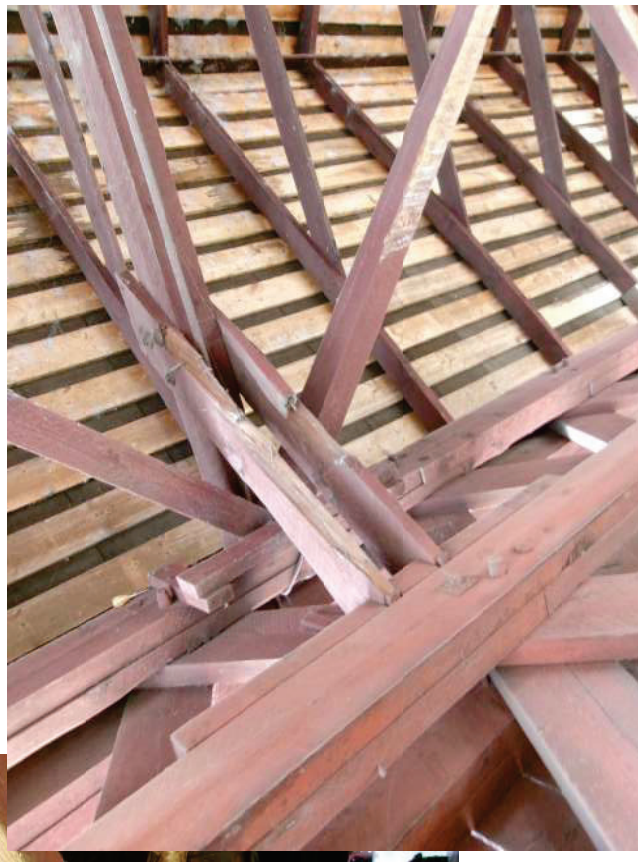
Upper Bracing Members

- Splits
- Breaks
- Rot
- Impact Damage

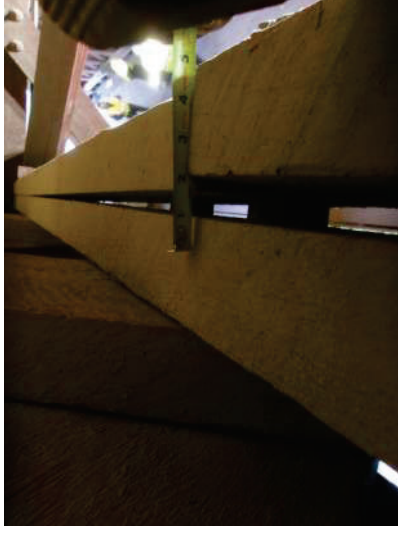
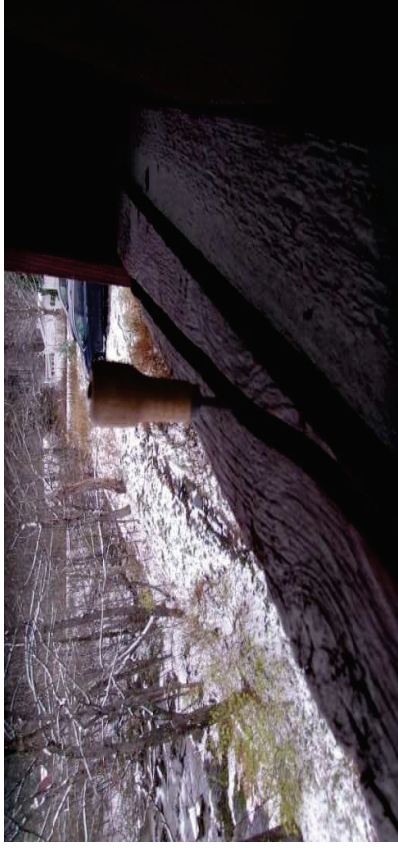
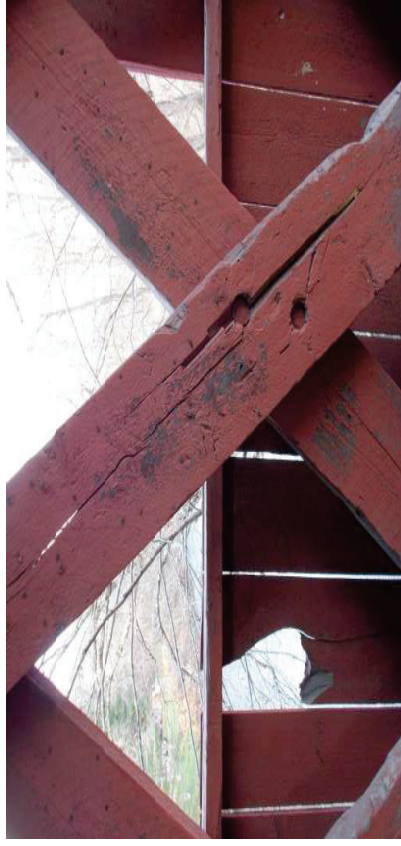
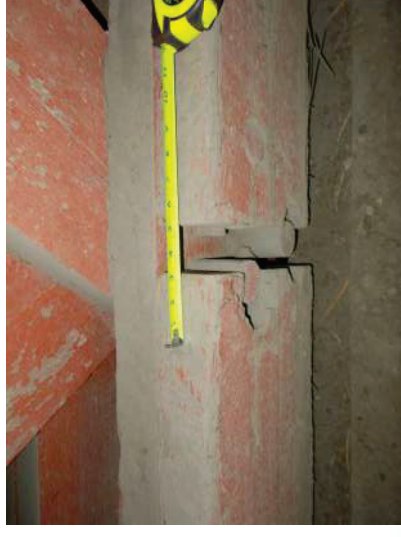
Truss Members

- Splits
- Breaks
- Rot
- Misalignment
- High Moisture Content

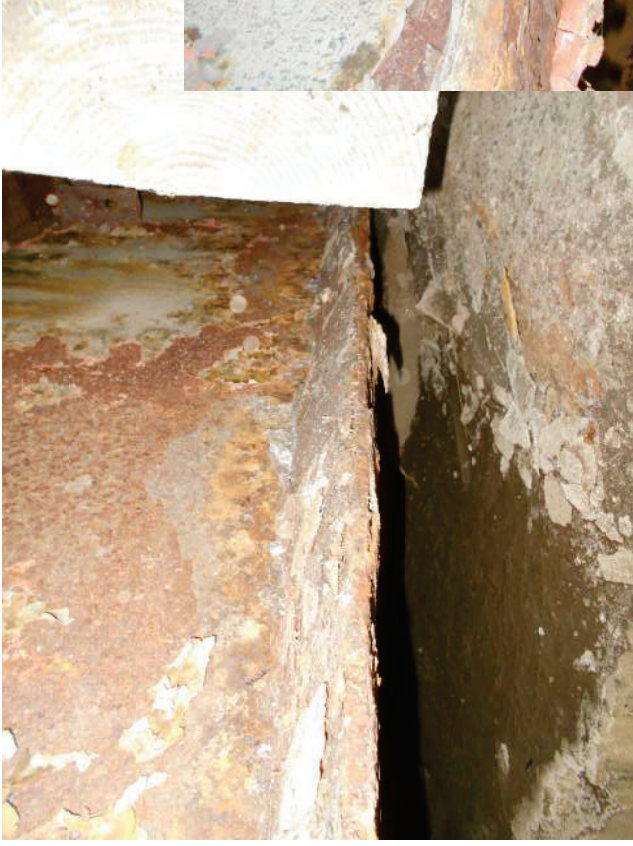
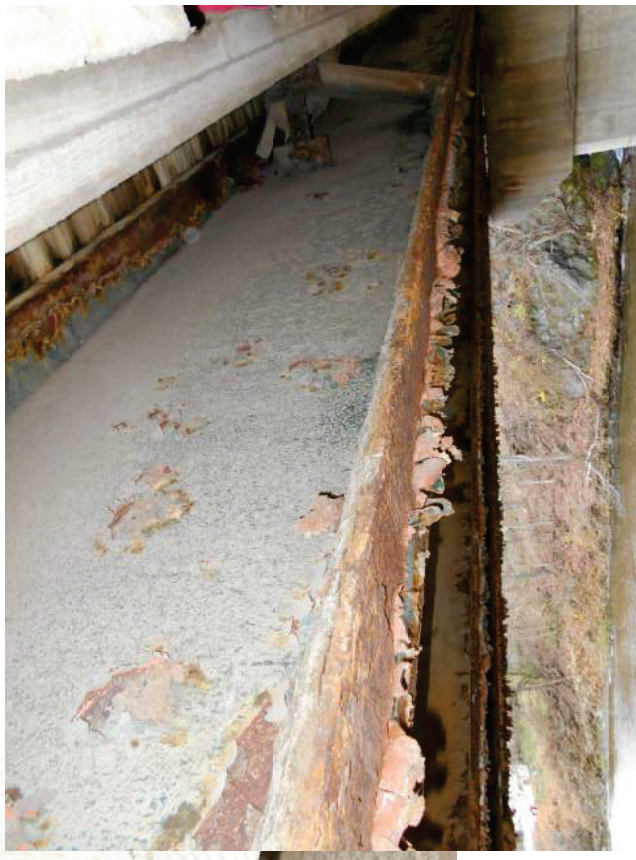
Steel Beams

- Rusting
- Advanced Corrosion

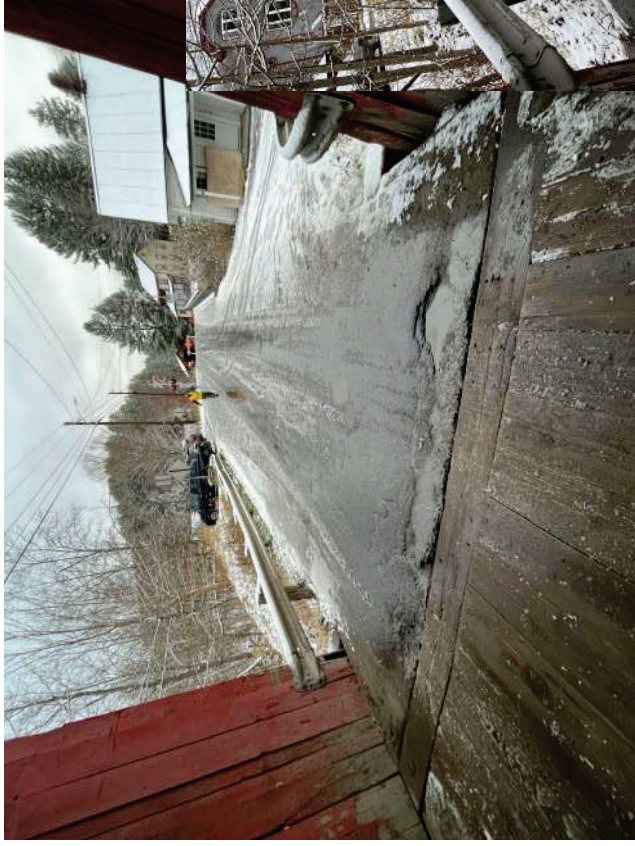
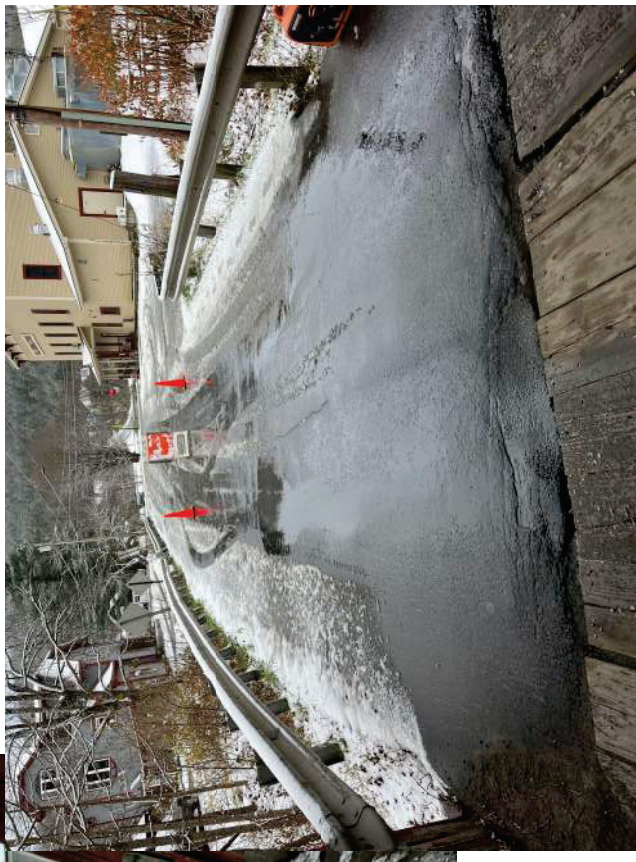
Approaches

- Drainage Issues
- Ponding

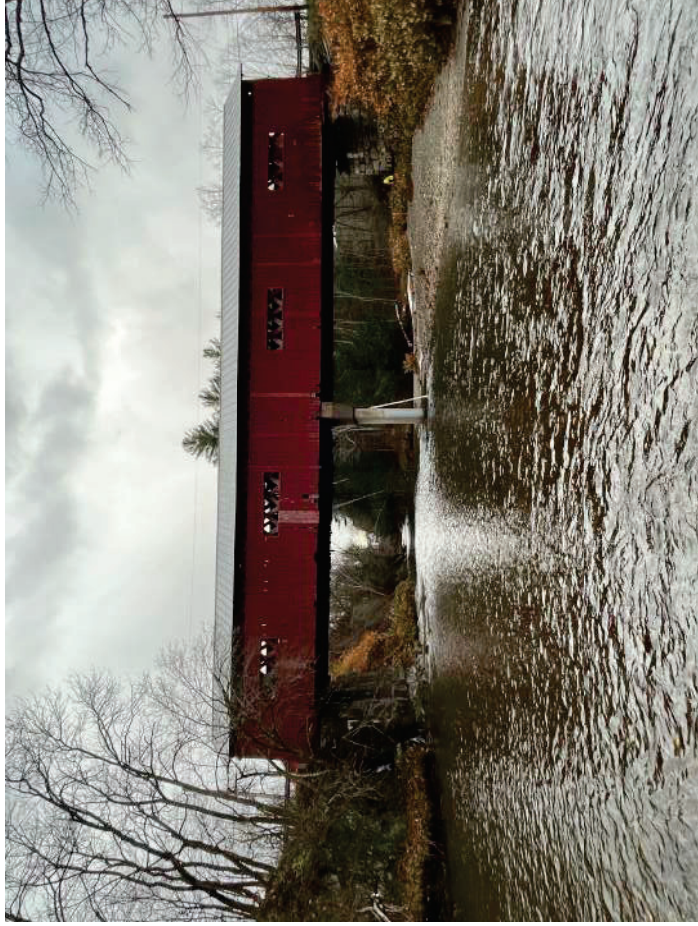
Recommended Work: Fascia & Portal Siding

- Existing
 - 1" Thick Boards
- Recommended Work
 - Replacement of all Existing Siding Boards (Eastern White Pine) (PTN 2)

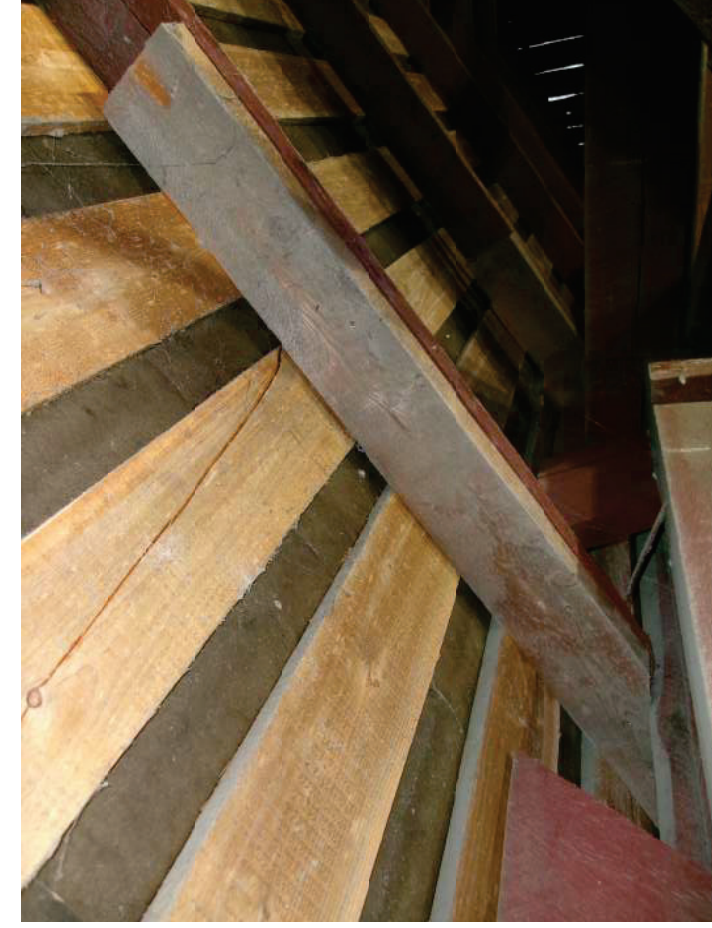
Recommended Work: Roof Members

- Existing
 - Standing Seam Metal Roof
 - 2"x6" Rafters, Eastern Spruce
 - 1"x8" Roof Boards, Eastern Spruce
- Recommended Work
 - New Standing Seam Metal Roof (PTN 2)
 - Replacement of Roof Boards (25%) (PTN 2)
 - 14 Rafters (20%) to be Replaced due to Condition (PTN 2)

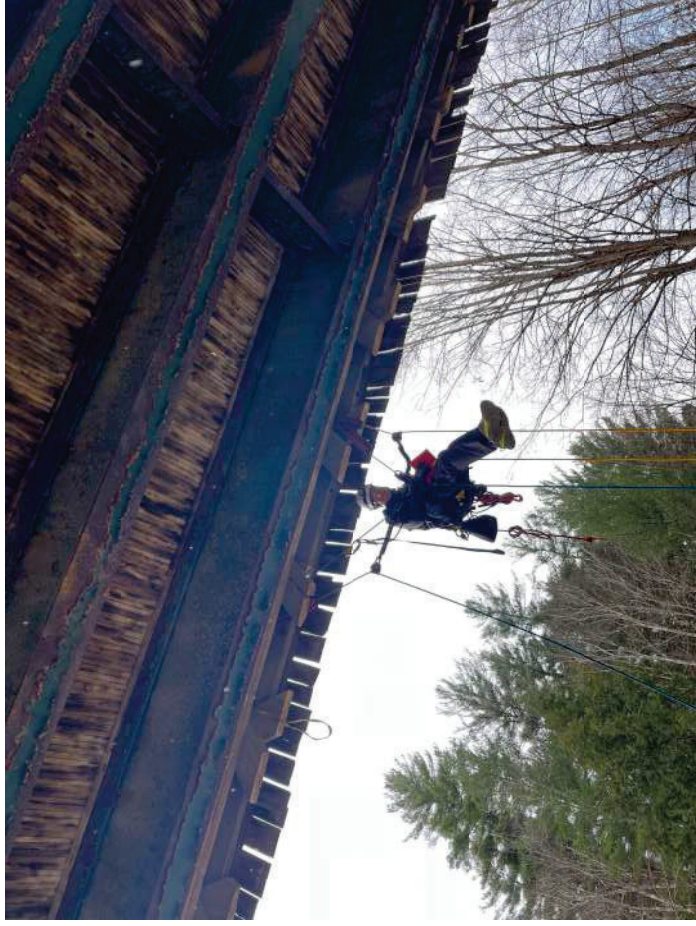
Recommended Work: Floor System

- Existing:
 - 33WF118 Steel Beams
 - C18x42.7 Steel Diaphragms
 - 2"x8" Nail Laminated Deck, Southern Yellow Pine
 - 1½" Thick Runner Boards, Eastern Hemlock
- Recommended Work
 - Replace Steel Stringers with new Steel Stringers (PTN 2)
 - Replace Deck with Nail Laminated (PTN 2), or Glulam Deck (PTN 2)
 - Replace Runner Boards with Full Width 1 ½" Thick Runners, White Oak (PTN 2)

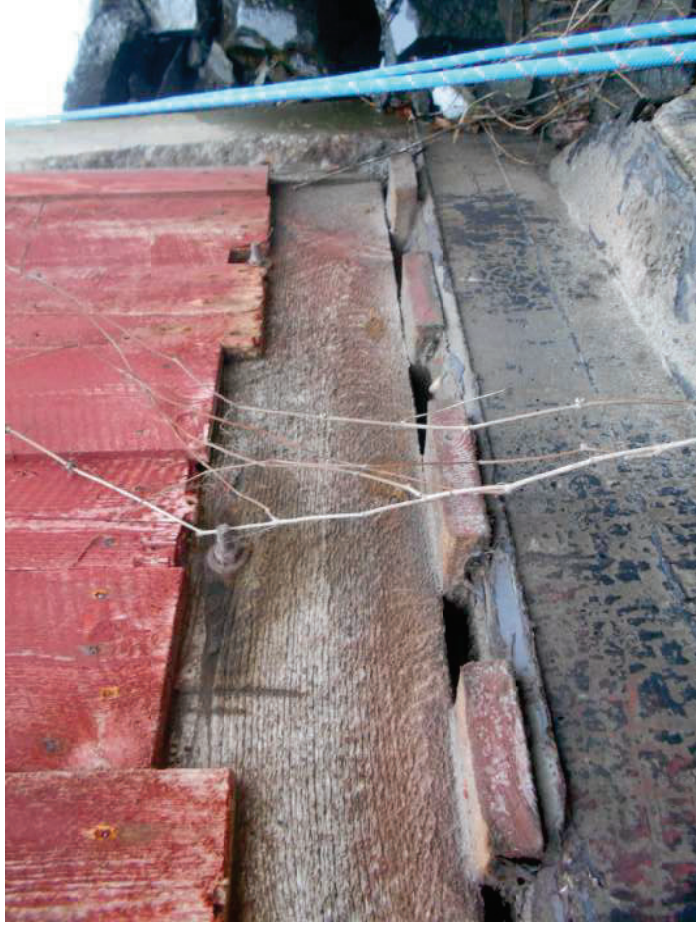
Recommended Work: Truss Bearings

- Replace Bearing Blocks at all 6 Truss Bearing Locations (PTN 2)

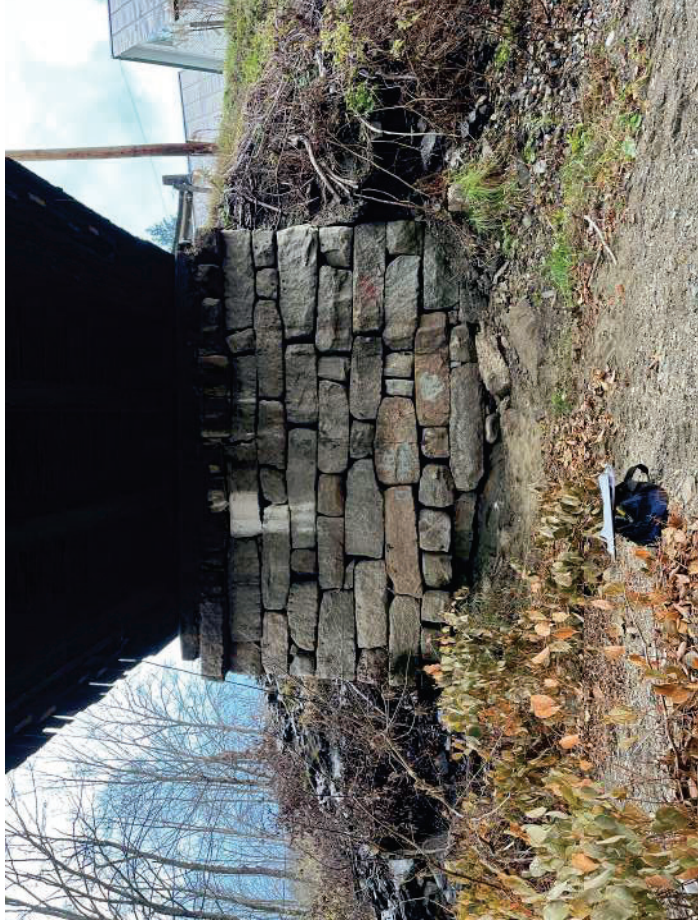
Recommended Work: Substructure

- West Abutment
 - Repair West Abutment (PTN 1)
 - Replace Concrete Cap (PTN 2)

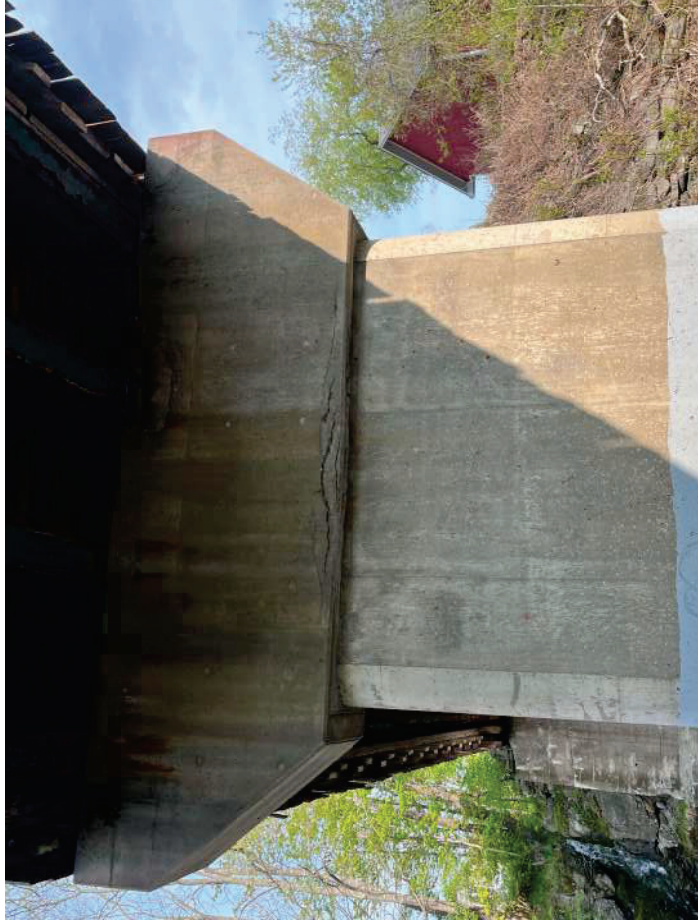
Recommended Work: Substructure

- Pier
 - Adjust Beam Seat Elevations for Steel Stringers (PTN 1)
 - Concrete Repair / Crack Sealing (PTN 1)
 - Stain And Seal Concrete (PTN 1)

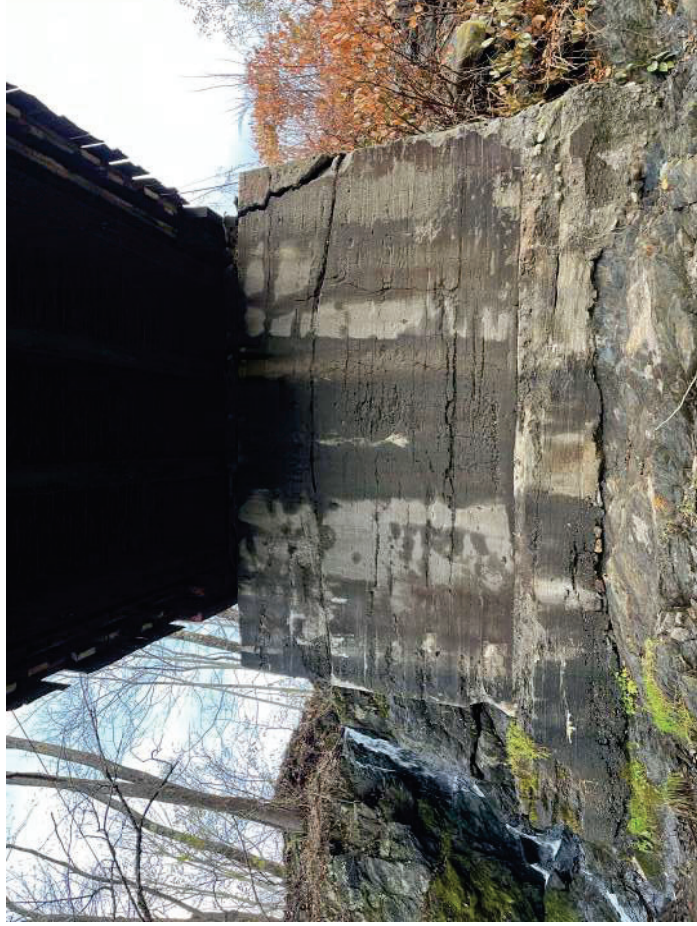
Recommended Work: Substructure

- Replace East Abutment (PTN 2)
 - Alternative 1 – Stone Masonry
 - Alternative 2 – Reinforced Concrete
