# Draft Scoping Report Lower Cox Brook Covered Bridge Town Highway 3 Bridge 11 over Cox Brook

Northfield BO CVBR(8)

**January 24, 2026**

Prepared for:  
Vermont Agency of Transportation

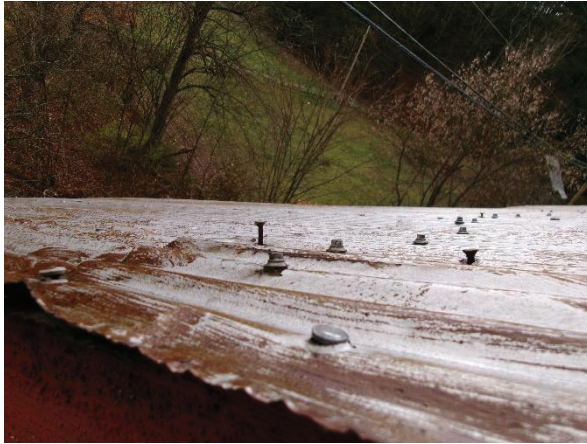
Metal Roof

- The metal roof is attached with nails, which allow water penetrations to underlying members.
- The roof boards and rafters exhibit through splits, breaks, insect damage, and rot. Rafters sit on two 2"x6" rafter support beams.
- The siding boards exhibit areas of faded paint. The siding is in good condition; however, removal and replacement will likely be required to provide access for the extensive truss member replacements.

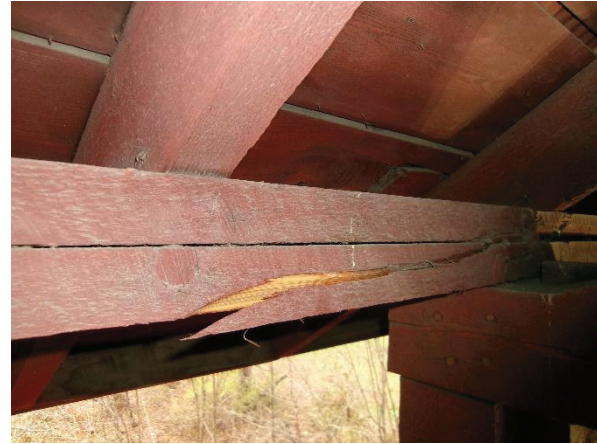
- The roofboards and rafters exhibit through splits, breaks, insect damage, and rot. It is estimated that all of the roofboards and 8% of the roof rafters will require replacement due to condition.
- The siding boards are in good condition; however, removal and replacement will likely be required to provide access for the extensive truss member replacements.

Splits and Breaks in Roof Boards and Rafters

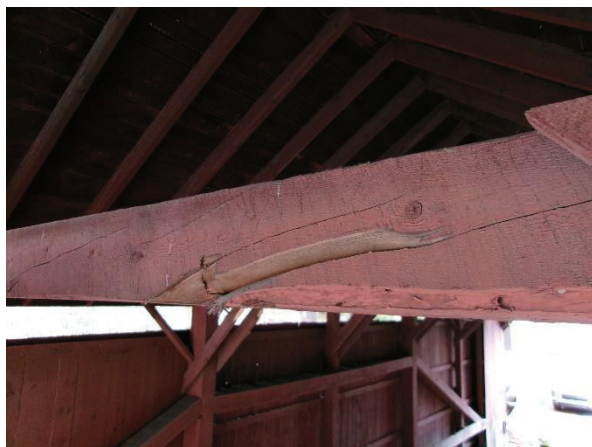
Split in Crossbeam

- Two crossbeams are split and show signs of impact damage. The cross beam at the south portal is broken.
- Crossbeams have been previously damaged from oversized vehicles and are not well connected to the vertical truss members.
- Some of the timber knee braces on the west truss have impact damage and splits.

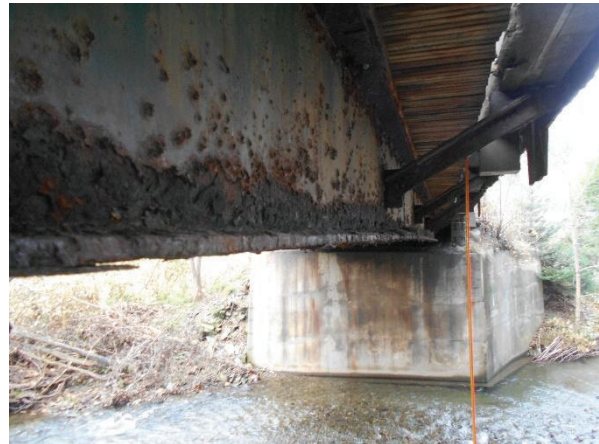
- The diaphragm between the northern interior and exterior beams (B3 and B4) at the east abutment has 100% section loss.
- The exterior beams had section loss that reduced flange thickness to  $\frac{7}{16}$ " typical, with isolated areas only  $\frac{3}{8}$ " thick. The top flange also had areas of section loss with a flange thickness of  $\frac{1}{2}$ " throughout. The webs were in fair condition with some areas of rust and section loss. By inspection, it appears the web had approximately  $\frac{1}{16}$ " section loss on both sides of the web.

Exterior Stringer

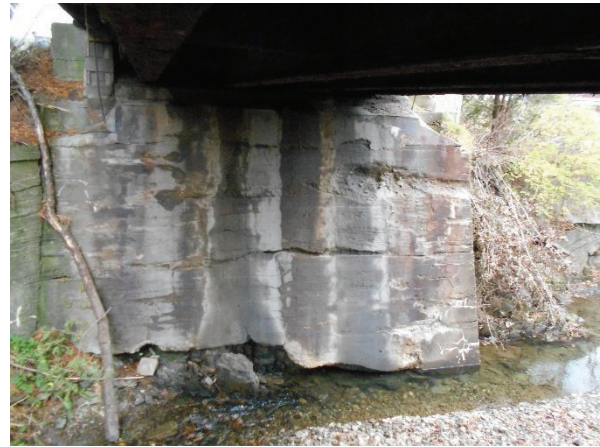
- Both abutments exhibit some areas of concrete spalling, delamination, efflorescence staining, and vertical, horizontal, and map cracking.
- At the spalled areas the concrete was not observed to contain rebar.
- The east abutment is in poor condition and needs to be replaced.

East Abutment

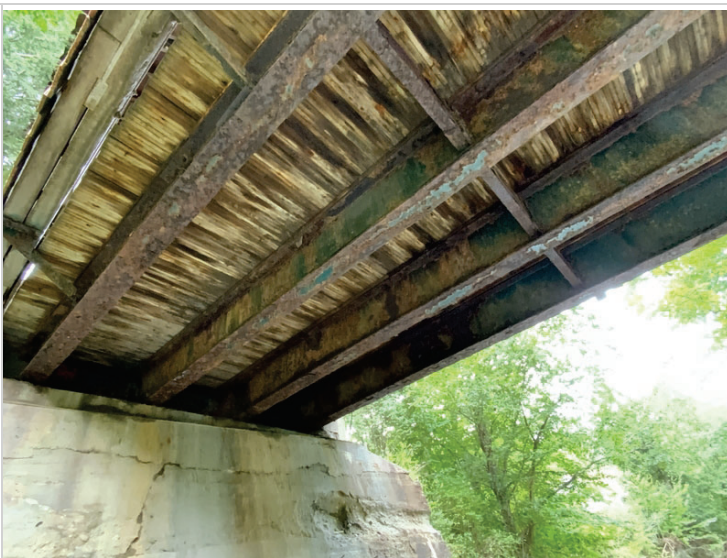
**59 - Superstructure** (5 - FAIR CONDITION - all primary structural elements are sound but may have minor section loss, cracking, spalling or scour.)

Superstructure

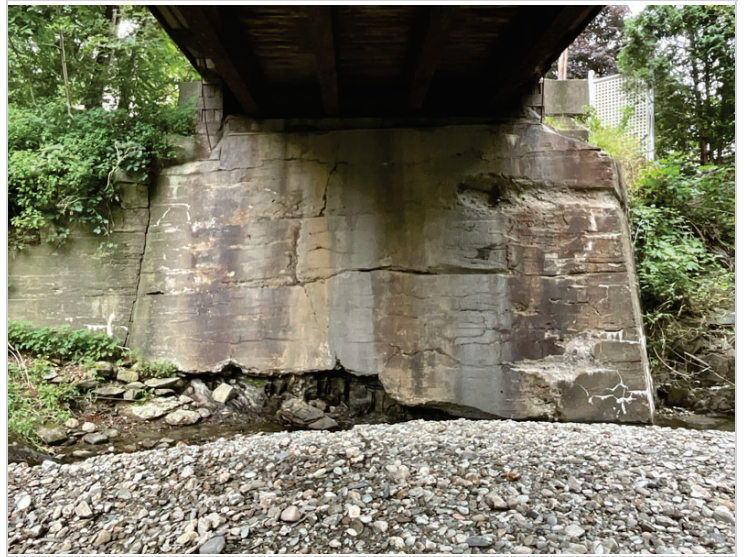
Abutment 1 has map cracking throughout with minor saturation with scattered small areas of rust staining. Abutment 2 has lineal cracking with minor separation along the pour joints, map cracking throughout with light staining and scattered small voided spalls with scaling.

Abutment 2

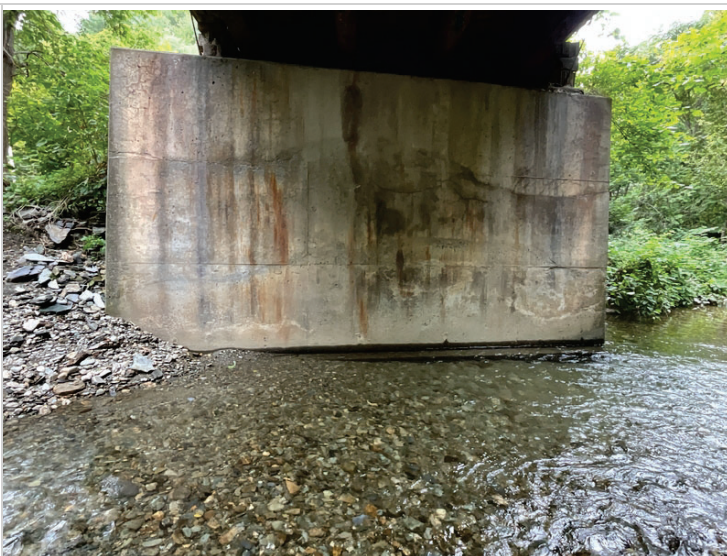
Abutment 1

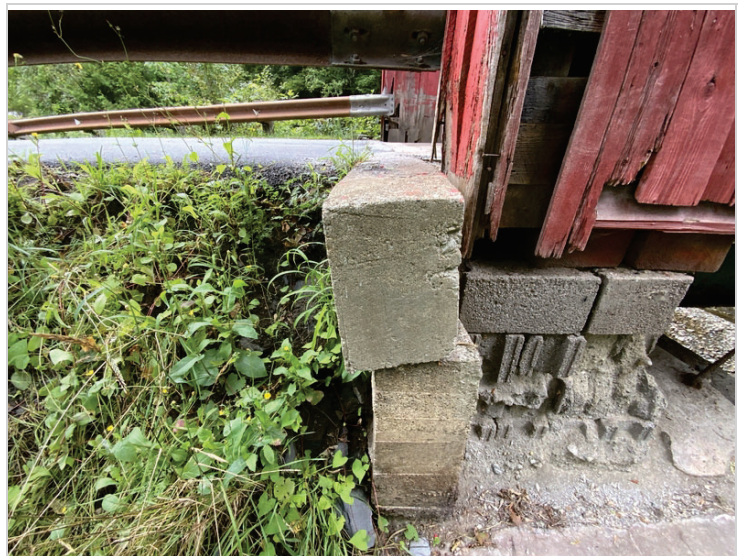
Minor abrasion and voided spalls throughout from tire wear. The added extension of the wall at abutment 1 is not attached and tips towards the backfill and is cracked through at the center.

Abutment 1 backwall

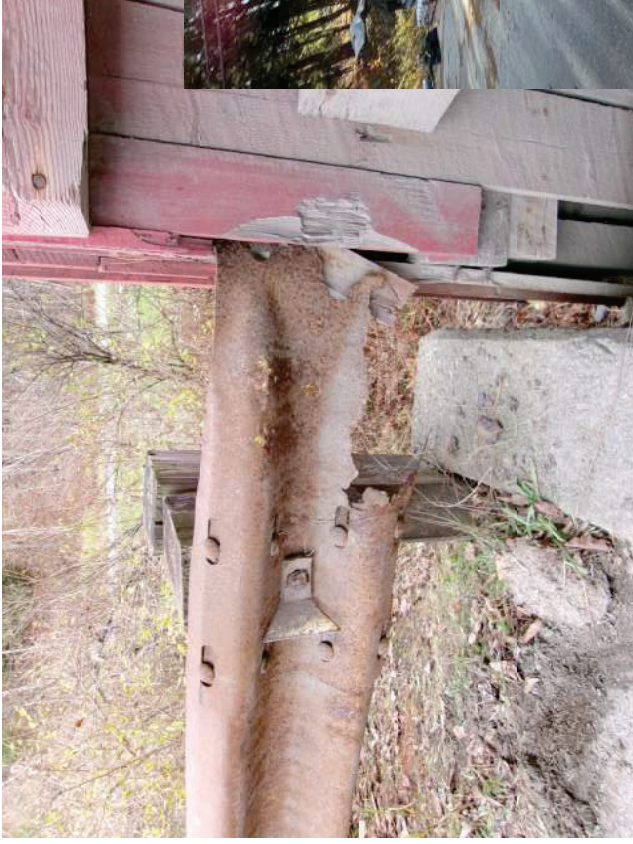
# Approach Railing

- Extensive Corrosion
- Rust Holes
- Rotted Wood Posts
- Impact Damage

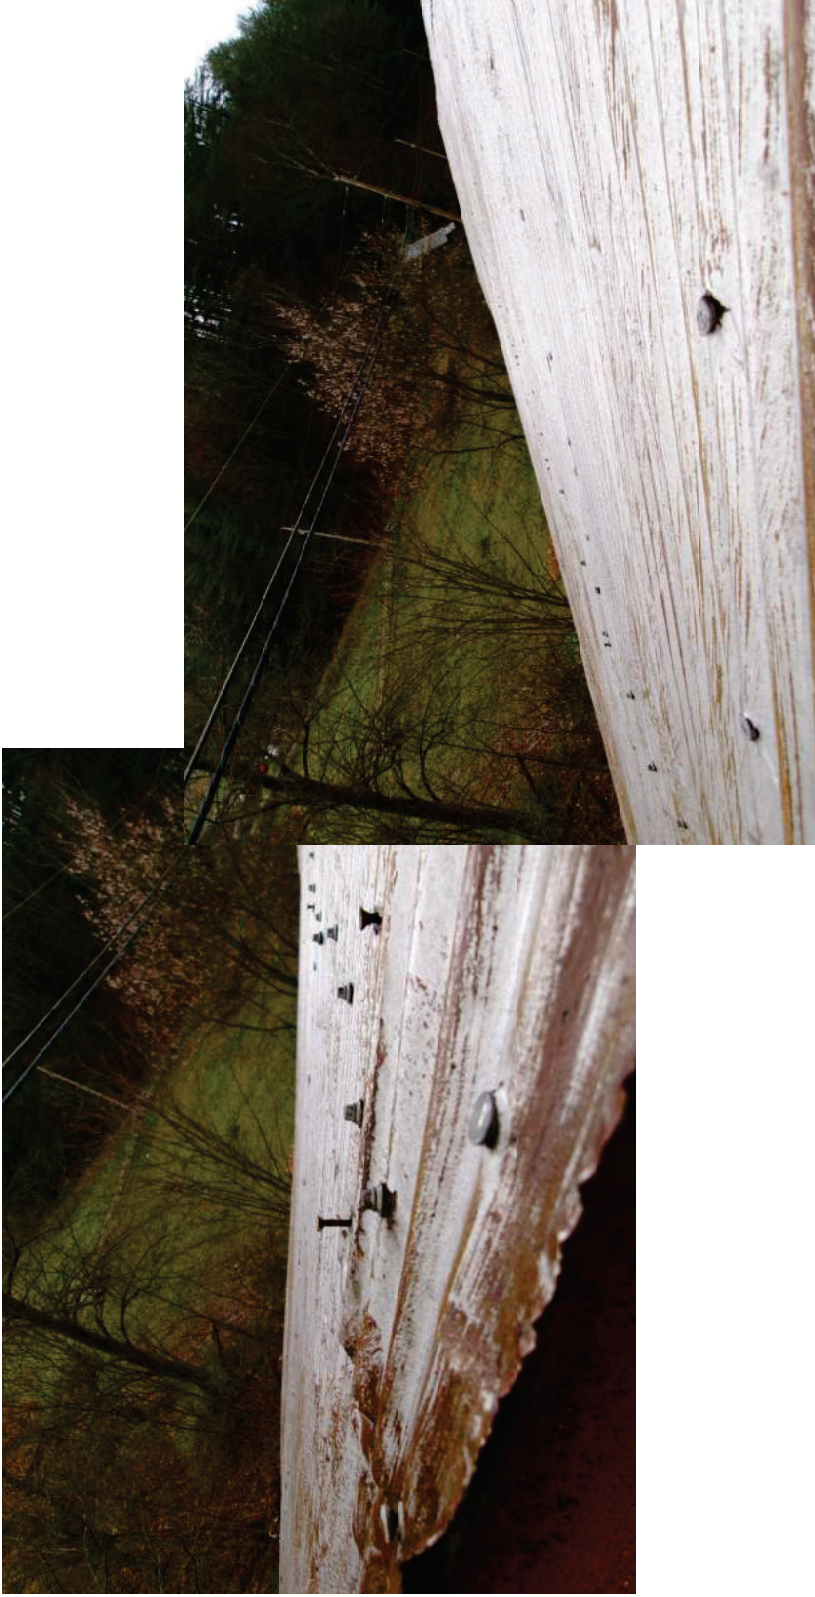
- Rusting
- Leaks
- Nail Attachment

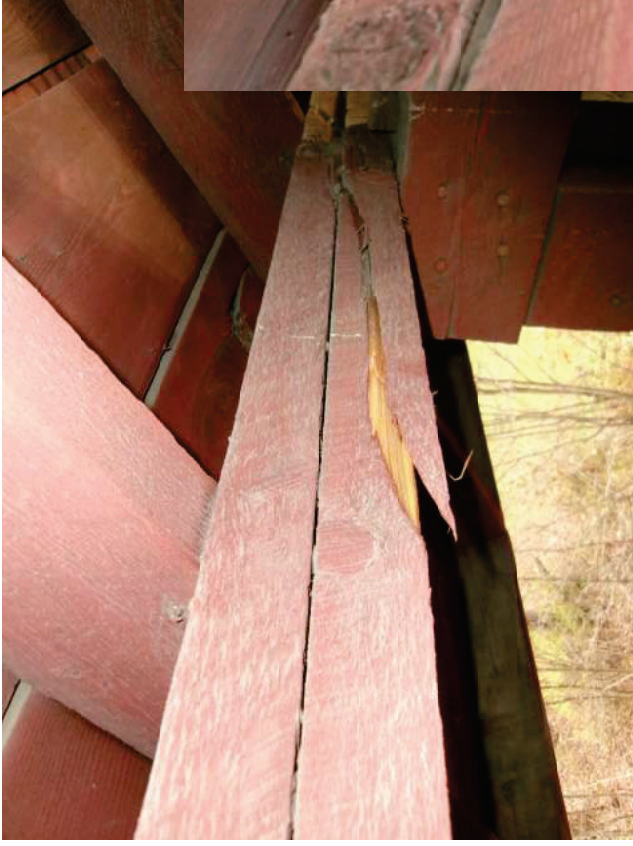
# Roofboards and Rafters

- Splits
- Breaks
- Rot
- Insect Damage

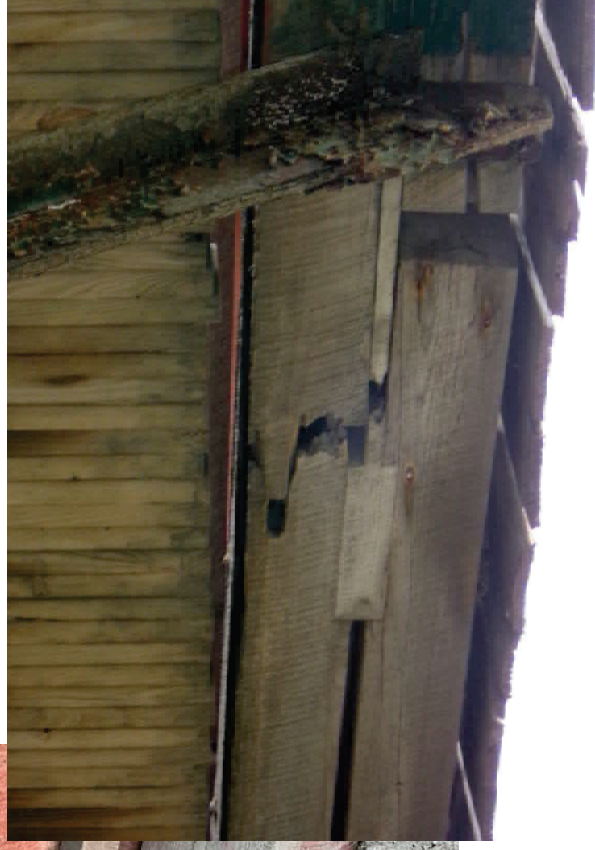
# Truss Members

- Splits
- Breaks
- Rot
- High Moisture Content

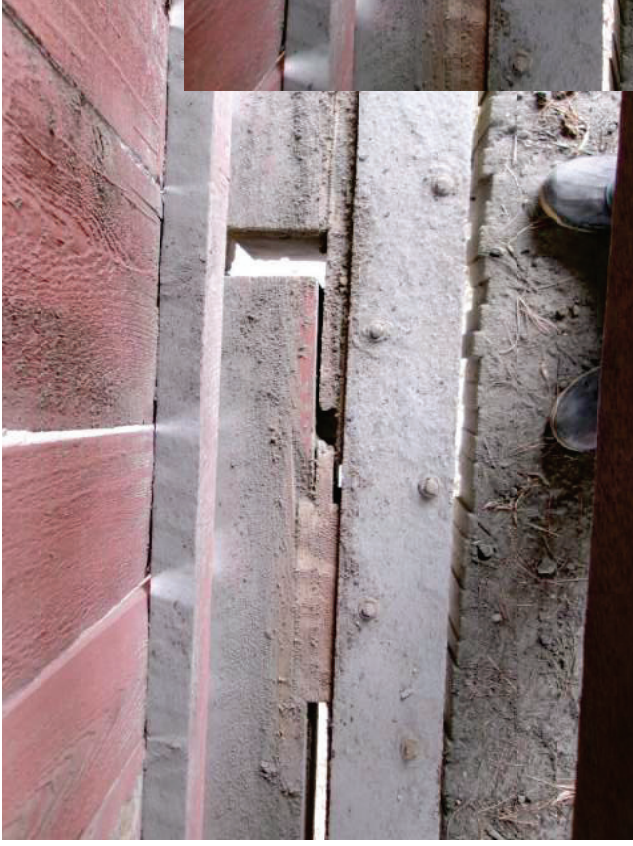
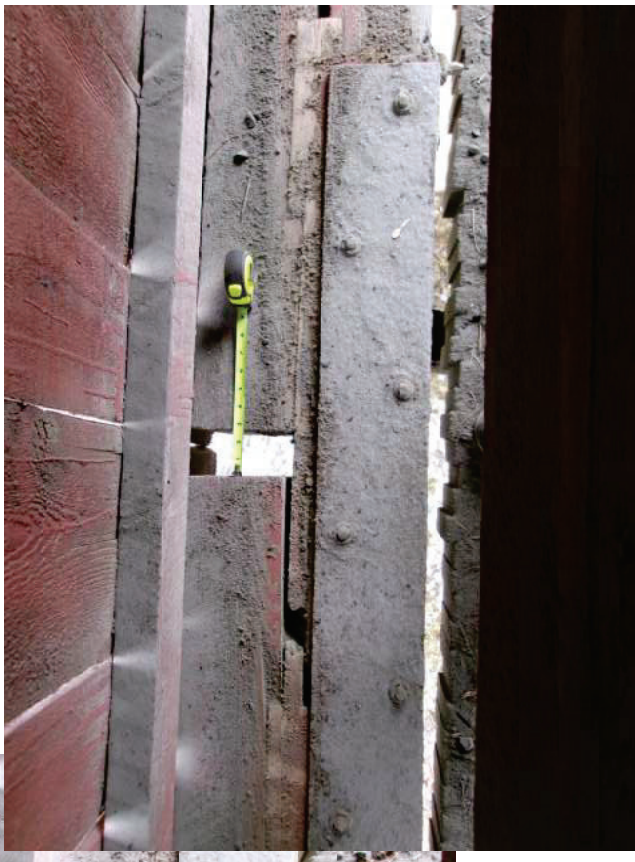
# Truss Members (Continued)

- Splits
- Breaks
- Rot
- High Moisture Content

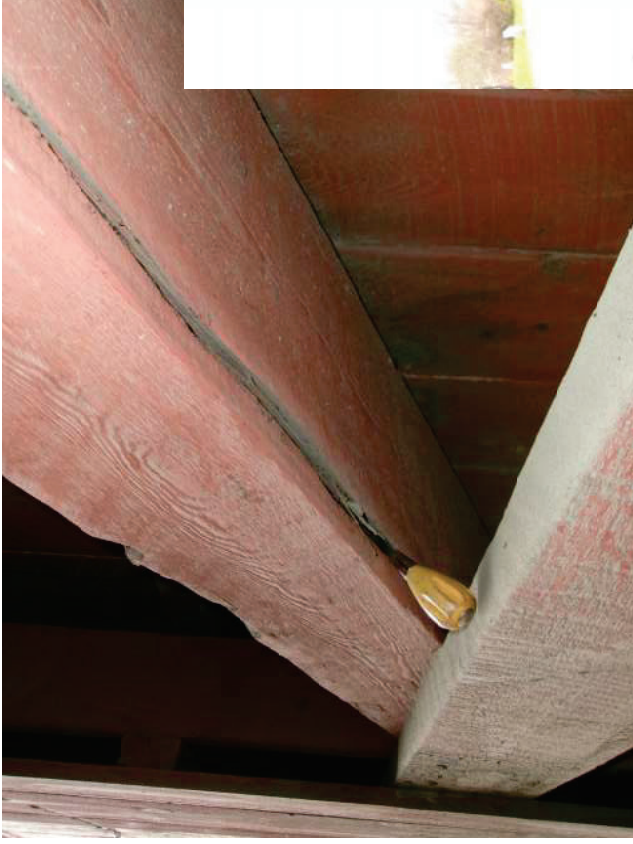
# Truss Members (Continued)

- Splits
- Breaks
- Rot
- High Moisture Content

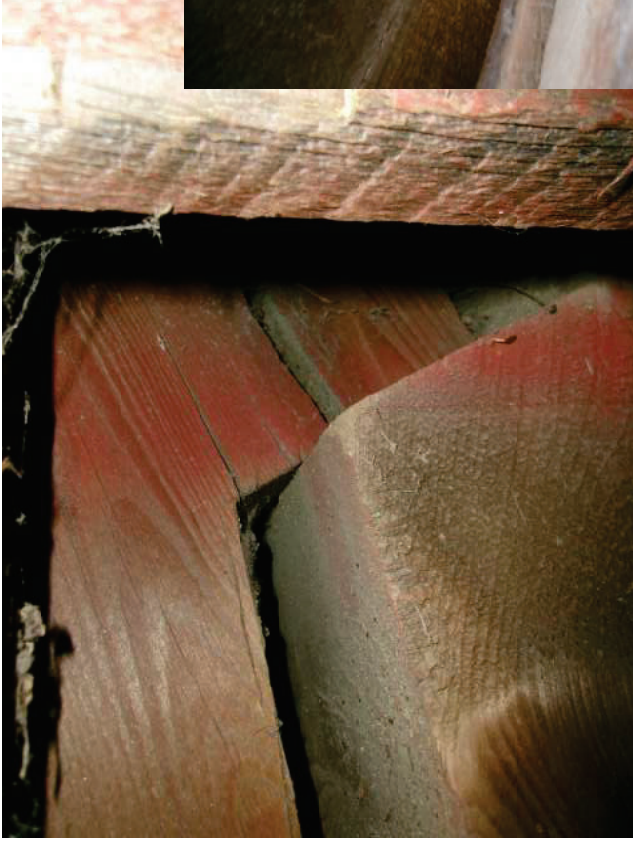
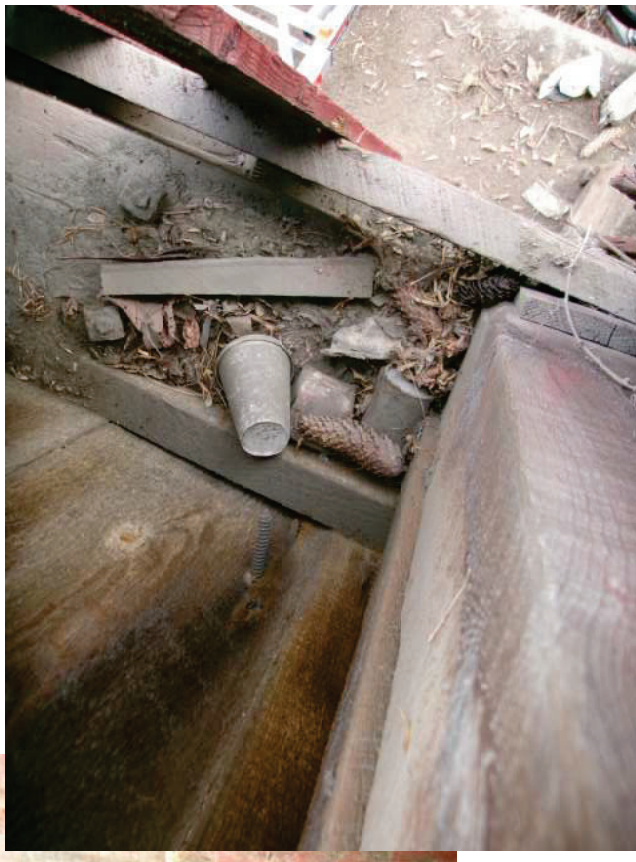
# Truss Members (Continued)

- Splits
- Breaks
- Rot
- High Moisture Content

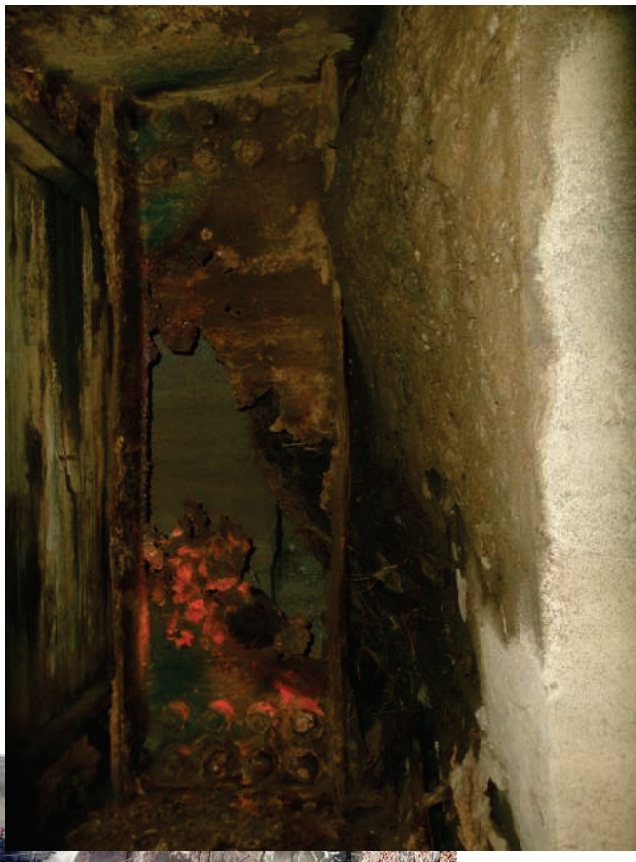
# Steel Beams

- Rust Holes
- Advanced Corrosion

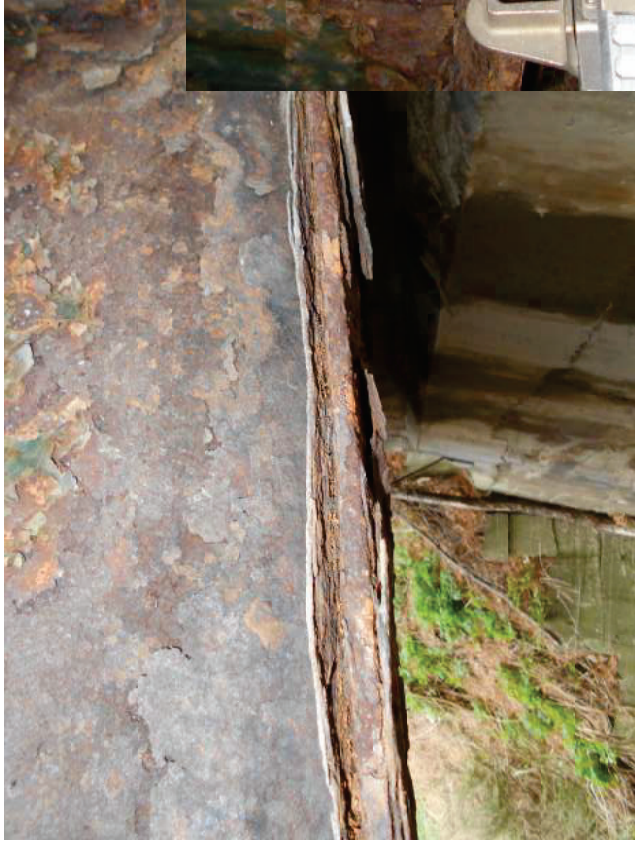
# Steel Beams (Continued)

- Rust Holes
- Advanced Corrosion

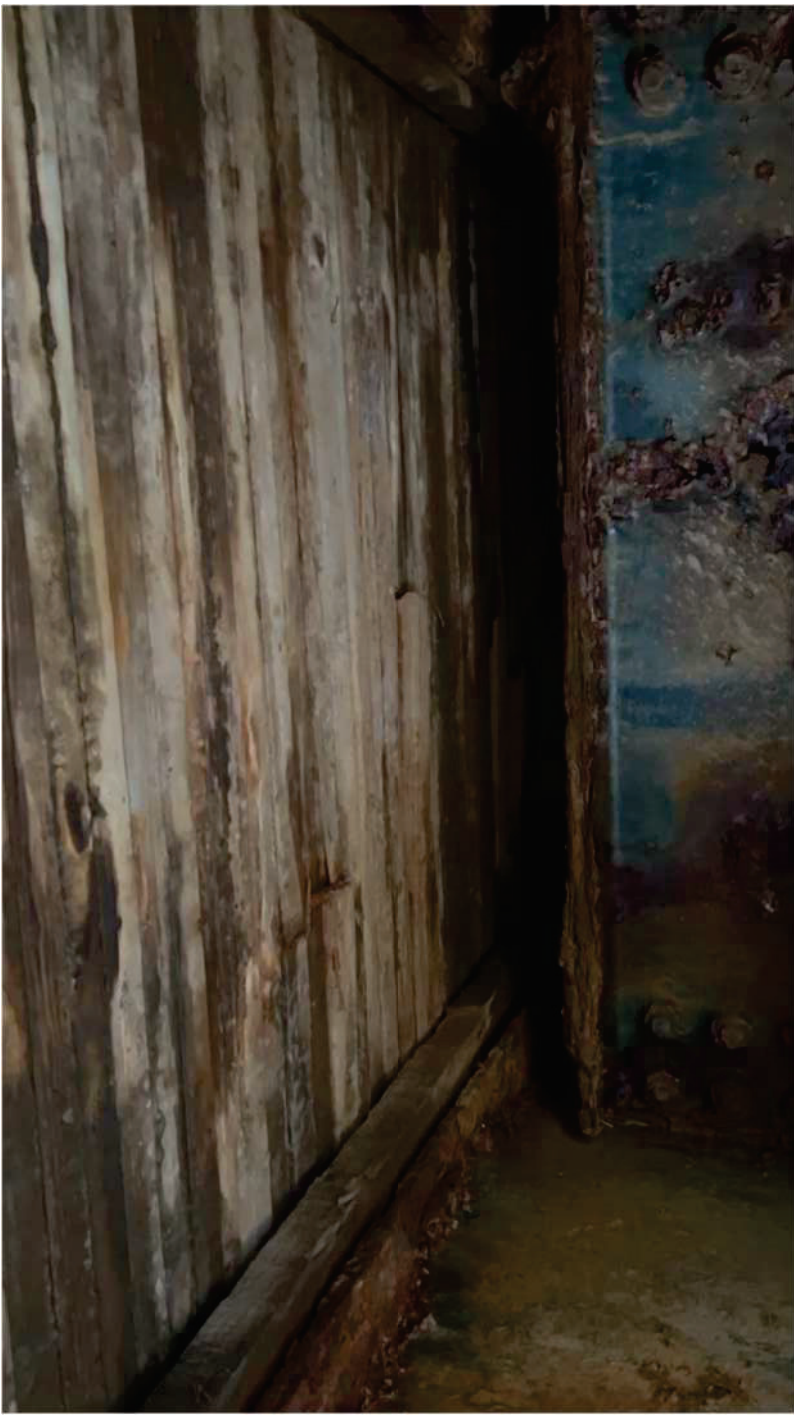
# Deck

- Breaks
- Poor Attachment

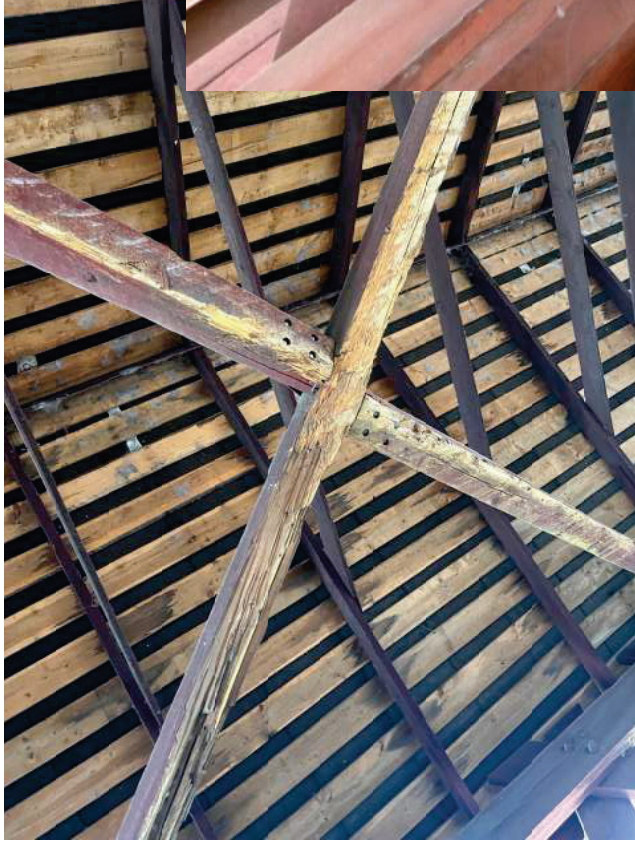
# Upper Bracing Members

- Splits
- Breaks
- Rot
- Impact Damage

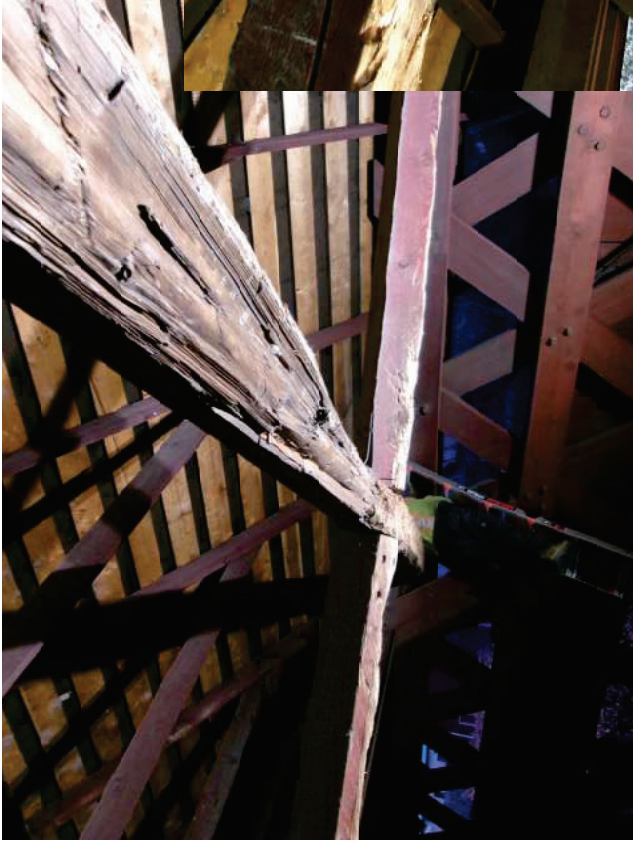
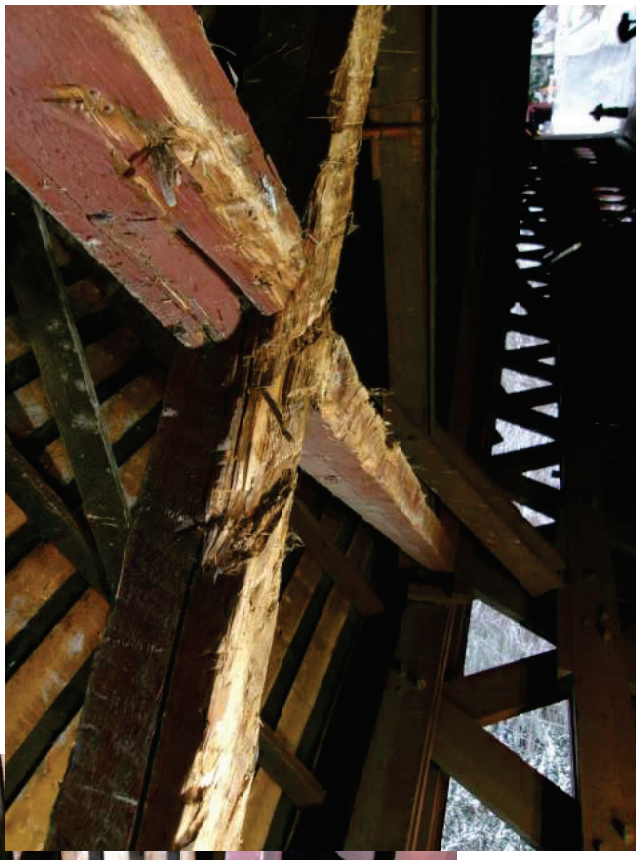
- Splits
- Breaks
- Rot
- Impact Damage

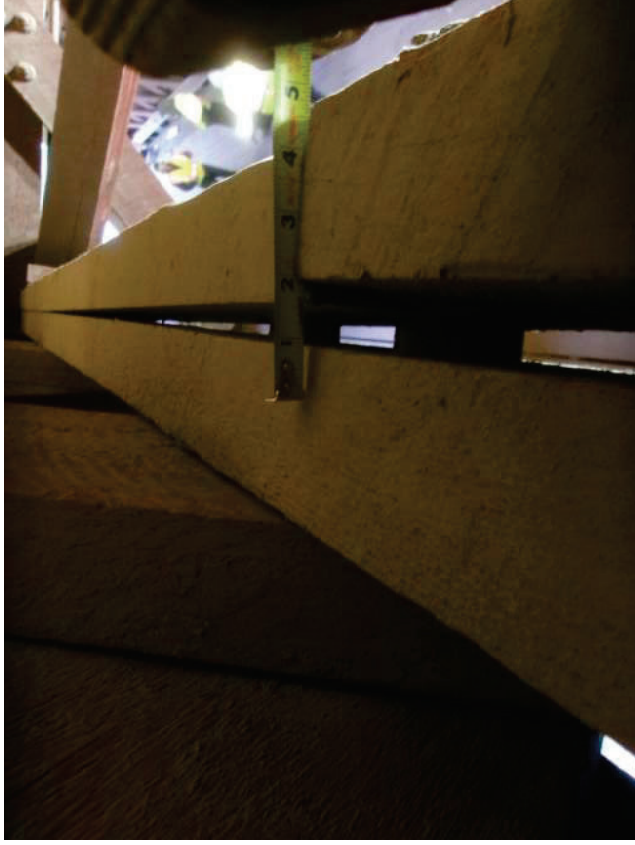
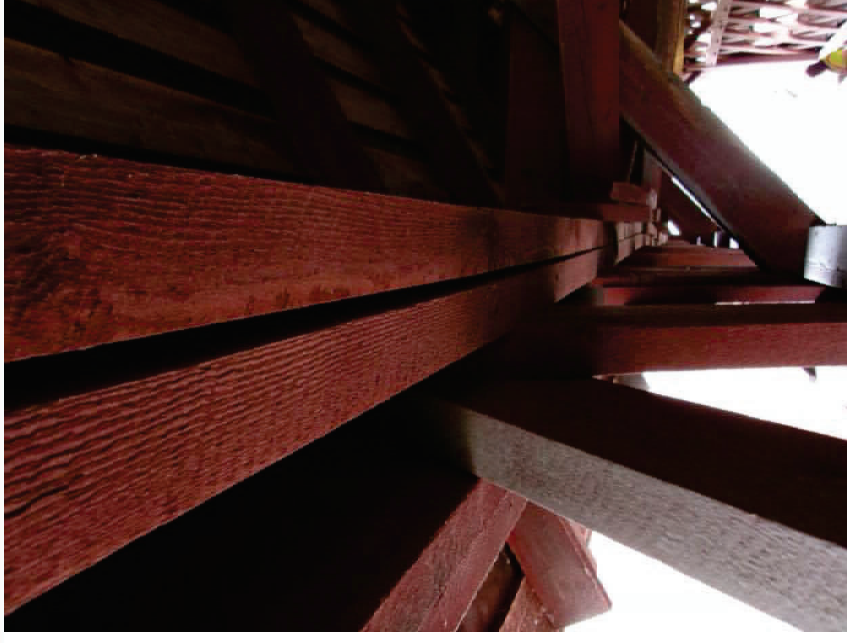
# Truss Members

- Splits
- Breaks
- Rot
- Misalignment
- High Moisture Content

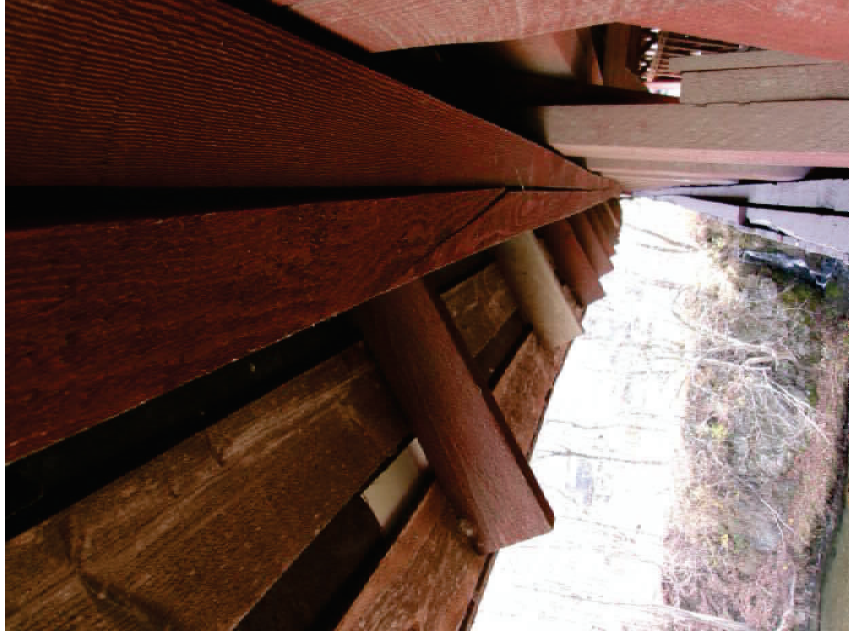
# Truss Members (Continued)

- Splits
- Breaks
- Rot
- Misalignment
- High Moisture Content

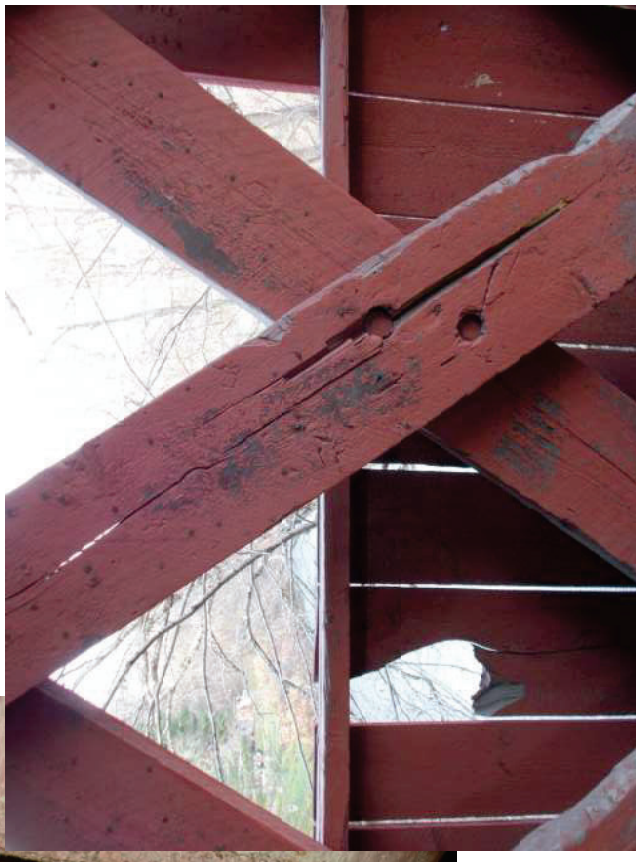
# Truss Members (Continued)

- Splits
- Breaks
- Rot
- Misalignment
- High Moisture Content

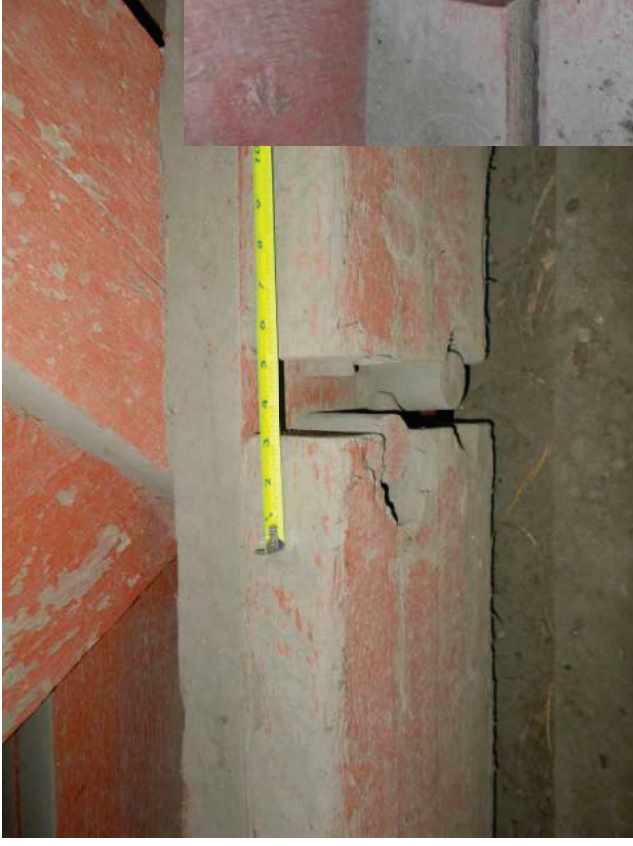
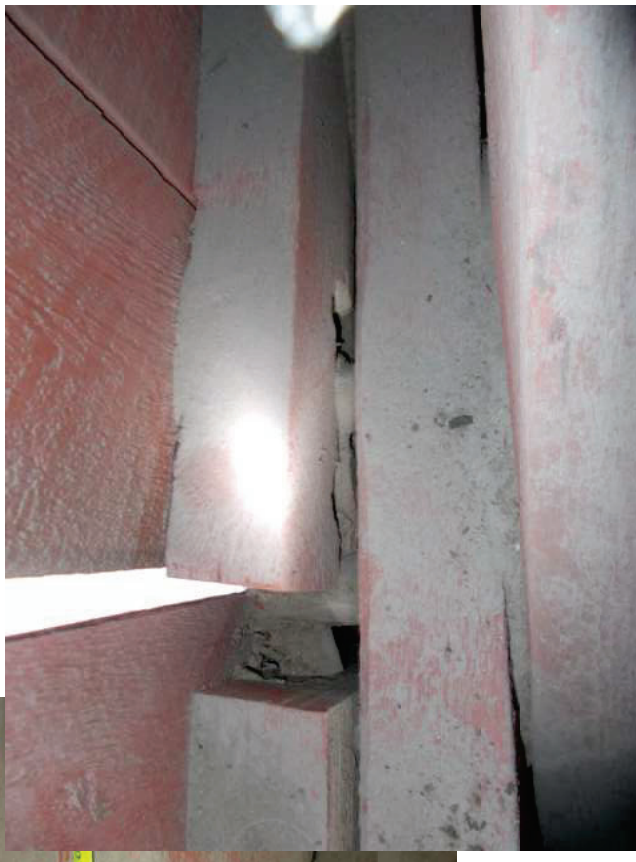
# Truss Members (Continued)

- Splits
- Breaks
- Rot
- Misalignment
- High Moisture Content

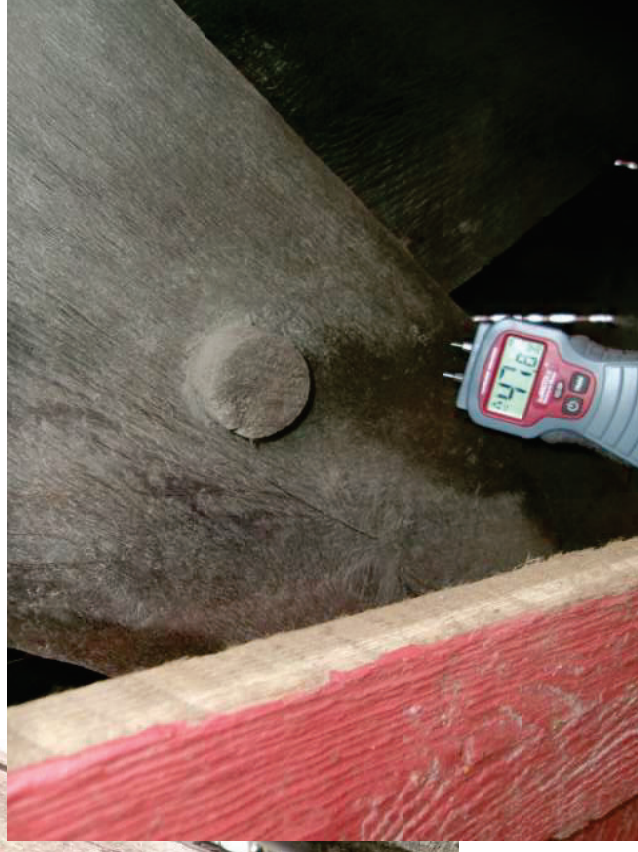
# Truss Members (Continued)

- Splits
- Breaks
- Rot
- Misalignment
- High Moisture Content

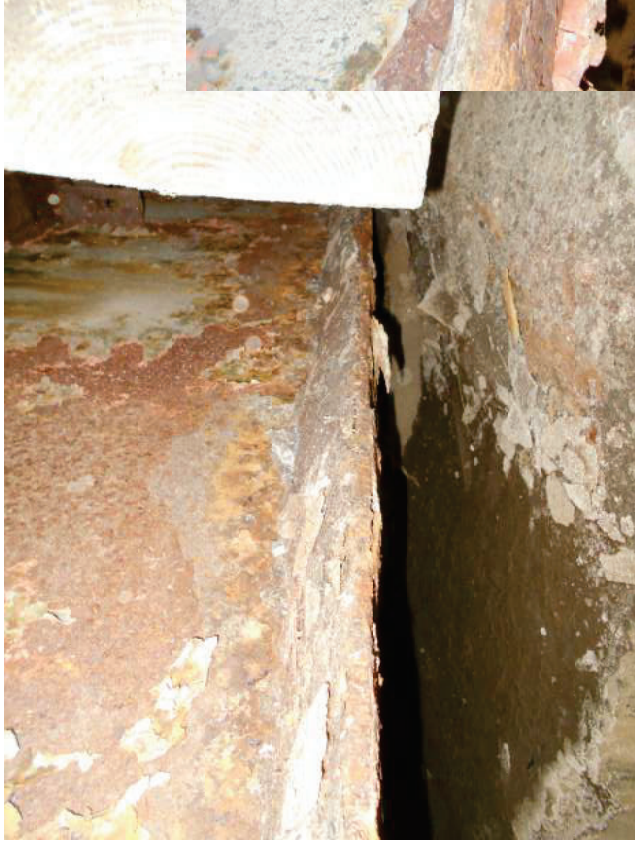
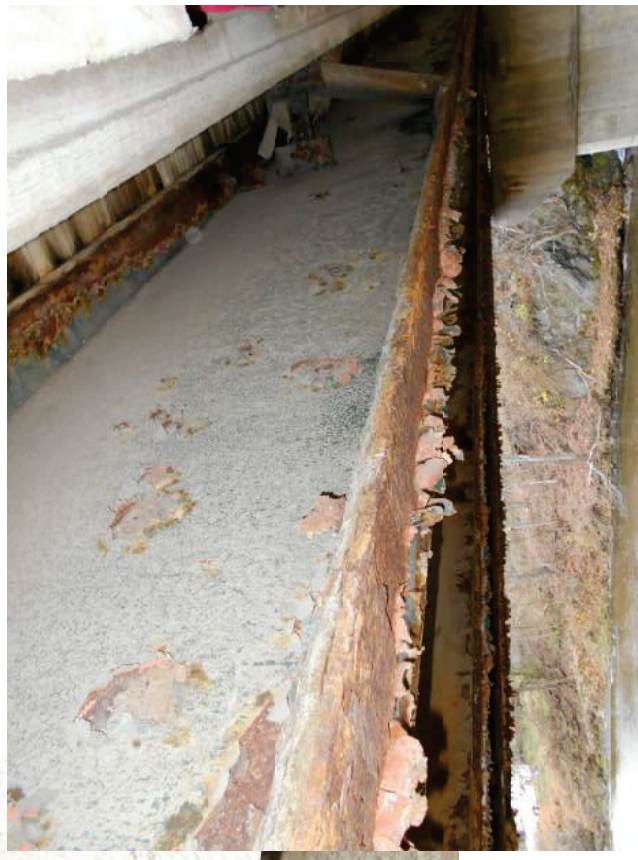
# Steel Beams (Continued)

- Rusting
- Advanced Corrosion

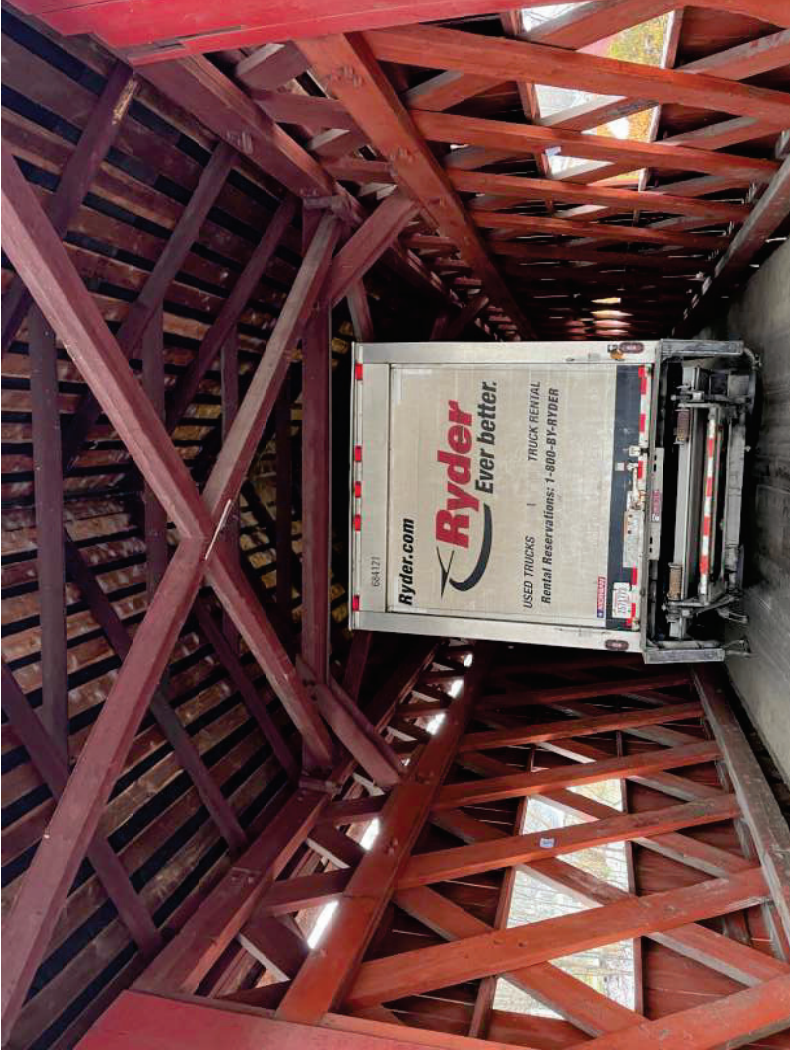
# Access

- Oversized Vehicles

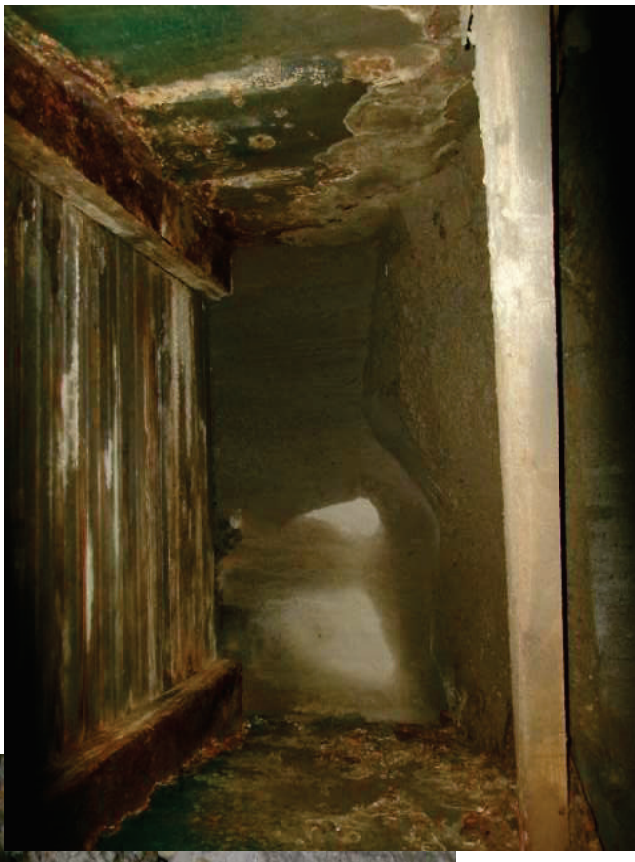
# Substructure

- Voids
- Spalling
- Exposed Rebar

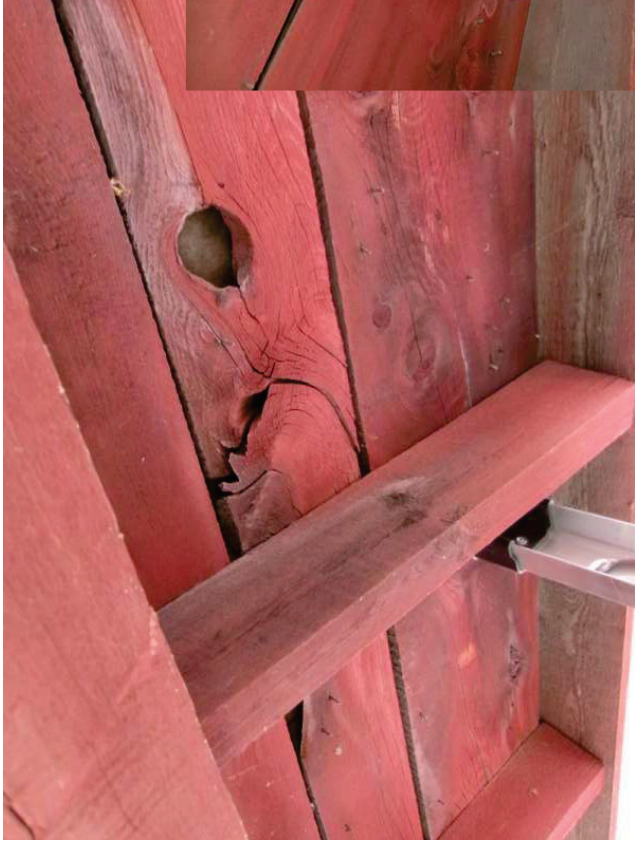
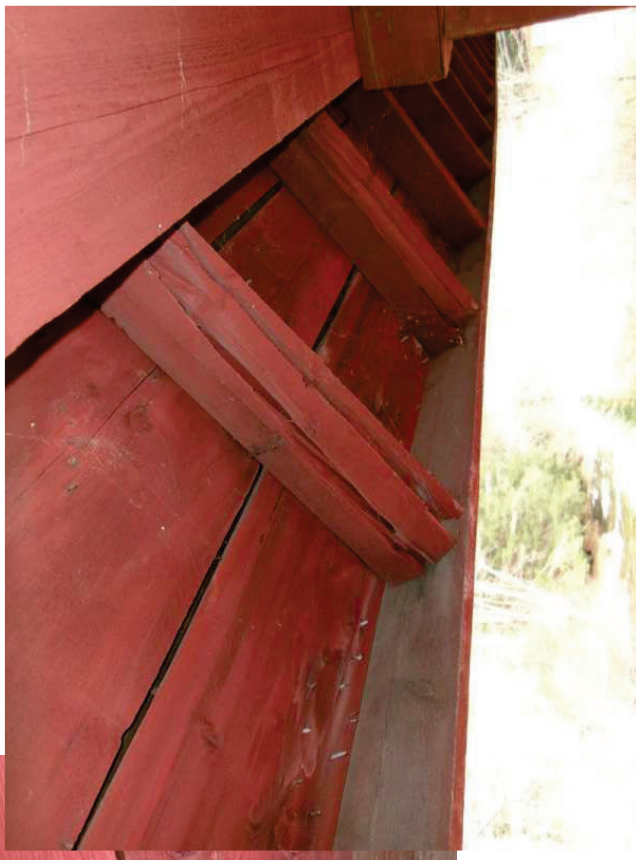
# Roofboards & Rafters

- Splits
- Breaks
- Rot

- Existing
  - Standing Seam Metal Roof
  - 2"x6" Rafters, Eastern Spruce
  - 1" Thick Roof Boards, Eastern Spruce
- Recommended Work
  - New Standing Seam Metal Roof (PTN 2)
  - Replacement all Existing Roof Boards (PTN 2)
  - 8 Rafters (14%) to be Replaced due to Condition (PTN 2)

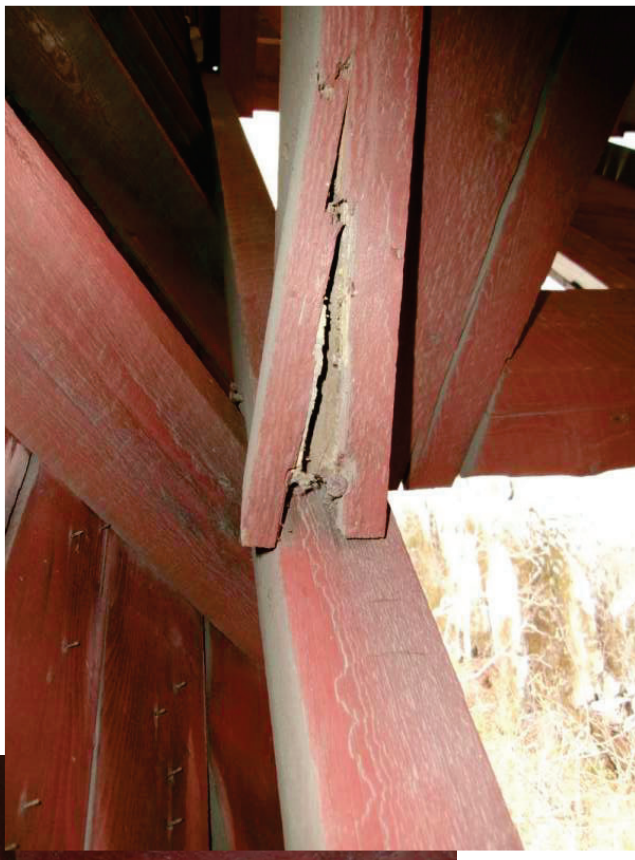
# Upper Bracing Members

- Splits
- Breaks
- Rot
- Impact Damage

- Existing
  - 6"x6" Crossbeams, Eastern Spruce
  - 2"x8" Diagonal Braces, Eastern Spruce
  - Steel Knee Braces
- Recommended Work
  - Replacement of all Upper Bracing (PTN 2)
  - 2 Cross Beams (22%) to be Replaced due to Condition (PTN 2)
  - Redo Steel Knee Braces?

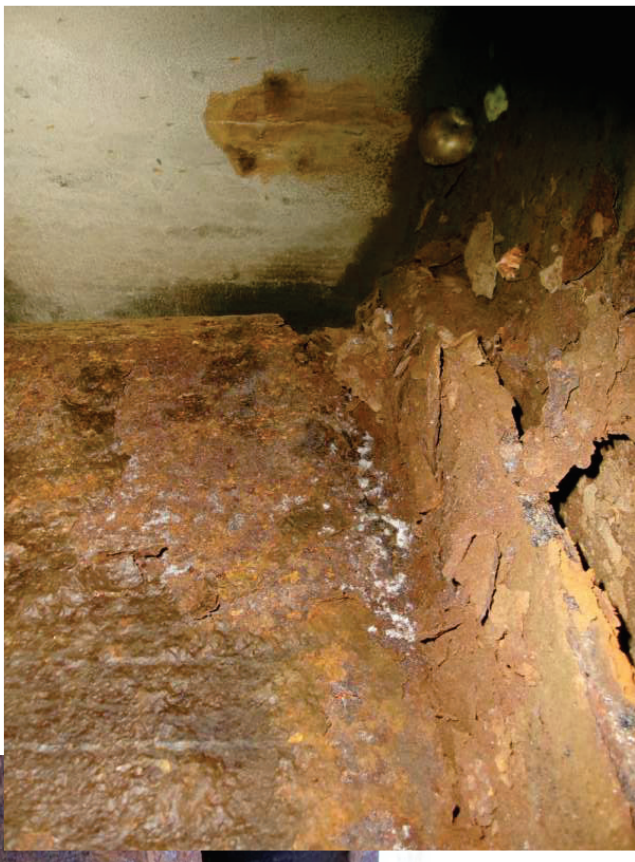
# Steel Beams

- Rust Holes
- Advanced Corrosion

- Existing:
  - 24WF100 and 21WF62 Steel Beams
  - C15x33.9 Steel Diaphragms
  - 2"x6" Nail Laminated Deck, Southern Yellow Pine
  - 1 ½" Thick Runner Boards, Eastern Pine
- Recommended Work
  - Replace Steel Stringers with new Steel Stringers (PTN 2)
  - Replace Deck with Nail Laminated (PTN 2), or Glulam Deck (PTN 4)
  - Replace Runner Boards with Full Width 1 ½" Thick Runners, White Oak (PTN 2)

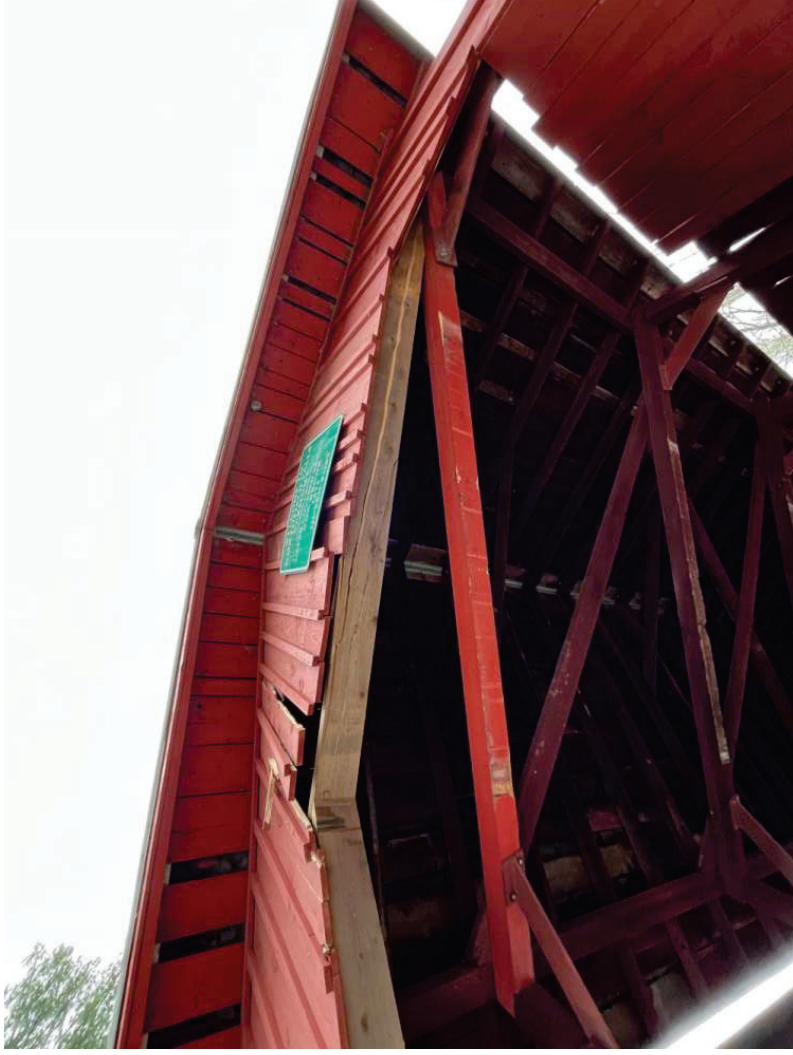
# Portals

- Breaks
- Impact Damage
