# Draft Scoping Report Lower Cox Brook Covered Bridge Town Highway 3 Bridge 11 over Cox Brook

Northfield BO CVBR(8)

**January 24, 2026**

Prepared for:  
Vermont Agency of Transportation

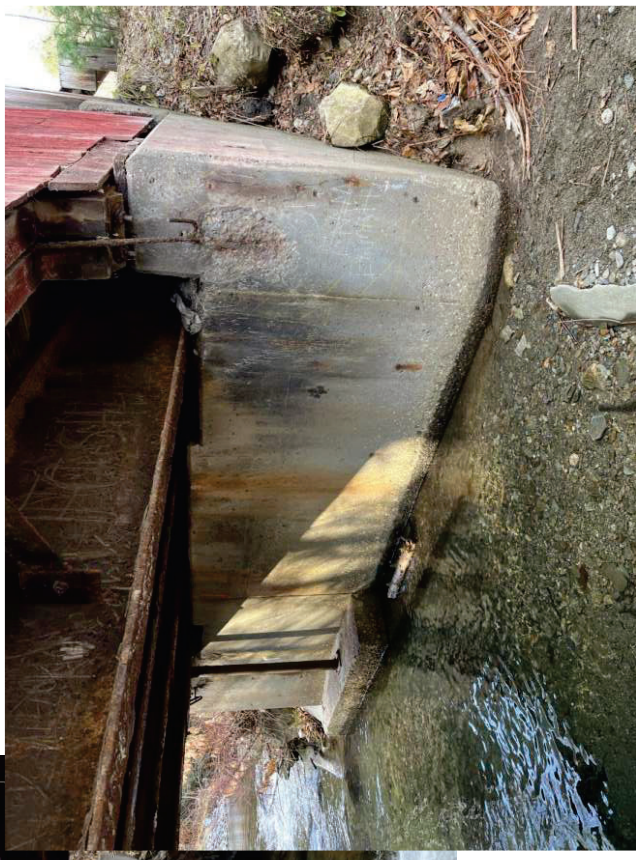
# Abutments

- Voids
- Spalling
- Exposed Rebar

- Bridge Seat Elevation Modification (PTN 1)
- Concrete Repair / Crack Sealing (PTN 1)
- Stain And Seal Concrete (PTN 1)

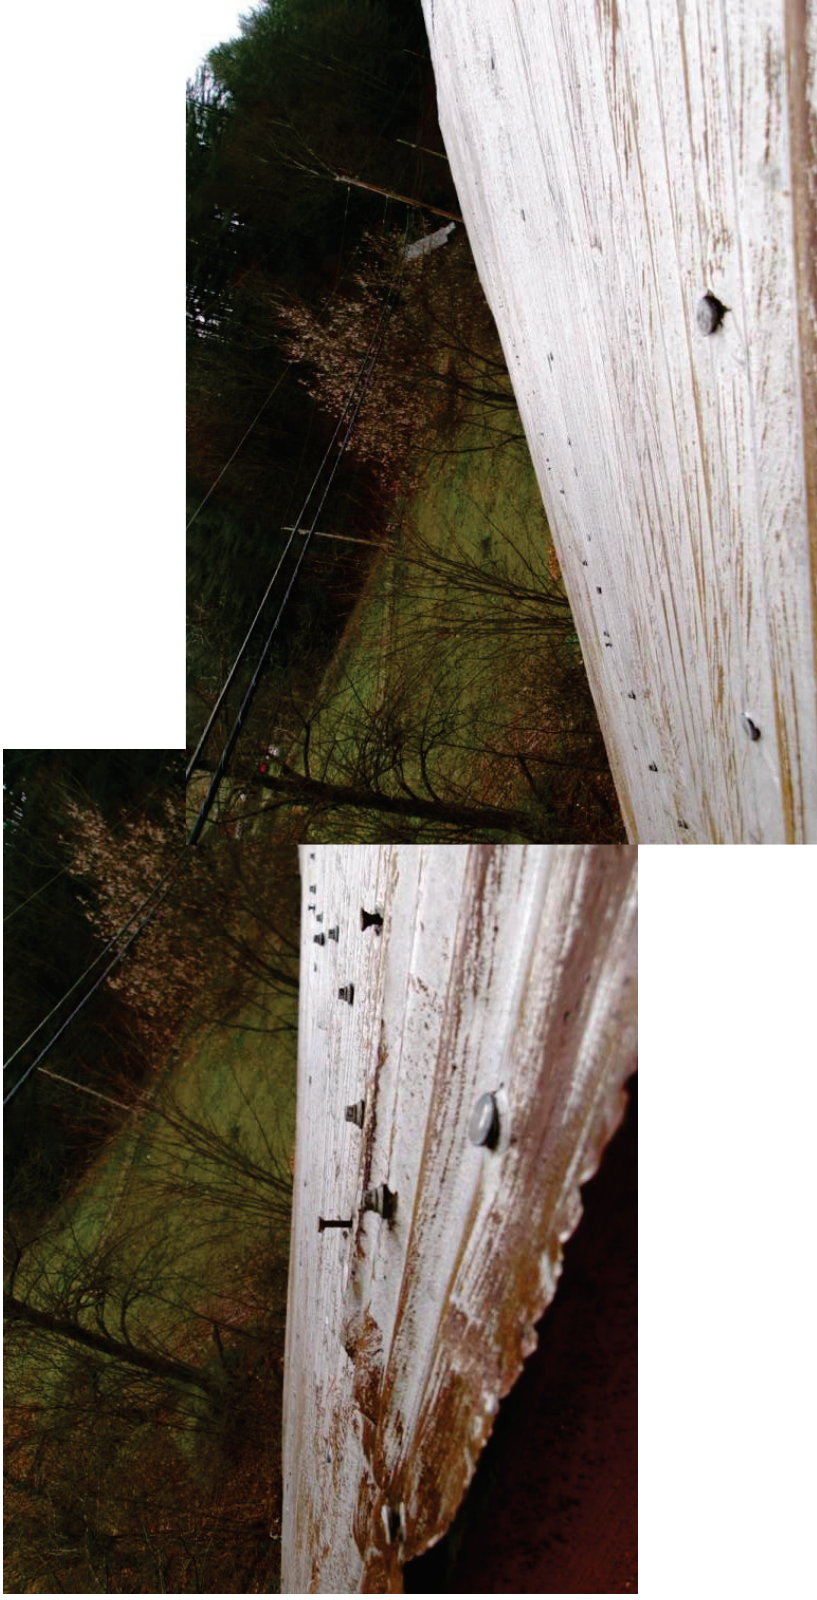
- Rusting
- Leaks
- Nail Attachment

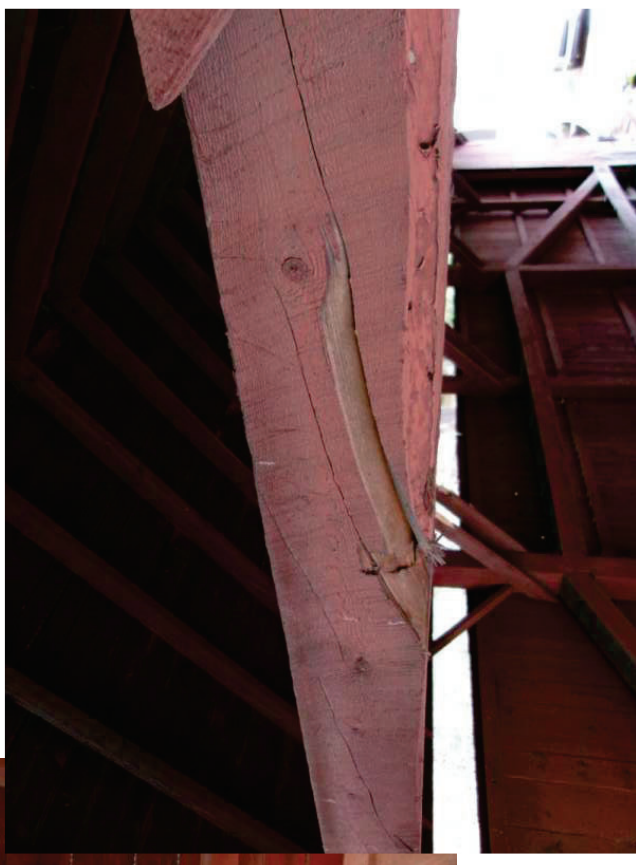
# Upper Bracing Members

- Splits
- Breaks
- Rot
- Impact Damage

- Replacement of all Upper Bracing (PTN 2)
- 2 Crossbeams (29%) to be **Replaced** due to Condition (PTN 2)
- 7 Knee Braces (29%) to be **Replaced** due to Condition (PTN 2)
- Strengthen all Knee Braces (PTN 3)

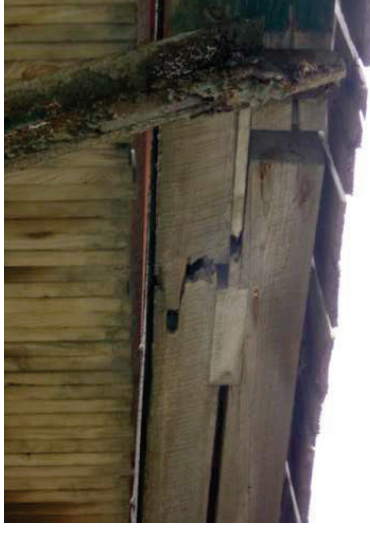
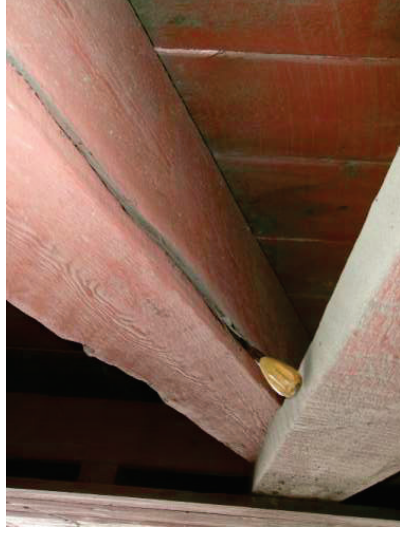
# Truss Members

- Splits
- Breaks
- Rot
- High Moisture Content

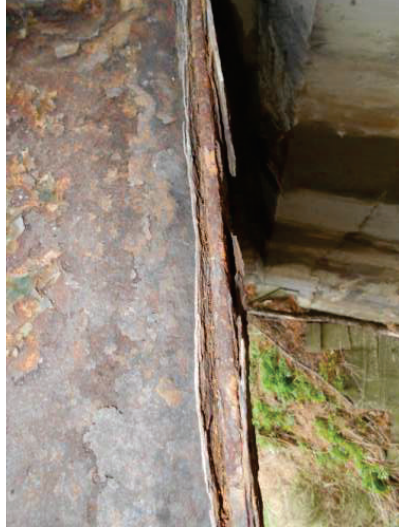
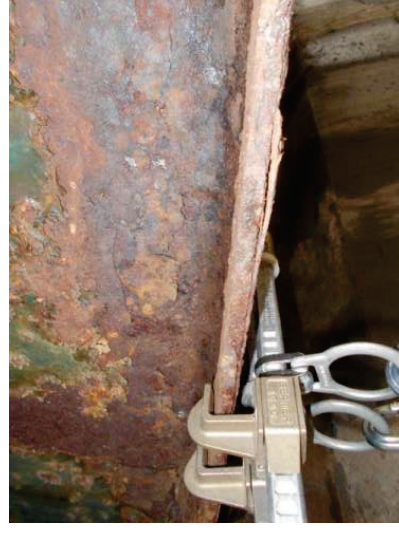
# Steel Beams

- Rust Holes
- Advanced Corrosion

- Existing:
  - 24WF84 Steel Beams
  - C15x33.9 Steel Diaphragms
  - 2"x6" Nail Laminated Deck, Southern Yellow Pine
  - 1 5/8" Thick Runner Boards, Eastern Spruce
- Recommended Work
  - Replace Steel Stringers with new Steel Stringers (PTN 2)
  - Replace Deck with Nail Laminated (PTN 2), or Glulam Deck (PTN 4)
  - Replace Runner Boards with Full Width 1 1/2" Thick Runners, White Oak (PTN 2)

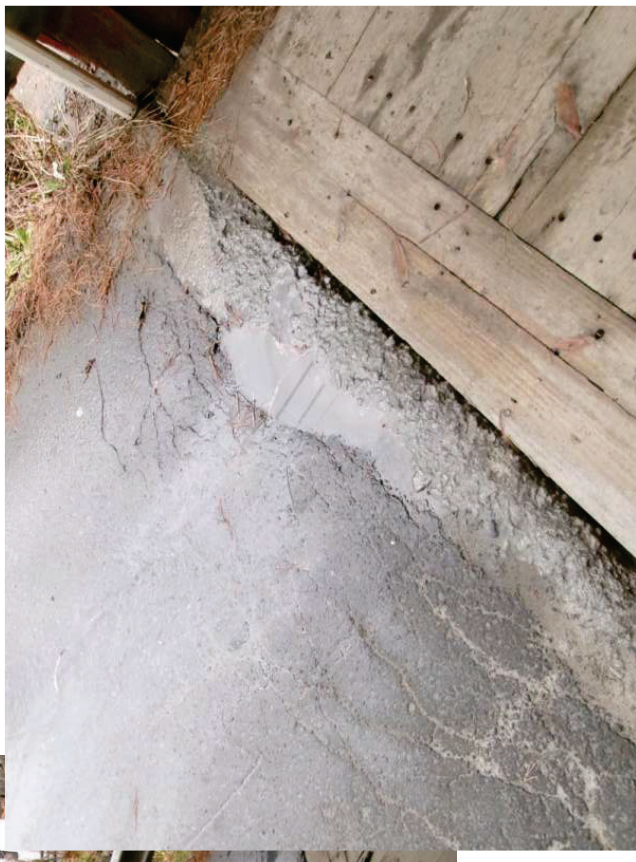
# Approaches

- Drainage Issues
- Ponding

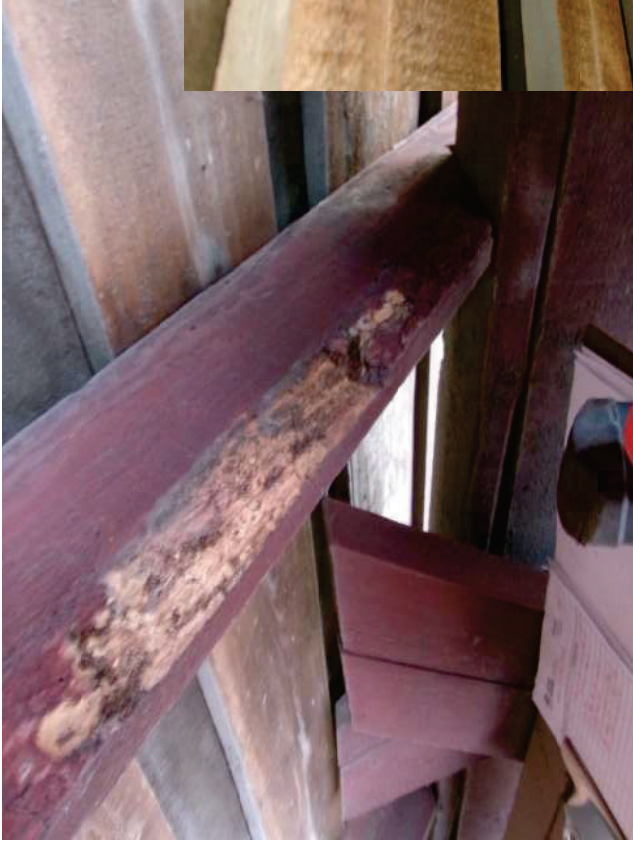
- Splits
- Breaks
- Rot
- Insect Damage

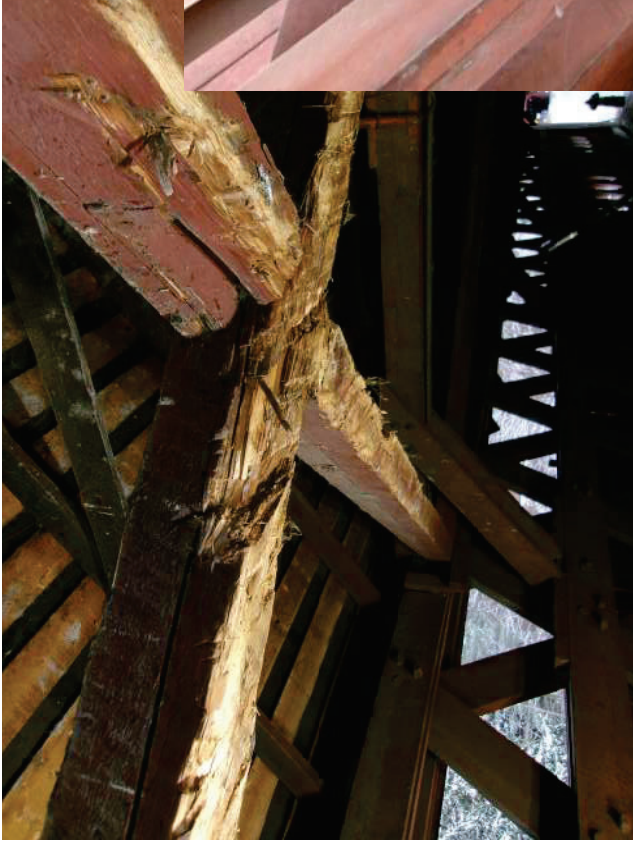
# Upper Bracing Members

- Splits
- Breaks
- Rot
- Impact Damage

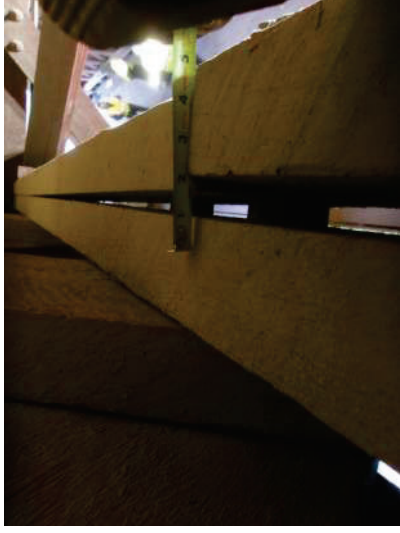
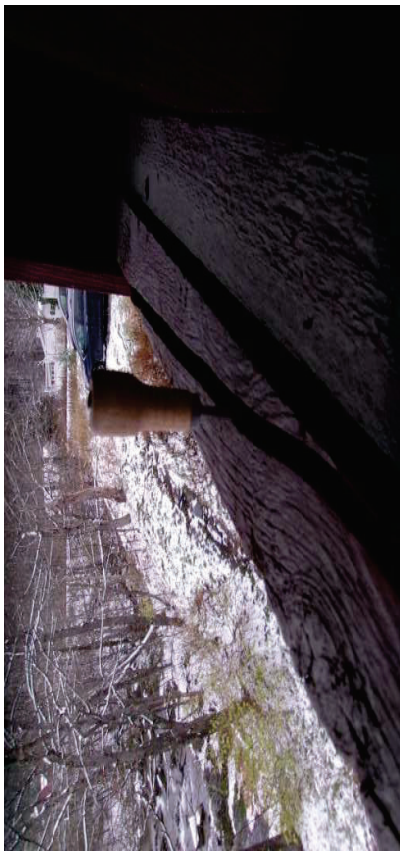
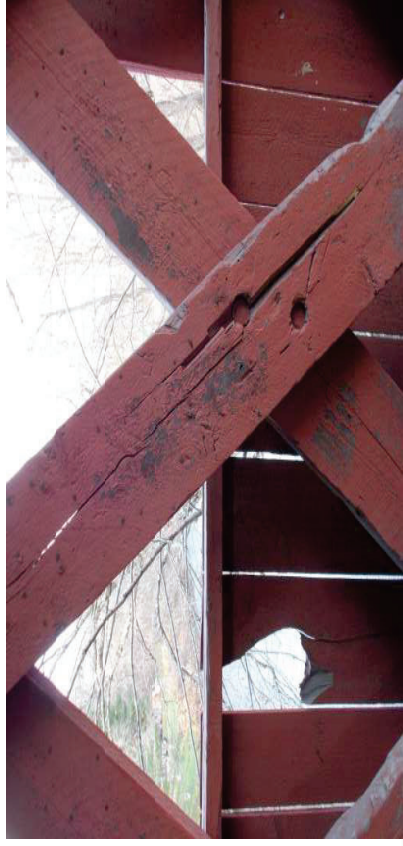
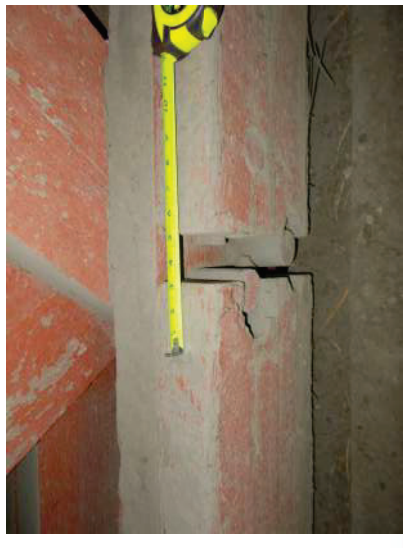
# Truss Members

- Splits
- Breaks
- Rot
- Misalignment
- High Moisture Content

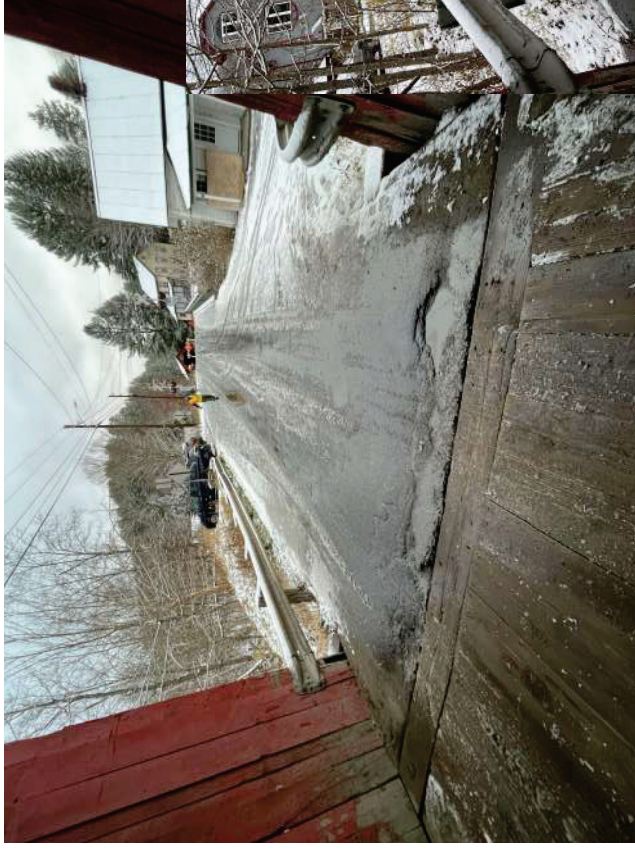
# Approaches

- Drainage Issues
- Ponding

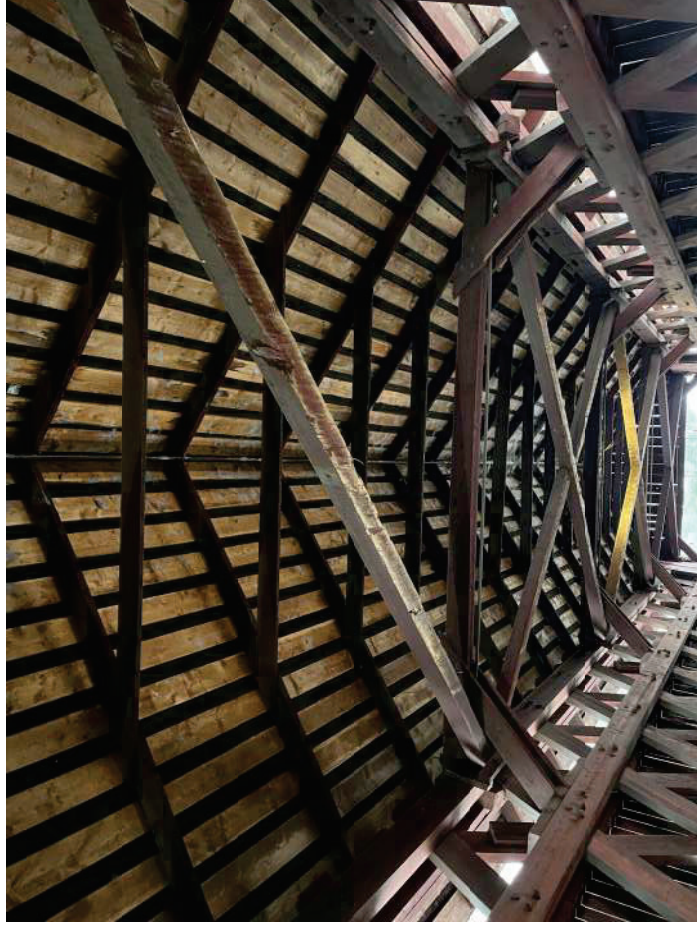
# Recommended Work: Lat. Bracing Members

- Existing
  - 6"x6" Upper Diagonal Braces, Eastern Spruce
  - 2"x8" Knee Braces, Eastern Spruce

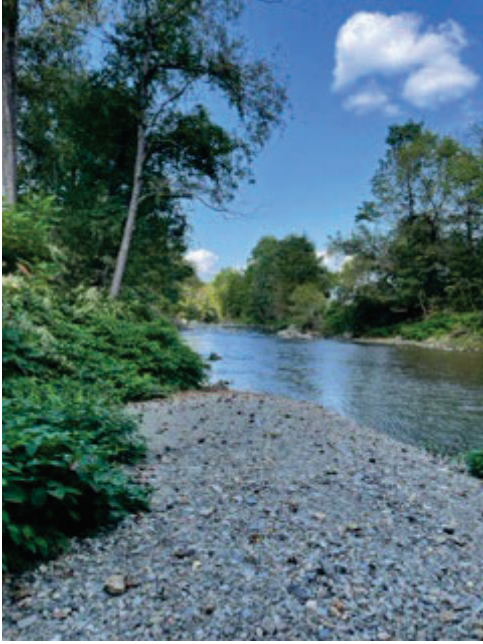
Cox Brook and the surrounding shoreline near bridge 11.
