# Draft Scoping Report Northfield Falls Covered Bridge Town Highway 3 Bridge 15 over Dog River

Northfield BO CVBR(9)

**January 24, 2026**

Prepared for:  
Vermont Agency of Transportation

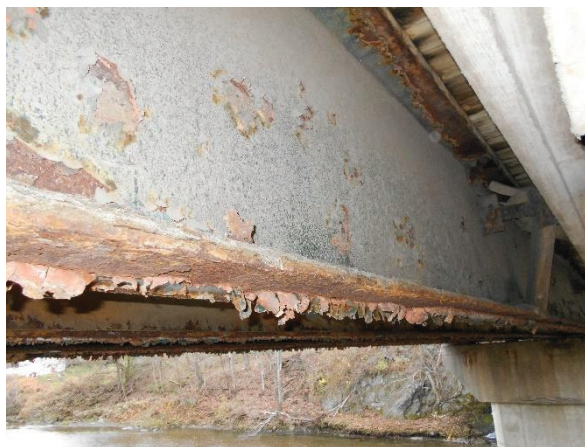
Exterior Stringer

- The runner boards exhibit areas of minor wear with sand debris build up at roadway shoulders.
- The beams exhibit significant corrosion along the bottom flange and paint failure of the webs.
- The truss lower lateral bracing connection to chord 4 exhibits moderate corrosion.
- The exterior stringers had section loss that reduced flange thickness to  $\frac{7}{16}$ " in isolated areas. The top flange also had areas of section loss with a flange thickness of  $\frac{7}{16}$ " throughout. The webs were in fair condition with areas of paint failure and rust. By inspection, it appears the web had approximately  $\frac{1}{16}$ " section loss on both sides of the web ( $\frac{1}{8}$ " total).
- Access was limited for the interior stringers. By inspection from the exterior stringers, it appeared the interior stringers had the same amount of section losses exhibited in the exterior stringers.

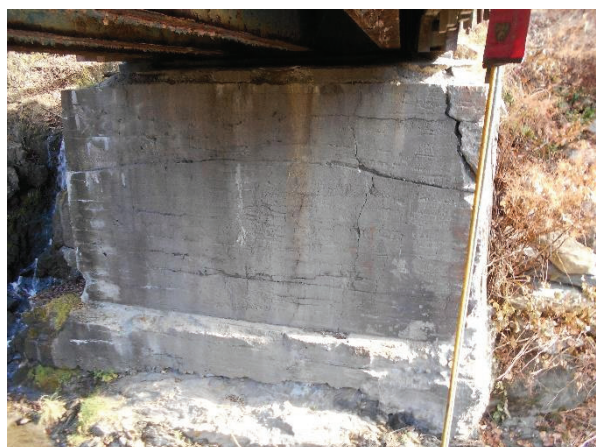
East Abutment Elevation

- The east abutment exhibits significant concrete spalling, efflorescence staining, delamination, and vertical, horizontal, and map cracking. The southeast beam seat corner has a large spall, and the concrete is coming loose from the structure. The concrete appears to be of poor quality with large round aggregates used.
- The west abutment masonry exhibits voids up to 5' deep. The concrete beam seat cap concrete has significantly deteriorated.
- The southwest wingwall is comprised of dry laid stacked stones which have failed, and the wall is no longer vertical.
- At the spalled areas, the concrete was observed to contain round river stones with no fractured faces, which significantly reduces the concrete strength and durability.
- The east abutment is in poor condition and needs to be replaced. The west abutment beam seat and backwall is in poor condition and needs to be replaced.

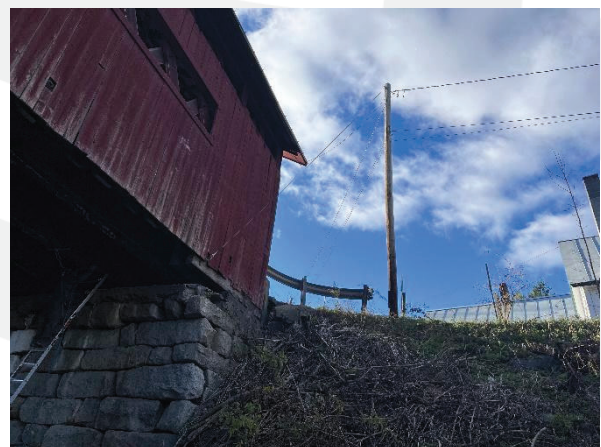
Guy Wire Attached to NW Corner of Bridge

An aerial utility relocation will be needed. Utility relocation plans will be determined once design plans are available.

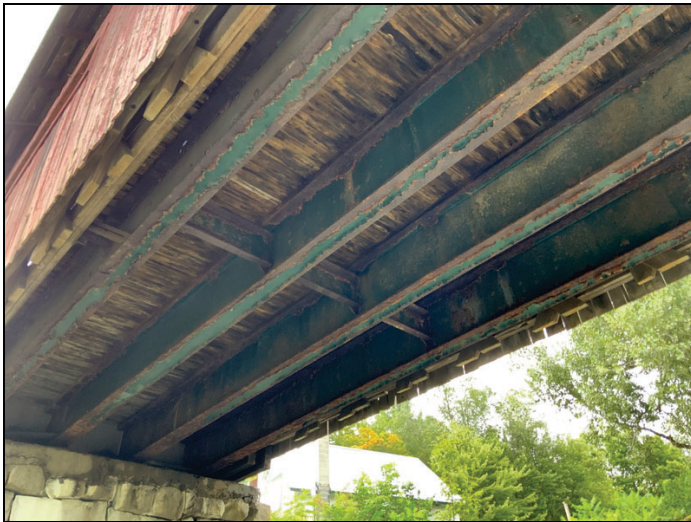
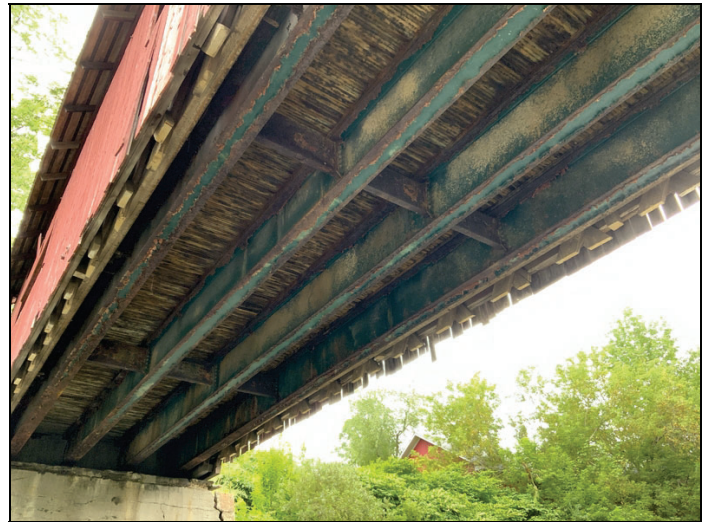
Superstructure

Heavy rust scale along the flanges and lower areas of the webs with minor to moderate section loss.

A paint project with extensive cleaning of the beams should be considered.

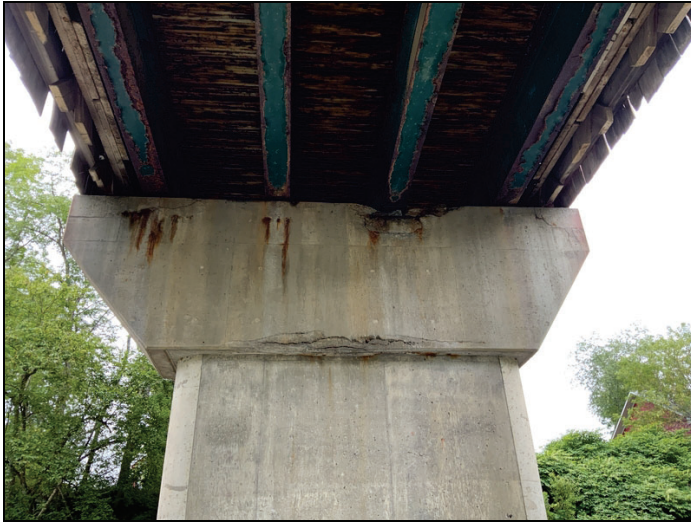
Pier cap

The area beneath beam 2 span 2 side has spalled out undermining the bearing 3"+/-.

Patching repairs are needed.

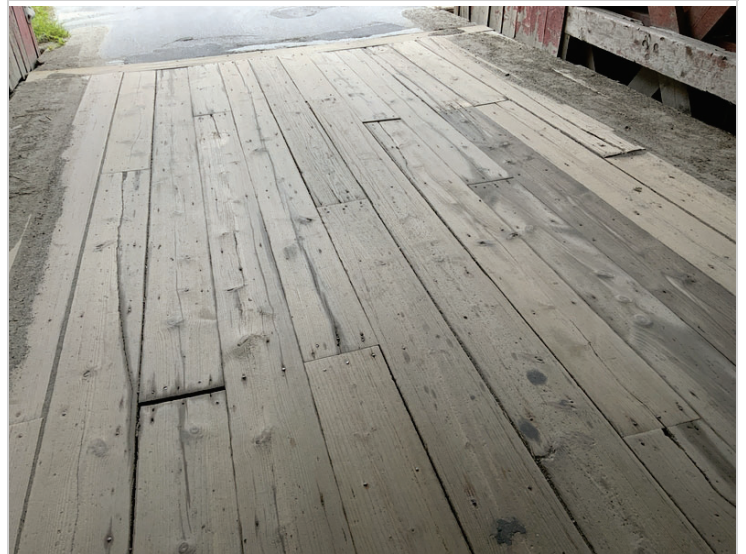
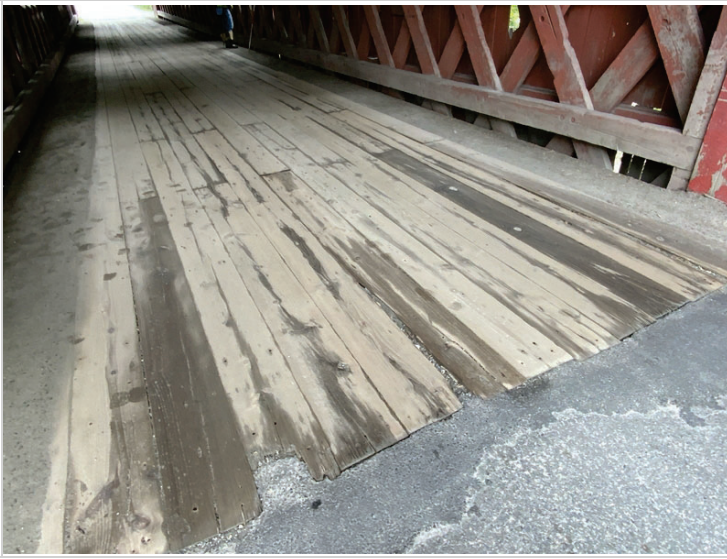
Wearing surface

**A21 - Deck Wearing Surface Condition** (Satisfactory)  
 Minor tire wear throughout with some split/broken ends ends at each portal.

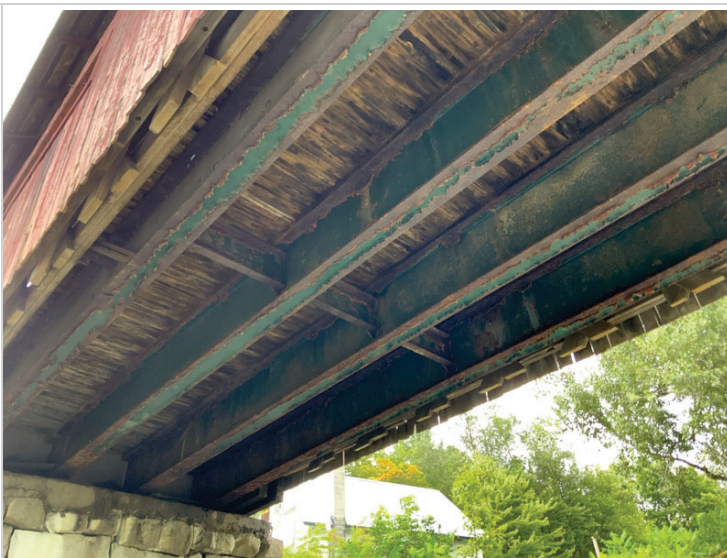
Superstructure

**59 - Superstructure** (6 - SATISFACTORY CONDITION - structural elements show some minor deterioration.)  
 Heavy rust scale along the flanges and lower areas of the webs with deep pitting and moderate section loss.

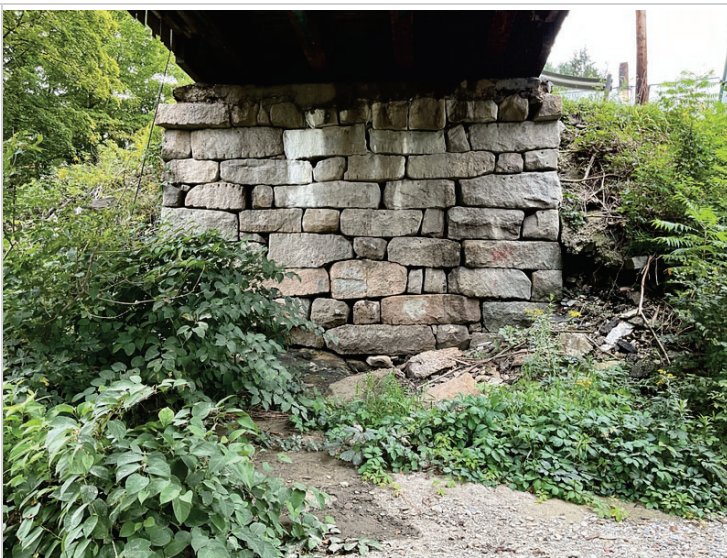
Abutment 2 laid up granite block wall has scattered small voids along the joints throughout. The concrete cap has voided spalling in each end end with scaling and surrounding delams.

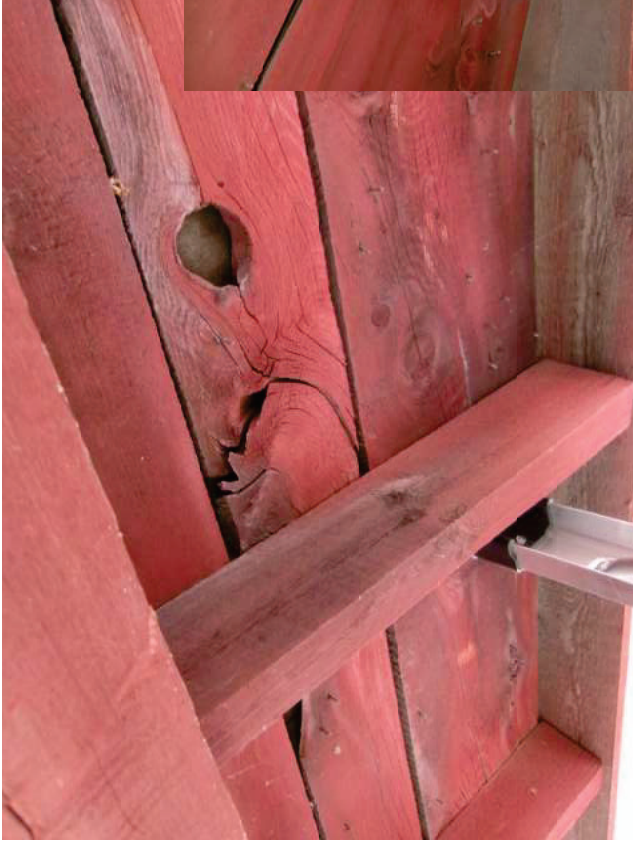
# Roofboards and Rafters

- Splits
- Breaks
- Rot

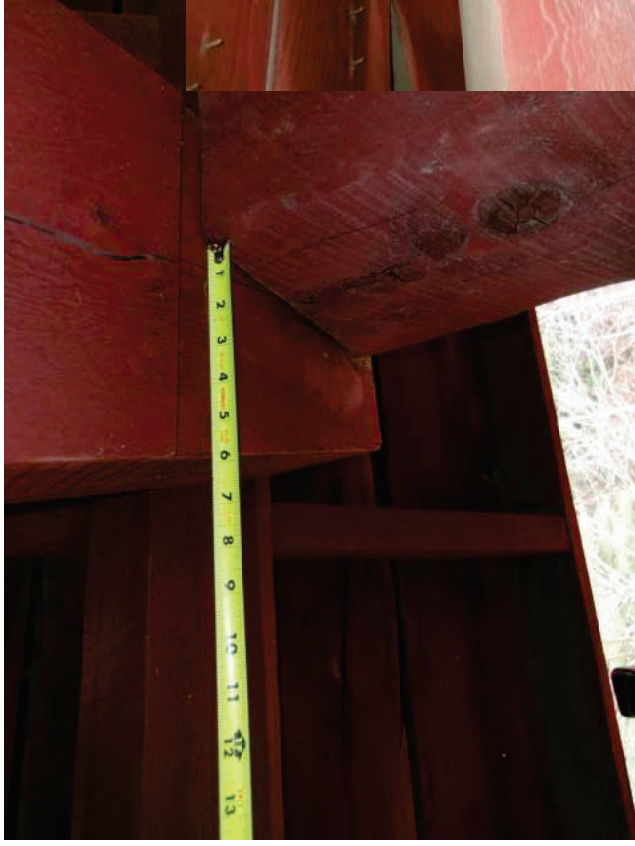
# Upper Bracing Members

- Splits
- Breaks
- Rot
- Impact Damage

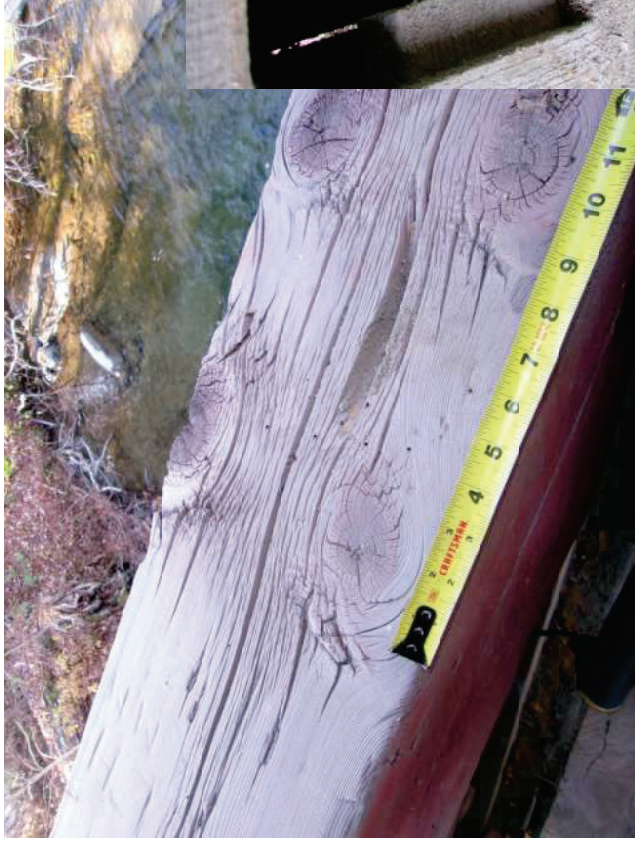
# Truss Members

- Splits
- Breaks
- Rot
- Weathering
- High Moisture Content

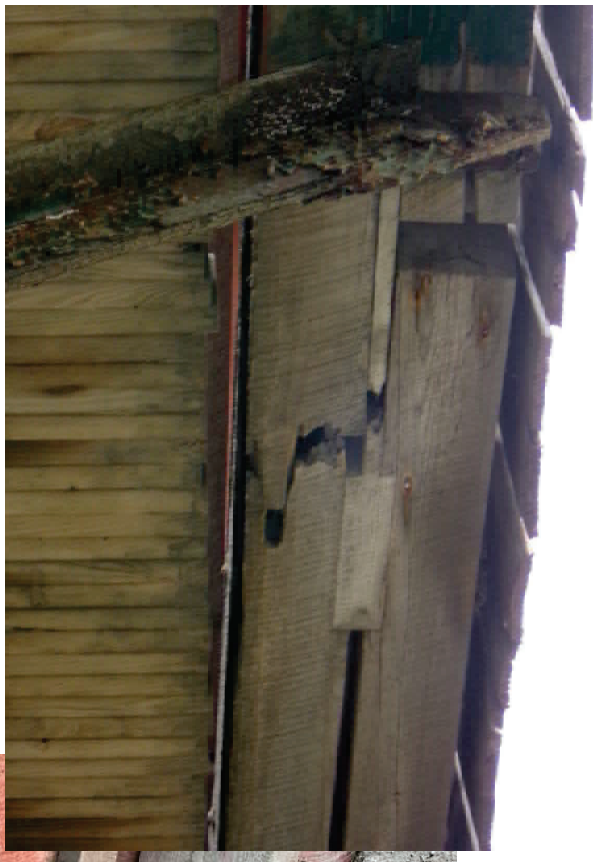
# Truss Members

- Splits
- Breaks
- Rot
- High Moisture Content

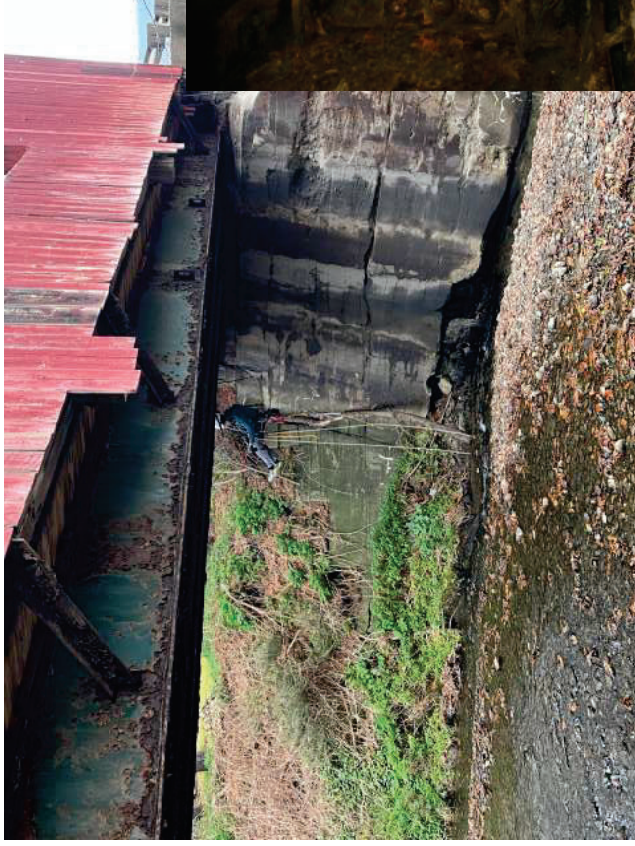
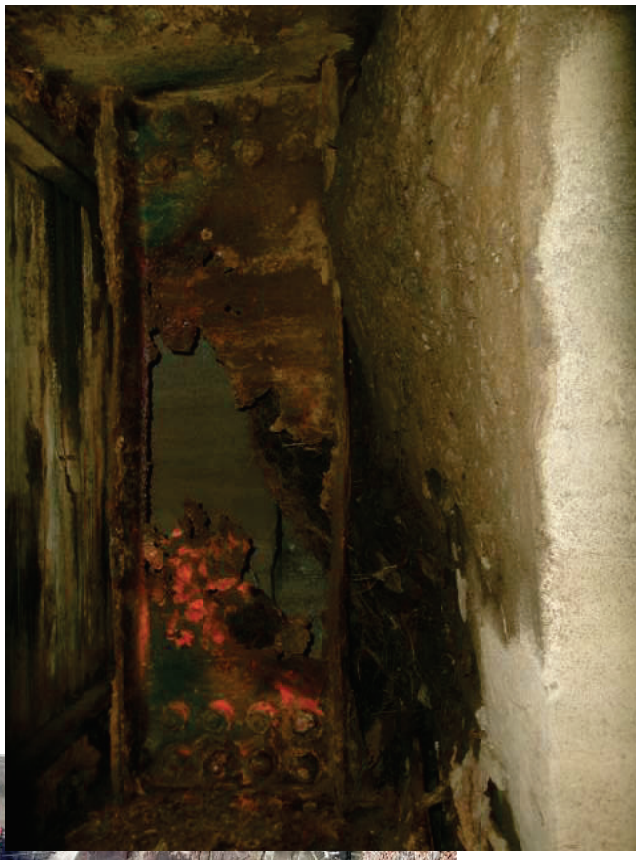
# Steel Beams

- Rust Holes
- Advanced Corrosion

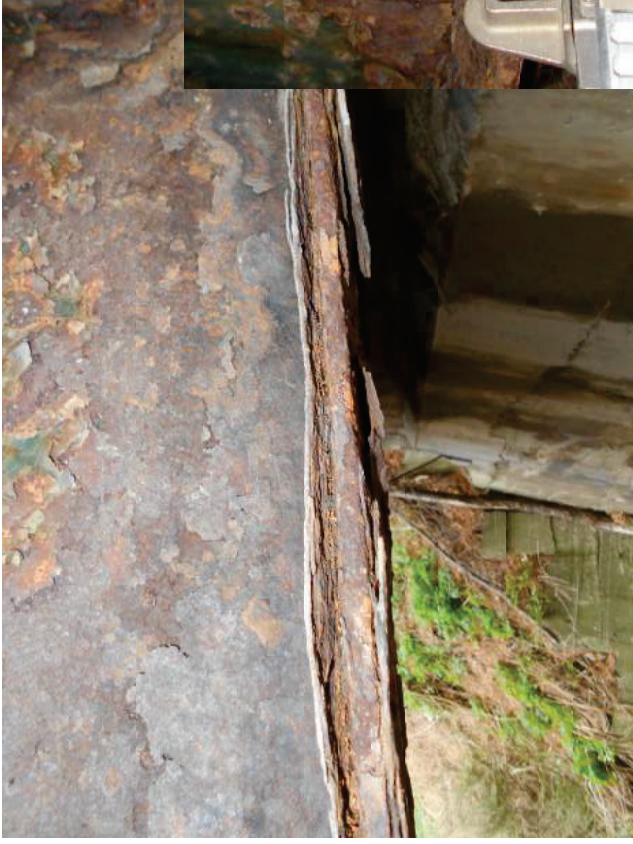
# Steel Beams (Continued)

- Rust Holes
- Advanced Corrosion

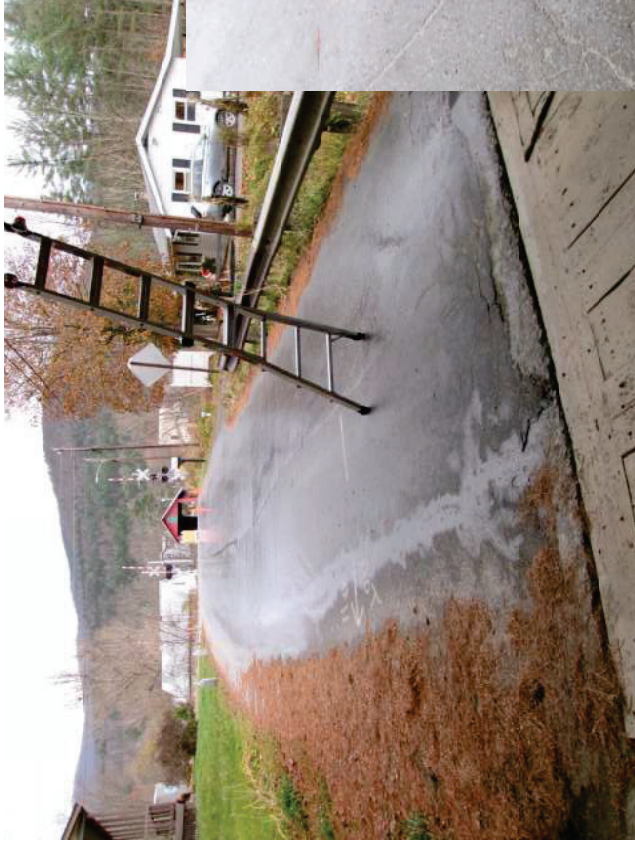
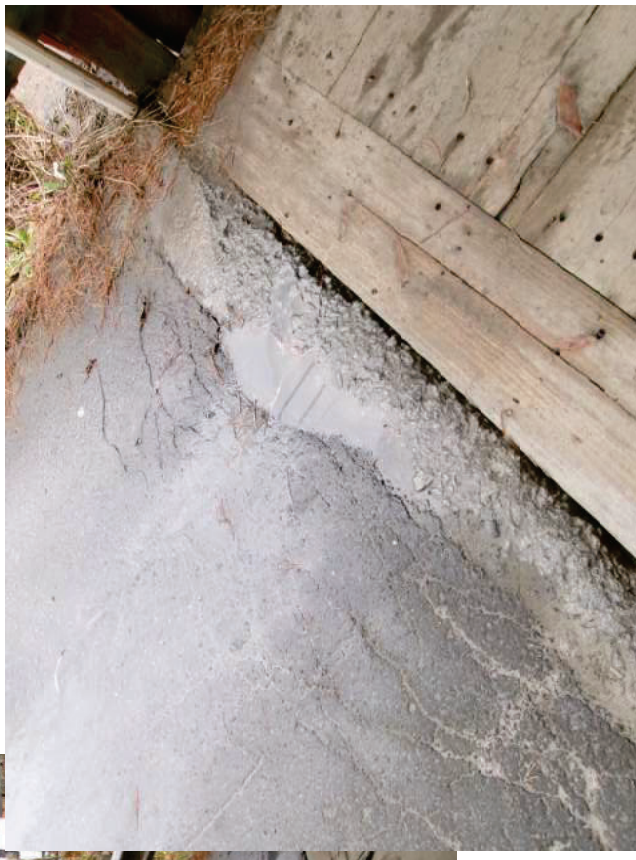
- Drainage Issues
- Ponding

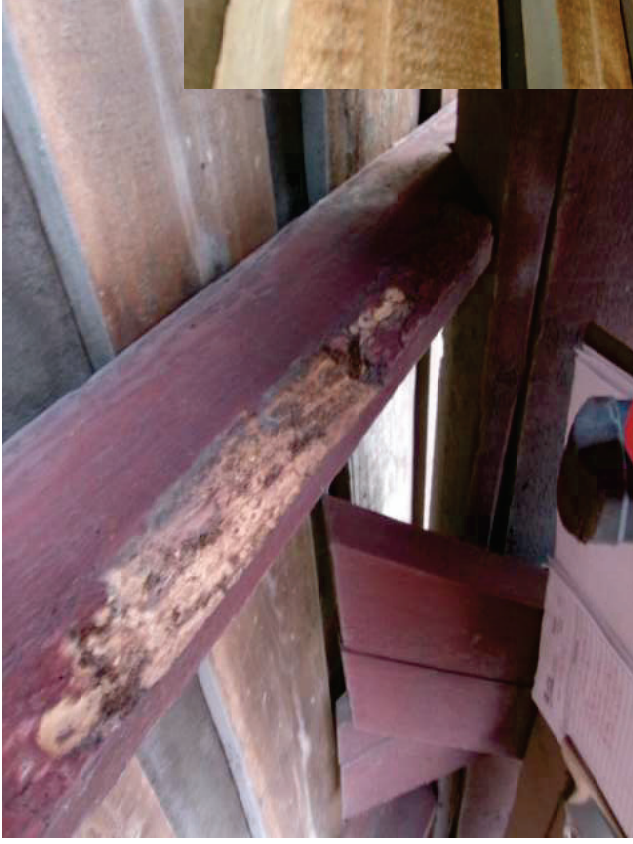
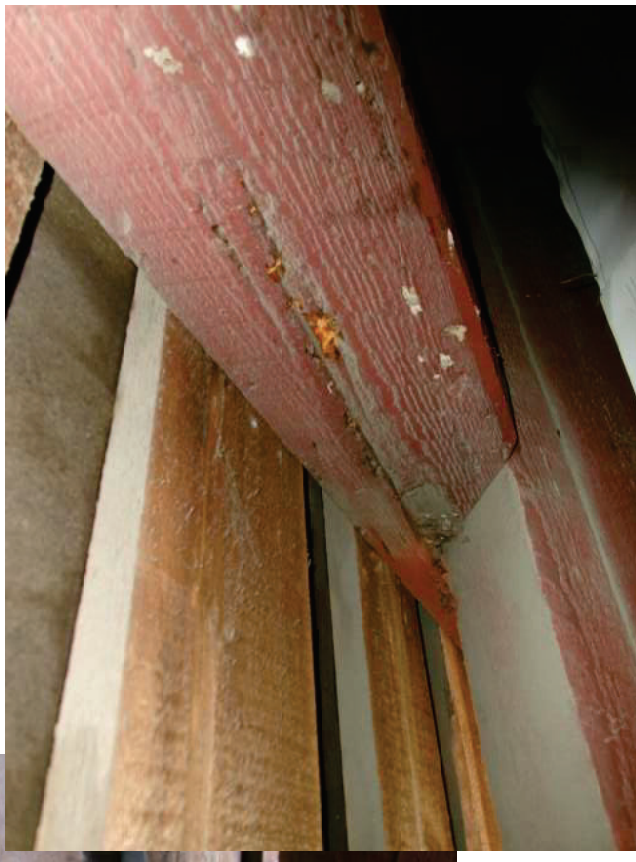
- Splits
- Breaks
- Rot
- Insect Damage

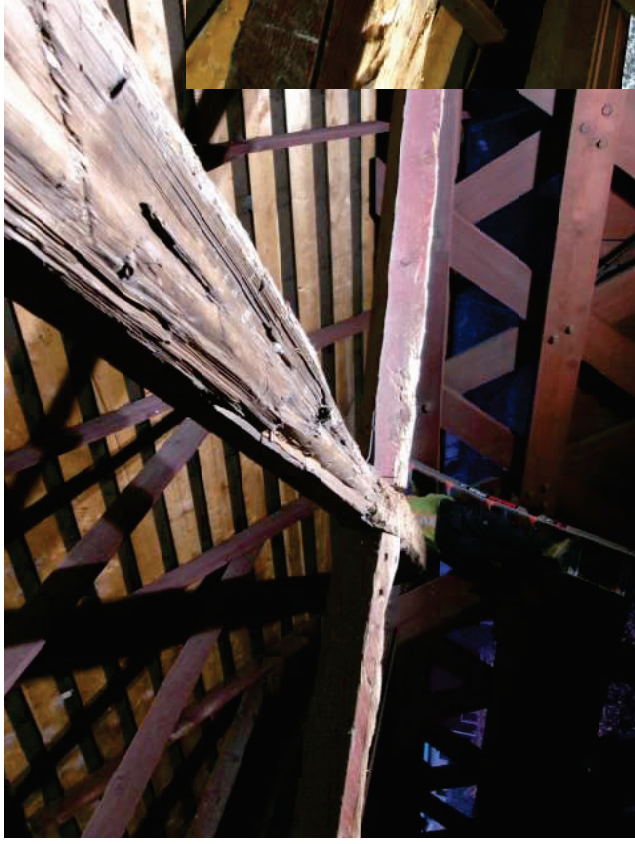
# Upper Bracing Members (Continued)

- Splits
- Breaks
- Rot
- Impact Damage

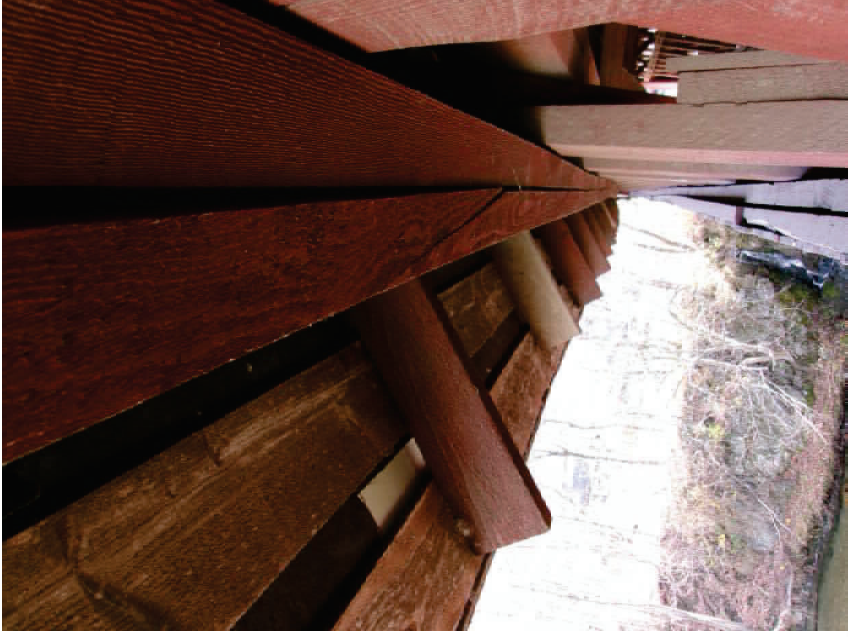
# Truss Members (Continued)

- Splits
- Breaks
- Rot
- Misalignment
- High Moisture Content

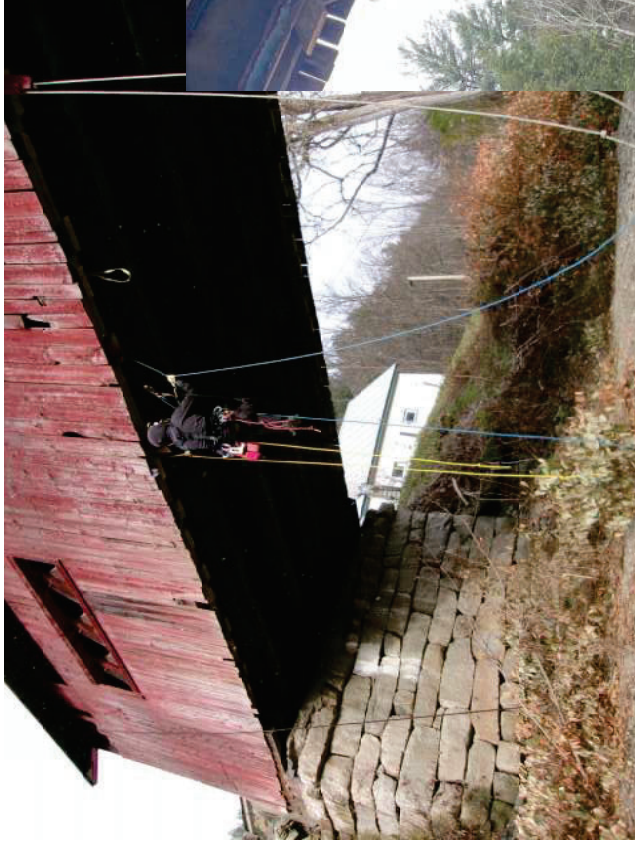
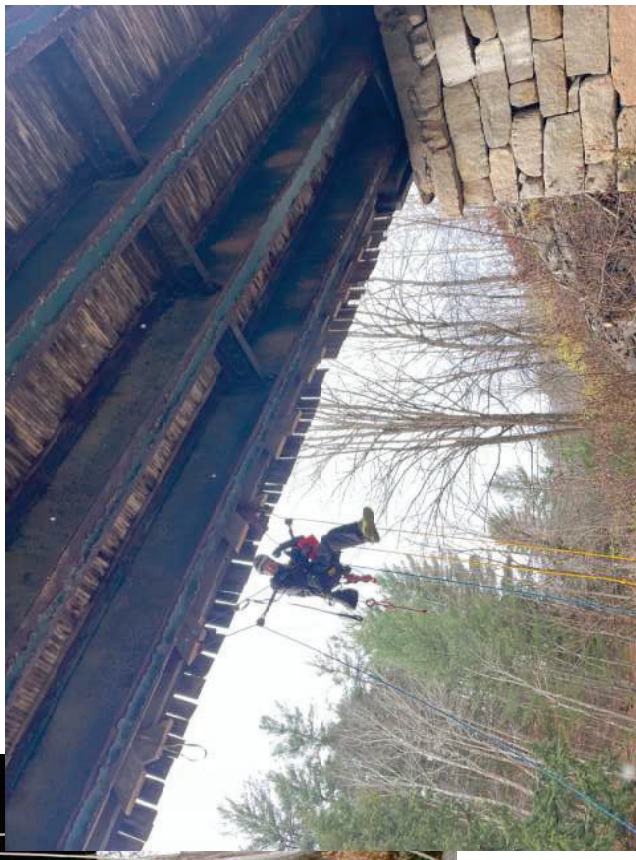
# Steel Beams

- Rusting
- Advanced Corrosion

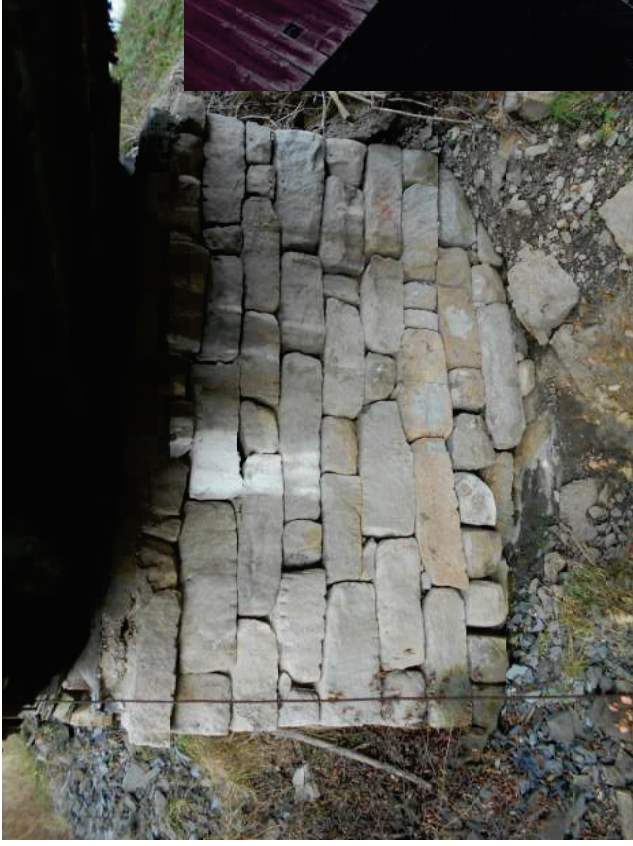
# Substructure

- Voids
- Spalling
- Exposed Rebar

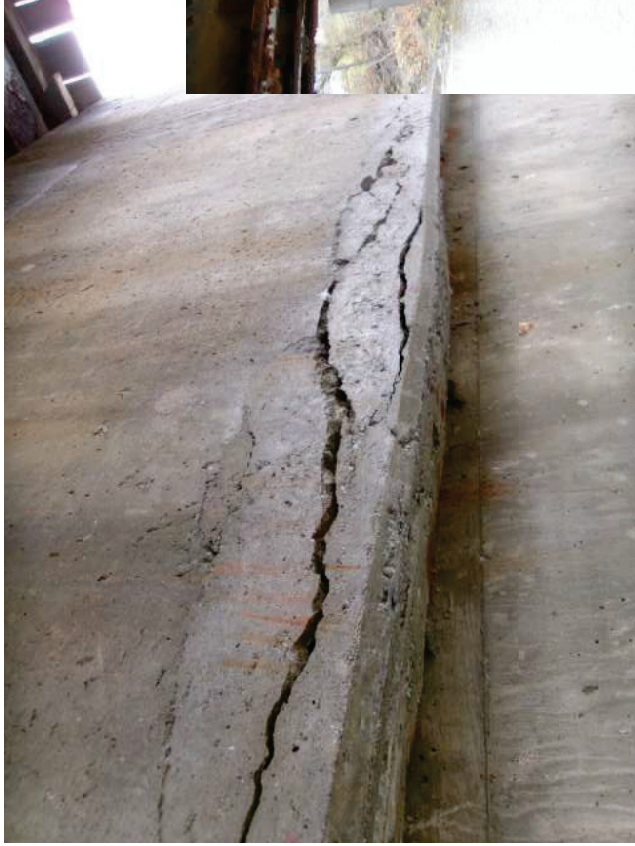
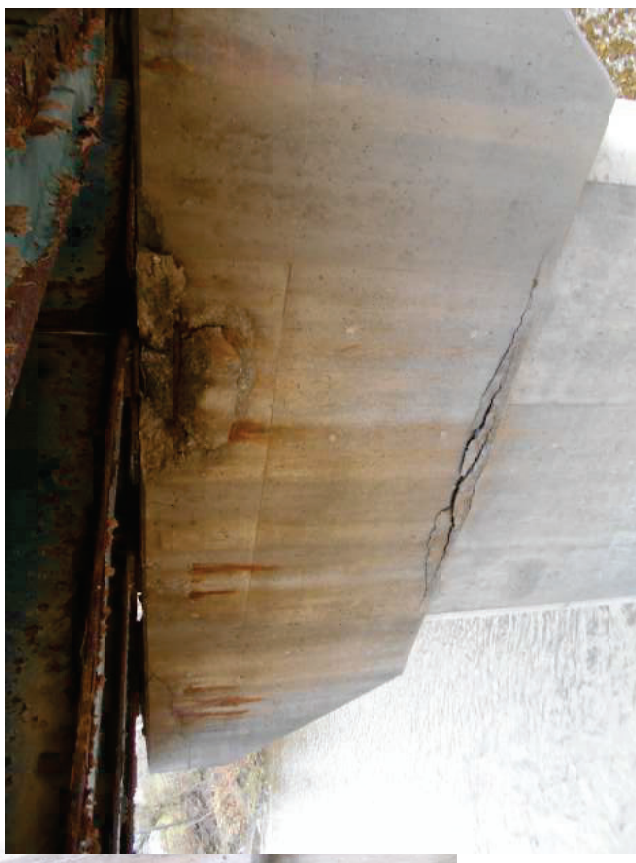
# Substructure

- Voids
- Spalling
- Exposed Rebar

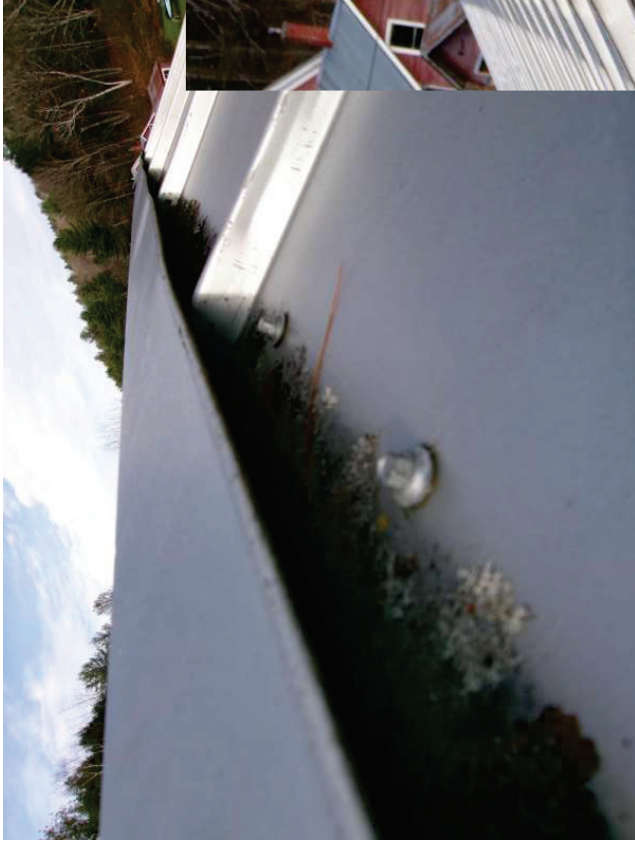
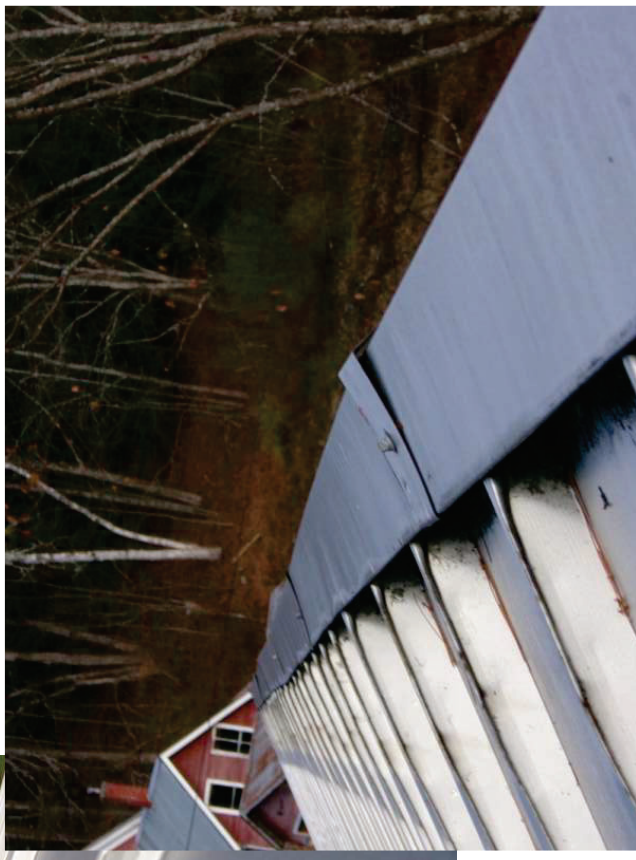
- Leaks
- Screw Attachment

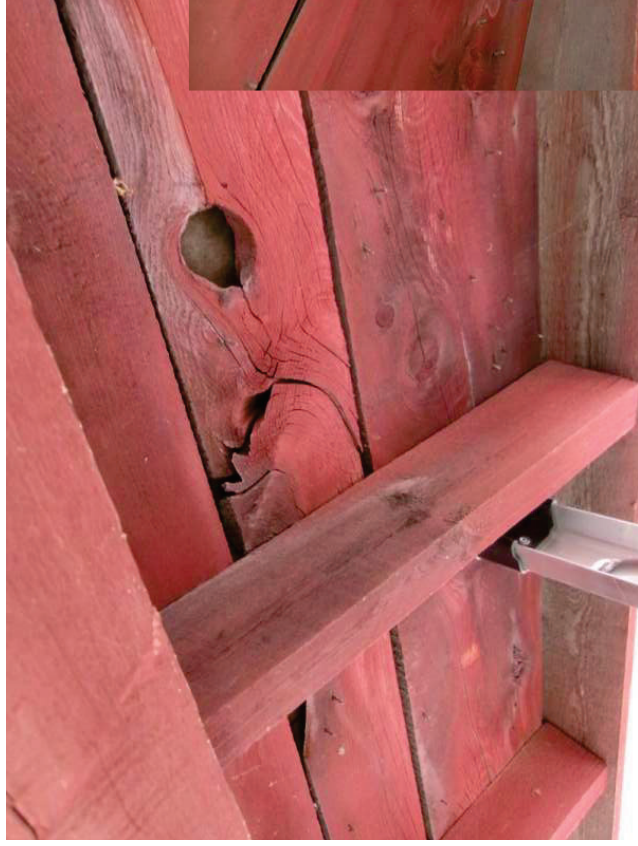
# Roofboards & Rafters

- Splits
- Breaks
- Rot

- Existing
  - Standing Seam Metal Roof
  - 2"x6" Rafters, Eastern Spruce
  - 1" Thick Roof Boards, Eastern Spruce
- Recommended Work
  - New Standing Seam Metal Roof (PTN 2)
  - Replacement all Existing Roof Boards (PTN 2)
  - 8 Rafters (14%) to be Replaced due to Condition (PTN 2)

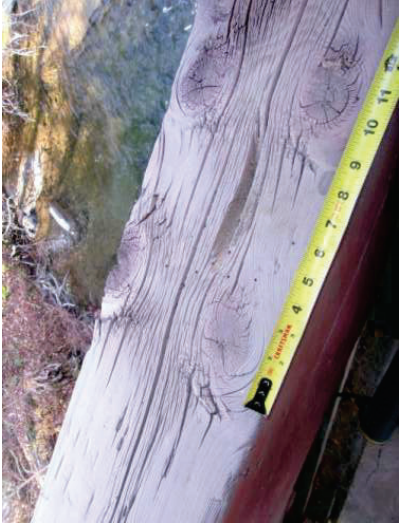
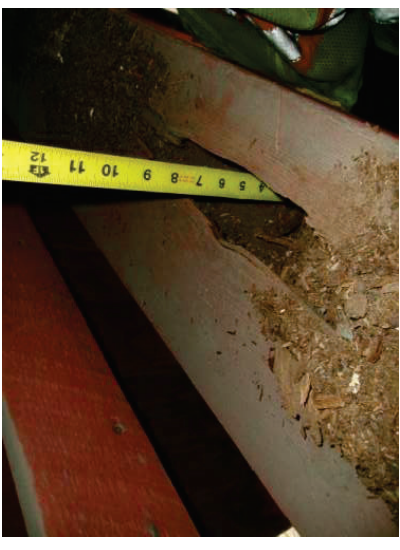
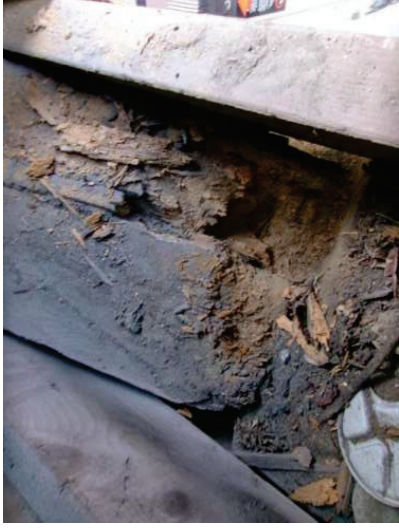
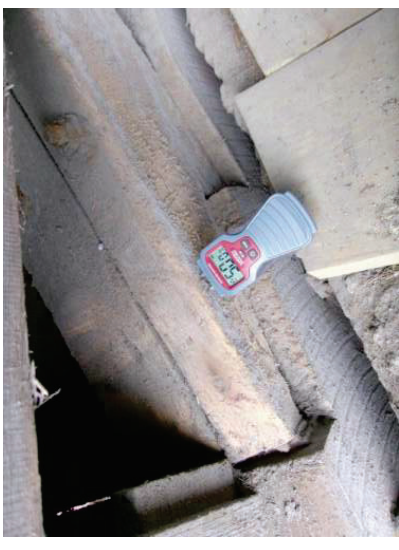
# Truss Members

- Splits
- Breaks
- Rot
- Weathering
- High Moisture Content

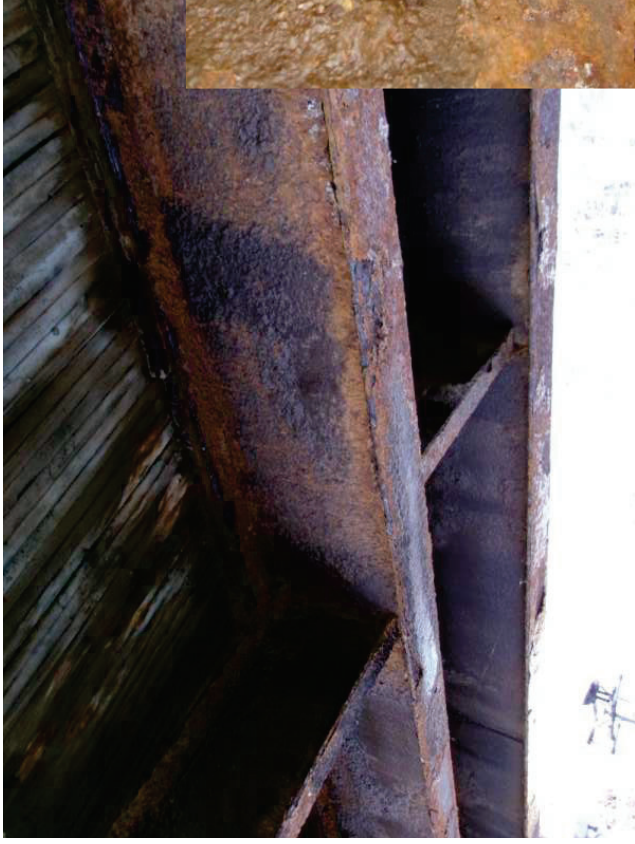
# Steel Beams

- Rust Holes
- Advanced Corrosion

- Existing:
  - 24WF100 and 21WF62 Steel Beams
  - C15x33.9 Steel Diaphragms
  - 2"x6" Nail Laminated Deck, Southern Yellow Pine
  - 1 ½" Thick Runner Boards, Eastern Pine
- Recommended Work
  - Replace Steel Stringers with new Steel Stringers (PTN 2)
  - Replace Deck with Nail Laminated (PTN 2), or Glulam Deck (PTN 4)
  - Replace Runner Boards with Full Width 1 ½" Thick Runners, White Oak (PTN 2)

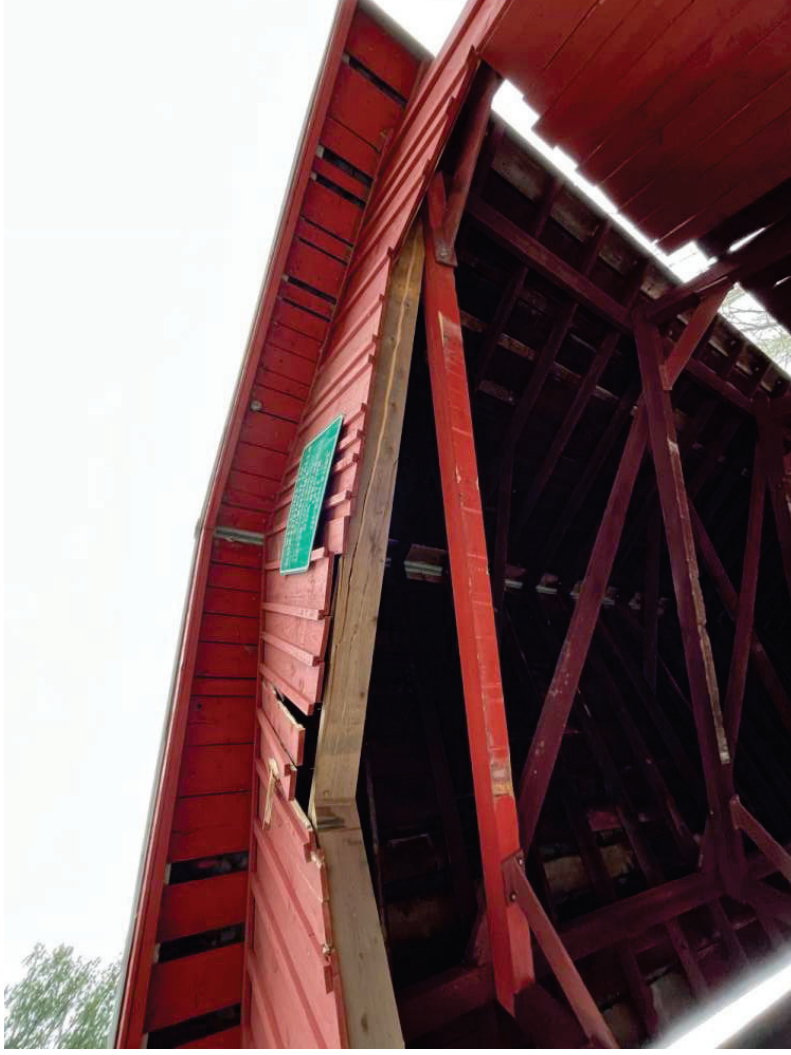
# Portals

- Breaks
- Impact Damage

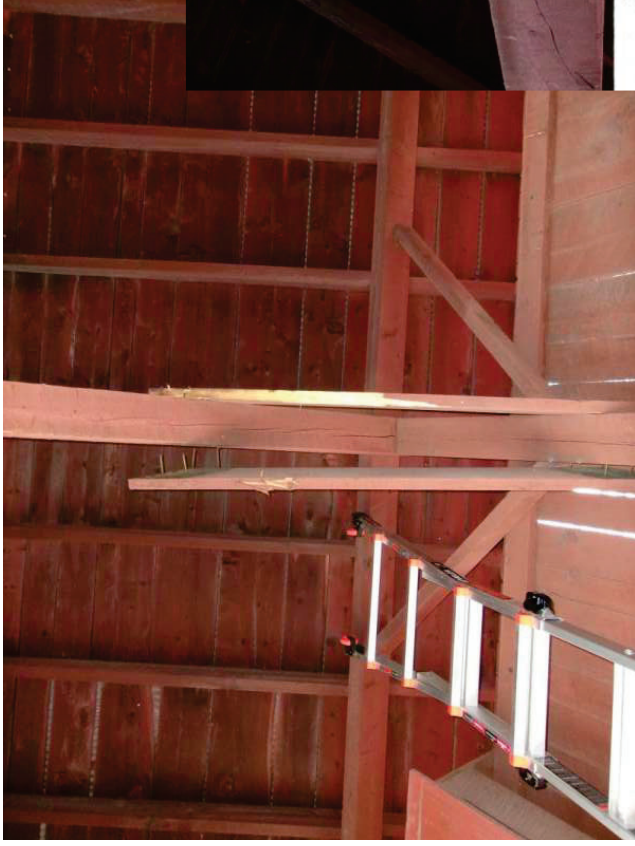
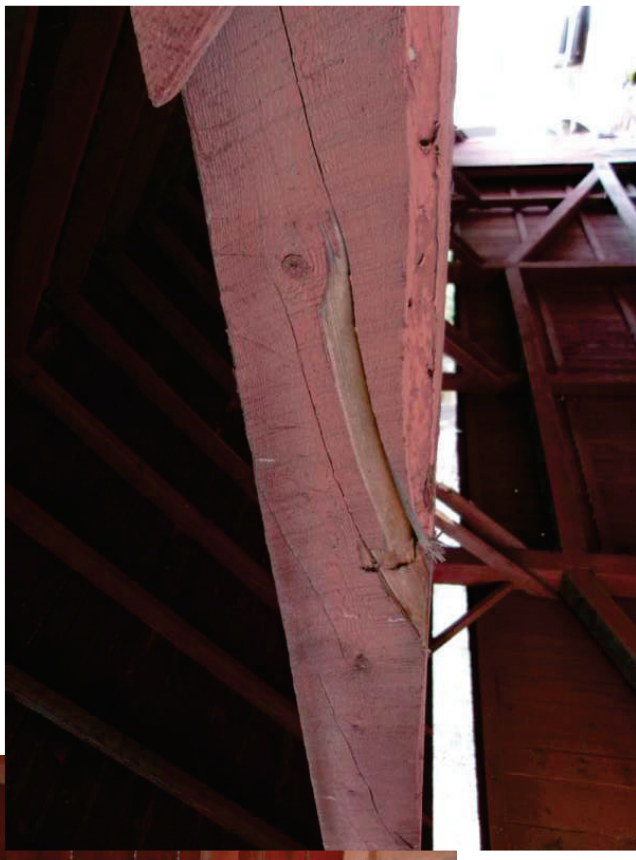
# Upper Bracing Members

- Splits
- Breaks
- Rot
- Impact Damage

- Replacement of all Upper Bracing (PTN 2)
- 2 Crossbeams (29%) to be **Replaced** due to Condition (PTN 2)
- 7 Knee Braces (29%) to be **Replaced** due to Condition (PTN 2)
- Strengthen all Knee Braces (PTN 3)

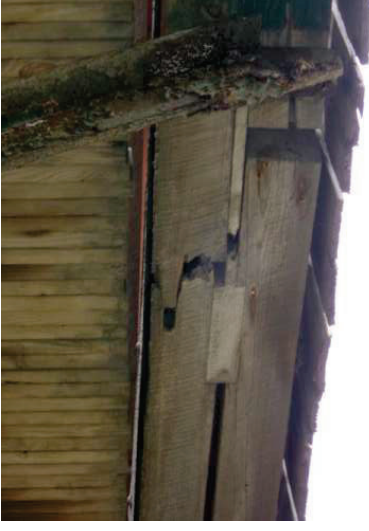
# Truss Members

- Splits
- Breaks
- Rot
- High Moisture Content

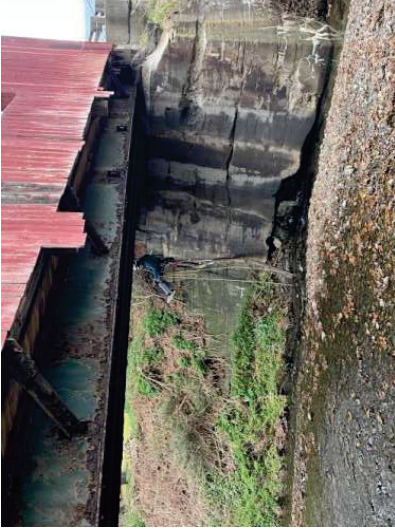
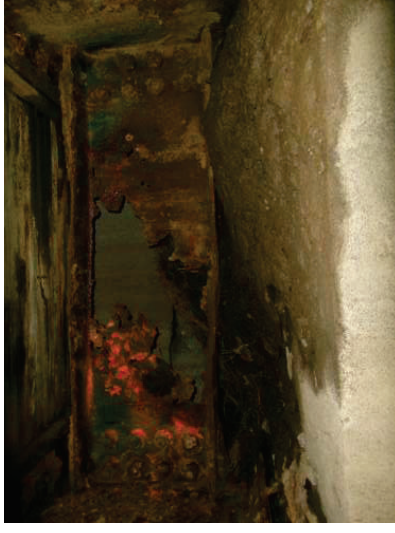
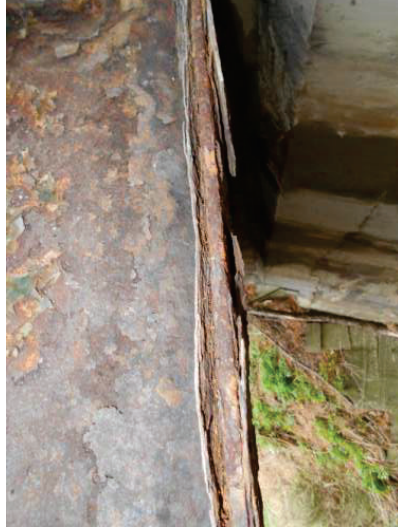
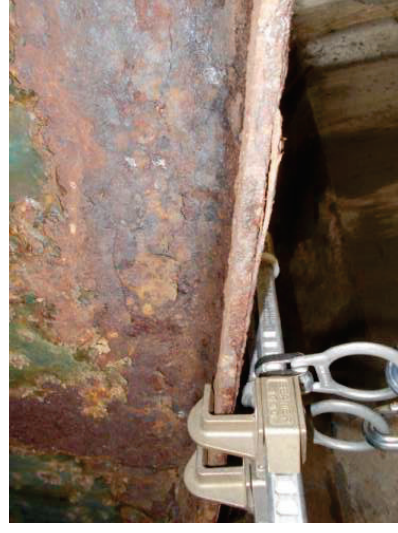
# Steel Beams

- Rust Holes
- Advanced Corrosion

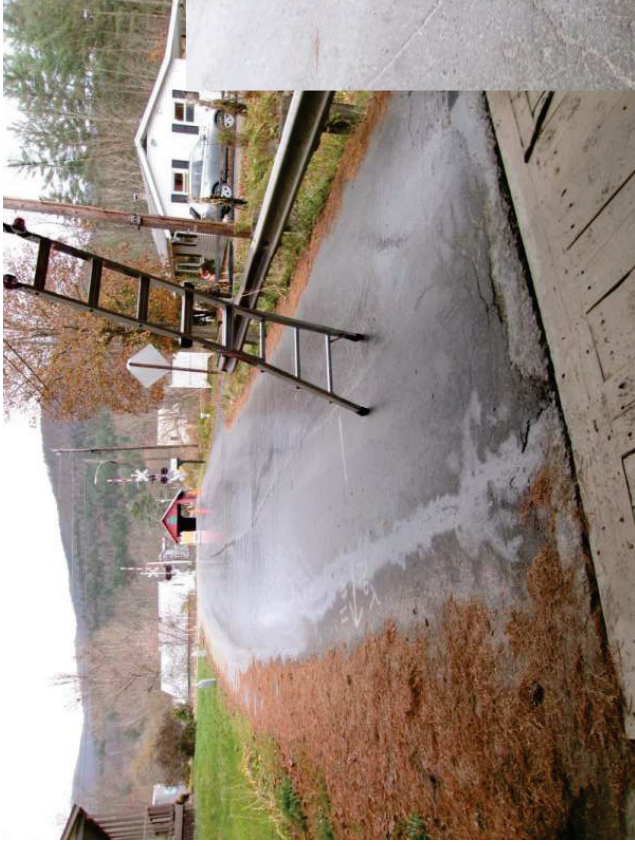
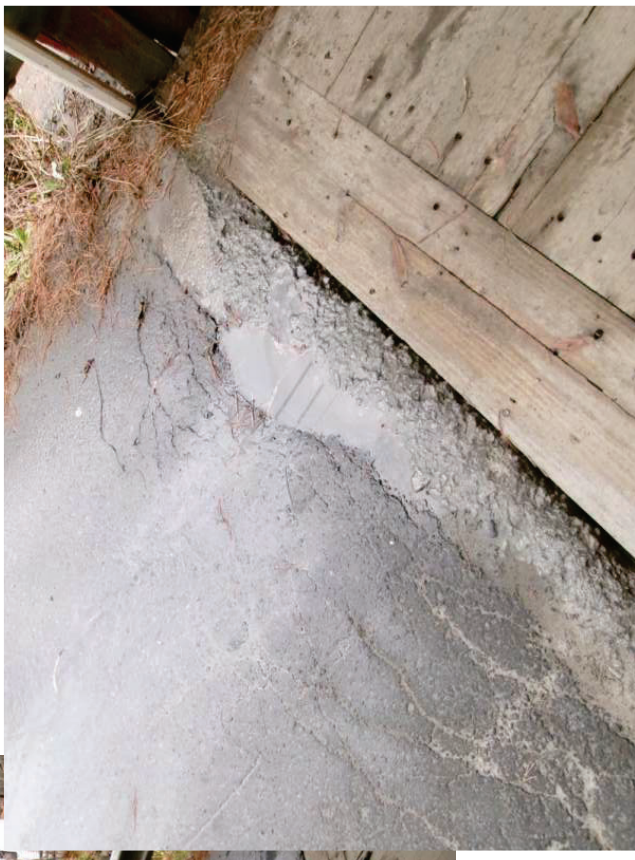
# Approaches

- Drainage Issues
- Ponding

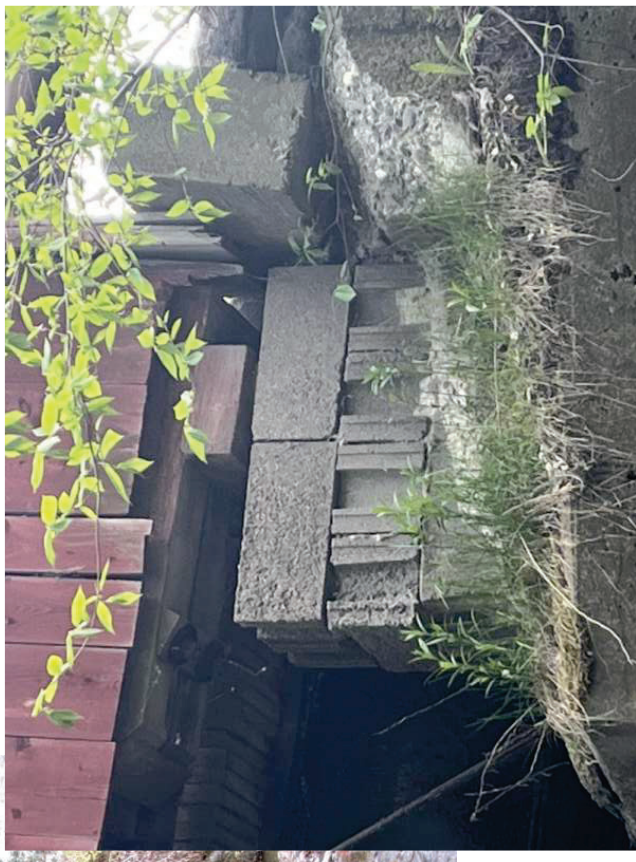
# Abutments

- Voids
- Spalling
- Exposed Rebar
- CMU Truss Bearings

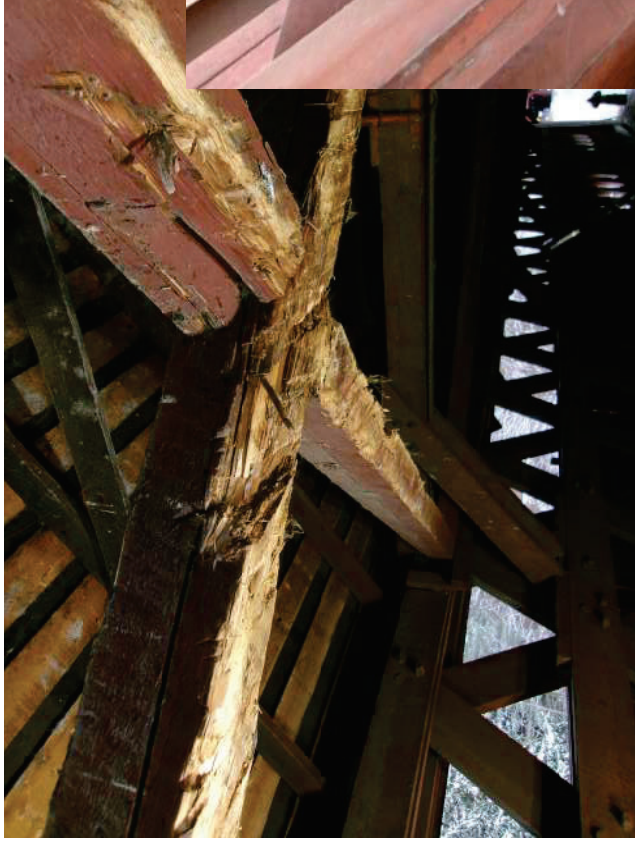
# Upper Bracing Members

- Splits
- Breaks
- Rot
- Impact Damage
