# Draft Scoping Report Northfield Falls Covered Bridge Town Highway 3 Bridge 15 over Dog River

Northfield BO CVBR(9)

**January 24, 2026**

Prepared for:  
Vermont Agency of Transportation

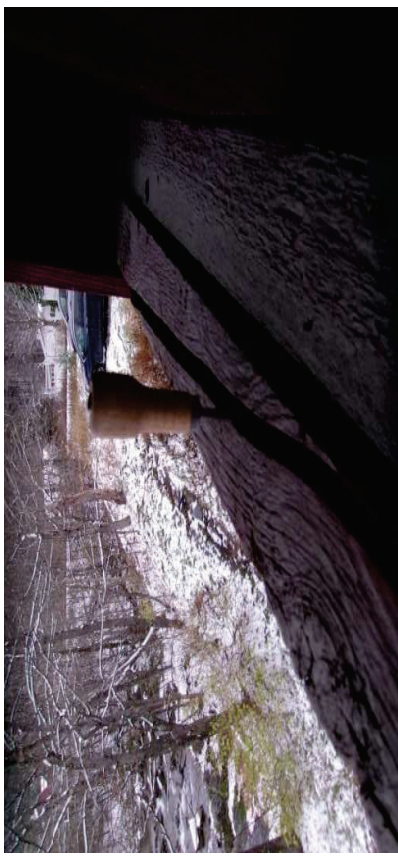
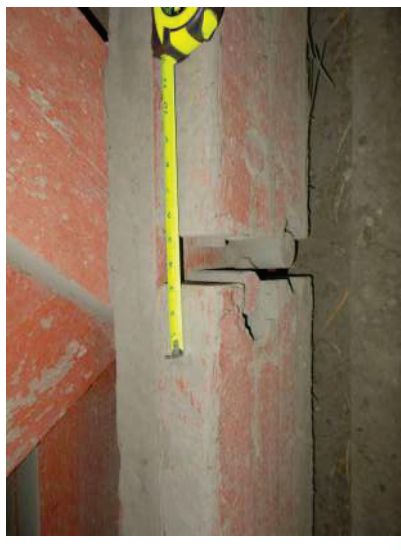
# Truss Members

- Splits
- Breaks
- Rot
- Misalignment
- High Moisture Content

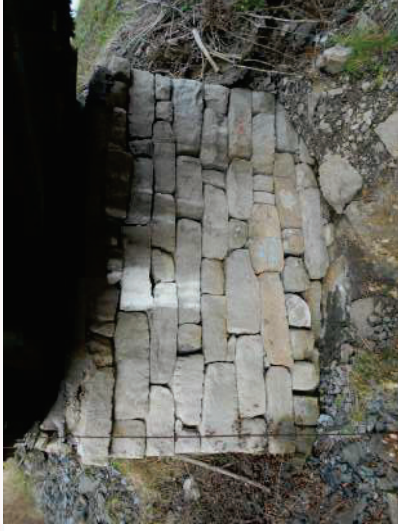
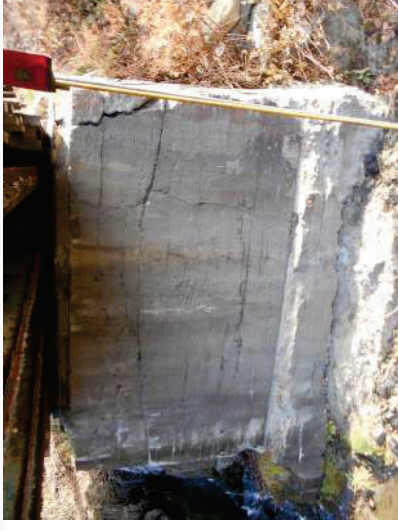
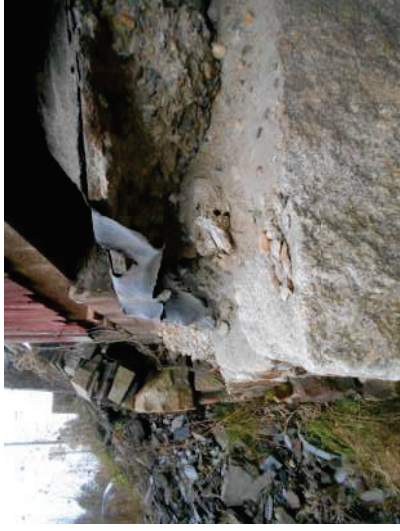
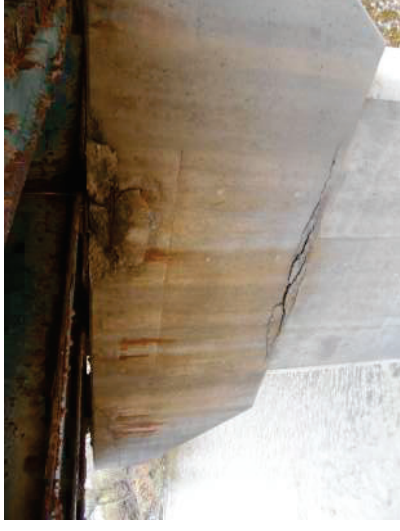
# Substructure

- Voids
- Spalling
- Exposed Rebar

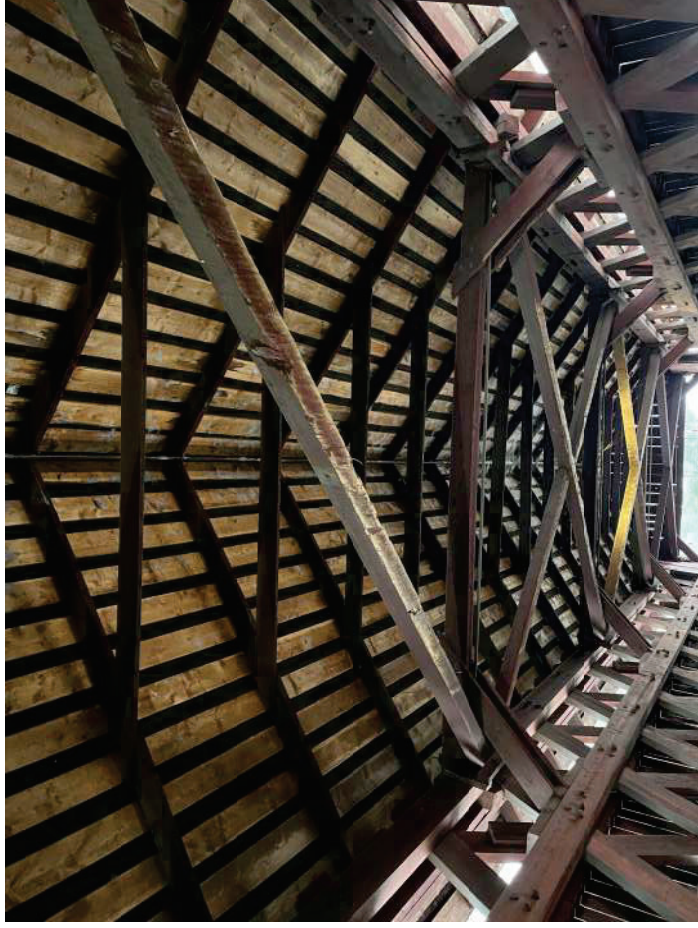
# Recommended Work: Lat. Bracing Members

- Existing
  - 6"x6" Upper Diagonal Braces, Eastern Spruce
  - 2"x8" Knee Braces, Eastern Spruce

- 1 Crossbeam (11%) to be **Replaced** due to Condition (PTN 2)
- All Braces to be **Replaced** due to Condition (PTN 2)
