**STATE OF VERMONT  
AGENCY OF TRANSPORTATION**

**Scoping Report**

**Wallingford BF 0133(18)**

**VT-155, Bridge 15 over The Mill River**

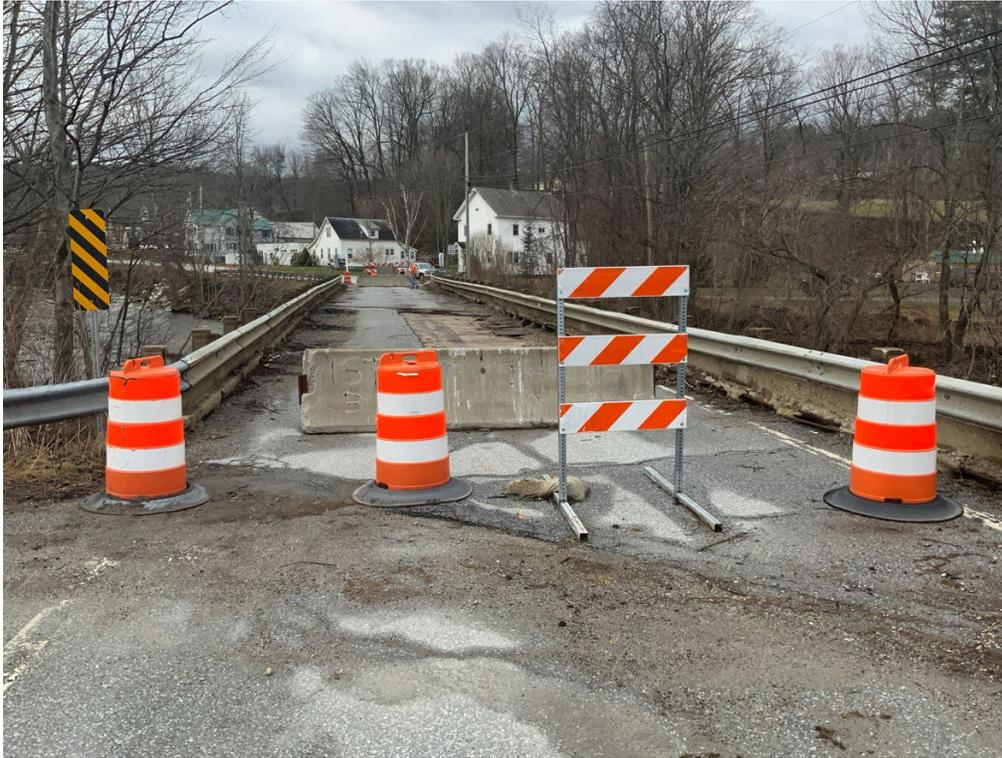
Looking south from 103 intersection

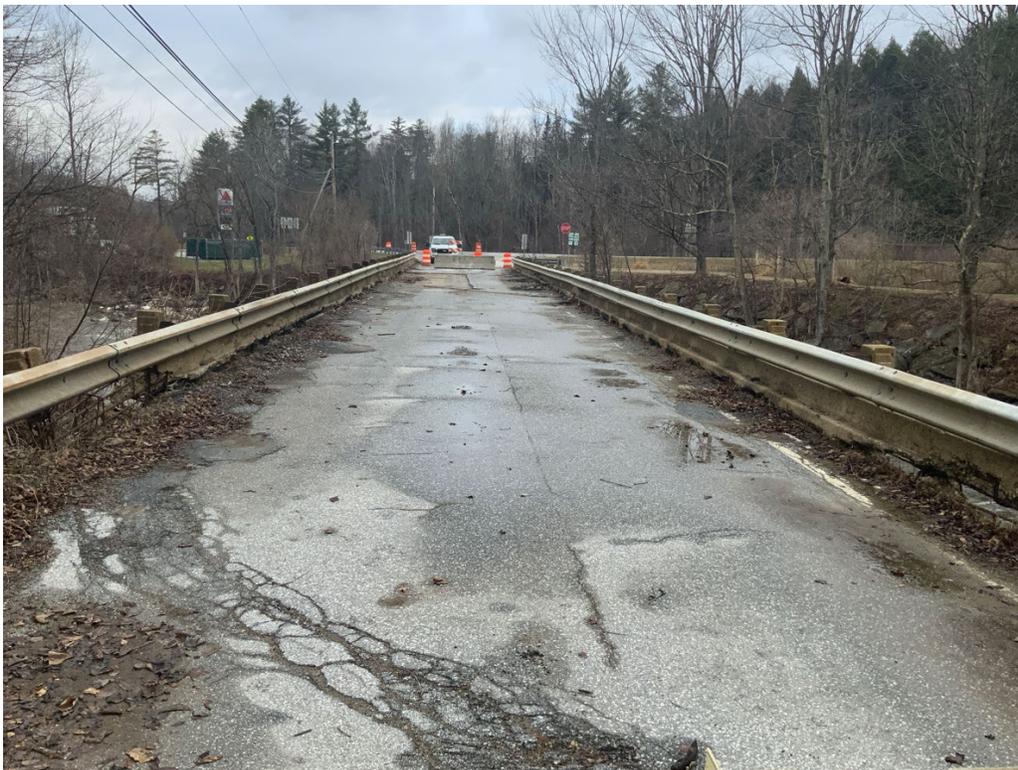
Looking north toward 103 intersection

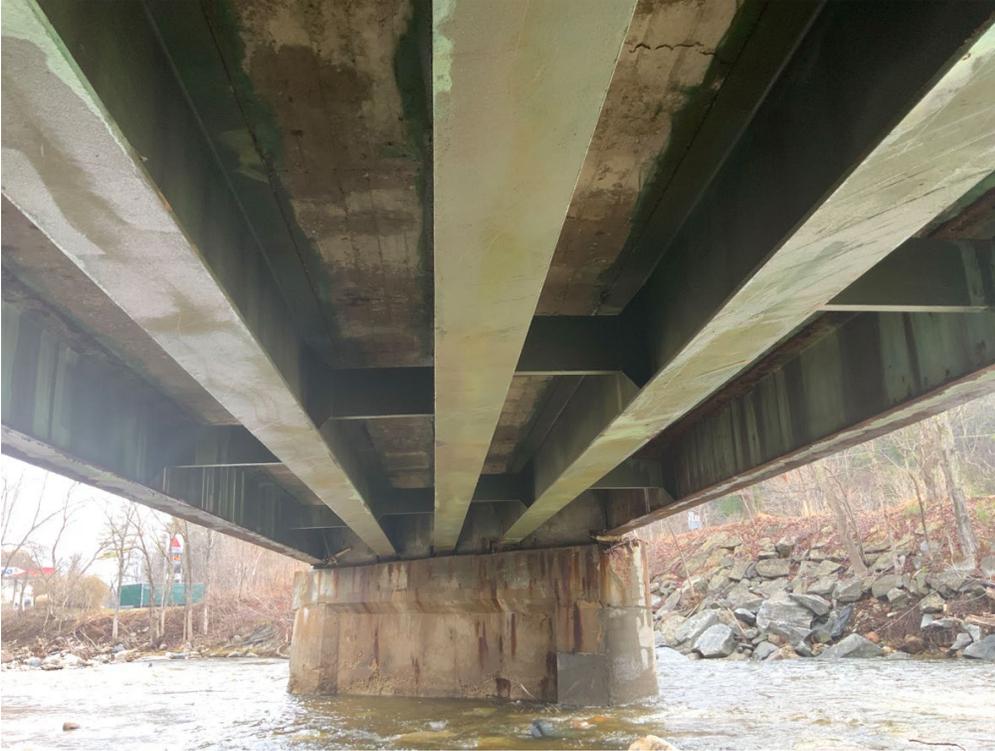
Span 1

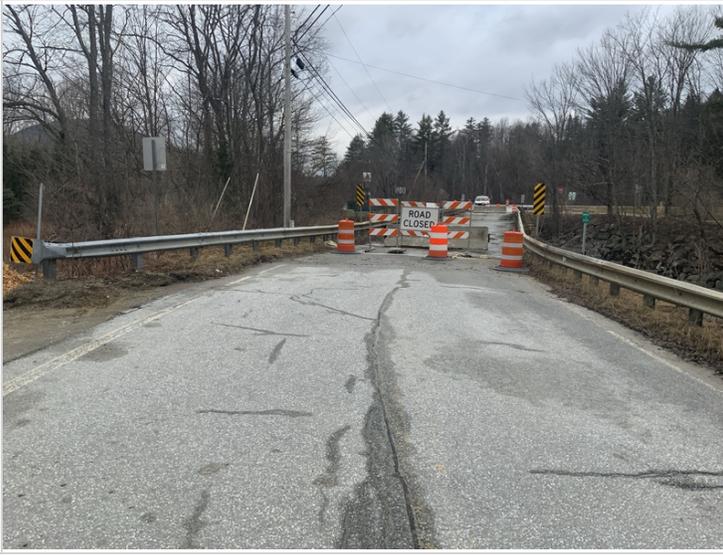
Abutment 1 approach

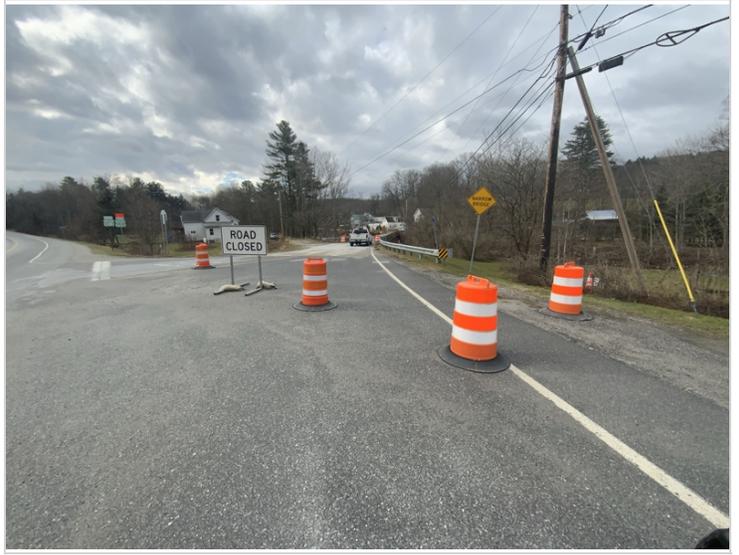
Abutment 2 approach

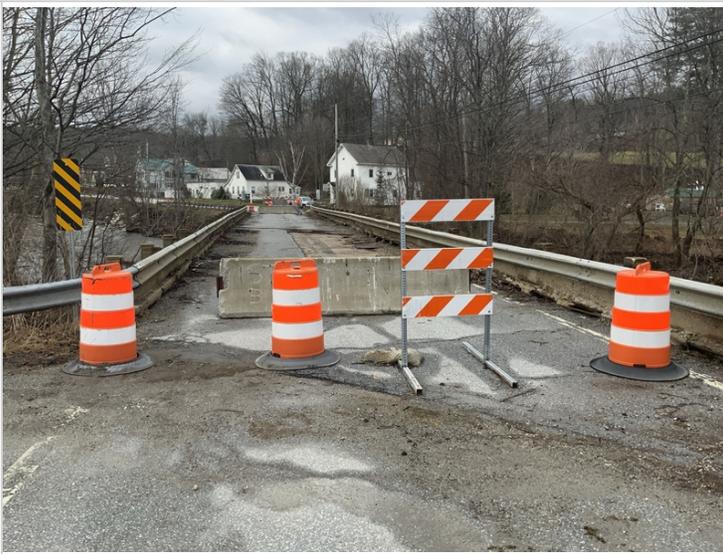
1. The bridge was closed to vehicle traffic on January 9th of 2023 due to deck failure.
  - a. The deck is in overall poor condition. A 3.5' x 2.5' hole has formed in span 2 along bay 1. Deteriorated concrete is possible for further full depth holes in the future. The condition along the curb line is poor with heavy breakup and past patching repairs. The deck curb and drain both have heavy spalling and exposed rebar.

Bridge closed

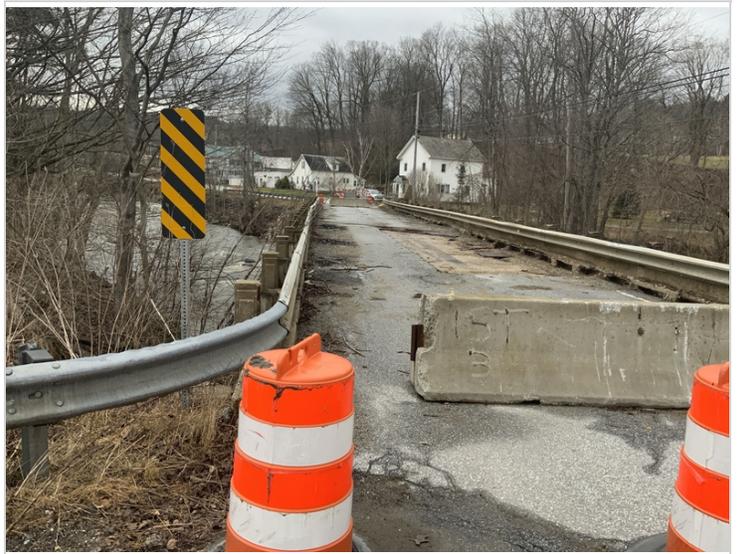
Upstream rail

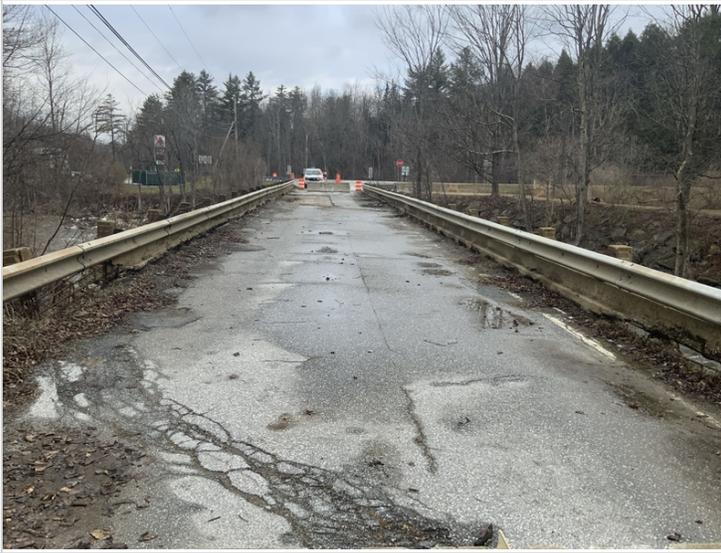
Wearing surface and deck

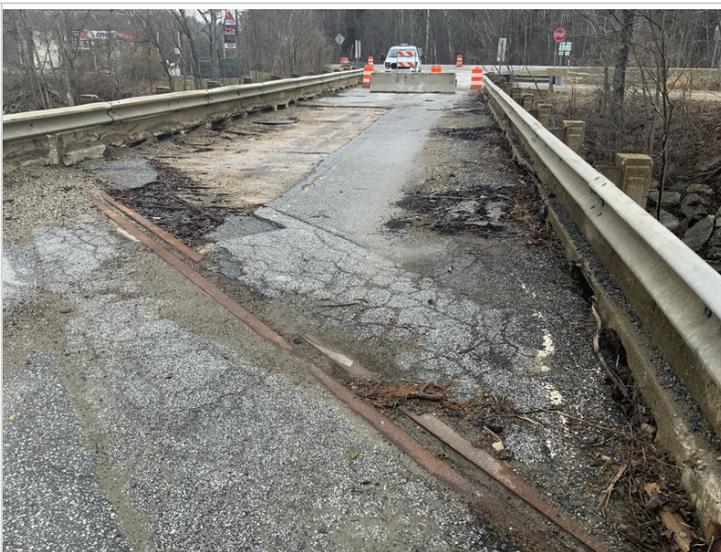
- b. The bridge joint compression seal and still armor have a couple of areas where steel has broken out.
  - c. The stringers have section loss at exterior beam ends and at the pier.

Joint over pier and deck span 2

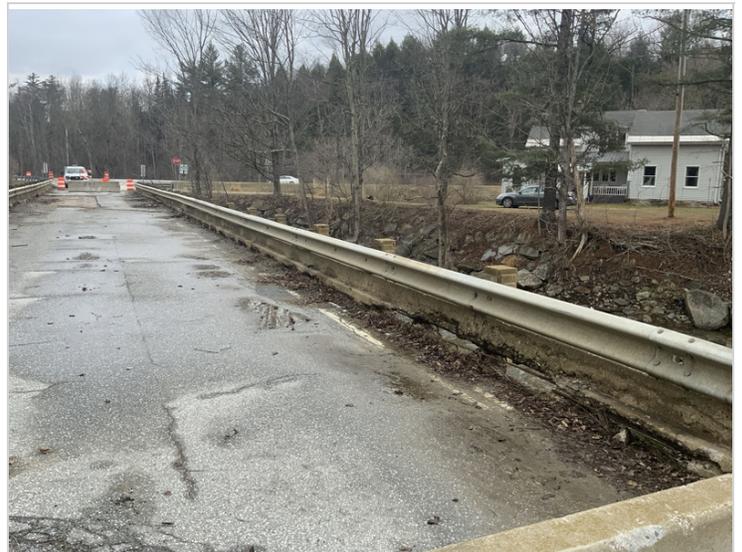
Upstream rail

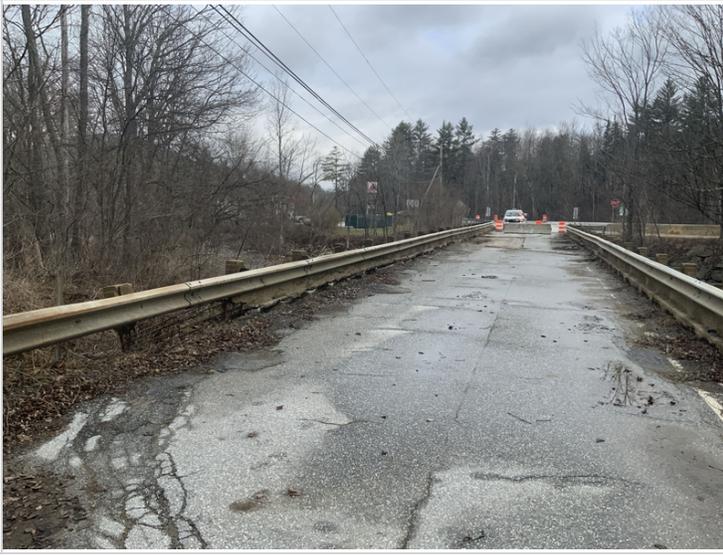
Down stream rail

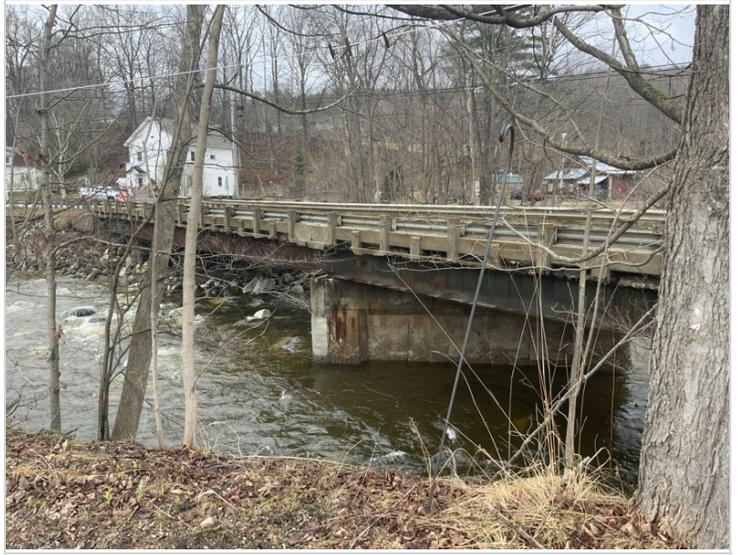
Upstream fascia

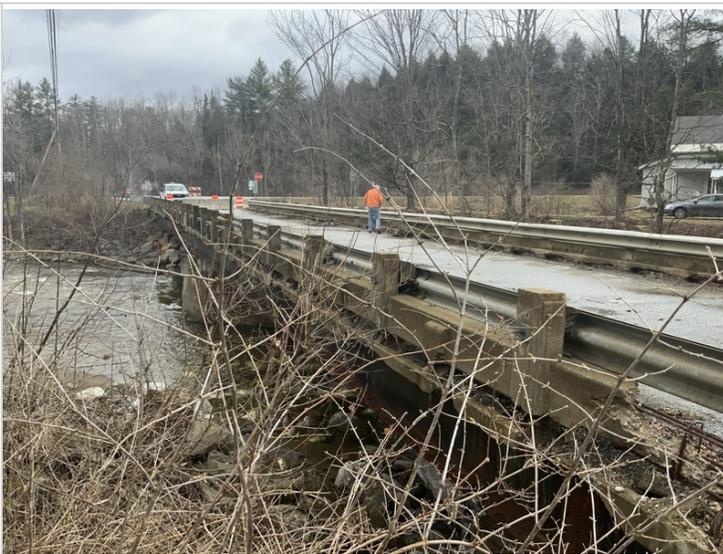
Down stream fascia

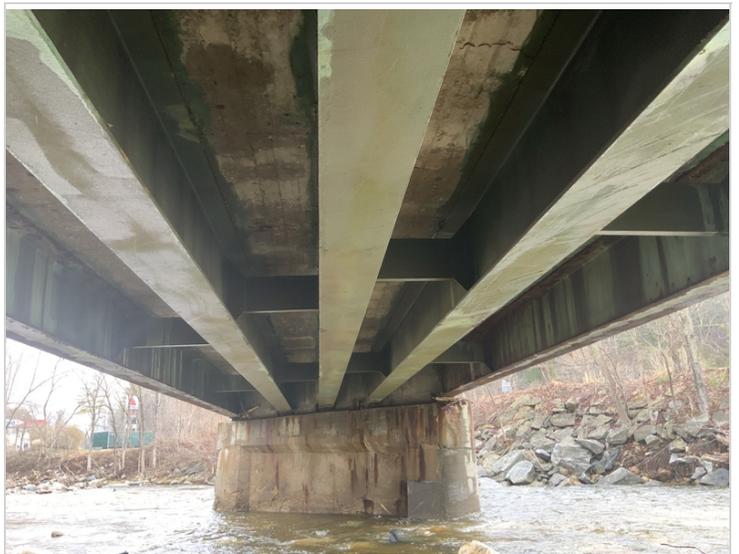
Span 1

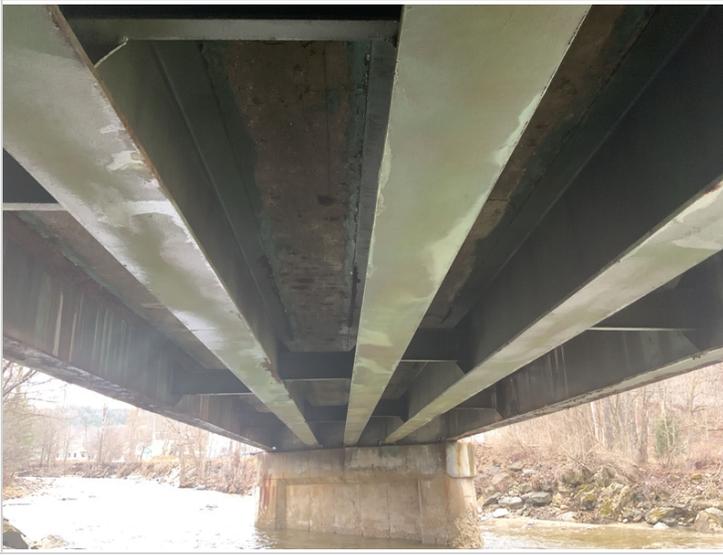
Span 2

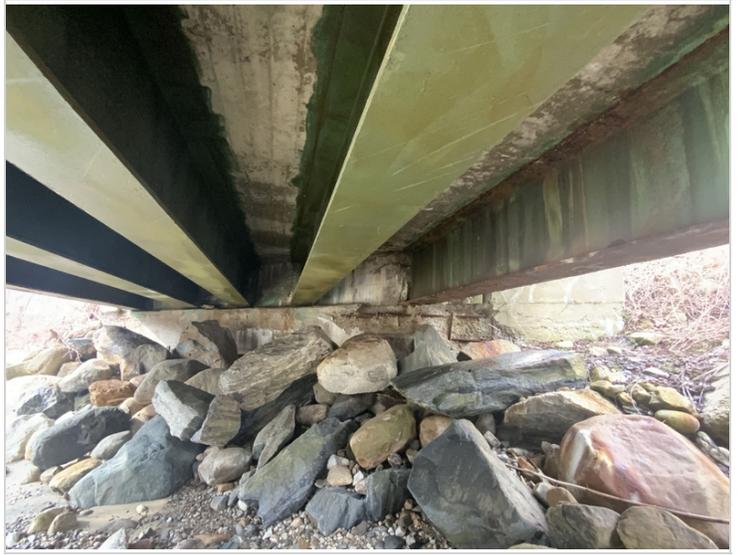
Abutment 1

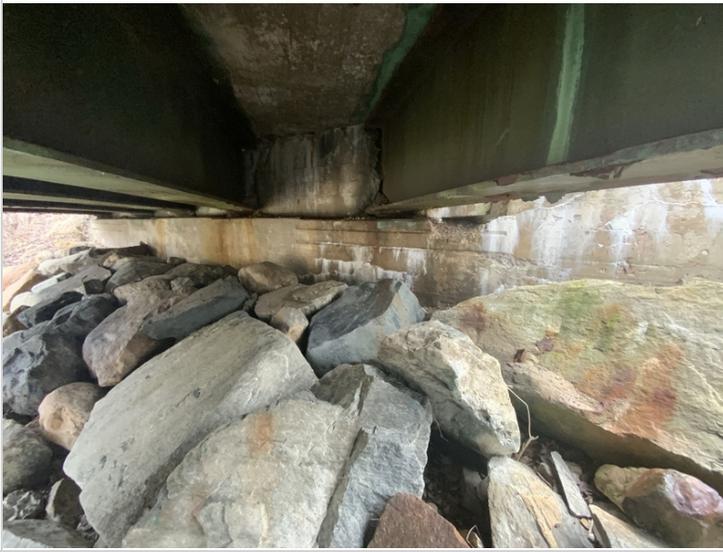
Abutment 2

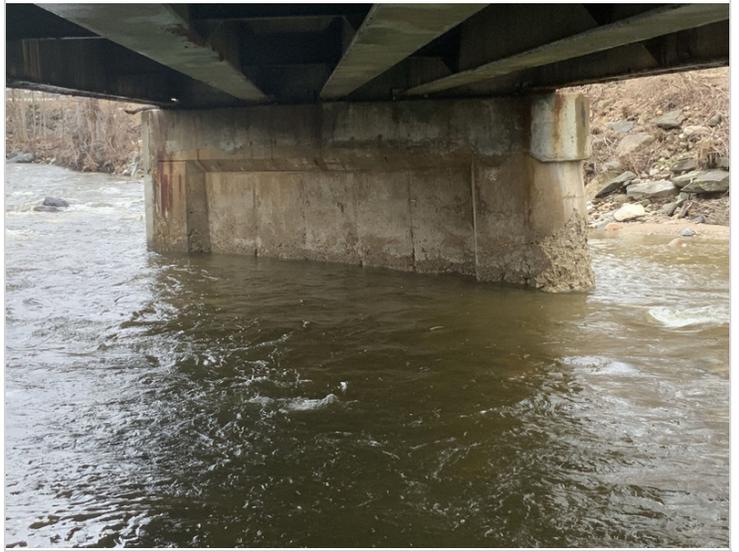
04/15/2024 - Since last inspection pier looks to have settled and most likely done during July 2023 flooding event. Structure is in poor condition due to deck failure and is closed. Heavy deterioration along curb line, deck has been patched numerous times and heavy debris from past patching material along curb line. Heavy scaling along abutment ends and bearing at beam 5 along pier upstream is undermined approx. 50% and should be fixed again. Structure needs extensive recon or replacement. (MK)

Pier from abutment 2

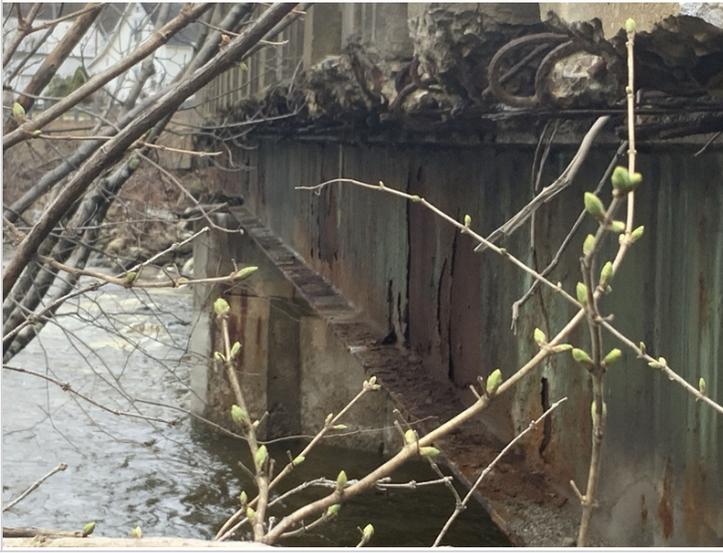
Upstream side of pier

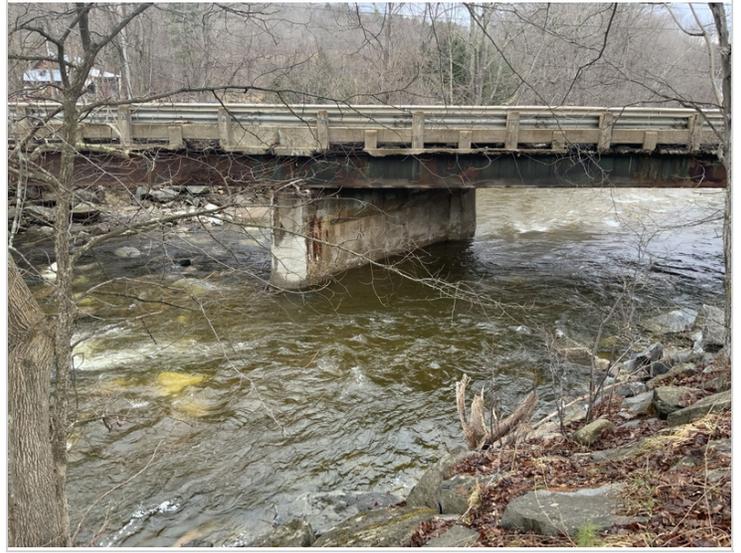
Upstream side of pier

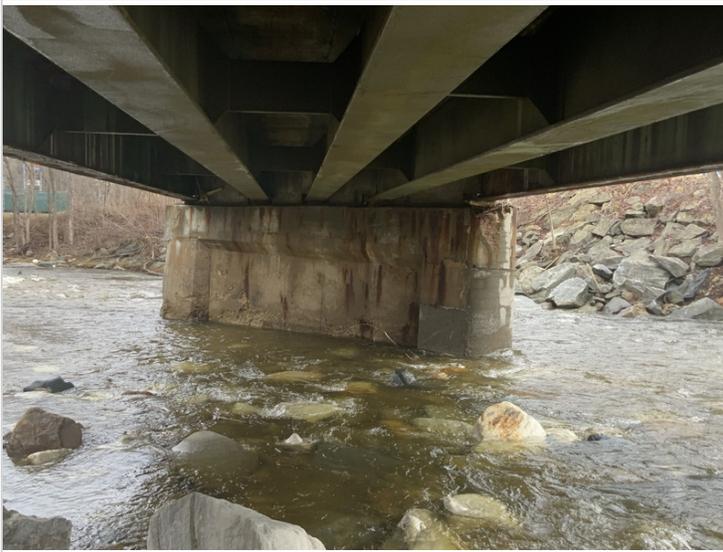
West side of pier

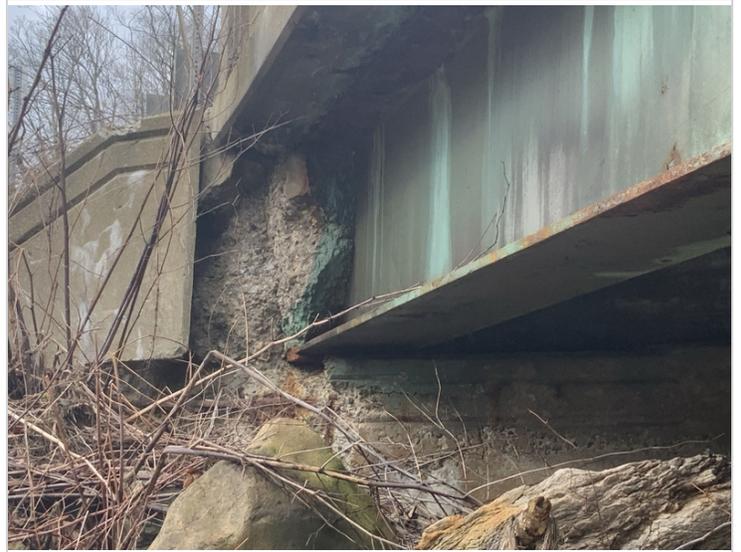
- d. The substructure is in poor condition. Abutment 1 has cracking and leakage with heavy deterioration and exposed rebar along the southwest corner. Abutment 2 also has cracking and staining, as well as heavy end deterioration along the northwest corner. Beam 5 seating area has been repaired multiple times and keeps popping off. The bearing area is undermined 50%.

Loss of bearing area beam 5 abutment 1

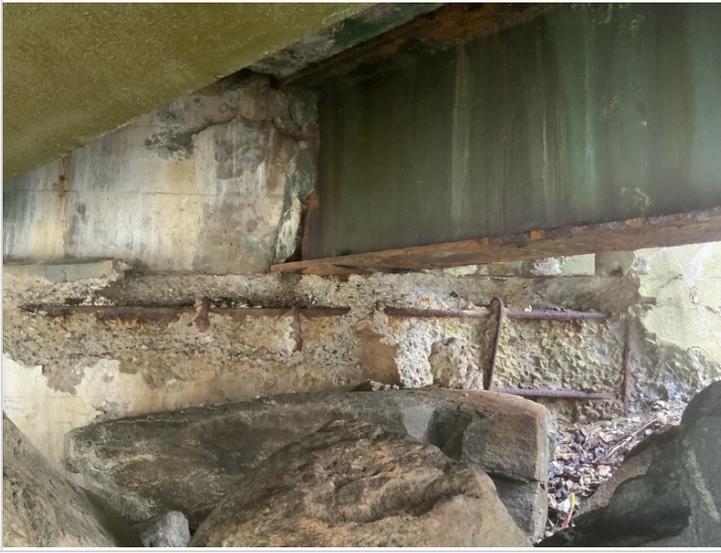
Loss of bearing area beam 1 abutment 1

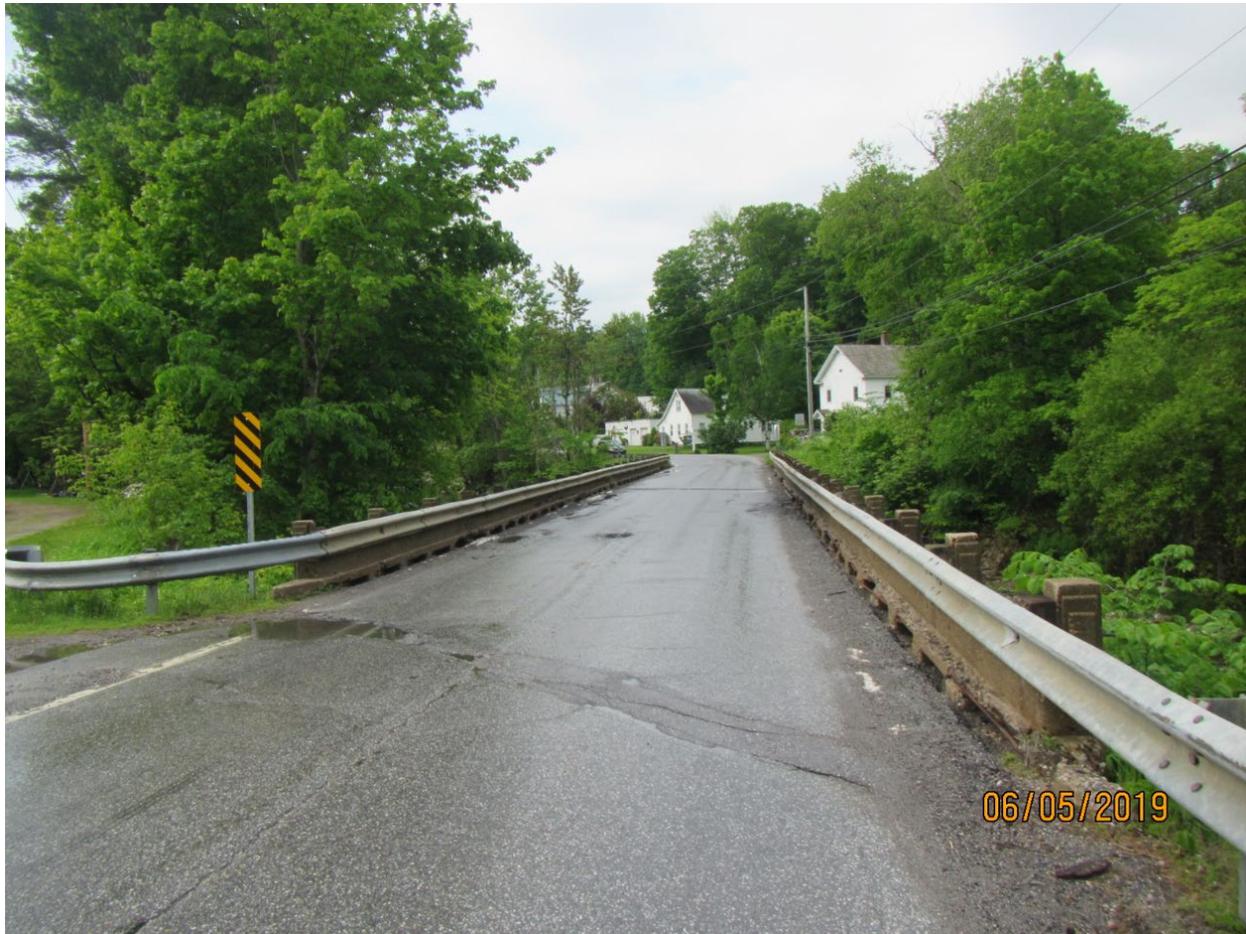
**Figure 3.1:** *Facing South on VT Route 115; overhead utilities parallel bridge and crossing south of abutment. [Inspection photo dated 2019]*

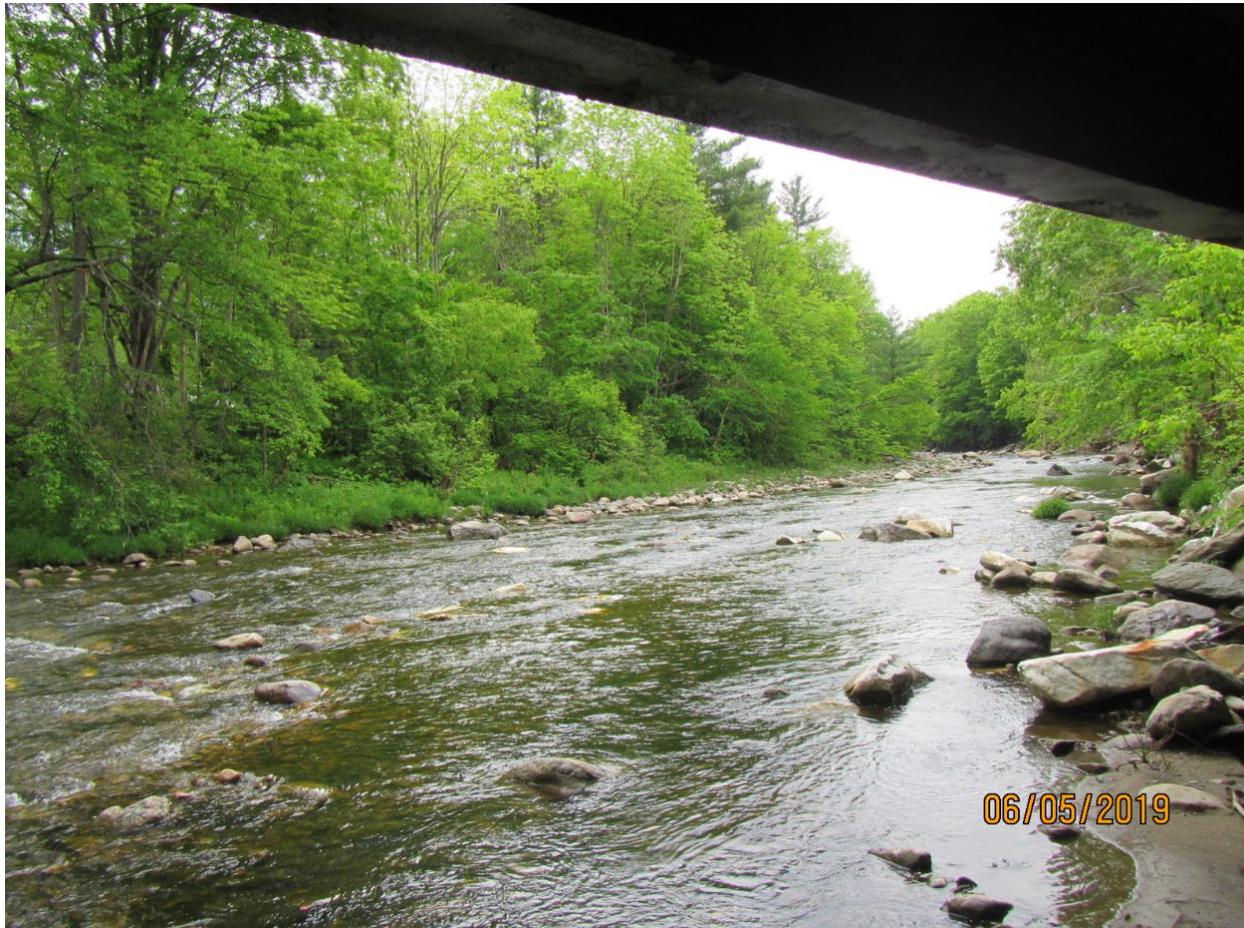
**Figure 3.2:** Facing South; note boulders and cobbles in riverbed. [Inspection photo dated 2019]

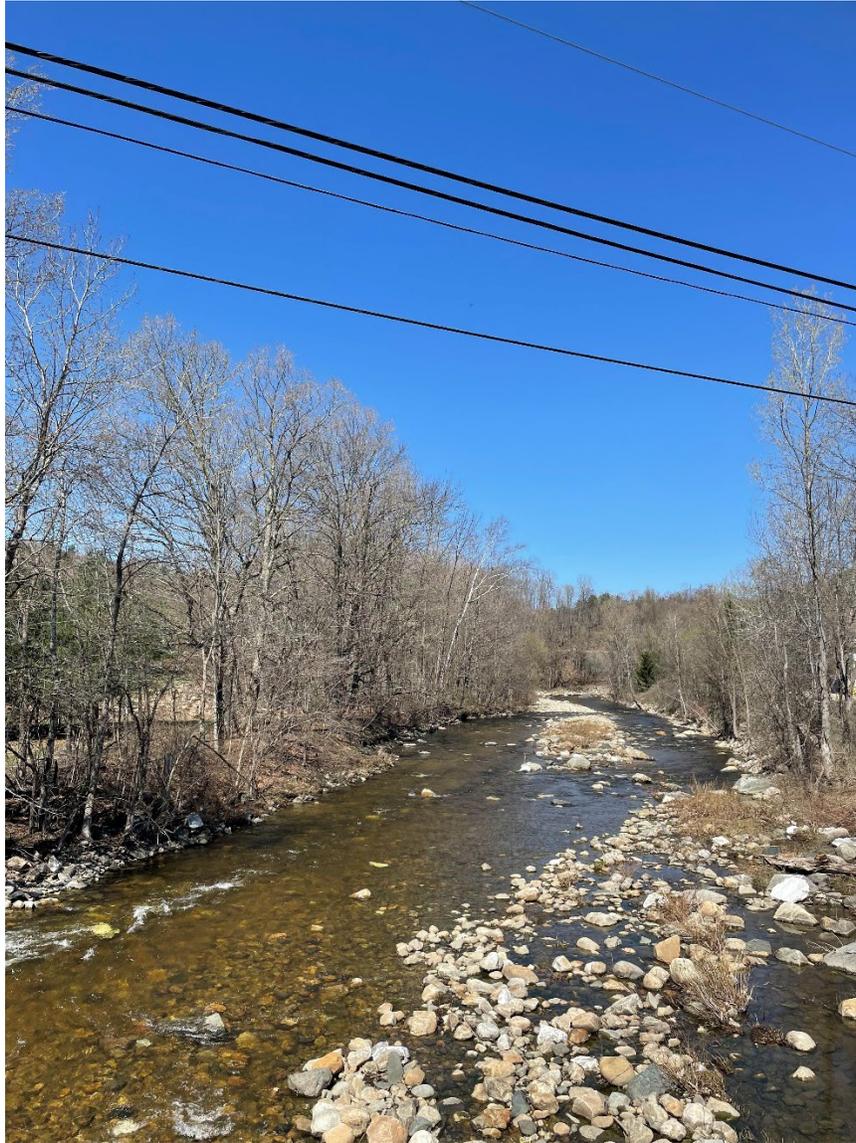
Figure 1: Picture from the top of the bridge facing east

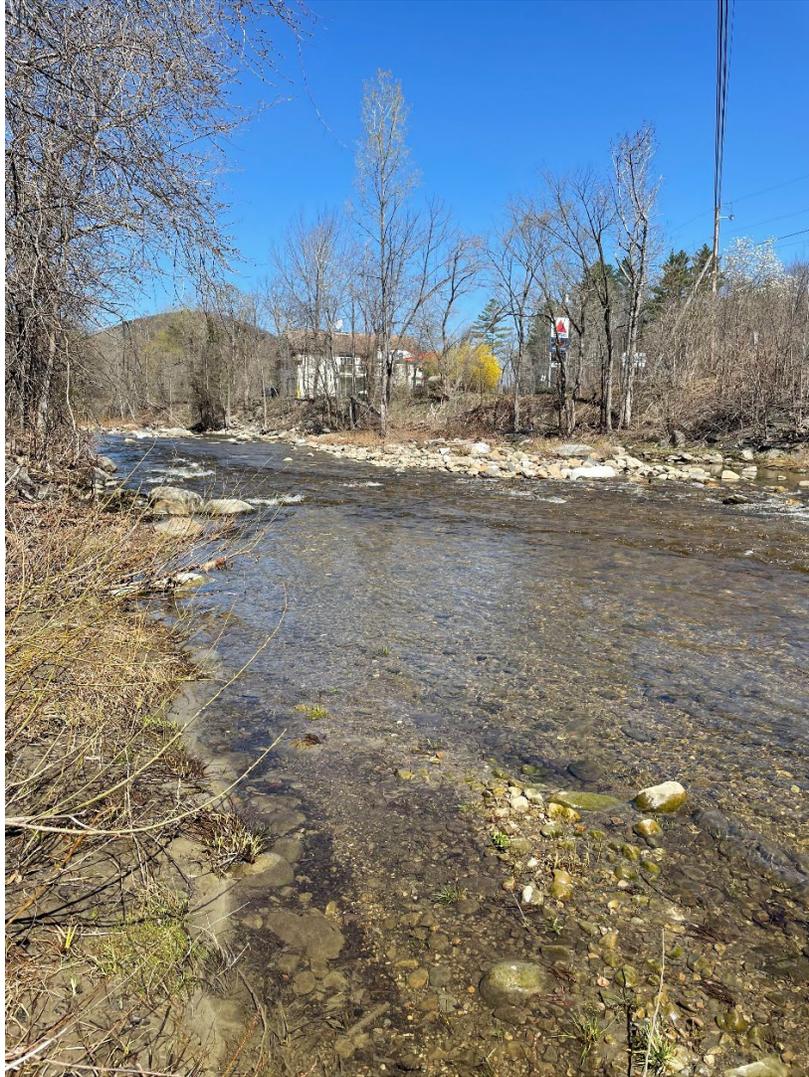
Figure 2: Picture from the side of the bridge, facing west

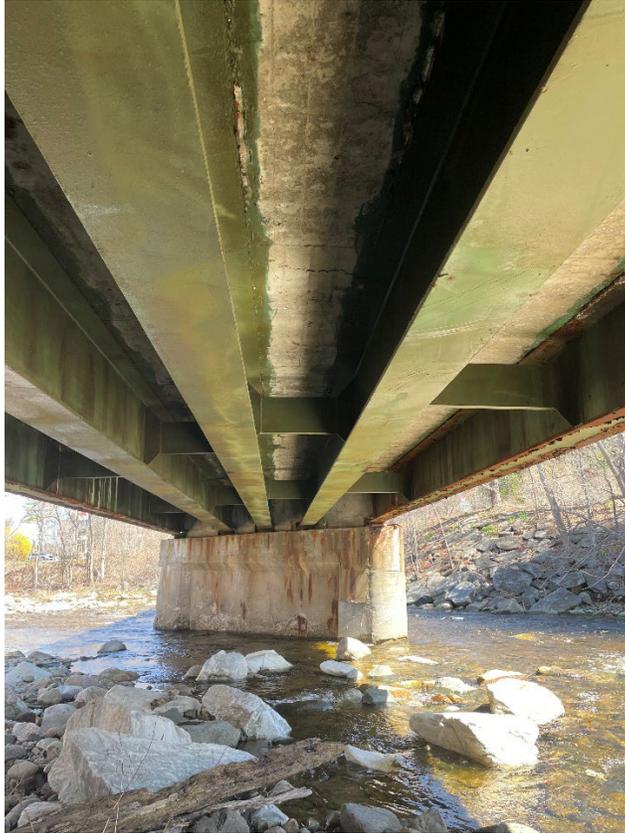
Figure 3: Picture under the bridge, facing north

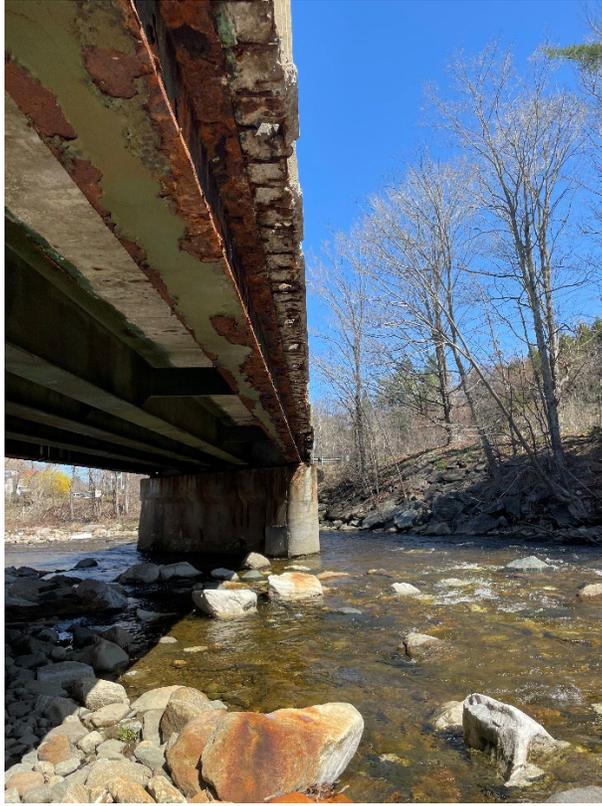
Figure 4: Picture of the northeast side of the bridge
