STATE OF VERMONT
AGENCY OF TRANSPORTATION

Scoping Report

FOR
**STATEWIDE NORTHWEST STP CULV(90):
ESSEX VT289 BR #17-A**

VT ROUTE 289, BRIDGE 17-A OVER UNNAMED BROOK

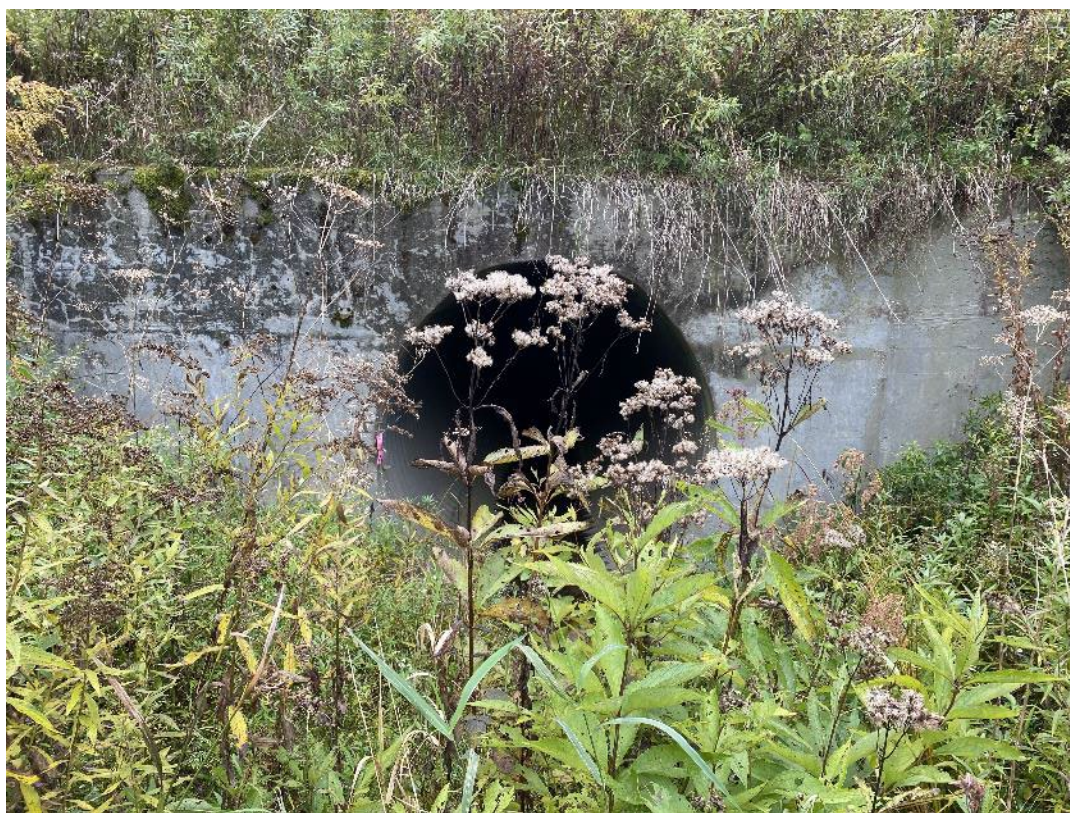
Structure inlet (Hydraulics/Scoping site visit photo 10/10/2022)

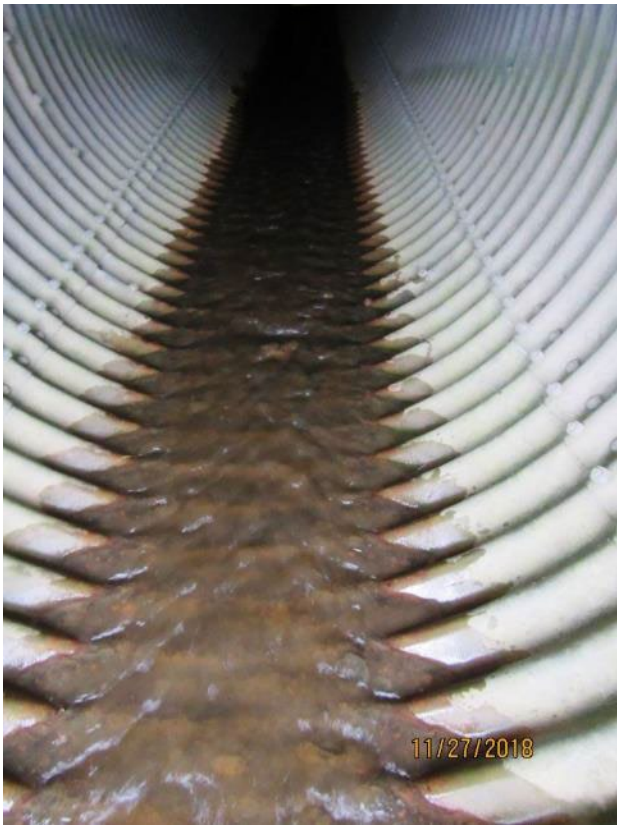
11/27/2018 Culvert barrel: along pipe invert has numerous holes anywhere from 1/2" to 6" in diameter mostly along the first third of the pipe, then more small holes forming from outside in, along haunch areas more near outlet third portion. Culvert Invert: rusted through in areas - shape of pipe is still good - no distortion to speak of. Pipe should be considered for a poured invert repair or sleeve repair. ~ MJ/SP

Barrel finding photo (Inspection photo 2018)

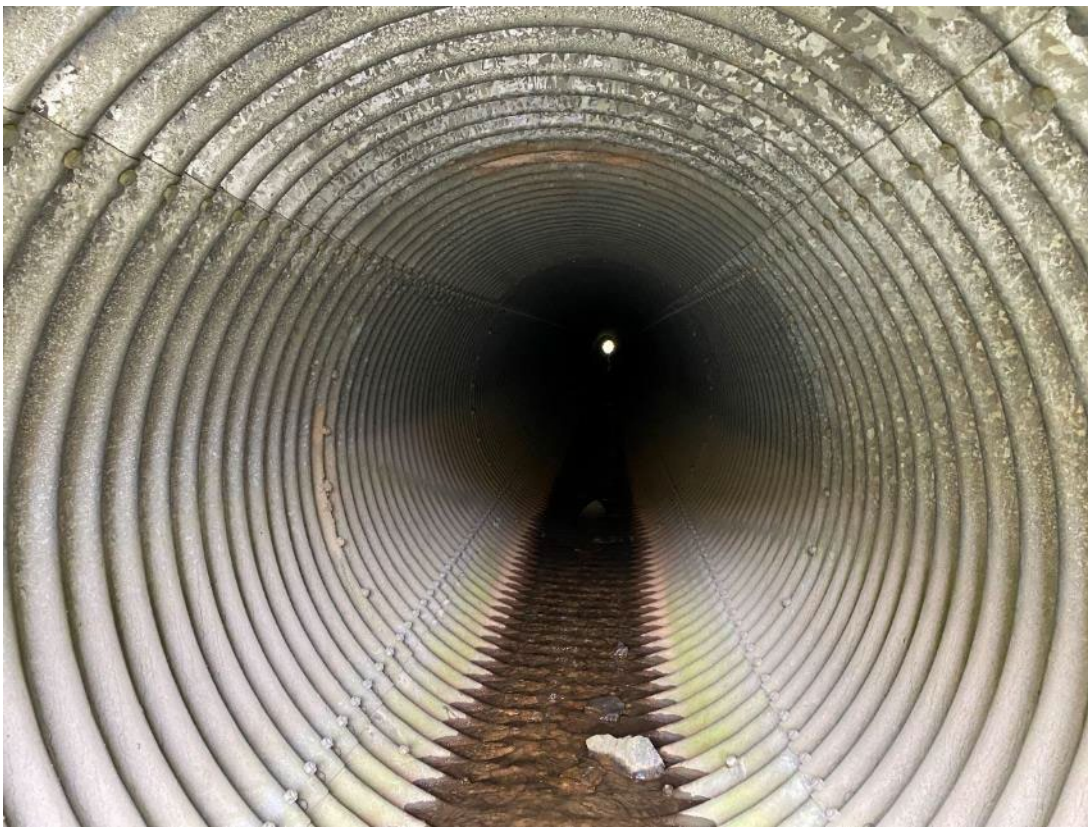
Culvert barrel (Hydraulics/Scoping site visit photo 10/10/2022)

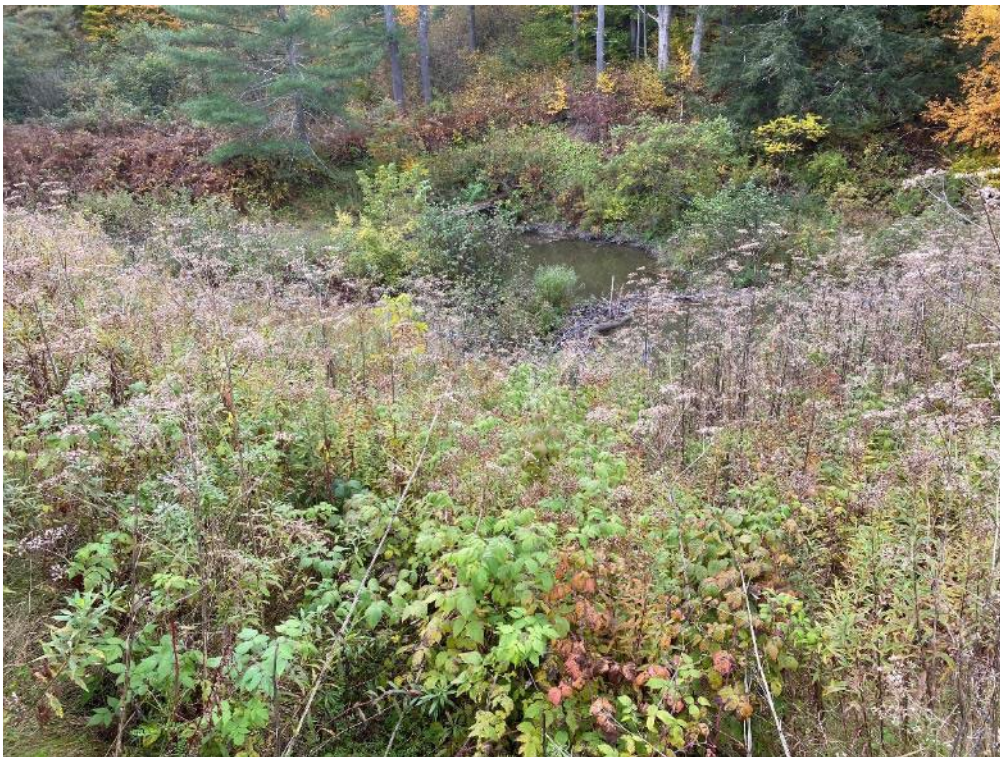
Downstream view (Hydraulics/Scoping site visit photo 10/10/2022)

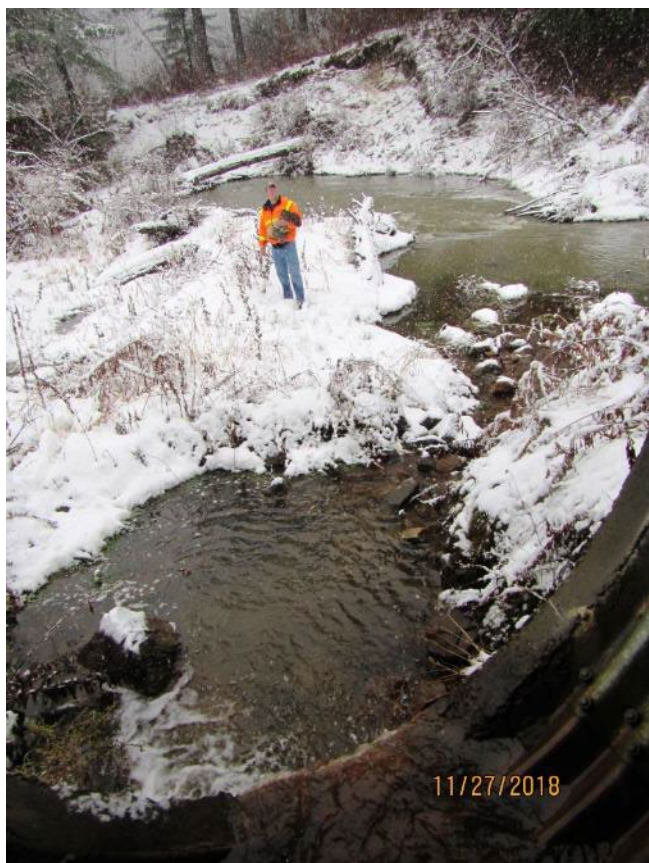
Downstream view from inside structure (Inspection photo 2018)

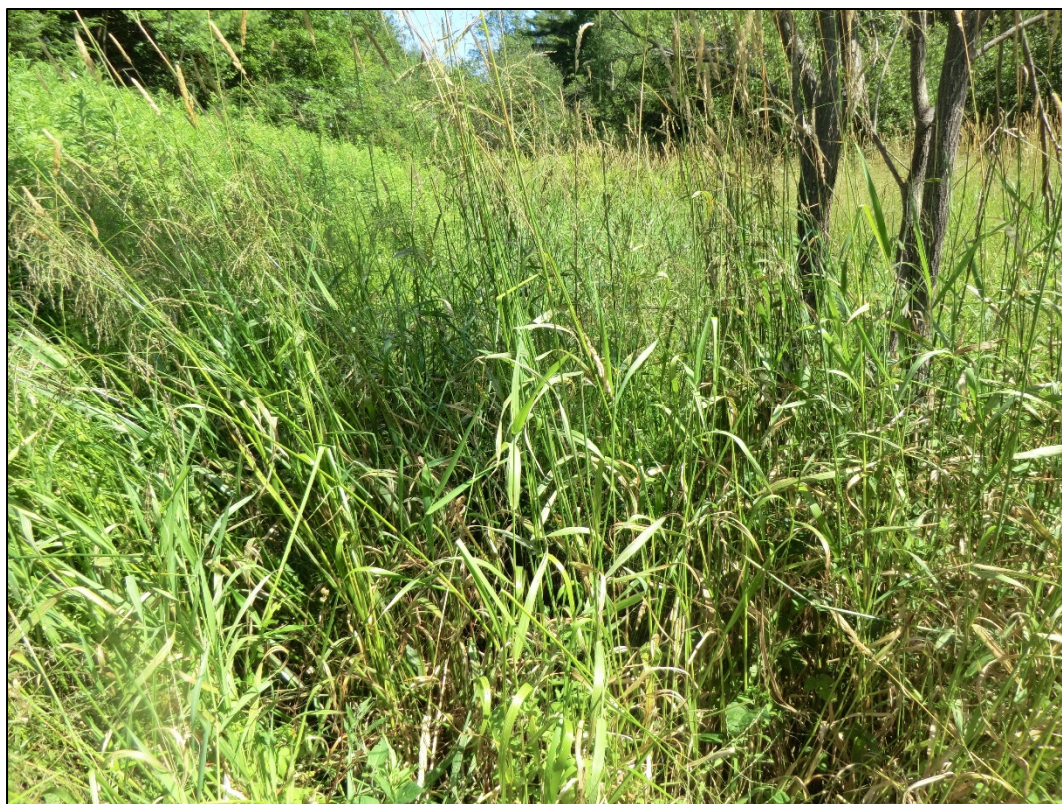
The wetland above the culvert inlet was dominated by Reed Canary Grass and an obligate wetland grass, *Glyceria striata* (Fowl Manna Grass) as shown in Figure 4. The wetland is Palustrine, dominantly Emergent, non-persistent wetland and is seasonally flooded (PEM2C). A small amount of *Salix bebbiana* (Bebb's Willow) was present in the upper layer of vegetation. Although the wetland area in the study area was less than 0.04 acres (page 3 of Appendix D), the wetland continues out of the study area to the north and appears to connect into a Class II wetland on the VSWI Class layer.

Figure 4. VT Route 289 BR 17 A wetland above culvert.

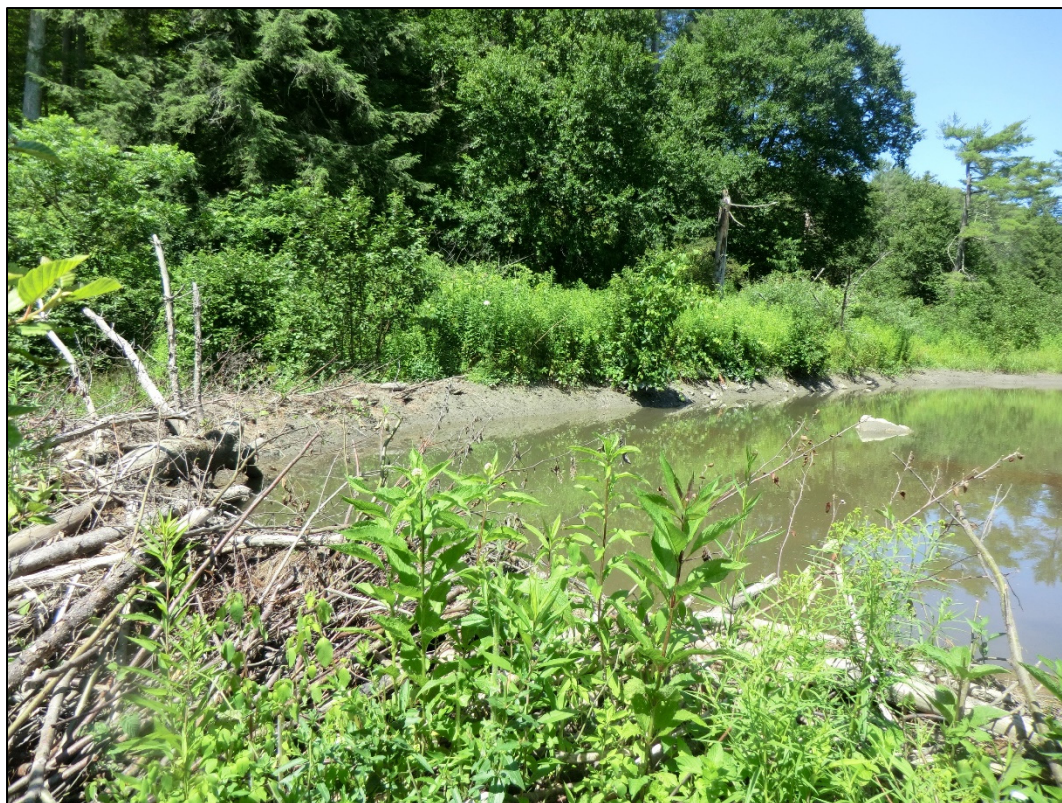
Figure 5. VT 289 BR 17A Beaver Influenced Wetland

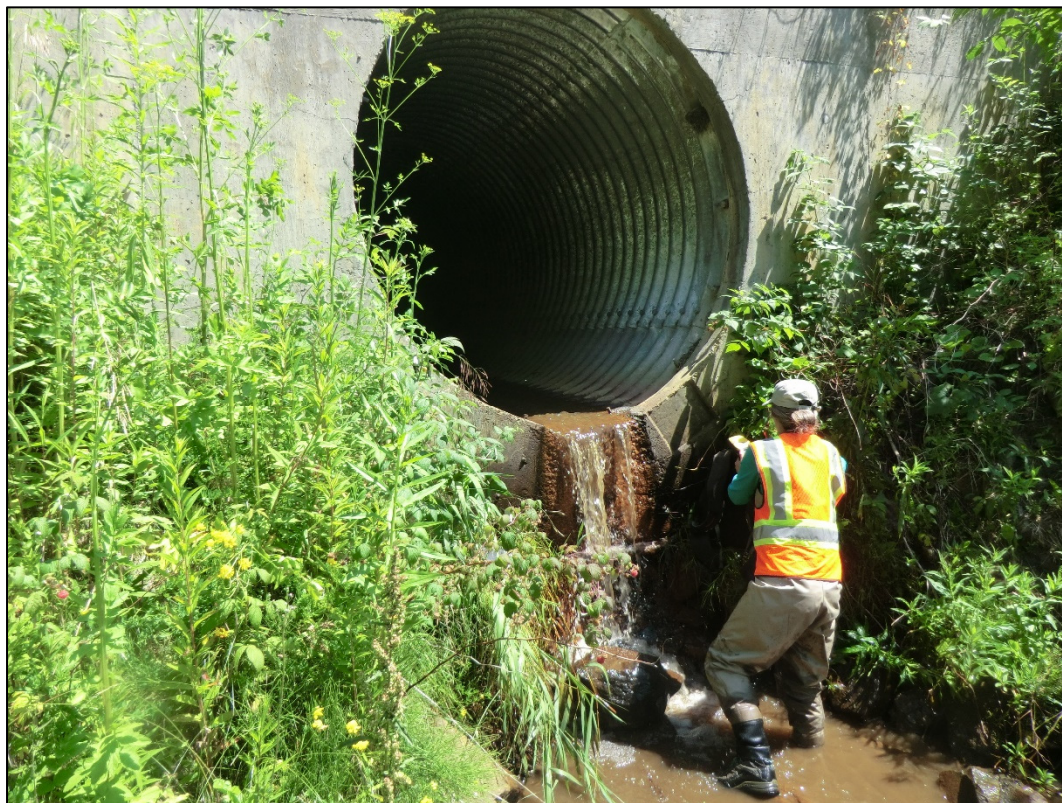
The Route 289 BR 17A culvert is greater than 500 feet in length and is a 7.1 ft high 6.6 ft high CMP. The outlet of the culvert is free fall (Figure 6) with a scour pool below the structure. At the time of the wetland delineation on July 15, 2022 there was very little water flowing through the structure; however, given the abnormally dry conditions at the time of the survey, it is likely the stream is perennial. Based on StreamStats, the drainage area at the culvert outlet of the unnamed Tributary to Alder Brook is 0.28 square miles.

Given the short distance from the outlet structure to Alder Brook (Figure 7) and the outlet drop of greater than a couple of feet, it would not be possible to retrofit the culvert for AOP. In addition, baffles would likely be needed throughout the 500-foot structure to address the velocity barrier.

Figure 6. VT Route 289 BR 17 A Culvert Outlet

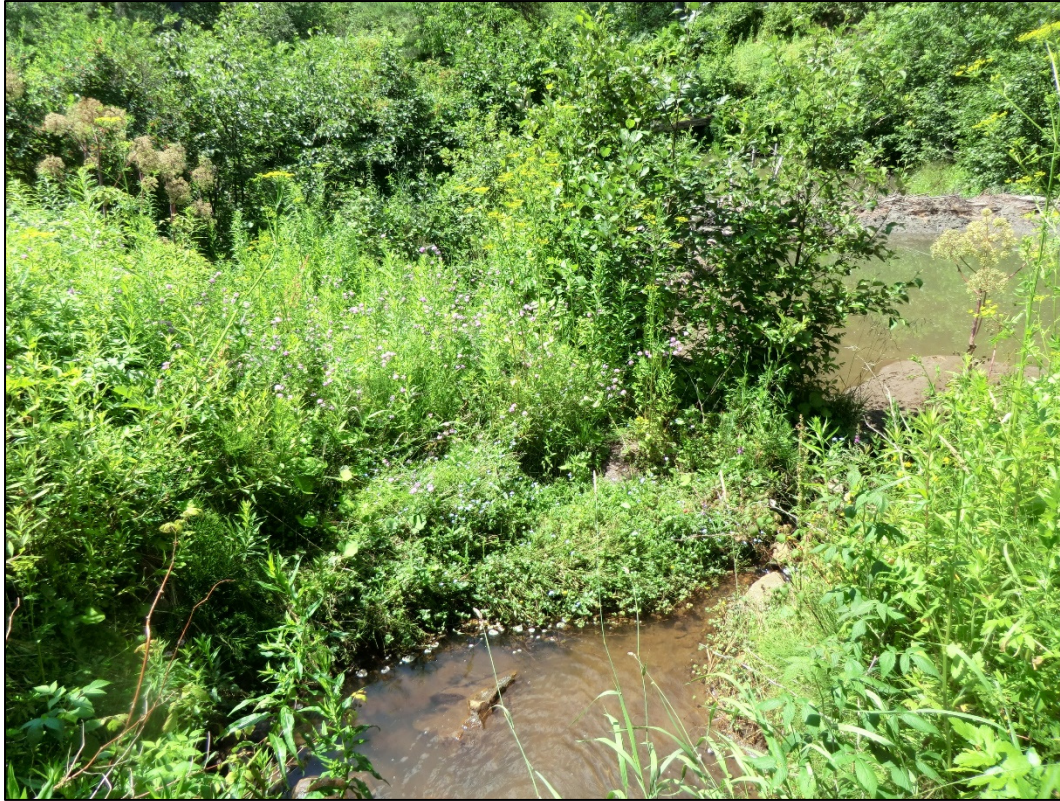
Figure 7. Unnamed Tributary to Alder Brook downstream of VT 289 Culvert
